S-21 Apparels Ltd. (11452)
Spencer Design Ltd (10074)
Fariha Accessories Int. Ltd.

Plot # 276, Narshingapur, Ashulia, Savar, Dhaka
(+23.92962N, 90.30895E)

31.MAY.2014

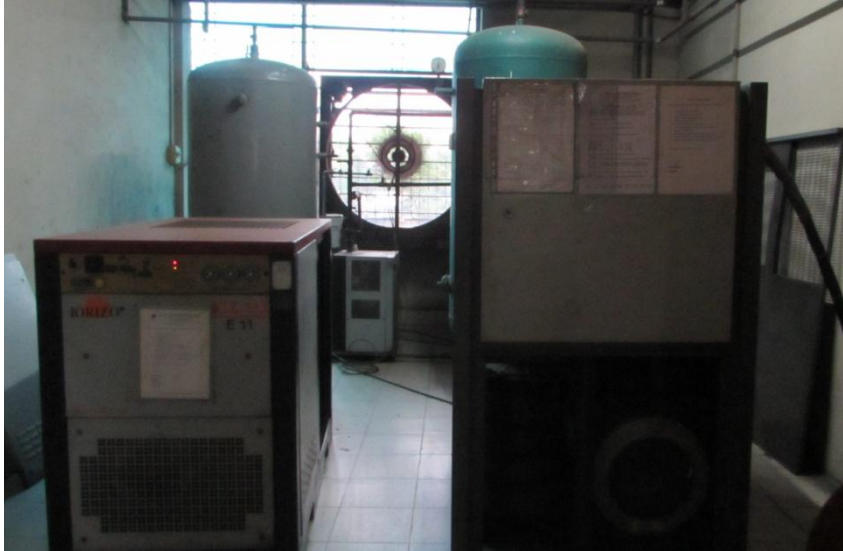
The machine in the Boiler & Compressor room doesn't have any information on its weight. The Client needs to review the weight of machines and to make sure that the floor loading does not exceed 3.0kPa (60psf). It is suggested that the boiler & compressor machine should be moved to the ground floor due to the vibrations they cause anyway.

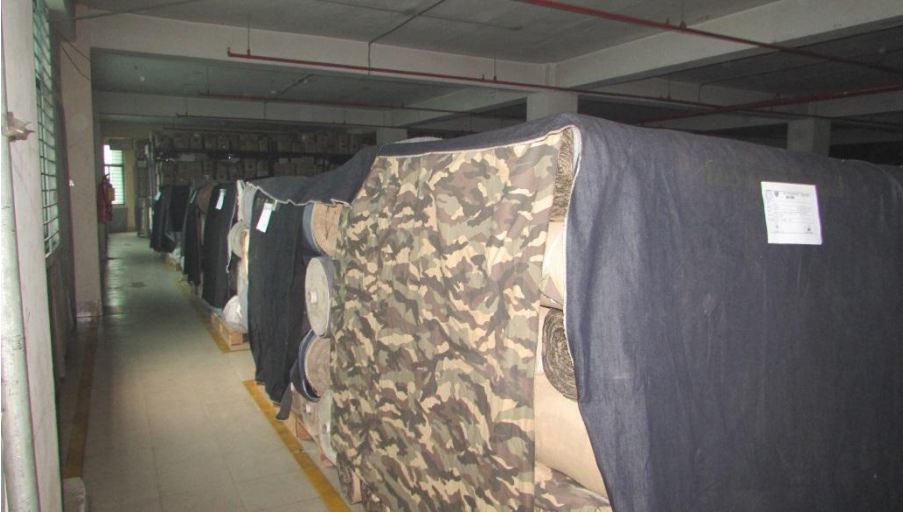
The fabric rolls on level 2 in the storage area is heavier than the design loading of 3.0 kPa (60psf). Each roll of fabric is estimated to be approximately 45 kg with 7 rolls per layer and a total of 7 layers. The plan area is 1.45x1.45m, so the live load for this area is 10.5 kPa (210psf) which is higher than the design loading.

The live load is higher than the imposed load, the stacking of the fabric rolls should be carefully monitored to ensure that there is no possibility of future overloading.

Item No.	Observation	Recommended Action Plan	Recommended Timeline
1	1st Priority 1 - Loading intensity appears to be greater than what should be allowable in some locations.	Immediately reduce stacking height of fabric bags, rolls and boxes to ensure total load does not exceed 3.0kPa (60psf)	Immediate - Now
2	1st Priority 1 - Loading intensity appears to be greater than what should be allowable in some locations.	Produce loading plans for each level to ensure full factory compliance.	6-weeks
3	1st Priority 1 - Loading intensity appears to be greater than what should be allowable in some locations.	Ensure continued compliance to the loading intensity limitations on a long-term basis. Maintain and enforce the loading plans.	6-months
4	1st Priority 2 - Typical columns have low factors of safety with respect to their loading capacity with 8 floors applied as per the Building permit drawing.	In the future, if Client wants to build the building up to the originally intended 8 floors as per their Building Permit drawing, A Structural Engineer needs to review the building design fully, its loads and column stresses before construction commences. Verify insitu concrete stresses either by 100mm dia. cores or existing cylinder strength data. Produce and actively manage a loading plans for all floor plates within the factory giving consideration to floor and column capacities.	6-months

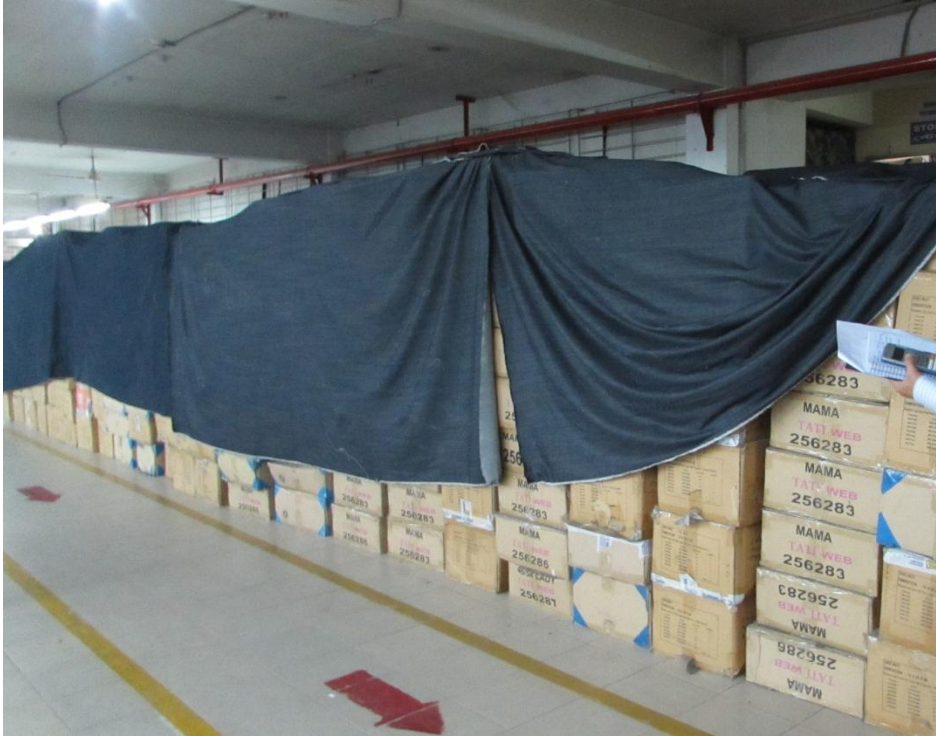
The stored boxes on level 2 are heavier than the allowable design loading of 3.0 kPa (60psf). Each box of fabric is estimated to be approximately 15kg with a plan dimension of 0.5x0.4m and 6 layers, the live load for this area is 4.5kPa (90psf).

The live load is higher than the imposed load, the stacking of boxes should be carefully monitored to ensure that there is no possibility of overloading in the future.

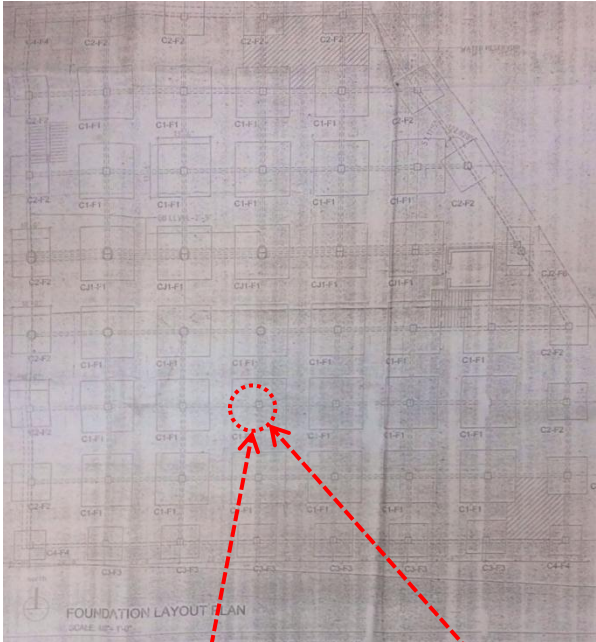
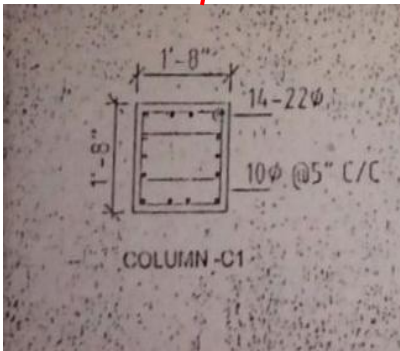
Column to be checked

Based on the load rundown analysis of the building with 8 floors, as per Building Permit drawing, it gives a YELLOW status result for all checked columns that have similar loading conditions and designs. This requires that all floor loadings must be carefully monitored and loading plans provided which must then be strictly maintained.

Based on the load rundown analysis of the building with the current existing 4 floors, the current building operates well within structural limits.

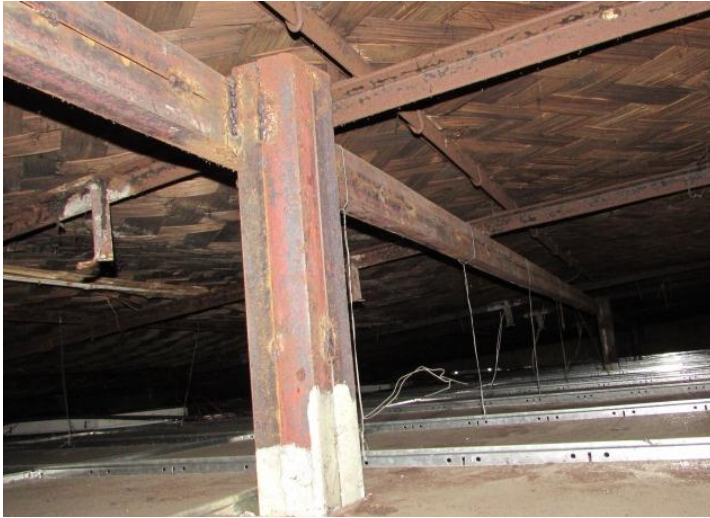
Dining room

The dining building appears to be a temporary structure. There are no structural records to show the structural layout or connection details.

The steel beams and columns are very small and don't have any longitudinal bracing and appear corroded.

We require that these items be investigated in a Detail Engineering Assessment

5	1st Priority 3 - The structure for the dining building needs to be reviewed and longitudinal bracing and connections improved.	The detailed design for the Dining Building to be fully reviewed to verify the lateral stability under wind loading.	6-months
6	2nd Priority 3 - There is no waterproofing provided on the existing roof.	Provide and maintain a proper waterproofing layer on the roof level.	6-months

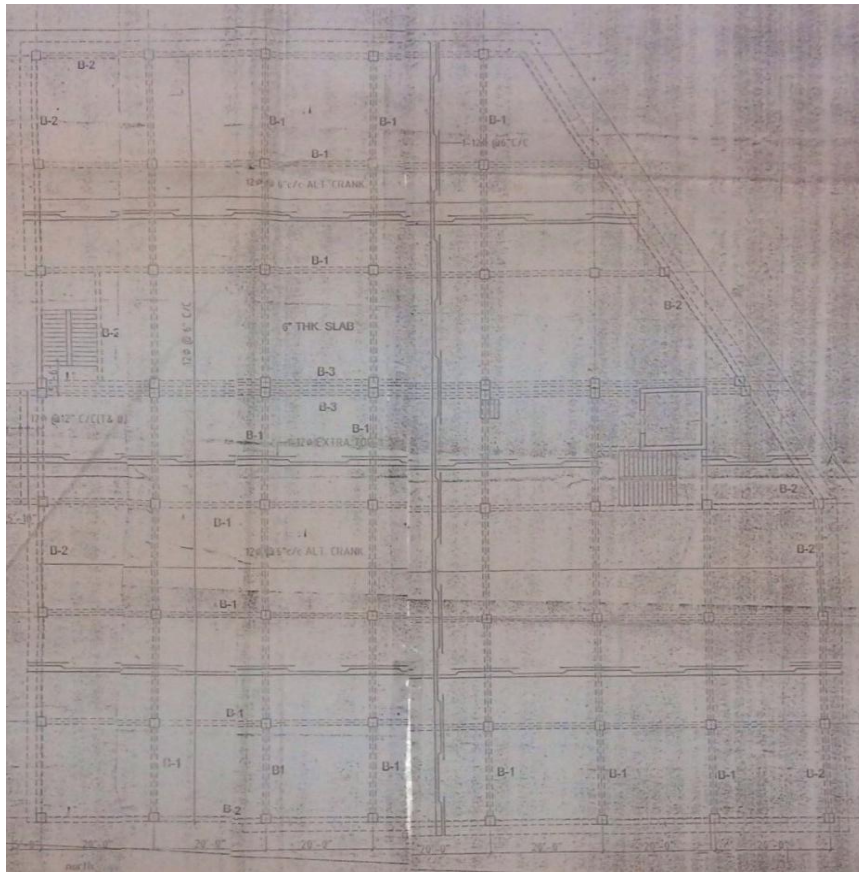
Overall Stability System

R.C Beam and column frame with a 2-way solid slab. Stability provided by moment frame system only.

Slab Thickness 152.4mm
Column Size 508x508mm (typ.)
Beam Size 305x533mm (typ.)

Grid 6.1m x 6.2m.

This type of structural framing is appropriate for a building of less than 10 storeys high, with this large plan area. However, it is required that A Structural Engineer reviews and checks the building's horizontal deflection and storey drift under wind and seismic load.

We require that these items be investigated in a Detailed Engineering Assessment
