# River Side Sweaters Ltd. (10343)

Hasnabad super market, Keranigonj, Dhaka

31.MAY.2014

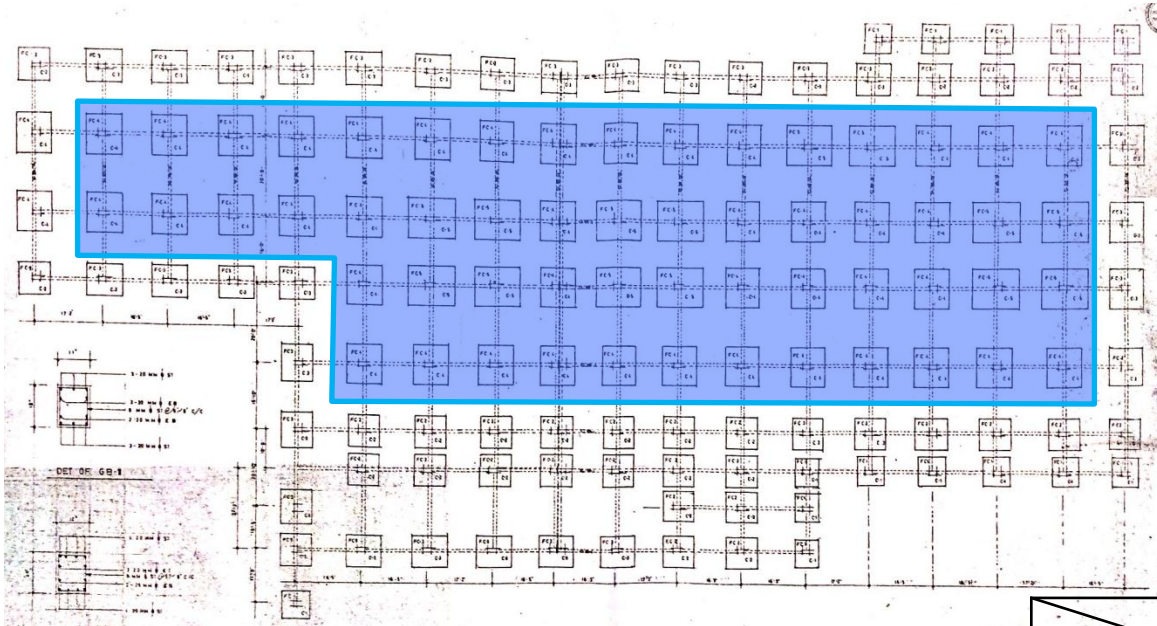
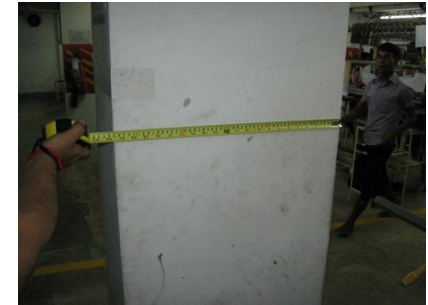
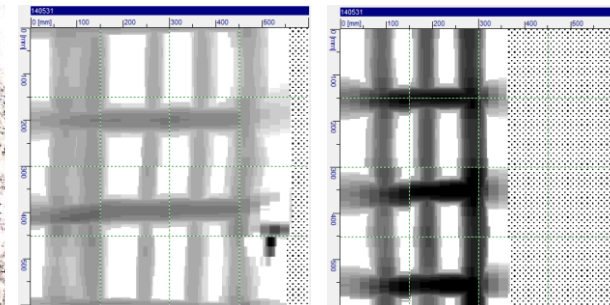
If the full construction of the 9 storeys is completed, the internal columns on basement floor shown in the picture below appear will be overstressed. The size of column is 21" x 14" at basement floor and will carry a full 9 storeys of building spanning 16' to 20' and 16'5" to 17'2" .

From the information above, for 9 storeys, the calculation check of typical columns show that they will be overstressed (FoS = **0.94**).

**Remark:** The size of column's rebar at basement floor is assumed to be similar to the size of column's rebar which left exposed on the top level.

| Item No. | Observation | Recommended Action Plan | Recommended Timeline |
|---|---|---|---|
| 1 | Priority 1 - In case of the full construction of the originally planned 9 storeys, internal columns on basement floor will be overstressed. | Factory Engineer to review design, loads and columns stresses in area identified above.<br>Verify in-situ concrete stresses either by cores or existing cylinder strength data for 4 columns.<br>A Detail Engineering Assessment of Factory to be commenced immediately. | Immediate – Now |
| 2 | Priority 1 - In case of the full construction of the originally planned 9 storeys, internal columns on basement floor will be overstressed. | Produce and actively manage a loading plan for all floor plates within the factory giving consideration to floor capacity and column capacity.<br>Detail Engineering Assessment to be completed. | 6-weeks |
| 3 | Priority 1 - In case of the full construction of the originally planned 9 storeys, internal columns on basement floor will be overstressed. | Continue to implement and maintain the loading plans.<br>Use the results of the DEA to determine if the 9 storeys can be constructed or not. | 6-months |

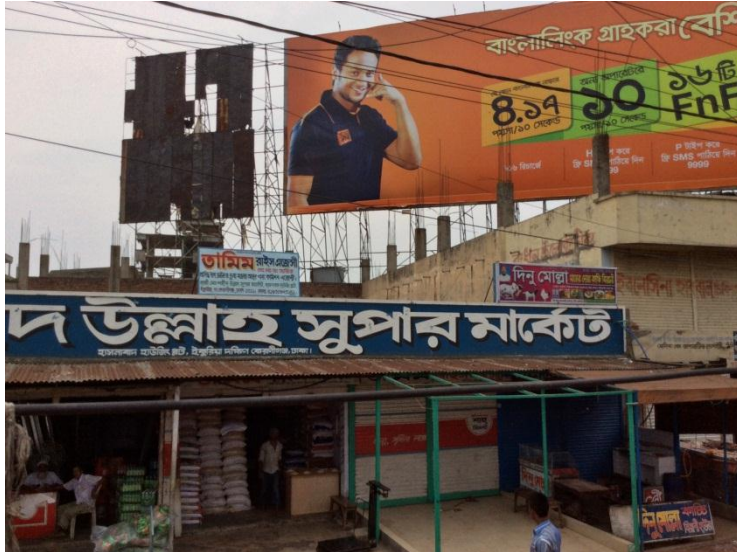
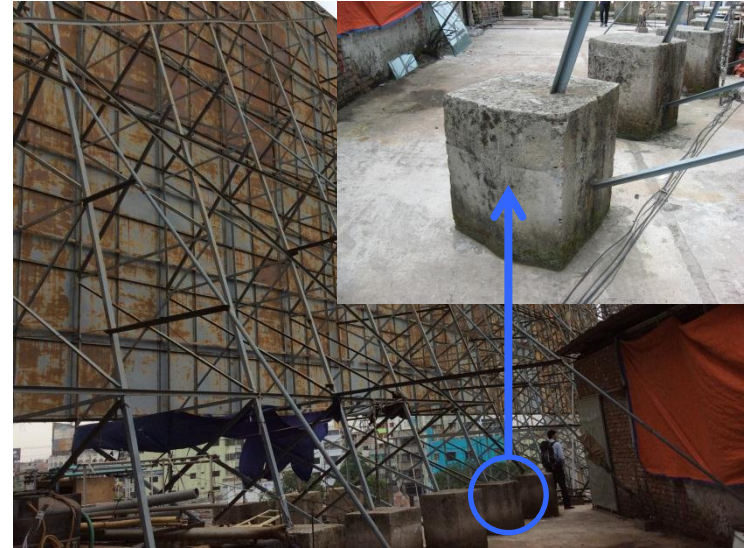
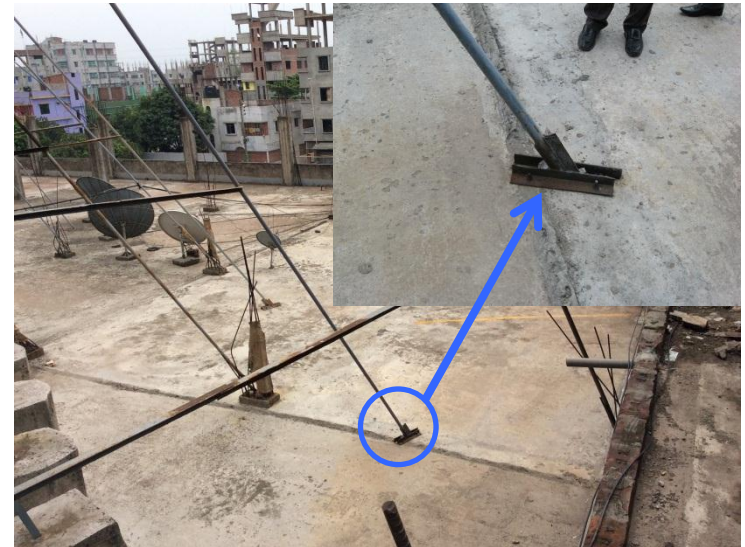
Advertising board was installed at roof level. Capacity and stability check of these items and related elements should be carried out.

| Item No. | Observation | Recommended Action Plan | Recommended Timeline |
|---|---|---|---|
| 4 | Priority 1 - Stability and capacity check of the structural elements supporting advertising board at roof level. | Request that the Detail Engineering Assessment of the structural elements supporting the advertising boards to be carried out and in particular, stability and connections aspects should be investigated in detail. | Immediate – Now |
| 5 | Priority 1 - Stability and capacity check of the structural elements supporting advertising board at roof level. | Detail Engineering Assessment to be completed. | 6-weeks |
| 6 | Priority 1 - Stability and capacity check of the structural elements supporting advertising board at roof level. | Complete any actions or recommendations from the DEA. | 6-months |

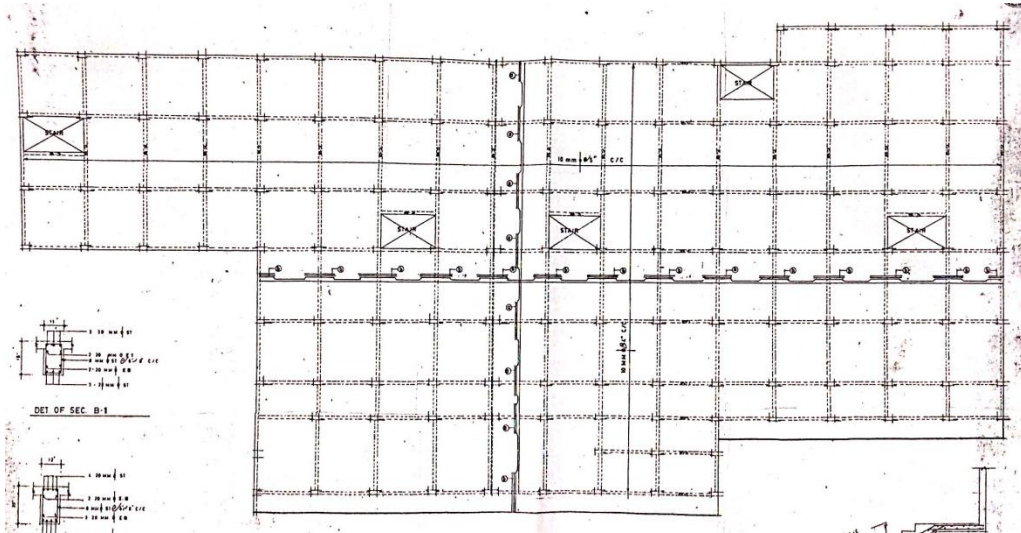
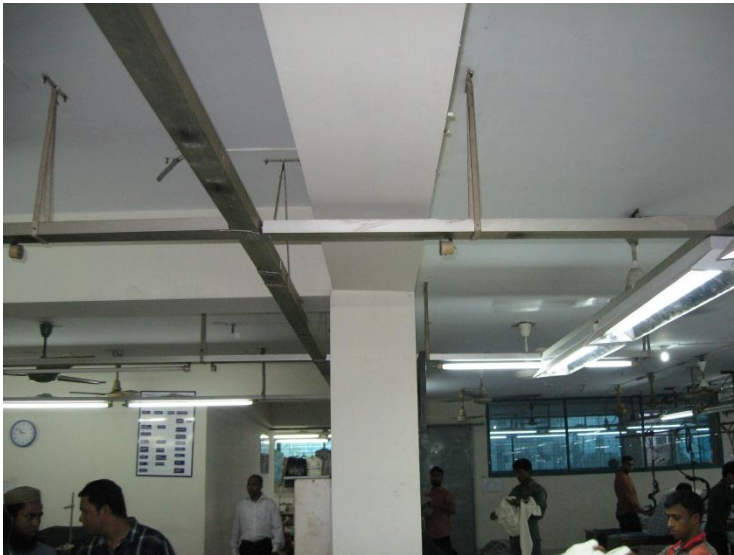
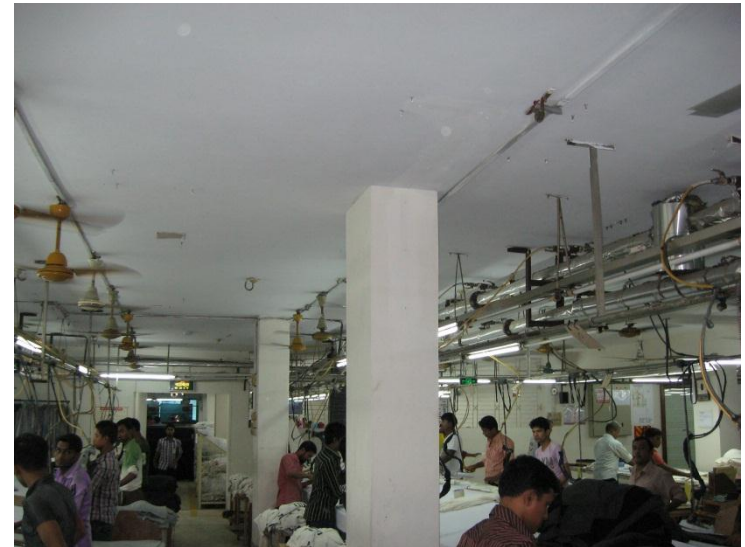
Some beams shown on the drawings were not found on-site.  
No column schedule was available.

| Item No. | Observation | Recommended Action Plan | Recommended Timeline |
|---|---|---|---|
| 7 | Priority 2 - Inconsistencies between the drawings and the actual as-built conditions. | Factory Engineer to survey the actual conditions and revise the drawings.<br>Any results of the DEA which affect the structure should be taken on board. | 6-weeks |

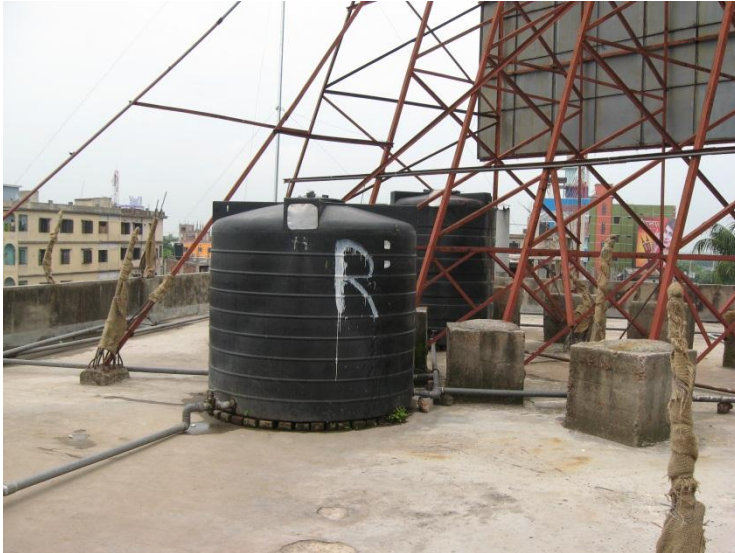
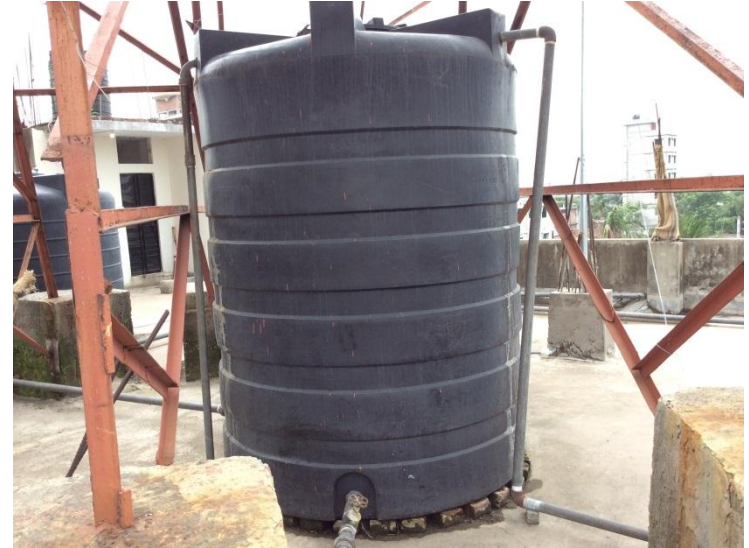
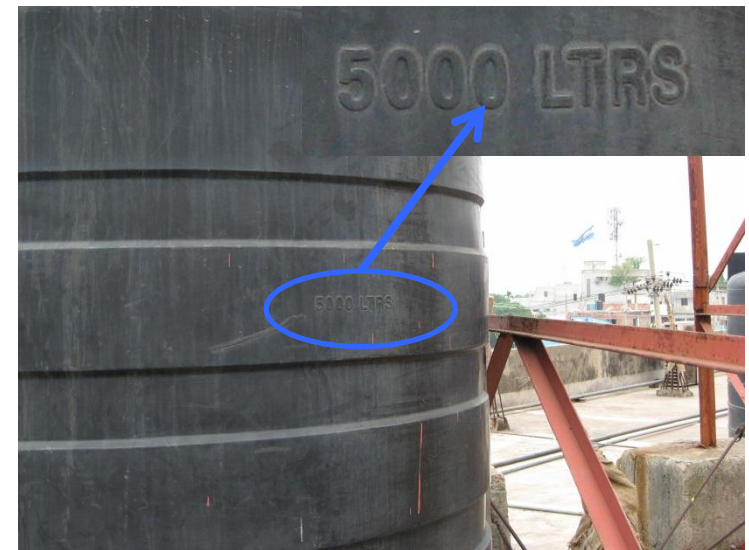
Water tanks of 5000 litres capacity were installed at roof level. Capacity and stability checks of the roof slab locally and any related elements should be carried out.

| Item No. | Observation | Recommended Action Plan | Recommended Timeline |
|---|---|---|---|
| 8 | Priority 2 - Stability and capacity check of roof slab supporting water tanks. | Factory Engineer to review design, loads and related elements in area identified above to confirm capacity and stability for these items. | 6-weeks |

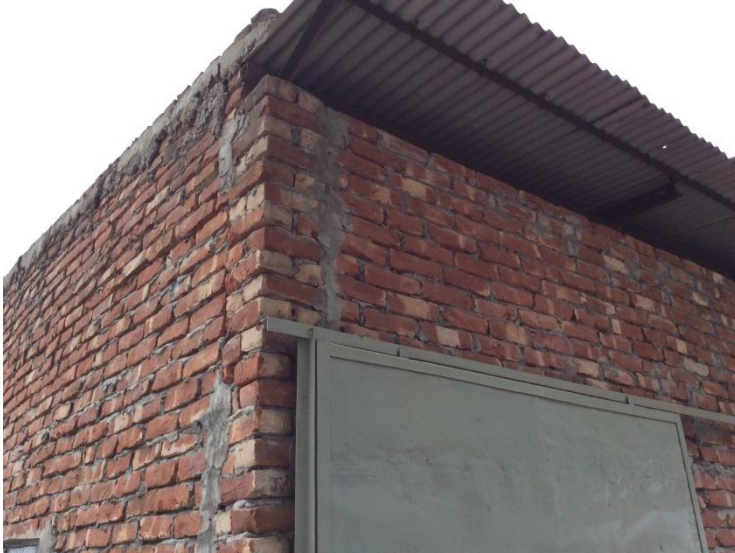
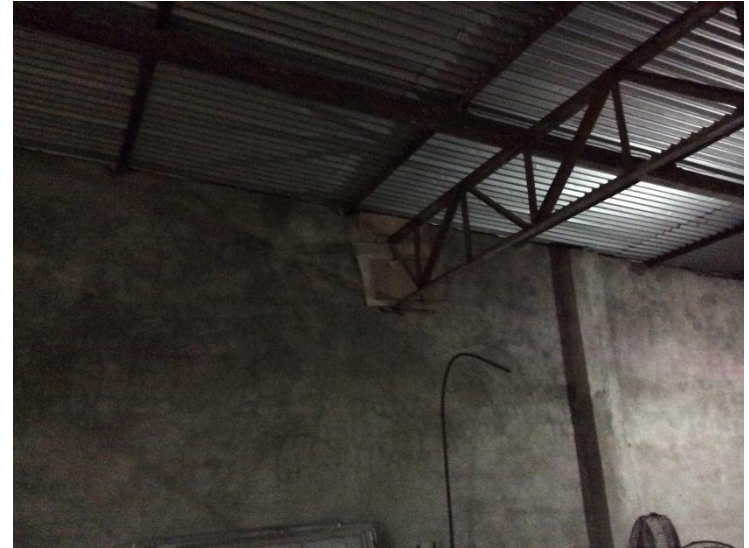
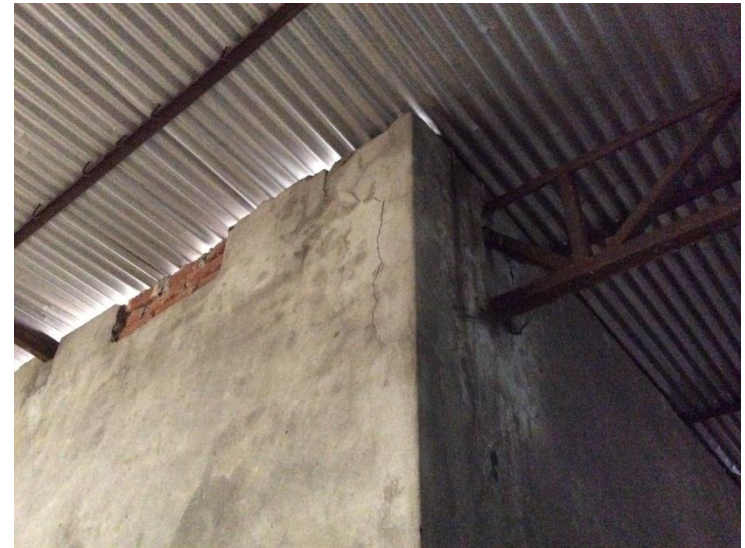
There are concerns on brick wall supporting roof elements. Capacity and stability check of these items and any related elements should be carried out.

| Item No. | Observation | Recommended Action Plan | Recommended Timeline |
|---|---|---|---|
| 9 | Priority 2 - Stability and capacity check of brick wall supporting roof elements. | Factory Engineer to review design, loads and related elements in area identified above to confirm capacity and stability for these items. | 6-weeks |

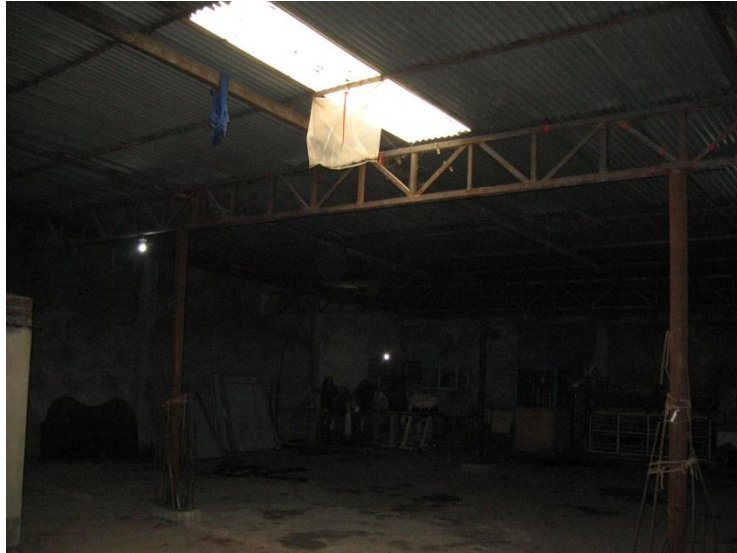
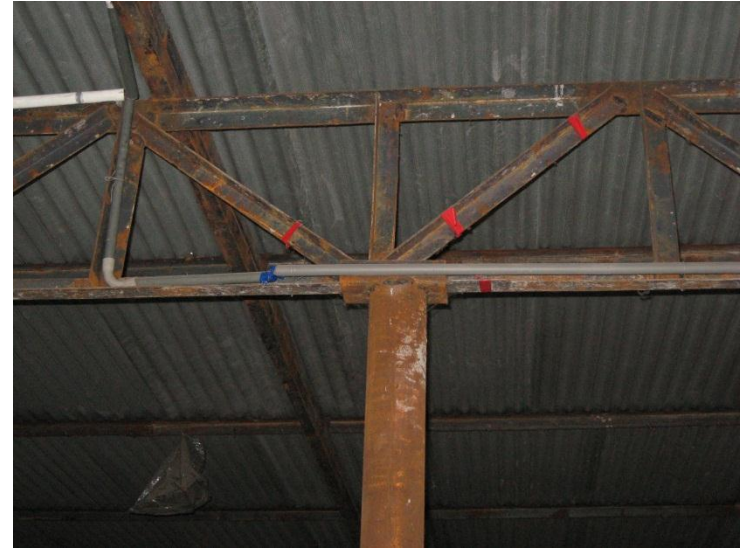
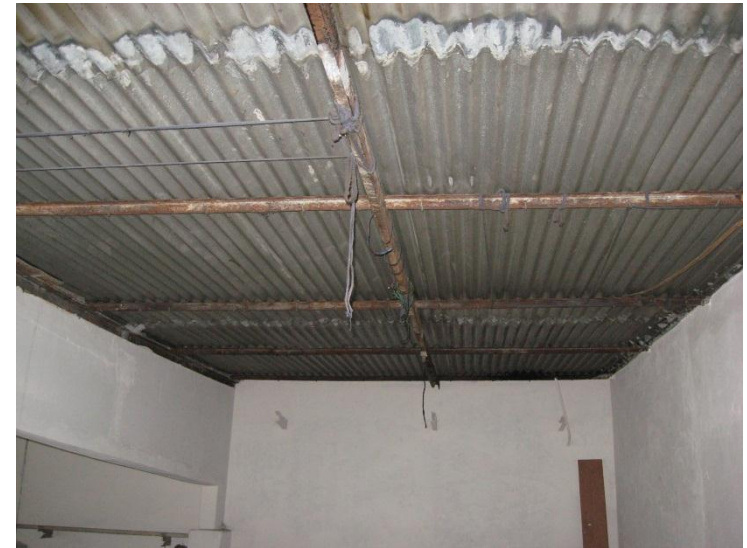
No fireproofing material was noted on structural steel elements of the roof shed. It is unclear whether this is required by BNBC.

| Item No. | Observation | Recommended Action Plan | Recommended Timeline |
|---|---|---|---|
| 10 | Priority 2 - No fireproofing material applied for structural steel elements (if required). | Fireproofing material for structural steel element is recommended as suggested in BNBC Codes. | 6-weeks |
| 11 | Priority 2 - No fireproofing material applied for structural steel elements (if required). | Maintain standard of quality control and protection of the fire protection. | 6-months |

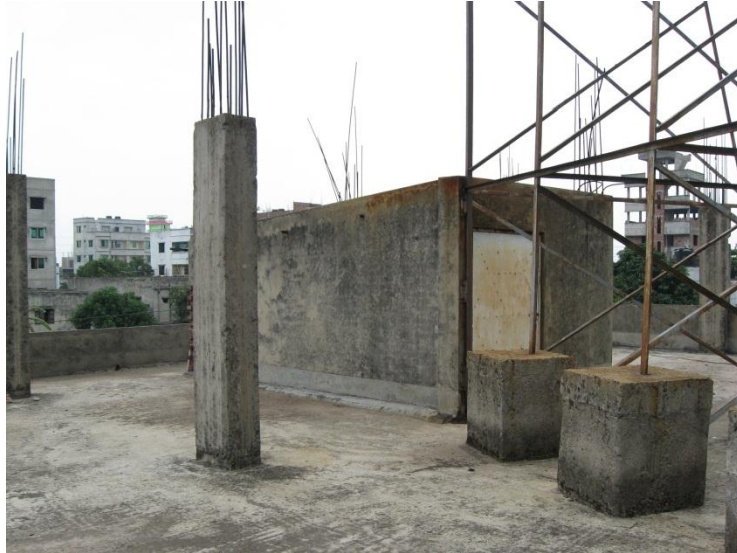
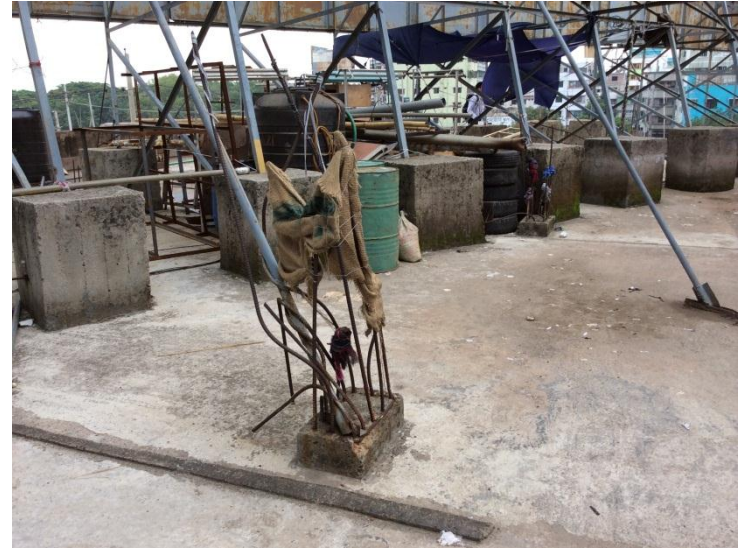
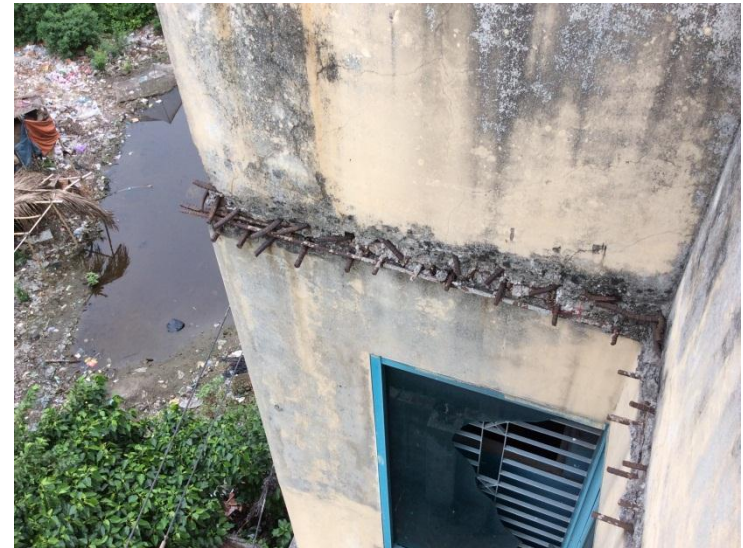
Reinforcement is left exposed at roof level.

| Item No. | Observation | Recommended Action Plan | Recommended Timeline |
|---|---|---|---|
| 14 | Priority 3 - Reinforcement left exposed at roof level. | For both durability and serviceability, rust proof paint or any appropriate methods is recommended. | 6-months |

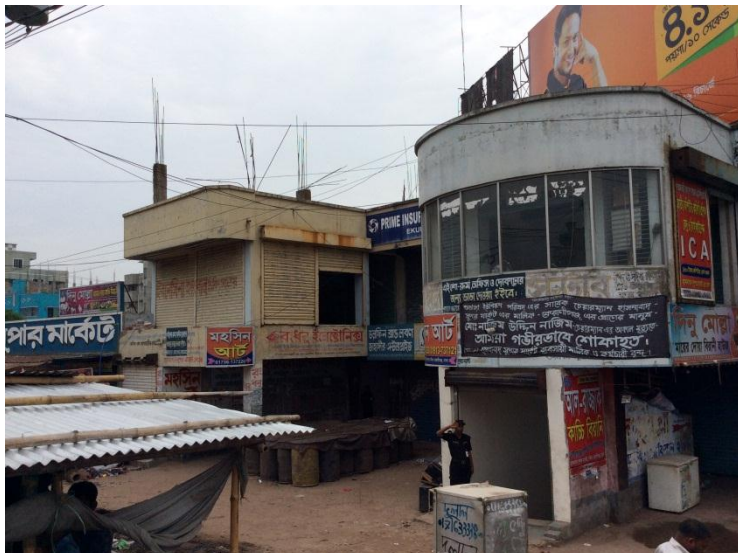
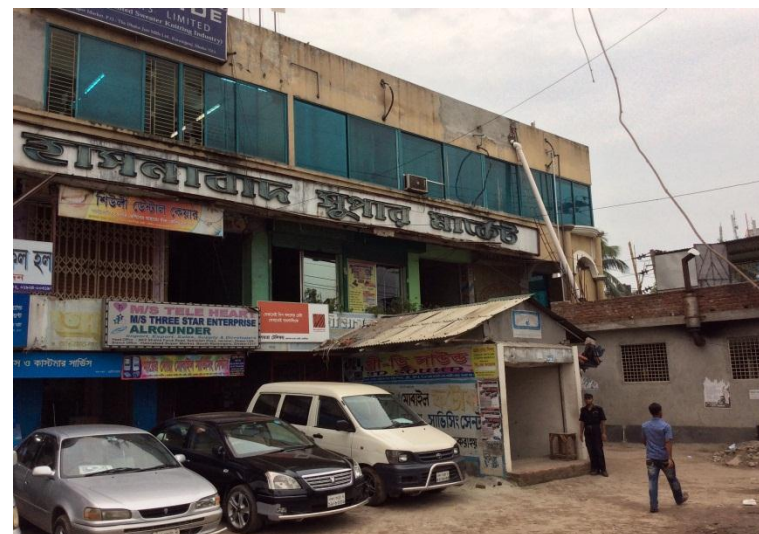
Concerns on the stability system for lateral loading. Façade brickwork walls lack any moment capacity between columns and beams.

We require that these items be investigated in a Detailed Engineering Assessment.

| Item No. | Observation | Recommended Action Plan | Recommended Timeline |
|---|---|---|---|
| 12 | Priority 2 - Overall stability system. | Request that the Detail Engineering Assessment of the overall building to be carried out and in particular, stability and foundation aspects should be investigated in detail. | 6-weeks |

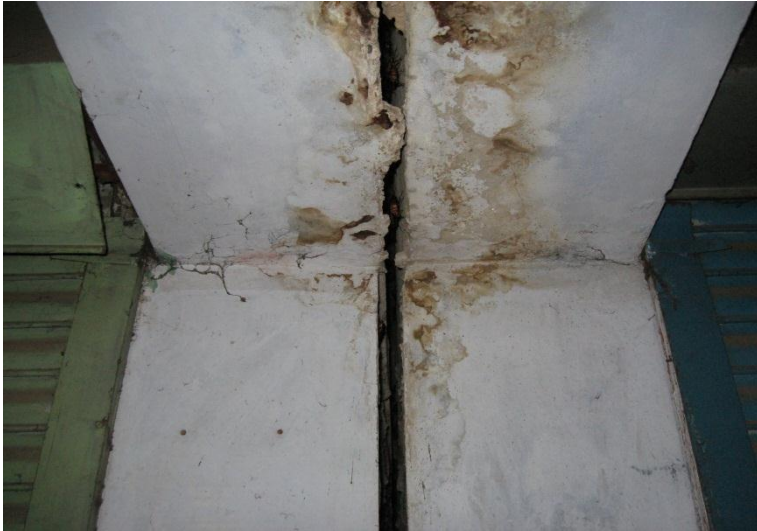
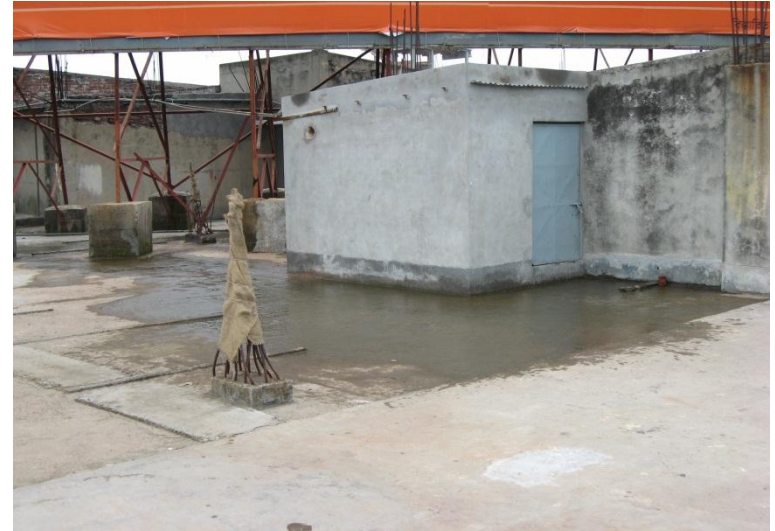
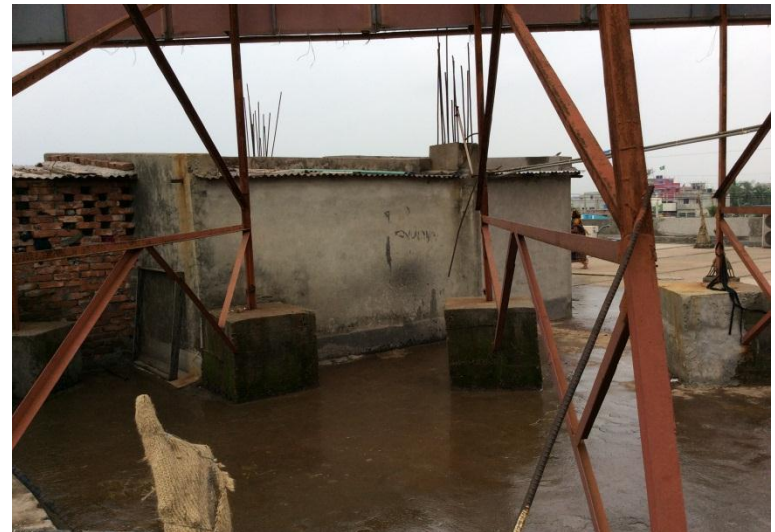
Distress due to water ingress was noted at the movement joint including water ponding on the roof slab.

| Item No. | Observation | Recommended Action Plan | Recommended Timeline |
|---|---|---|---|
| 13 | Priority 3 - Distress due to water ingress. | Factory Engineer to inspect water damaged structures and repair with a suitable methods.<br>Waterproofing on the roof slab is to be applied. Moreover the roof slab drainage system should be investigated and improved. | 6-months |
