# SF Sweaters Ltd. Building – 2

P.O. Salna Bazar, Gazipur, South Salina (Opposite of ABC Complex)

17<sup>th</sup> May 2017

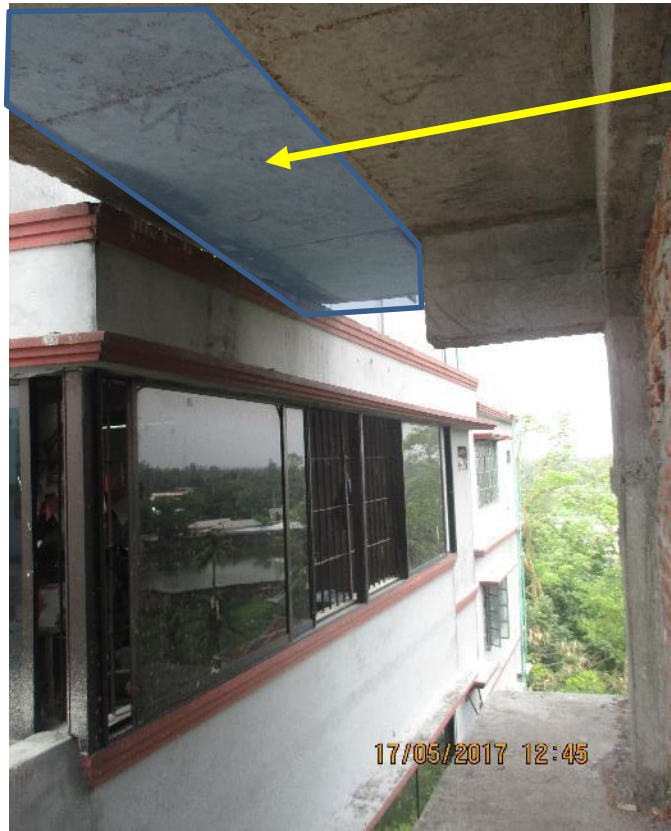
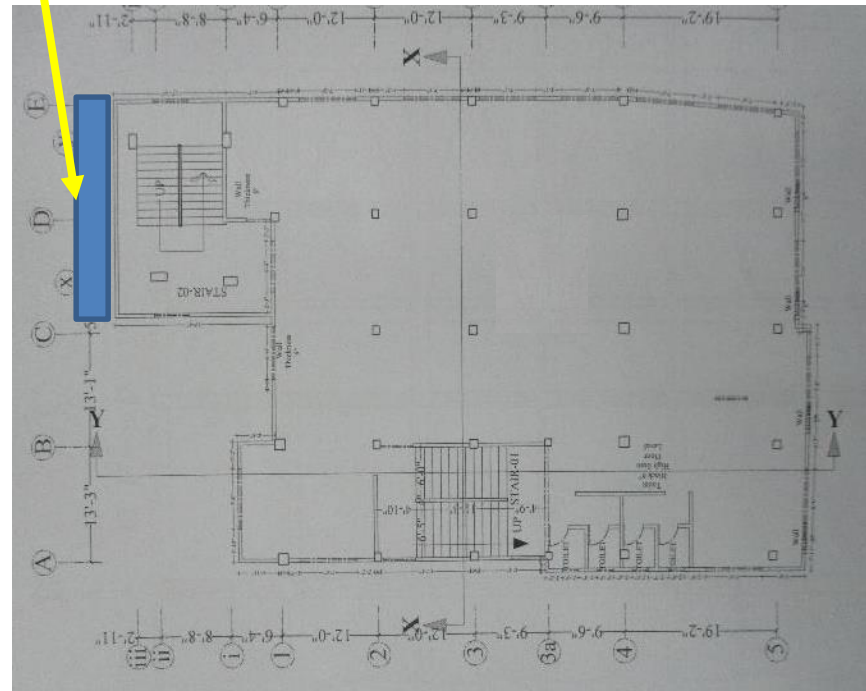
Undocumented cantilever portion  
observed on roof.

Building Engineer required to update As-Built drawings incorporating the extended portion of roof.

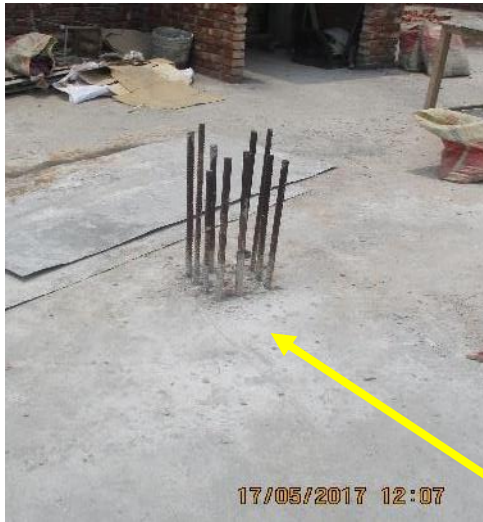
C2: 7- 20mm+3-16mm on roof

Building Engineer required to update As-Built drawings incorporate the verified number of reinforcement in columns.

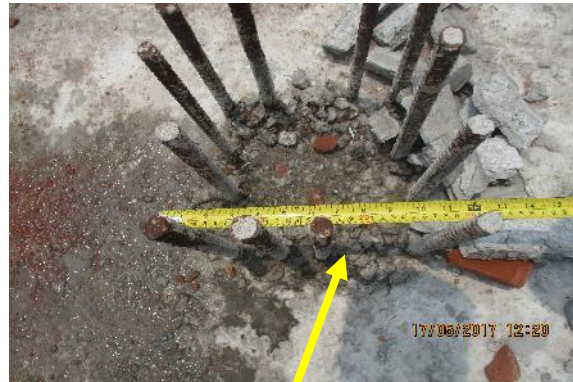
C1: 3- 16mm+9- 20mm on roof

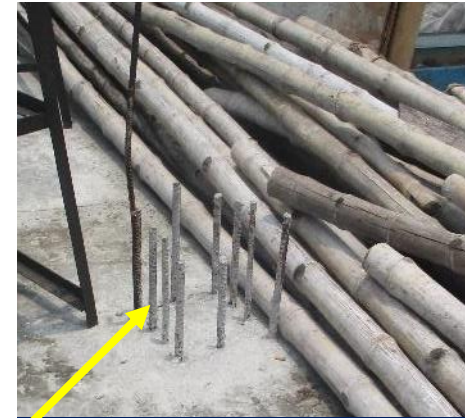
C1: 2- 16mm+5-20mm+2- 16mm on roof

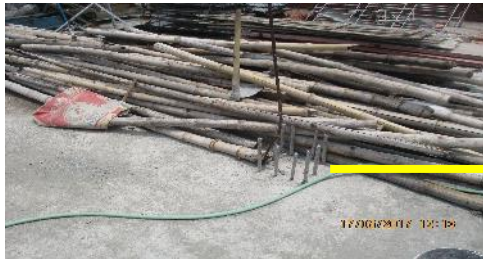
C1: 2- 16mm+5-20mm+2- 16mm on roof

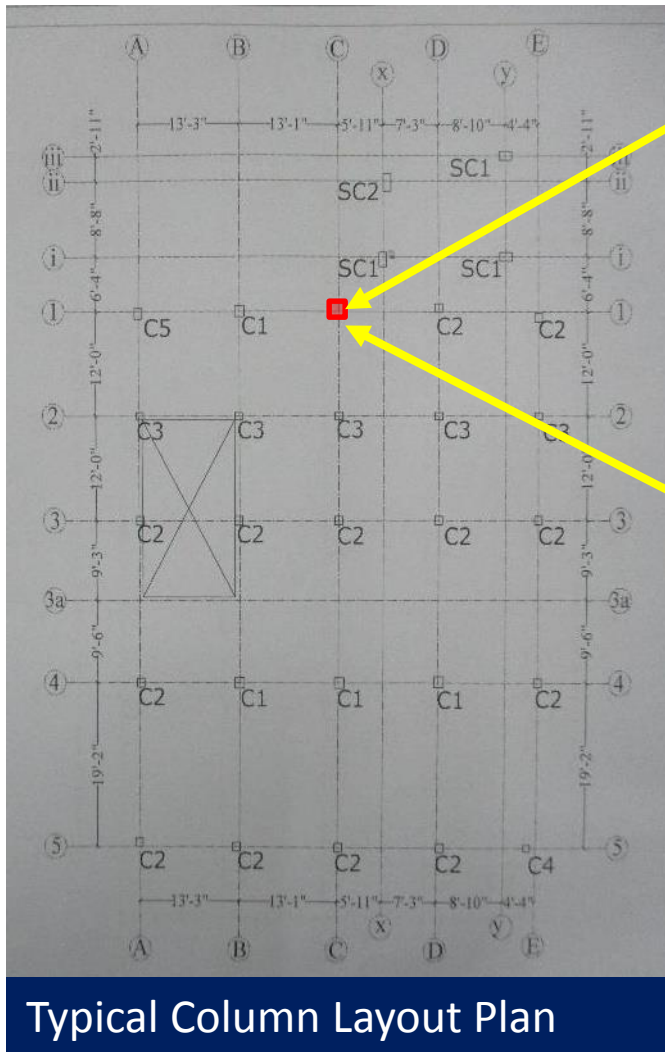
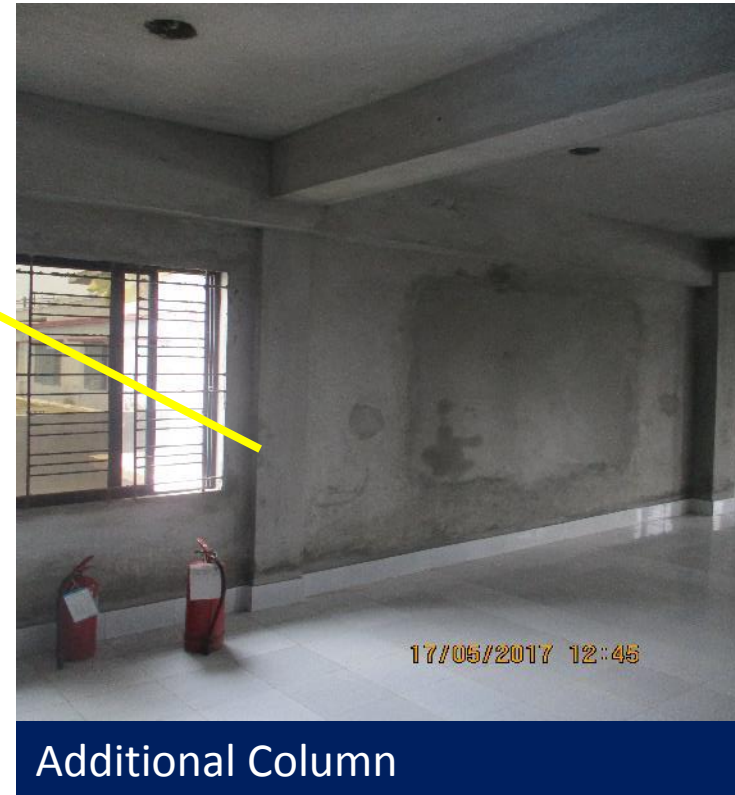
Additional Column was observed from 2<sup>nd</sup> floor to roof.

| Item No. | Observation | Recommended Action Plan | Recommended Timeline |
|---|---|---|---|
| 3 | (Building-2)<br>Discrepancy observed between As-Built drawing and actual condition | Building engineer to survey the whole building and produce as-built documentation reflecting the as constructed condition | 6-weeks |

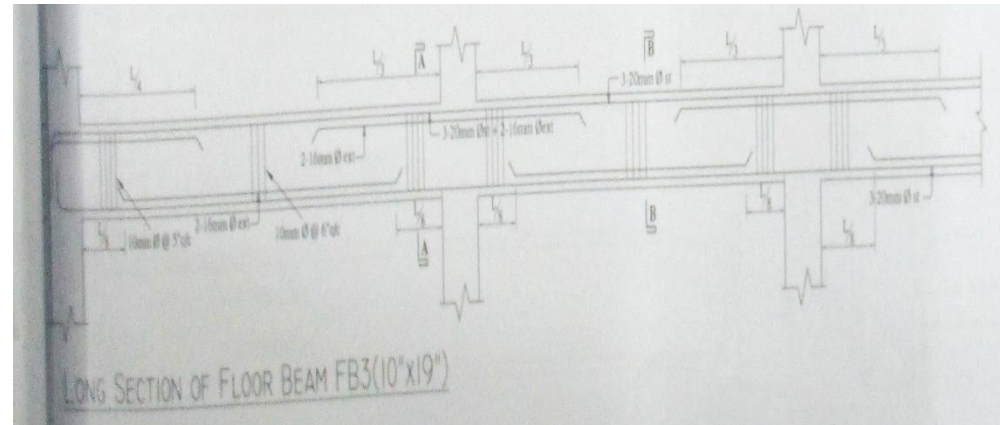
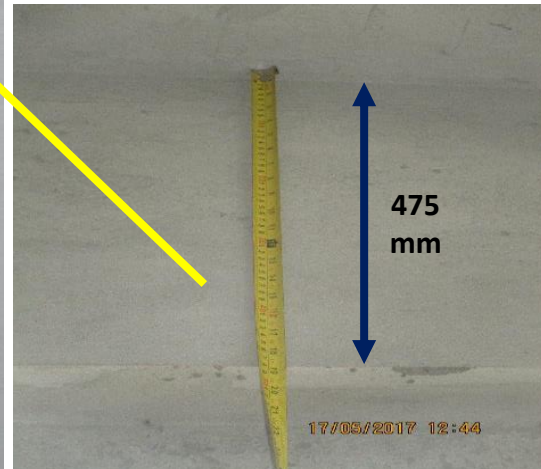
Down stand of beam  
observed 475mm instead  
of 350mm

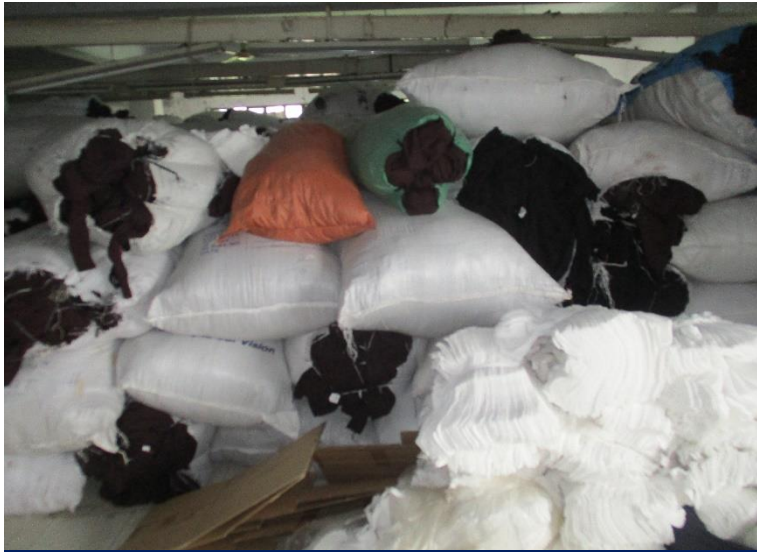
Loading on 1<sup>st</sup> floor above 2Kpa

No load management programs were visible. Factory is required to implement load management program as per its floor loading capacity and Follow the load plans for all floors of the buildings and make sure that the workers understand the loading requirements.

| Item No. | Observation | Recommended Action Plan | Recommended Timeline |
|---|---|---|---|
| 4 | (Building-2)<br>Implement floor load management program | Maintain floor loading below 2Kpa | Immediate - Now |
| 5 | (Building-2)<br>Implement floor load management program | Factory is required to implement load management program as per its floor loading capacity. | 6-weeks |

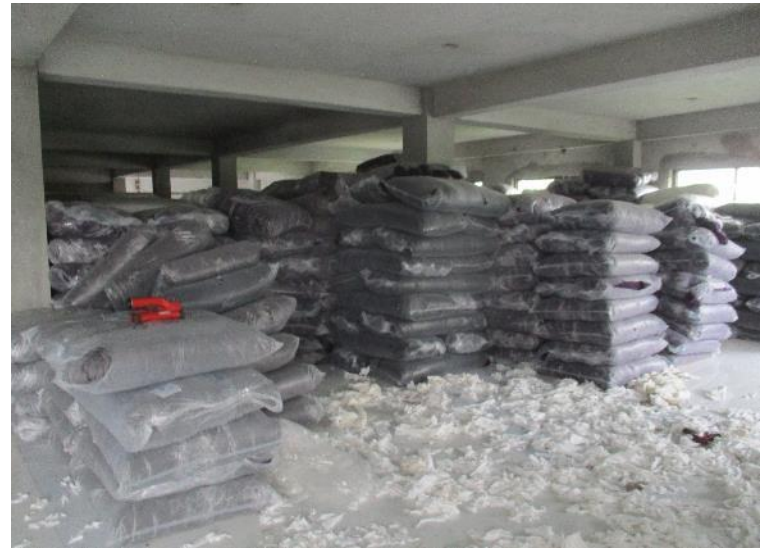
Loading on 4<sup>th</sup> floor above 2Kpa

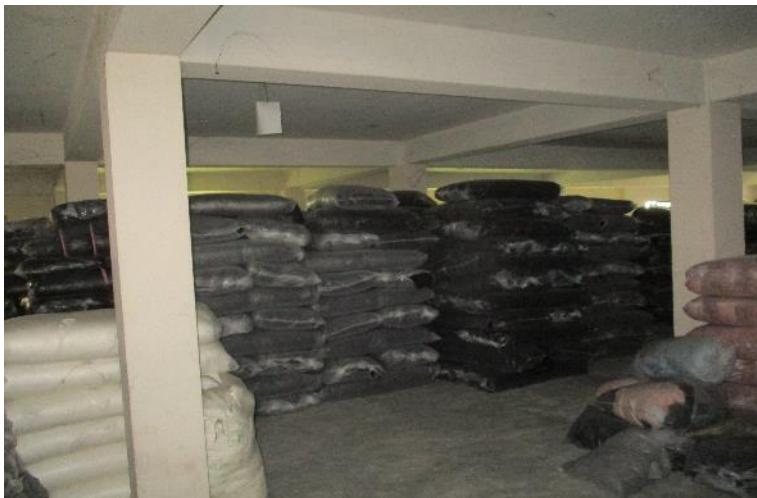
Loading on 2<sup>nd</sup> floor above 2Kpa

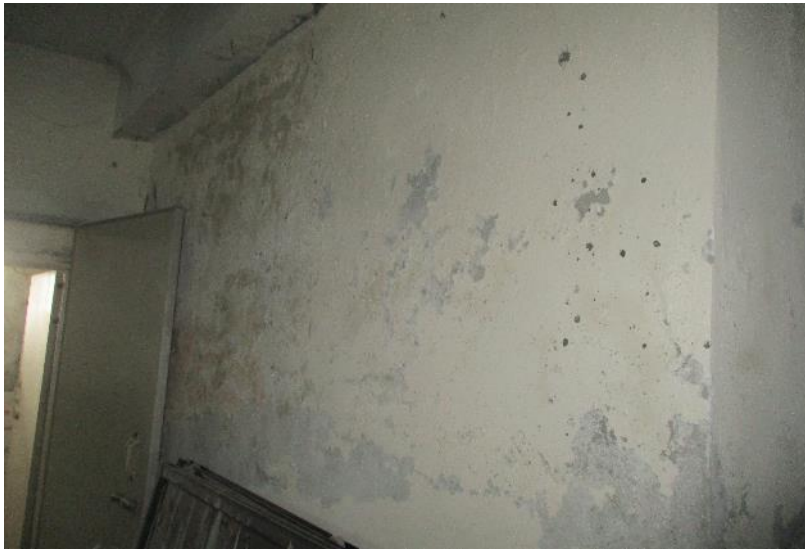
Dampness observed on wall beside toilet area.

Dampness observed on several places of the building. Building Engineer is required to investigate the extent of dampness and suggest necessary remedial action.

| Item No. | Observation | Recommended Action Plan | Recommended Timeline |
|---|---|---|---|
| 7 | (Building-2)<br>Dampness observed on several Floors | Building Engineer is required to investigate the extent of dampness and suggest proper remedial measures accordingly. | 6-weeks |
| 8 | (Building-2)<br>Dampness observed on several Floors | Carry out remedial works as per recommendation of investigation report. | 6-months |

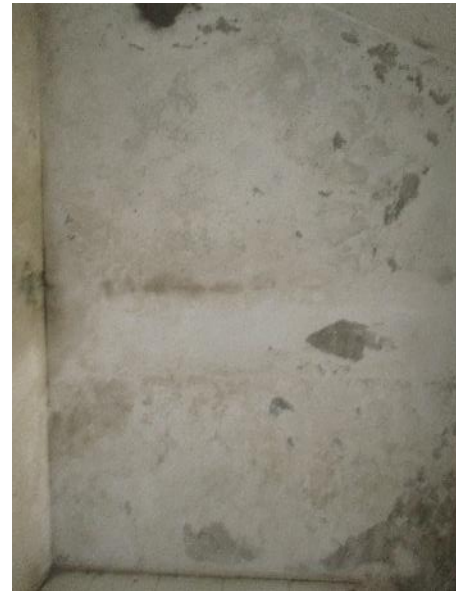
Dampness observed on stair portion

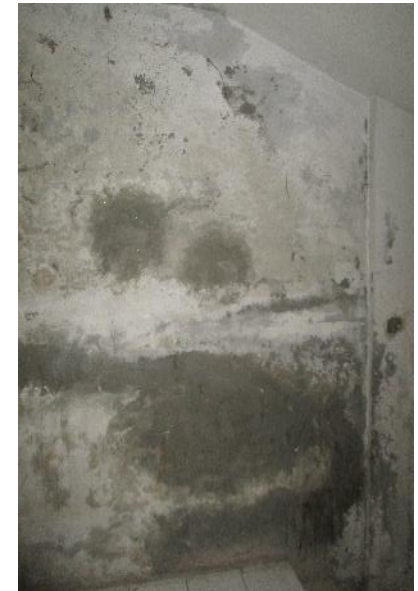
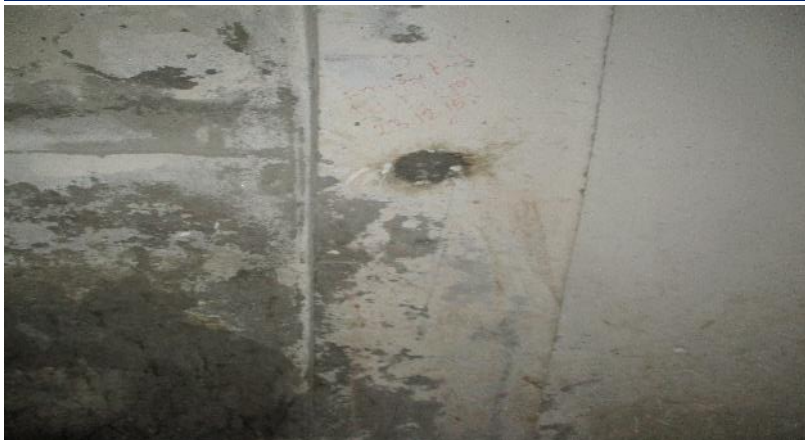
Dampness observed on Peripheral Wall

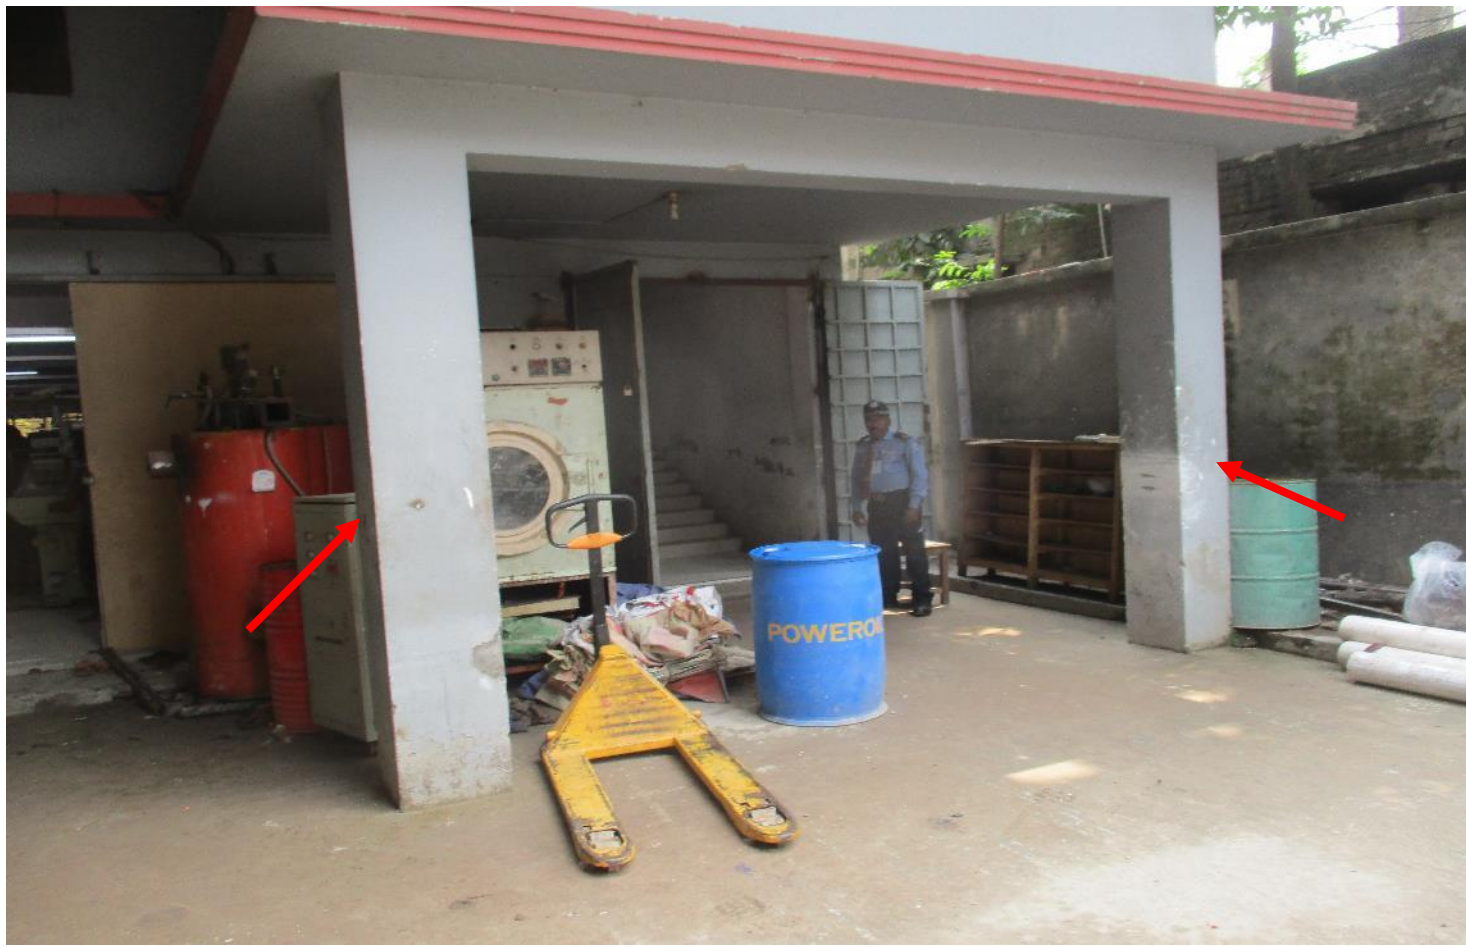
The highlighted columns is susceptible to vehicle impact. It is required to take necessary measures to protect the columns.

| Item No. | Observation | Recommended Action Plan | Recommended Timeline |
|---|---|---|---|
| 9 | (Building-2)<br>Column susceptible to vehicle impact | Place protective barrier around susceptible columns. | Immediate - Now |

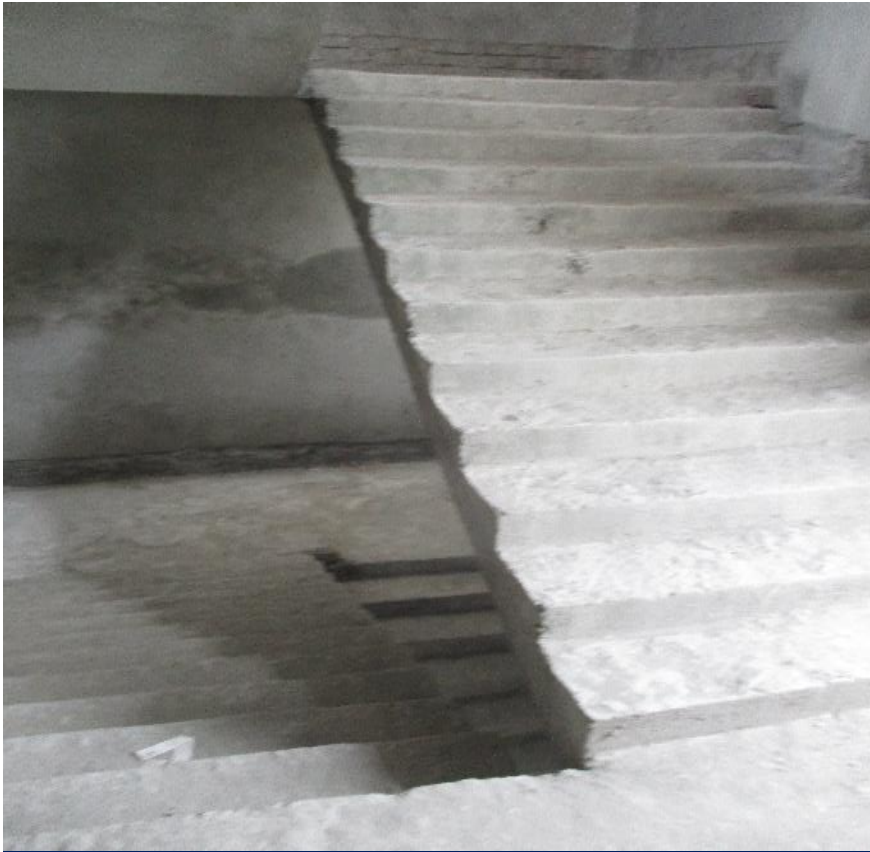
Stair- 01 portion(3<sup>rd</sup> floor to roof)

Railing was missing on both stair portion. Factory is required to install railing to avoid falling hazard.

| Item No. | Observation | Recommended Action Plan | Recommended Timeline |
|---|---|---|---|
| 10 | (Building-2)<br>Railing missing on stair portion | Install railing properly to avoid falling hazard. | Immediate - Now |

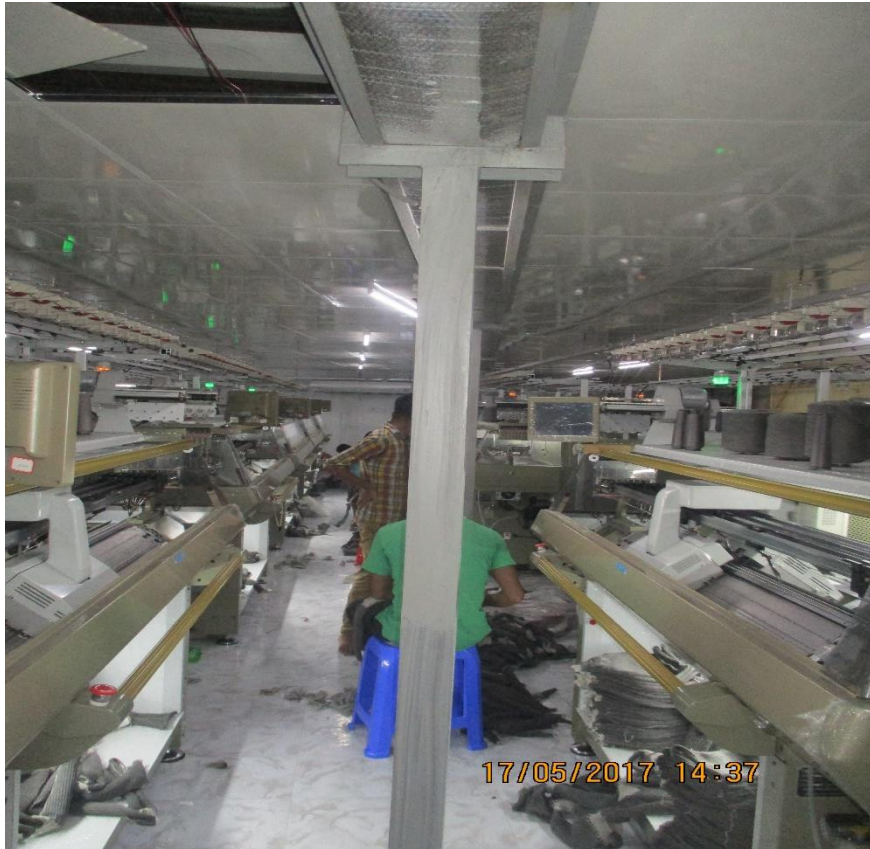
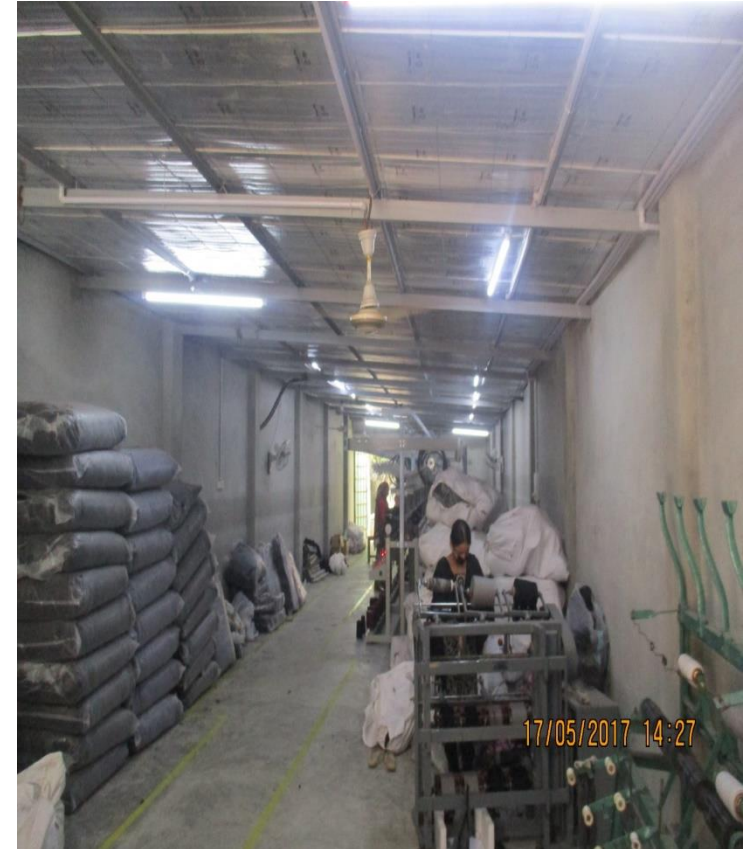
Internal view of shed-2

During inspection, no as built documentation was found for the steel shed. Besides, the shed seems to be non-engineered. Factory is required to produce as built documentation and check the adequacy of the shed against lateral loads.

| Item No. | Observation | Recommended Action Plan | Recommended Timeline |
|---|---|---|---|
| 11 | (Shed-2)<br>No Documents observed of the steel shed-2 | Factory is required to produce a set of As Built drawings with respect to the actual condition. | 6-weeks |
| 12 | (Shed-2)<br>No Documents observed of the steel shed-2 | Factory is required to check the adequacy of the roof shed against lateral loads. | 6-weeks |
