# Mahmuda Attires Ltd.

Balitha, Saha-belishwar, Dhamrai, Dhaka, Bangladesh

5<sup>th</sup> July 2017

# Observation

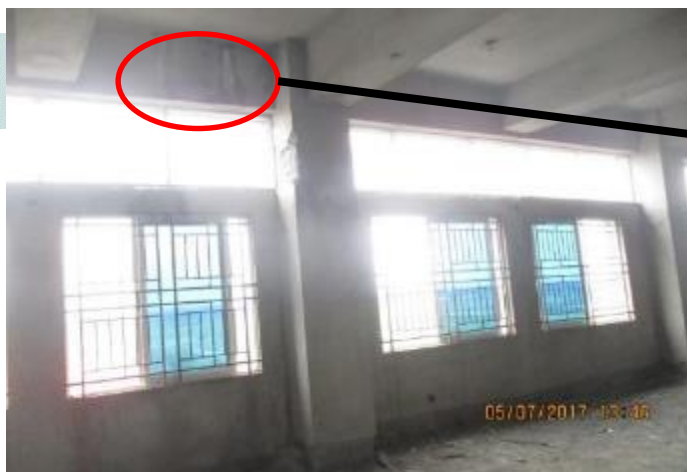
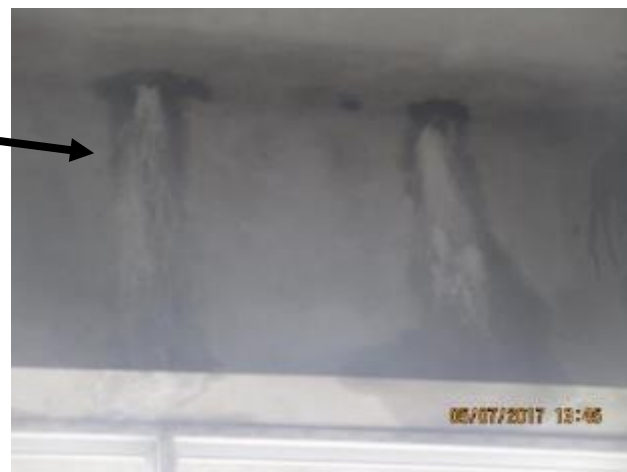
Dampness was found on beam slab joint on exterior side

Dampness was found in several locations along with the movement joint and exterior side. Factory engineer is required to check the affected beam and take proper remediation for preventing further dampness.

| Item No. | Observation | Recommended Action Plan | Recommended Timeline |
|---|---|---|---|
| 1 | Dampness due to water ingress on movement joint and exterior beam | Factory engineer is required to investigation the cause of dampness and intensity of concrete damage of beams. | 6-weeks |
| 2 | Dampness due to water ingress on movement joint and exterior beam | Factory engineer is required to provide proper remedial method. | 6-weeks |
| 3 | Dampness due to water ingress on movement joint and exterior beam | Implement the repair works suggested by the factory engineer | 6-months |

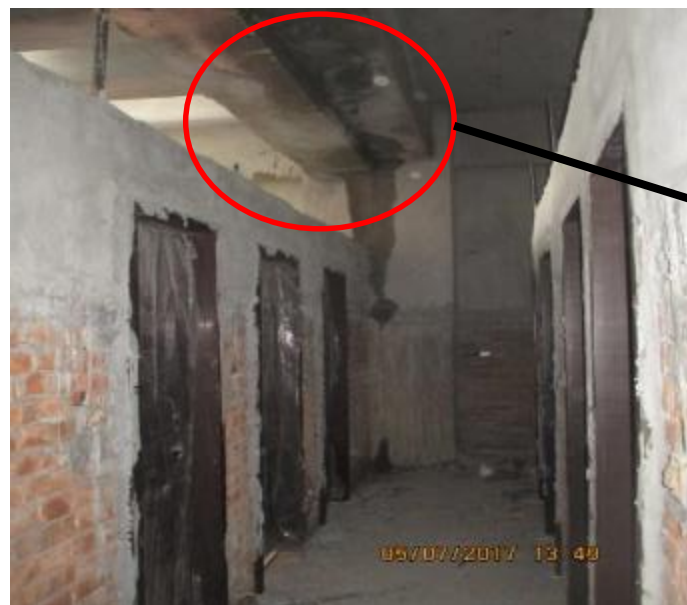
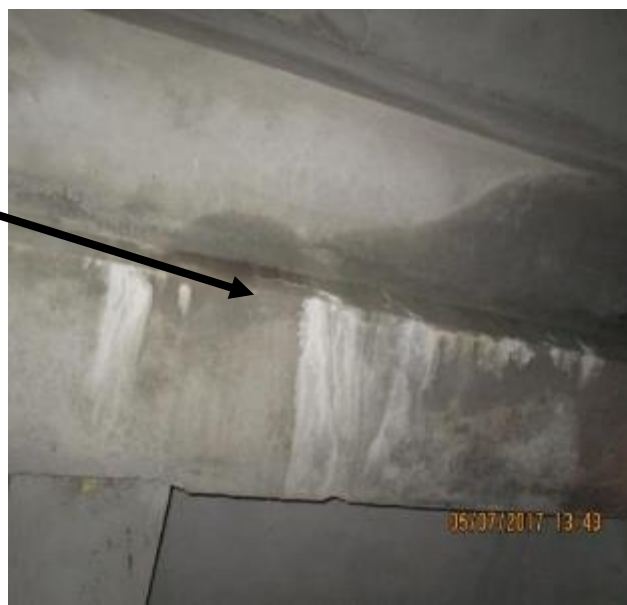
Excessive dampness was found on movement joint of toilet area(6<sup>th</sup> floor)

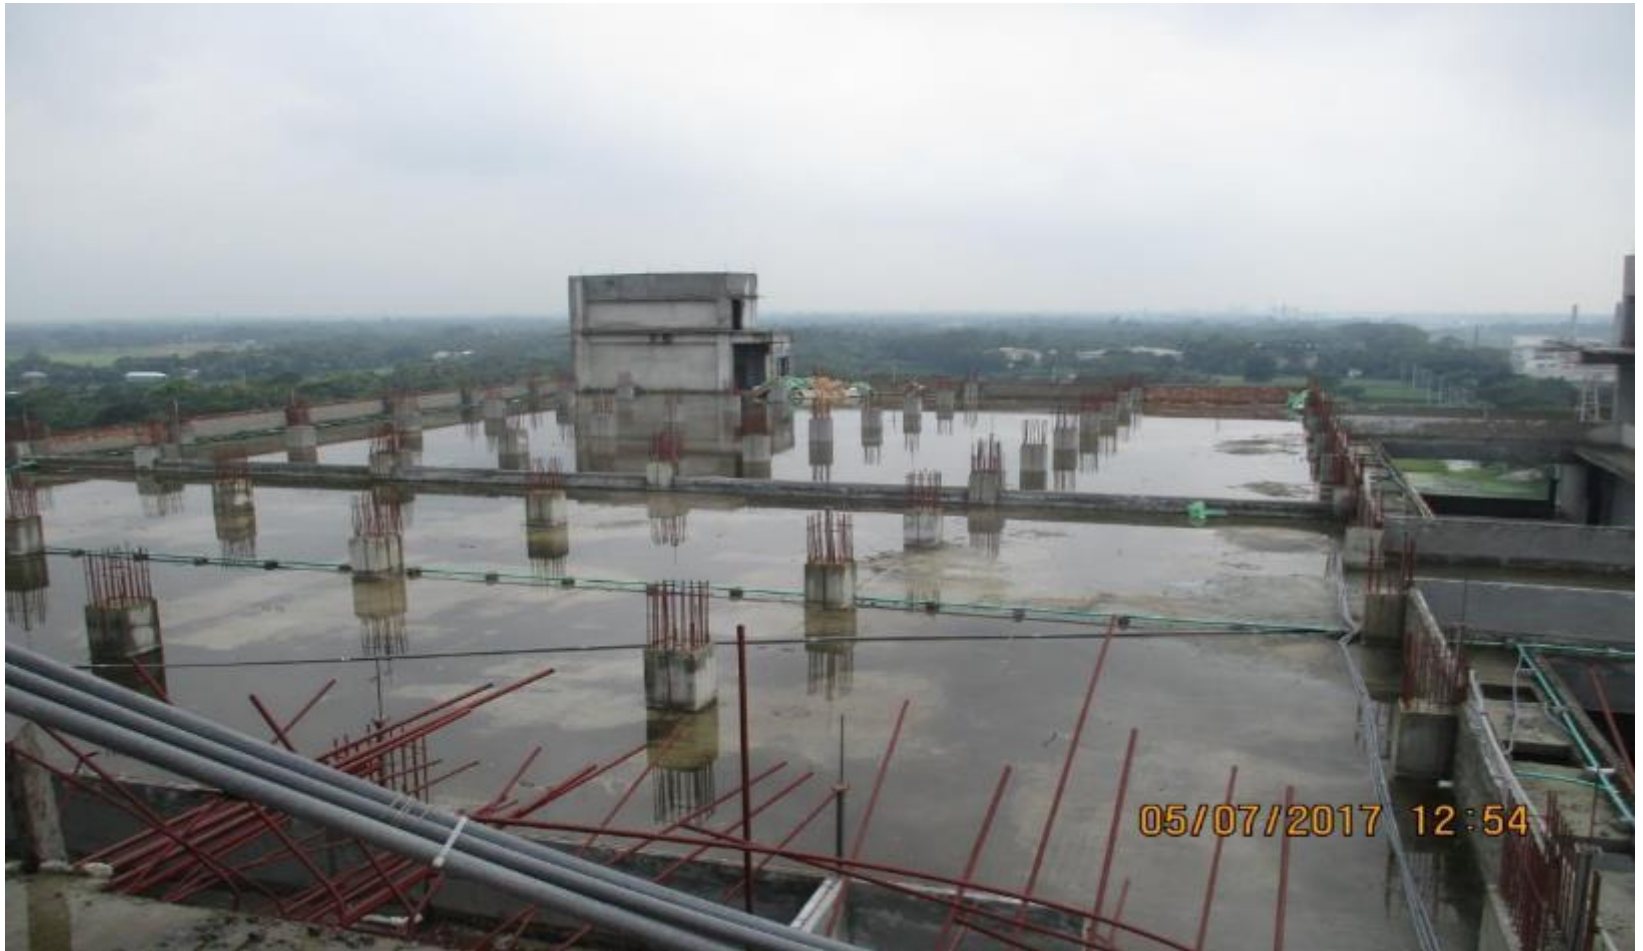
# Water clogging on roof

Water clogging was observed on roof. Factory is required to install the proper drainage system for preventing water clogging.

| Item No. | Observation | Recommended Action Plan | Recommended Timeline |
|---|---|---|---|
| 4 | Water clogging on roof | Factory is required to install the proper drainage system for preventing water clogging. | 6-weeks |

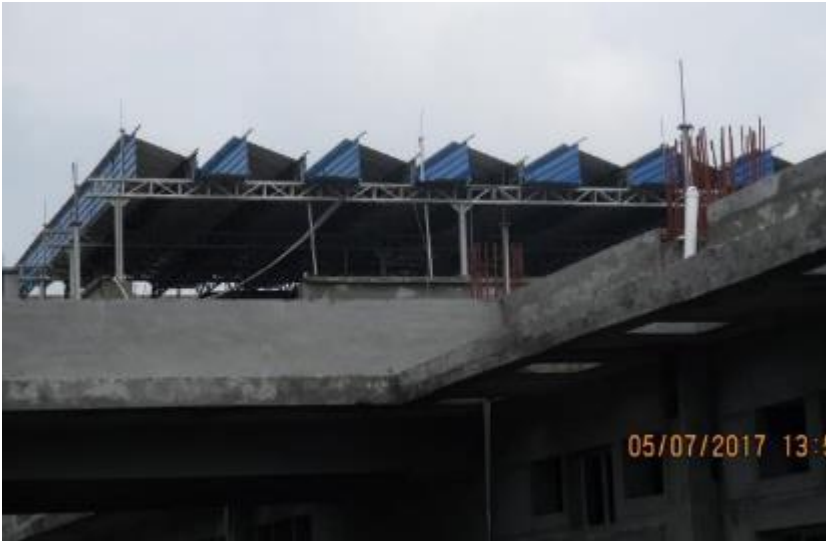
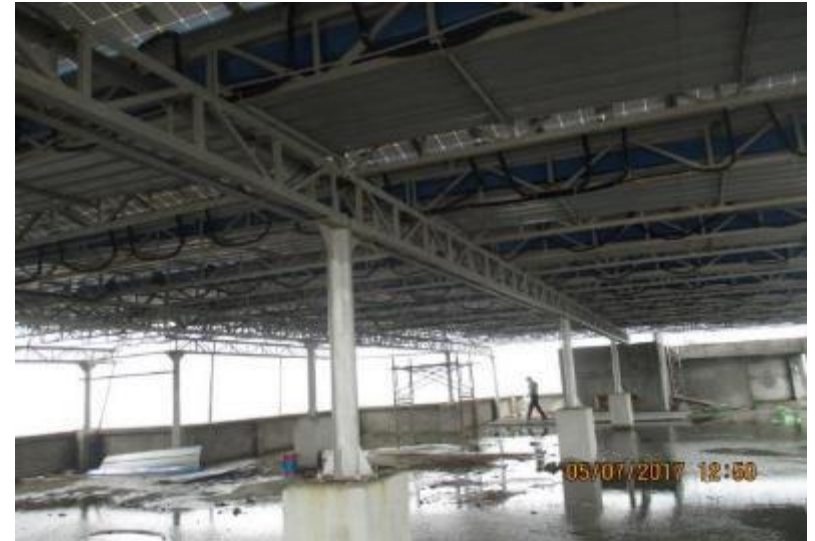
Roof top Solar panel

Apparently lack of lateral stability system observed on truss supported Solar panel.

No As built drawing was found during inspection. Factory engineer is required to update the as-built drawing and check the stability against lateral load.

| Item No. | Observation | Recommended Action Plan | Recommended Timeline |
|---|---|---|---|
| 5 | Lateral stability of the roof top solar panel | Factory engineer to survey the roof top Solar panel structure and update the as-built drawing of building. | 6-weeks |
| 6 | Lateral stability of the roof top solar panel | Factory engineer to check the stability of the Solar panel structure against lateral loads. | 6-weeks |
| 7 | Lateral stability of the roof top solar panel | Carry out remedial works resulting from engineering assessment if necessary. | 6-months |

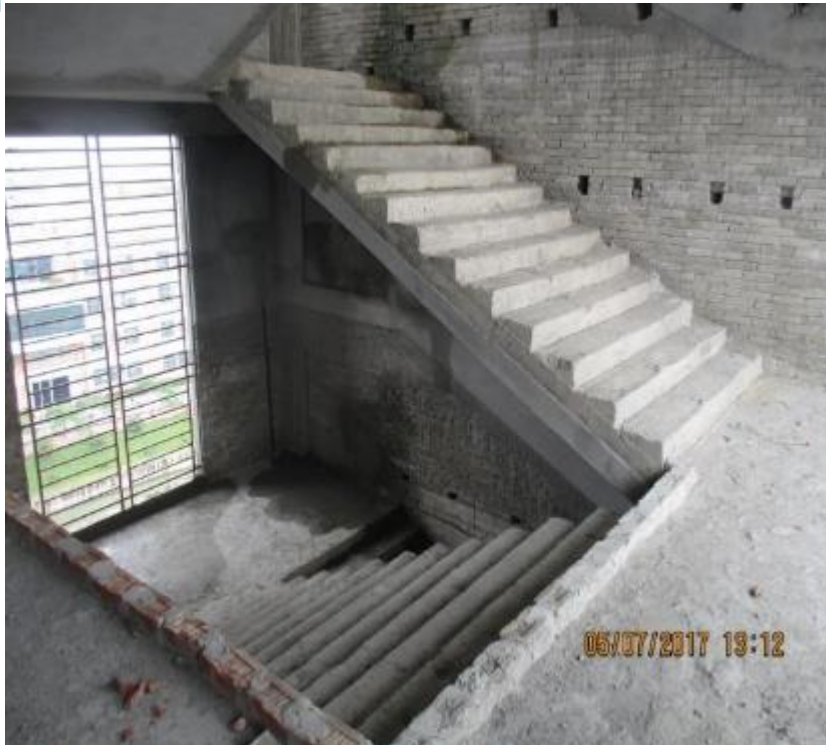
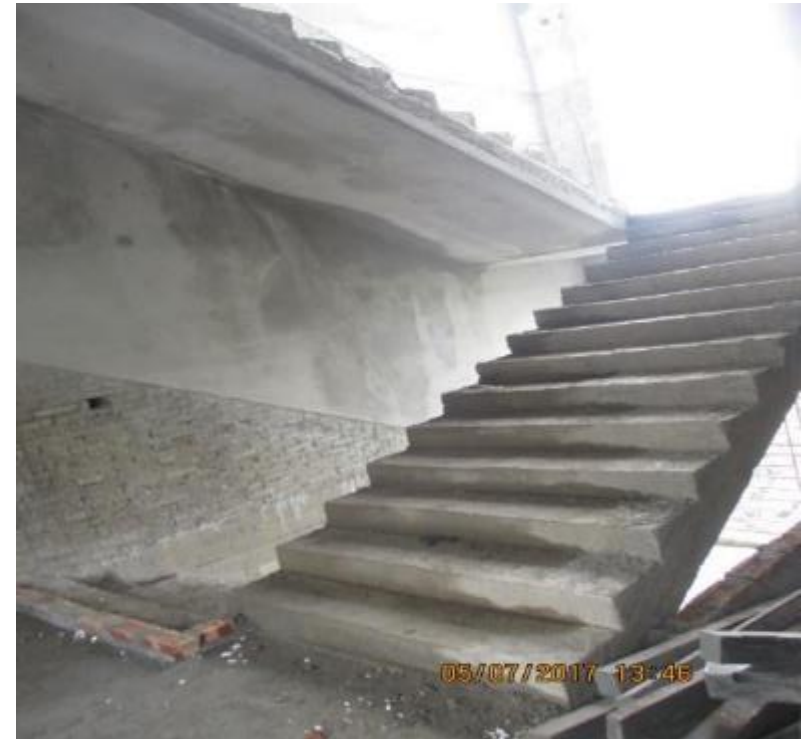
**Edge protection was absent around staircase**

No edge protection was observed on top three floors staircase. Factory engineer is required to install the edge protection for preventing the falling hazard.

| Item No. | Observation | Recommended Action Plan | Recommended Timeline |
|---|---|---|---|
| 8 | Edge protection was absent on staircase | Factory is required to install proper edge protection on all stair case where it needs. | Immediate - Now |
