# Romo Fashion Today Ltd. (9373)

Vannera Road, Mouchak, Kaliakoir, Gazipur

31.05.2014

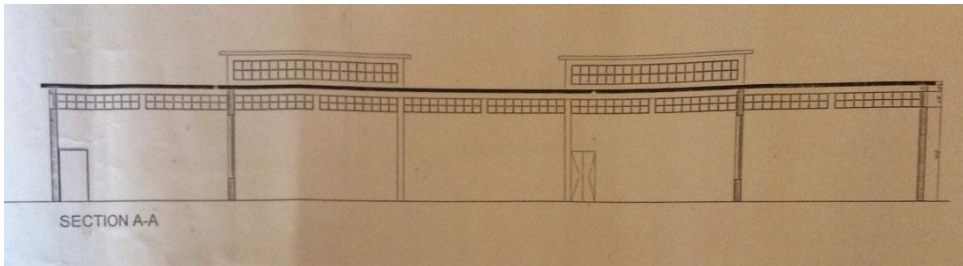
For the Office Building, there were no structure documents for the roof, the walls or the foundations.

Item No.	Observation	Recommended Action Plan	Recommended Timeline
1	Priority 2 - Factory and Office Building - Incomplete documents.	The Factory Engineer must review survey all buildings and update all record information, adding new drawings where information is completely missing.	6-weeks
2	Priority 3 - Toilet, Generator and Maintenance Sheds - Poorly built roofs.	The Factory Engineer is to carry out an assessment of the lightweight roofs to all of the sheds.	6-months
3	Priority 3 - Factory Building - Reinforcement steel exposed at roof level.	The reinforcement is to be removed and a new waterproofing layer applied to both main building roofs.	6-months

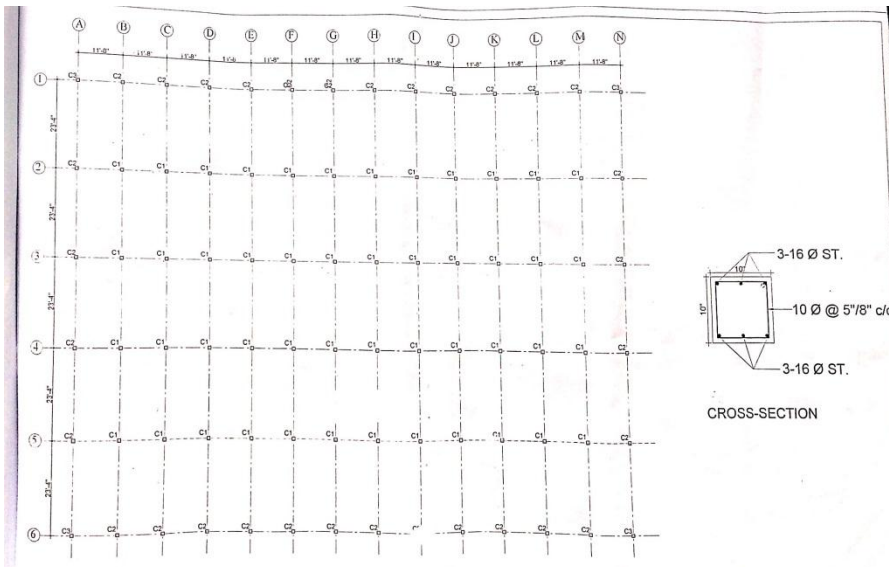
For the Factory Building, the column schedule is incomplete; we noted some columns were not listed at all.

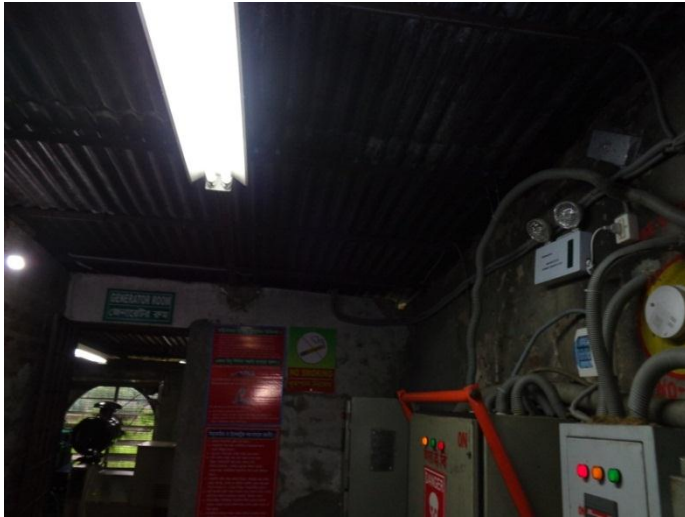
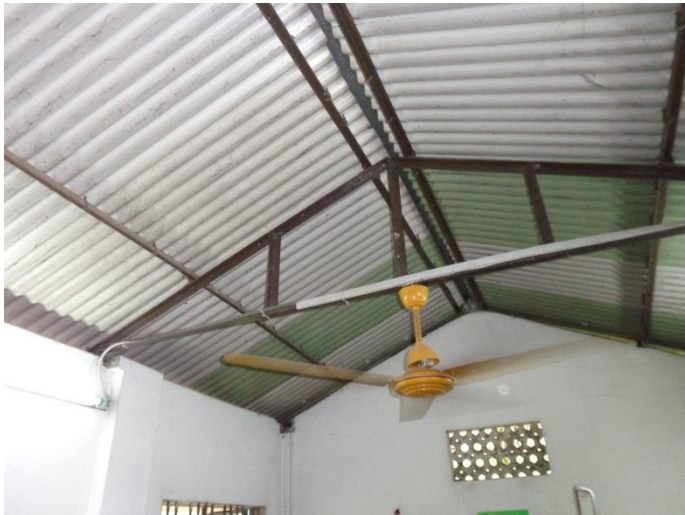
The Generator shed, Toilet shed and Maintenance shed - all the steel roofs must be verified and checked against wind uplift. A design check of all of these sheds and their details must be included in an Engineering Assessment.

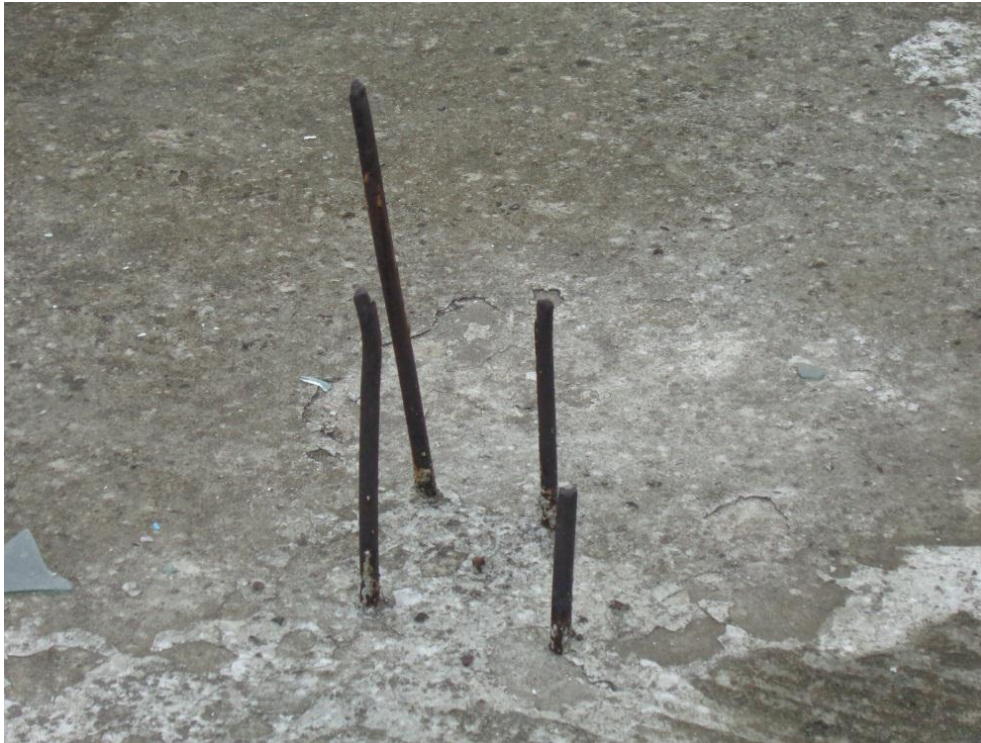
The Factory Building has reinforcement steel bars extended above the roof slab. This will allow rainwater to seep into the concrete slab and cause long-term soaking of the slab. The reinforcement should be removed and new waterproofing should be applied to the entire roof..

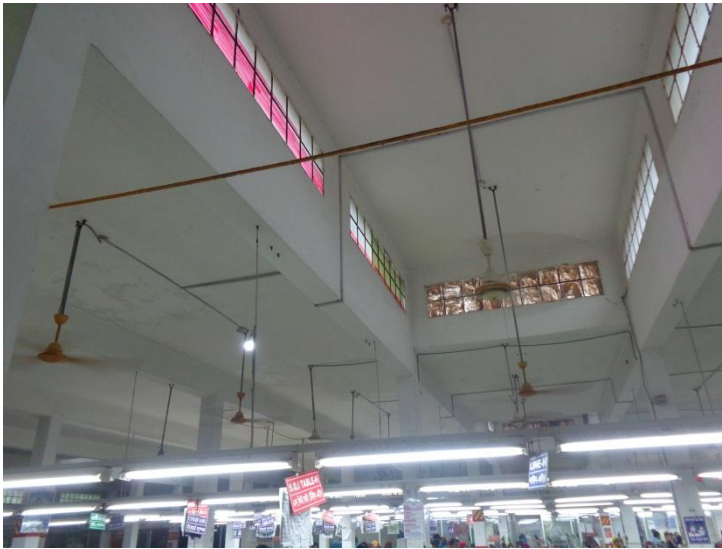
in the Factory Building, we believe that the intent of the original structural design was to use the main grid line beams to provide some form of lateral stability via moment frame action. However, the grid line beams only exist in one direction (north to south). In the other direction (east to west) there are no beams.

We require that the lateral support system is investigated as part of a Engineering Assessment.

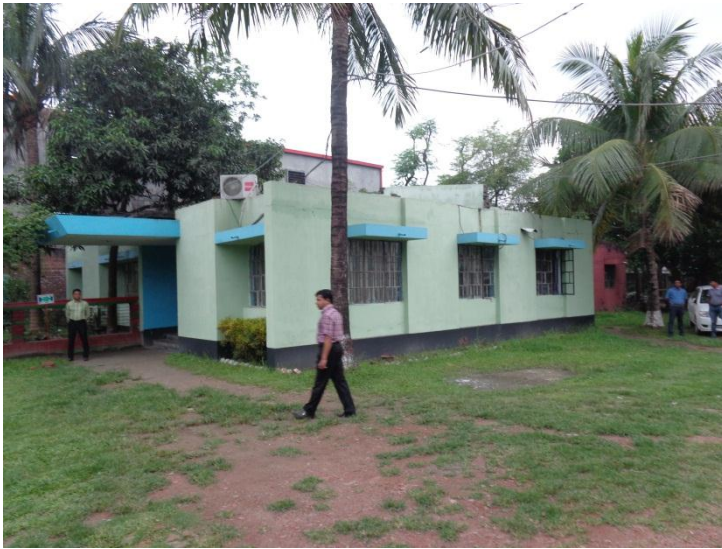
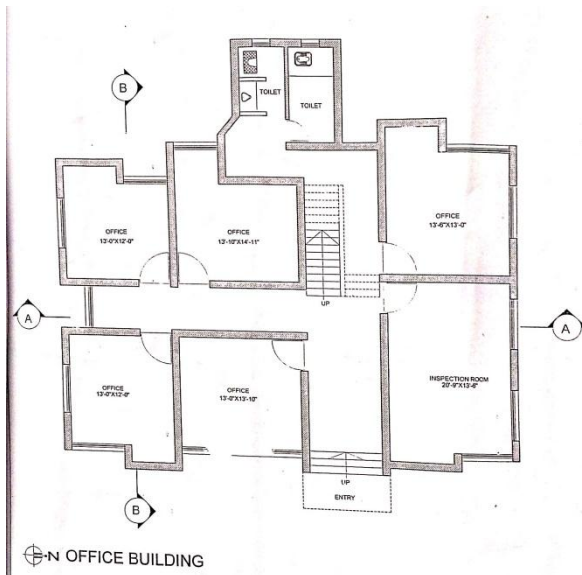
OFFICE BUILDING

In the Office Building, the building structure is composed of concrete slab at the roof. This slab is supported by masonry walls of 250mm thick. These walls are used also as architectural partitions and provide the overall stability.

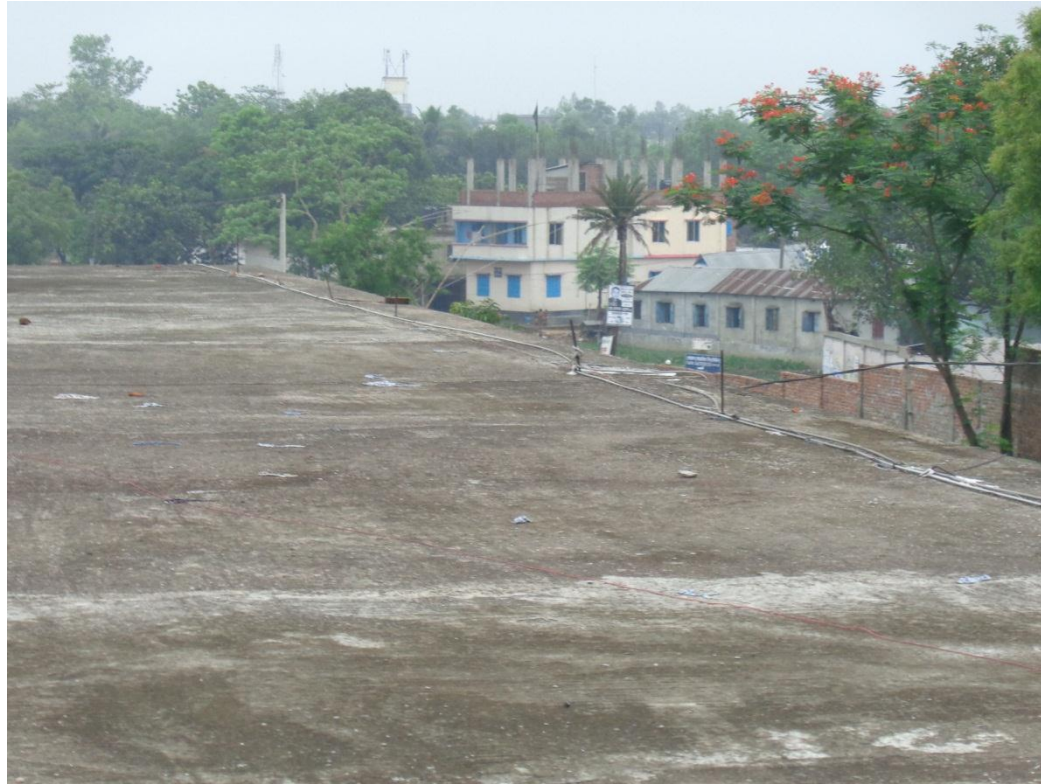
The concrete roofs of the Factory Building and the Office Building have no waterproofing membrane. This means that any cracks in the surface will allow water to seep into the concrete slab and cause long-term soaking of the slab.
