Fin Bangla Apparels Ltd.

72, Degarchala Road, Chaydana, National University, Gazipur
(23.963968N, 90.384676E)

31th July 2017

Discrepancies between provided drawing and on site condition of Main building

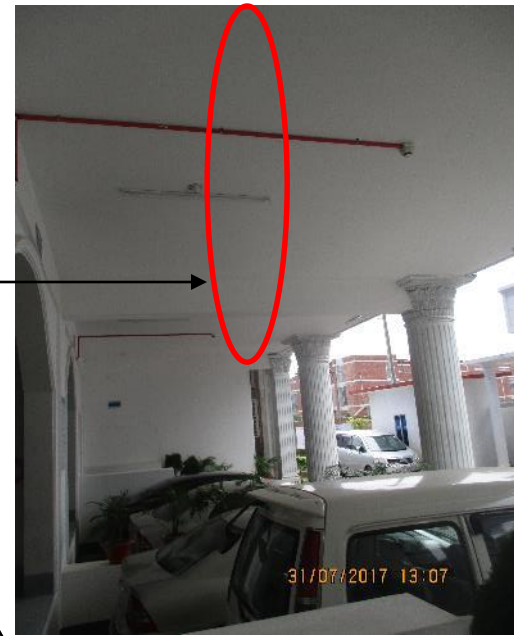
Secondary beam was not observed on east side loading/unloading area

Building Engineer required to prepare As –Built drawings reflecting the actual condition.

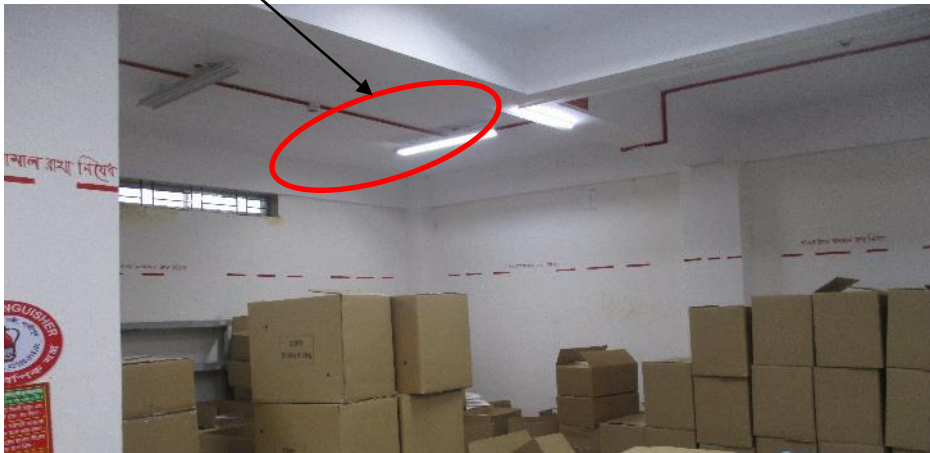
Secondary beam was not observed on south-west side in storage area

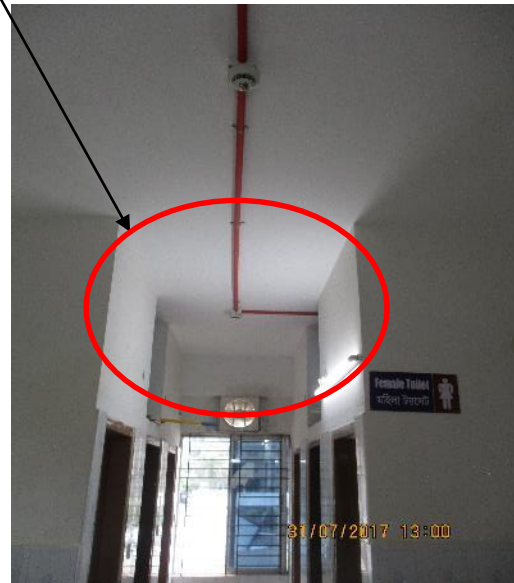
Secondary beam was not observed on east side toilet area

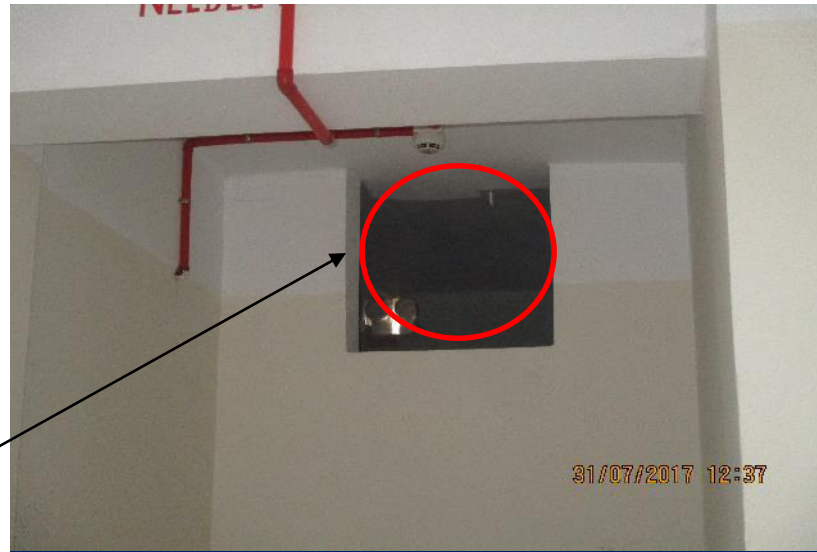
Secondary beam was not observed on east side toilet area on 1st to 3rd floor

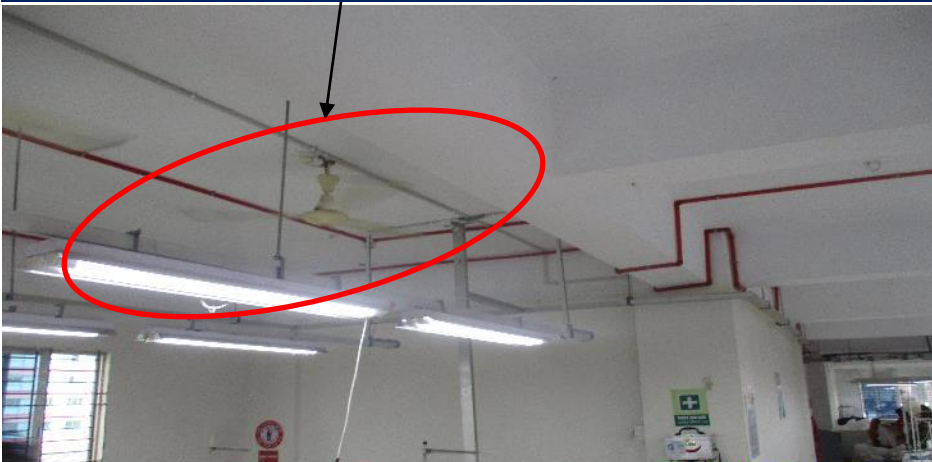
Secondary beam was not observed on south-west side on 1st to 3rd floor

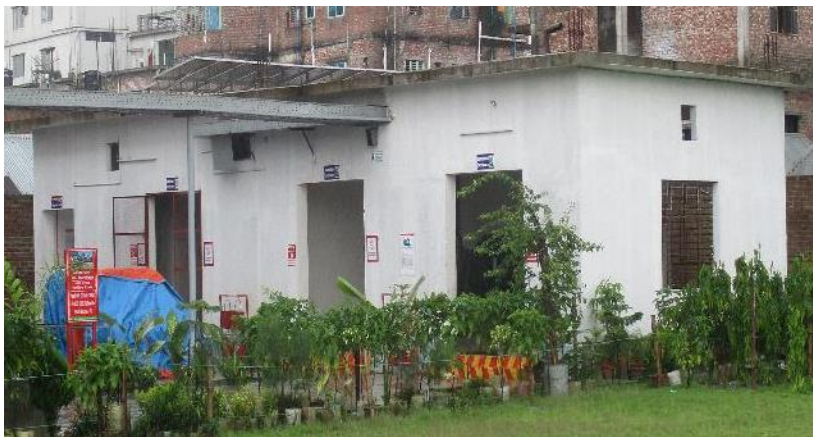
Utility Building

Lack of as-built documentation (Five buildings except Main Building)

Factory could not provide any structural drawing for above these buildings. Building Engineer is required to produce a full set of as built drawing reflecting on site condition for those buildings.

- Factory engineer is required to survey and produce accurate as-built drawing as per actual condition.

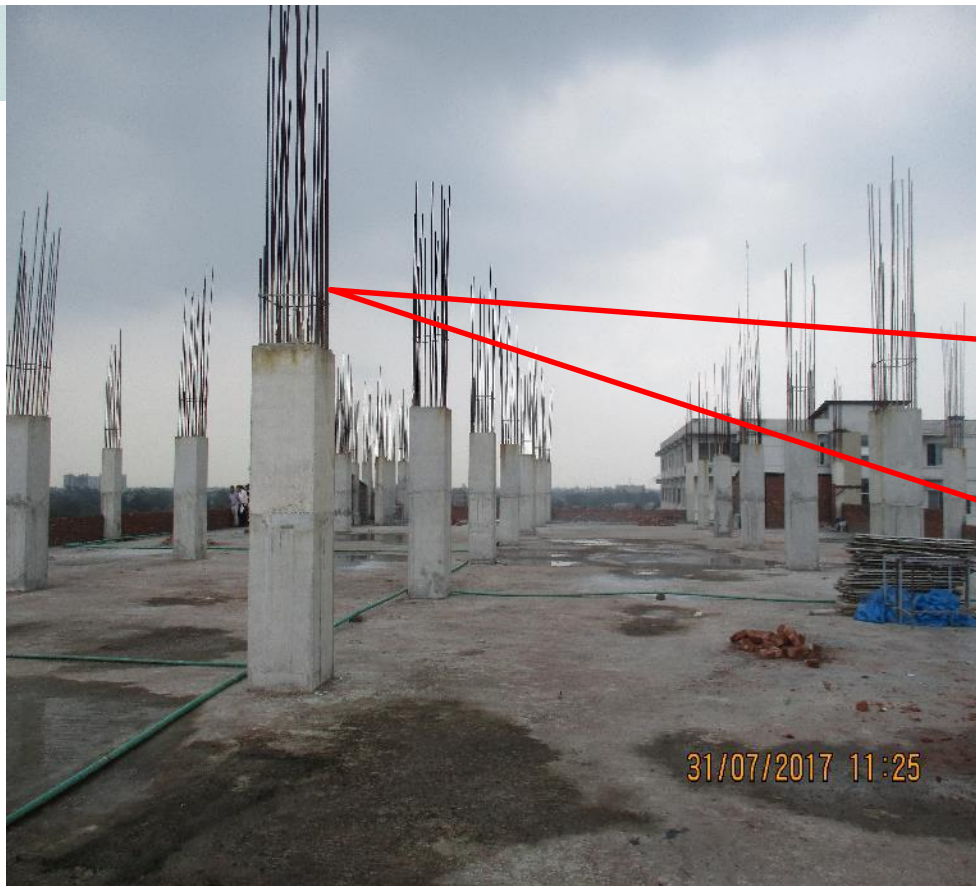
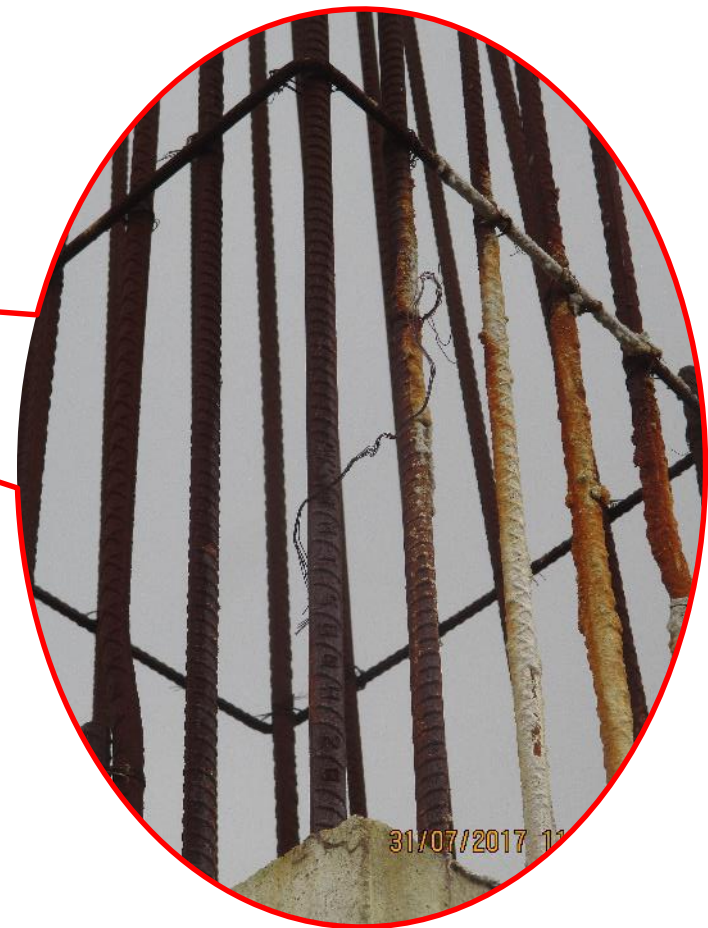
Corrosion on roof top exposed reinforcement of Main building

During inspection, corrosion was observed on almost all exposed reinforcement of column on roof top

- Building Engineer is required to investigate the extent of corrosion and suggest necessary repairing action.

- Implement repairing works as per engineer's advice.

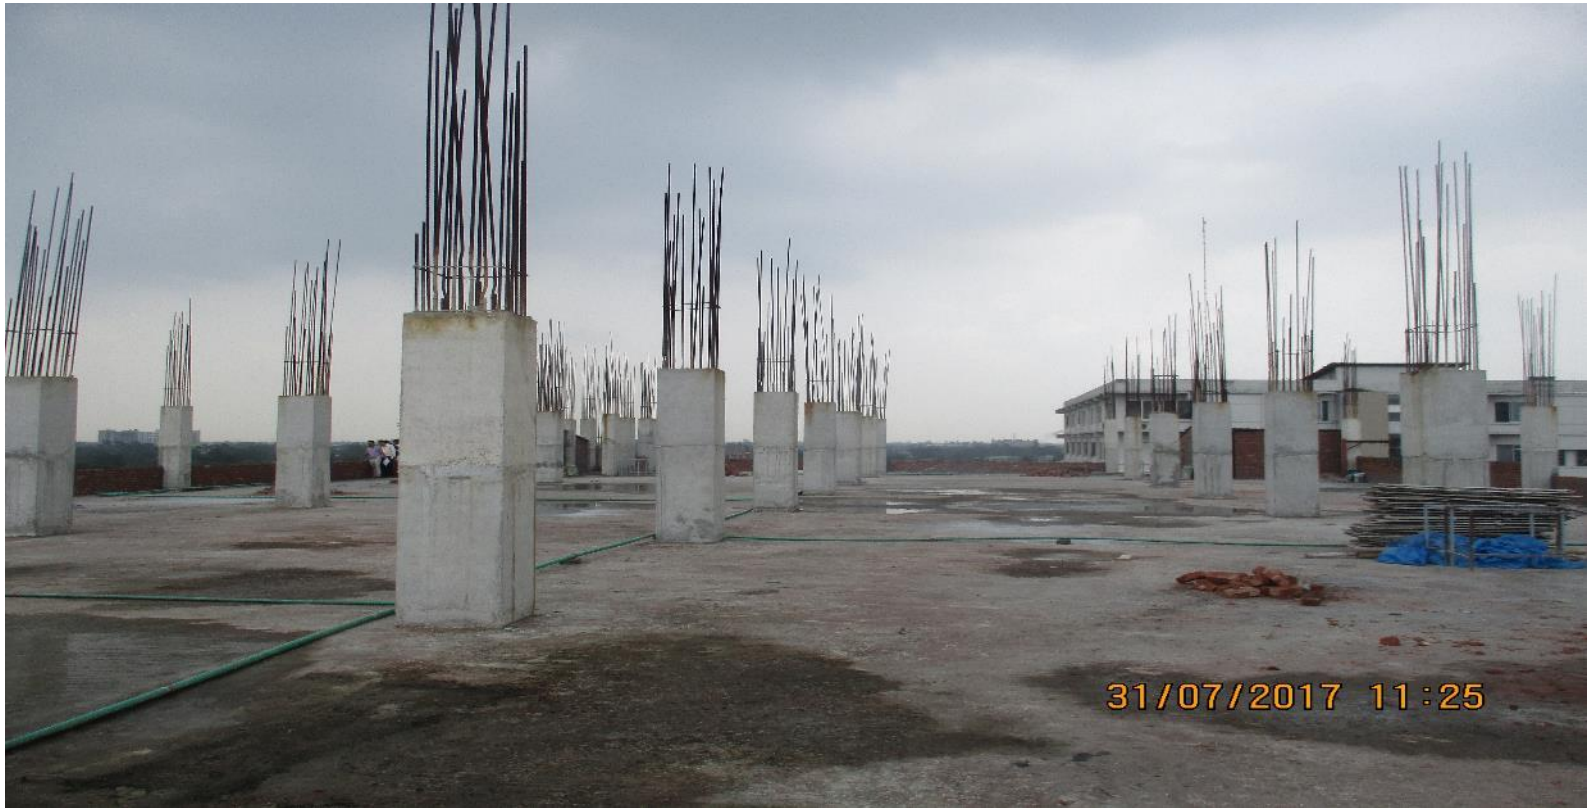
Excessive column stresses in fully completed Main building (8-storeys)

Exposed reinforcement on roof top and building permission for 8-storey was indicate further extension of the building. For any future extension may cause a significant increase in column loads. Details Engineering Assessment would required to be carryout before construction of additional floor above 4 storey.

- In case of any extensions or modifications of the existing building needs to be carryout Details Engineering Assessment by a Structural Engineer and in full compliance with the BNBC provision.
