# P.M. Knittex (Pvt) Ltd. (9944)

Chowdhurry Bari, Godhnail, Narayangonj.

01.June.2014

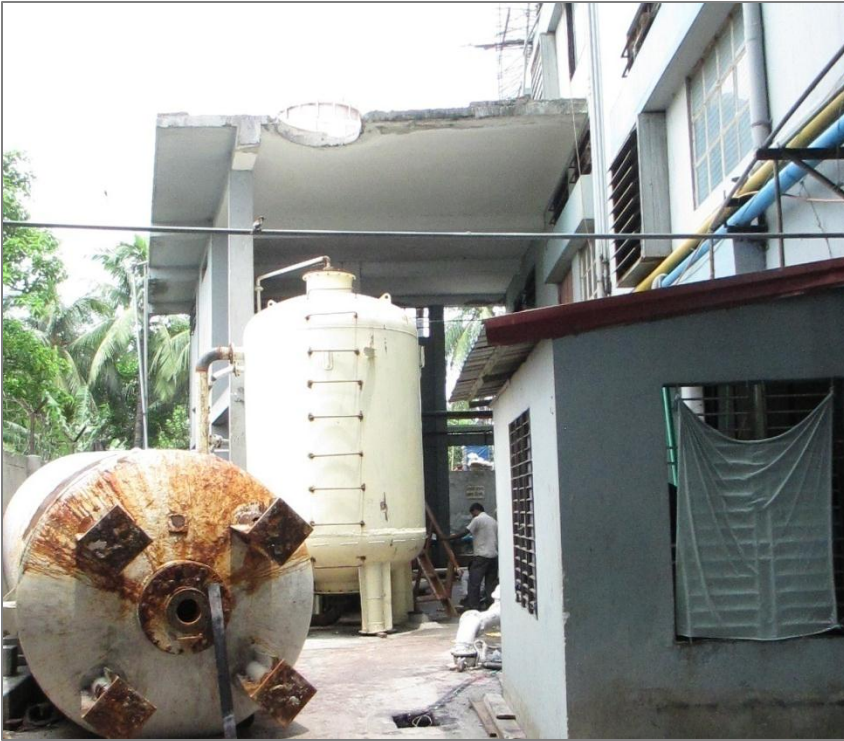
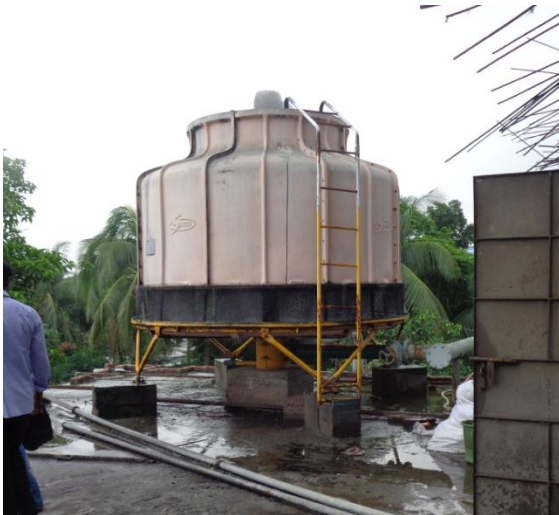
Cooling towers are located on the corner of Building #1.

- The support structure (a propped slab) is not shown on the provided structural drawings so there was no way to assess the load carrying capacity of the slab.
- The slab is approximately 6m high and supports two large air conditioning outdoor cooler units.

| Item No. | Observation | Recommended Action Plan | Recommended Timeline |
|---|---|---|---|
| 3 | Priority 1 - Building #1 Cooling Tower support structure appears inadequate. | The Factory Engineer is to carry out an Engineering Assessment on the RC cooling tower support structure, checking foundations, columns, beams and slab. | 6-weeks |
| 4 | Priority 1 - Building #1 Cooling Tower support structure appears inadequate. | If deemed necessary by the Factory Engineer, carry out any remedial works recommended. | 6-months |

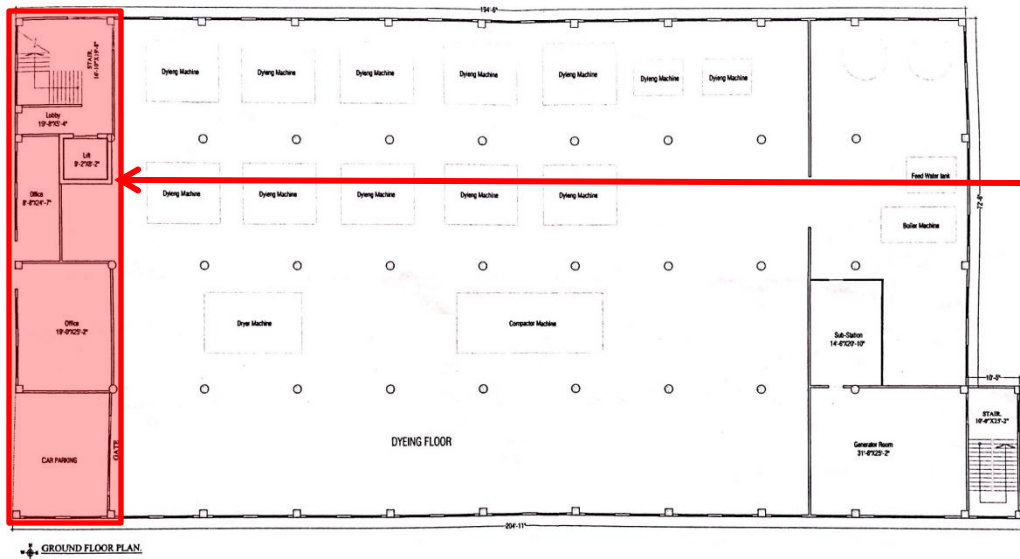
Building #1 has a mezzanine between the ground floor and the 1st floor. It is located along the front face of the building. The ground floor plan does not show the mezzanine or indicate its structural design.

| Item No. | Observation | Recommended Action Plan | Recommended Timeline |
|---|---|---|---|
| 5 | Priority 2 - Building #1 – Mezzanine between and the ground floor and first floor no design documents were provided. | The Factory Engineer is to carry out a full Engineering Assessment of the mezzanine and produce as-built drawings. | 6-weeks |
| 6 | Priority 2 - Building #1 – Mezzanine between and the ground floor and first floor no design documents were provided. | If deemed necessary by the Factory Engineer, carry out any remedial works recommended.<br>Produce as-built drawings according to the assessment. | 6-months |

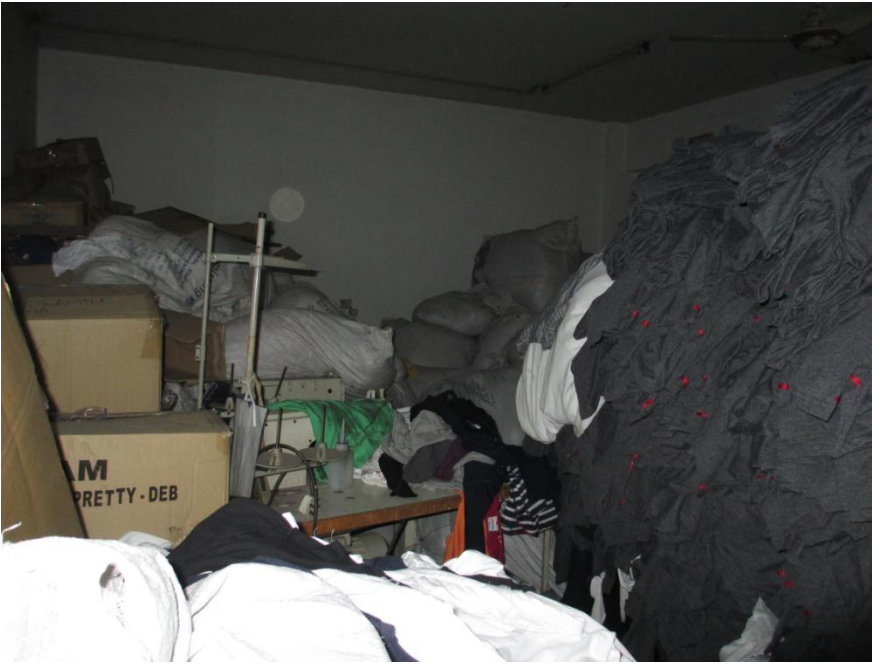
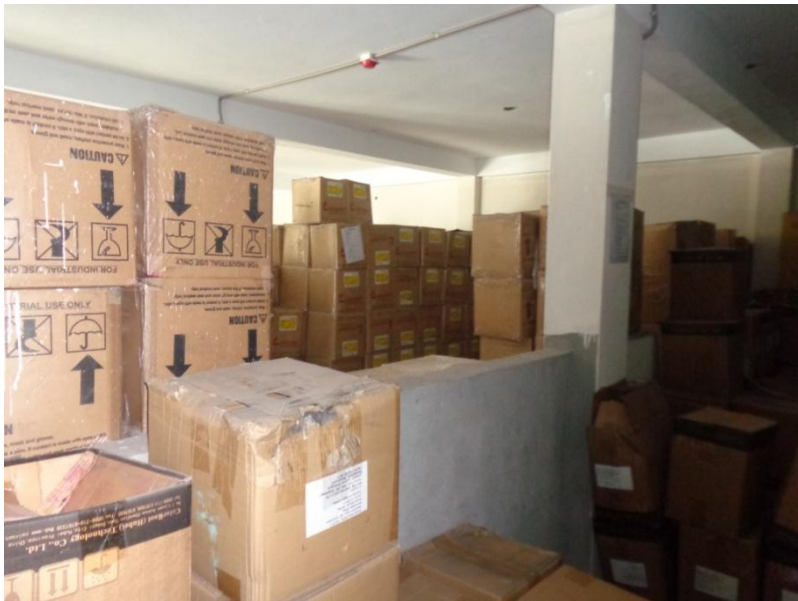
Uncontrolled loading in Building #1. In Building #2; the first floor is used mainly for chemical storage. Most of the floor was loaded with more than 2.0kPa. There were no loading plans available and no method of monitoring the live load on each floor.

| Item No. | Observation | Recommended Action Plan | Recommended Timeline |
|---|---|---|---|
| 7 | Priority 2 - Buildings #1 & #2 floor loading should be controlled. | Reduce all floor loading to below 2.0kPa. | Immediate - Now |
| 8 | Priority 2 - Buildings #1 & #2 floor loading should be controlled. | Produce and maintain floor loading plans accordingly for each building and all floors. | 6-weeks |
| 9 | Priority 2 - Buildings #1 & #2 floor loading should be controlled. | Maintain and enforce all loading plans. | 6-months |

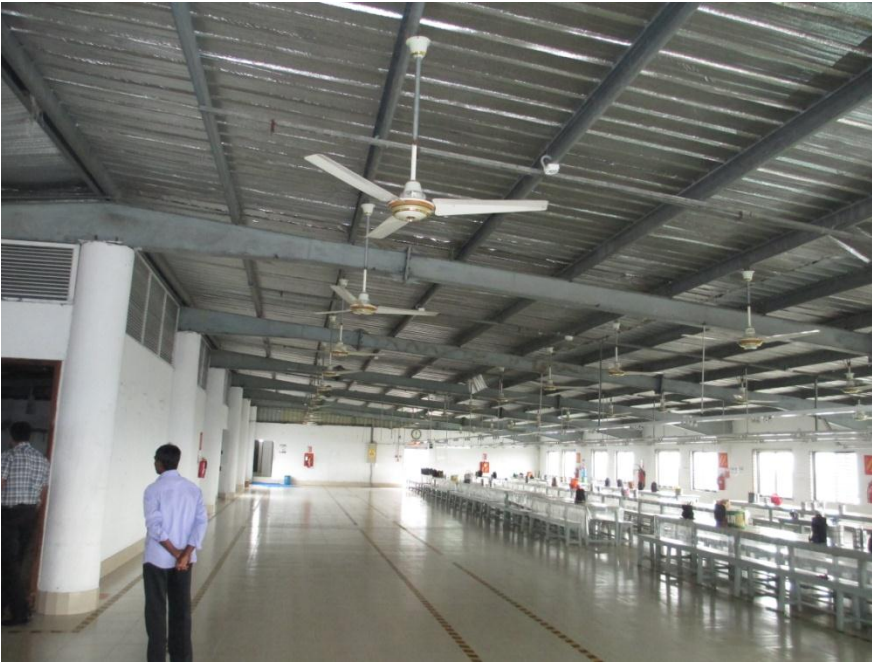
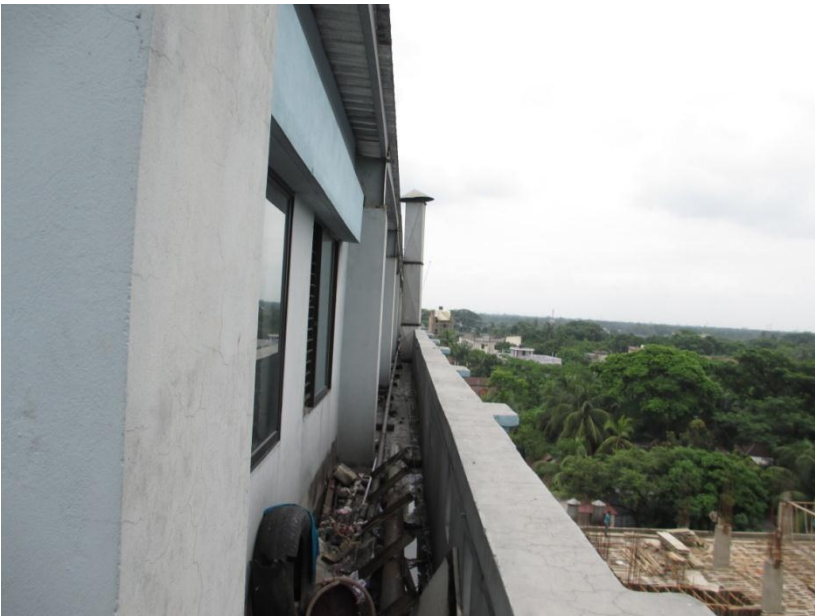
No documents were provided for the Dining space on the top of the building. From a visual observation we note a lack of any lateral stability support; no bracing or compression/tie beams were provided between columns. The brick walls were not aligned with the columns so cannot therefore be considered to provide any form of lateral restraint.

| Item No. | Observation | Recommended Action Plan | Recommended Timeline |
|---|---|---|---|
| 10 | Priority 2 - Building #1, No documents were provided for the dining room on the roof. | The factory Engineer is to full survey and produce as-built drawings for the roof top structures. | 6-weeks |
| 11 | Priority 2 - Building #1, No documents were provided for the dining room on the roof. | The Factory Engineer is to provide details to reinforce and stabilise the structural elements. | 6-months |

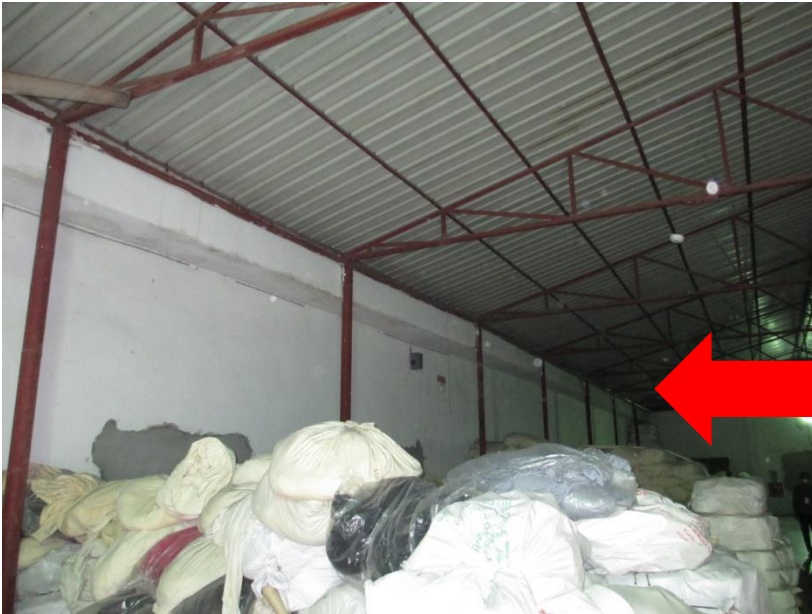
Knitting shed

- Trusses were supported by a brick lintels.
- Steel members not properly restrained or tie down against uplift wind forces.
- Improvised truss support details.
- Weak bamboo and timber supporting members.

| Item No. | Observation | Recommended Action Plan | Recommended Timeline |
|---|---|---|---|
| 12 | Priority 2 - Knitting, Generator, Chemical storage and waste storage sheds are poorly constructed. | The Factory Engineer is to carry out an assessment of all of the sheds. Their roofs, walls and columns. | 6-weeks |
| 13 | Priority 2 - Knitting, Generator, Chemical storage and waste storage sheds are poorly constructed. | If deemed necessary by the Factory Engineer, carry out any remedial works recommended.<br>Produce as-built drawings reflecting the site conditions. | 6-months |

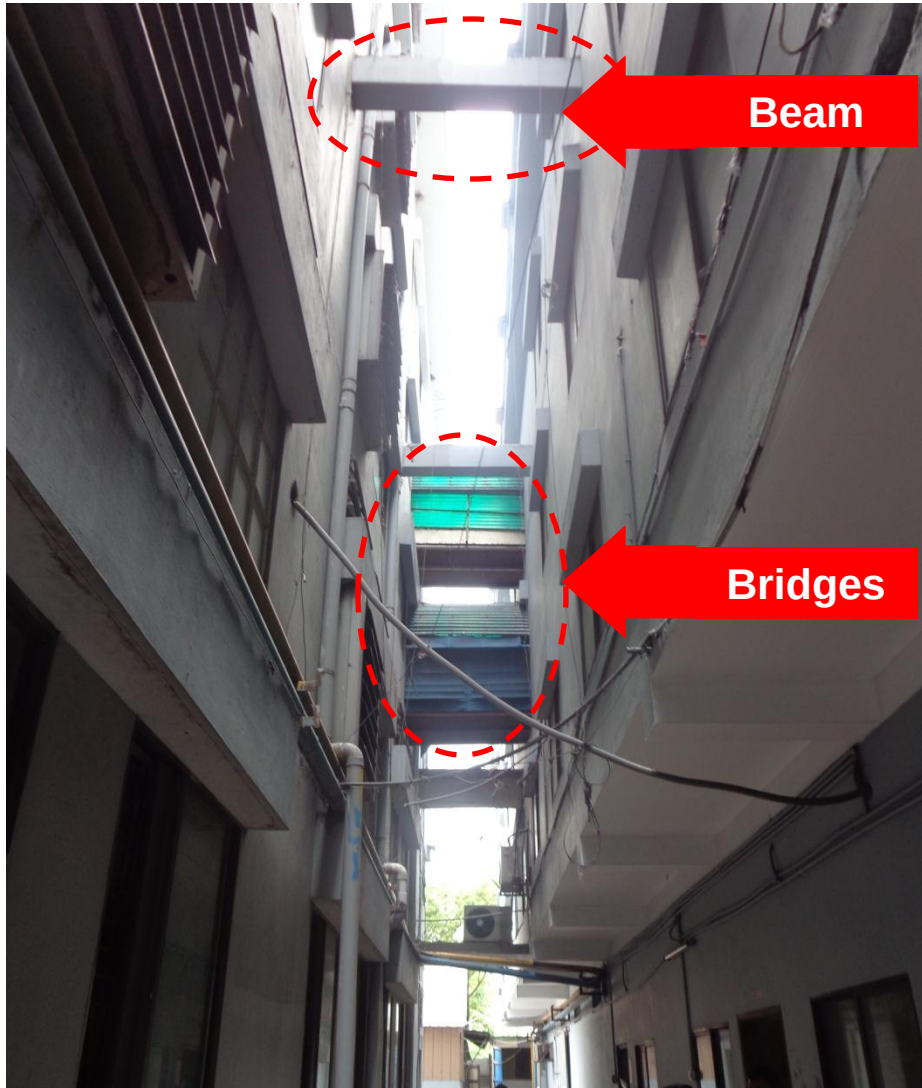
We found several improvised beams and two footbridges between Building #1 and Building #2. These are not mentioned in the documents. The original Design Engineer confirmed that these beams and bridges were not present on the original construction drawings. Their positions, reinforcement details, actual sizes and joint details are unknown, these need to be assessed and verified.

| Item No. | Observation | Recommended Action Plan | Recommended Timeline |
|---|---|---|---|
| 14 | Priority 3 - Buildings #1 & #2 - Improvised footbridge and connecting beams between the two buildings. | The Factory Engineer is to carry out an Engineering Assessment of the foot bridge | 6-weeks |
| 15 | Priority 3 - Buildings #1 & #2 - Improvised footbridge and connecting beams between the two buildings. | If deemed necessary by the Factory Engineer, carry out any remedial works recommended. | 6-months |

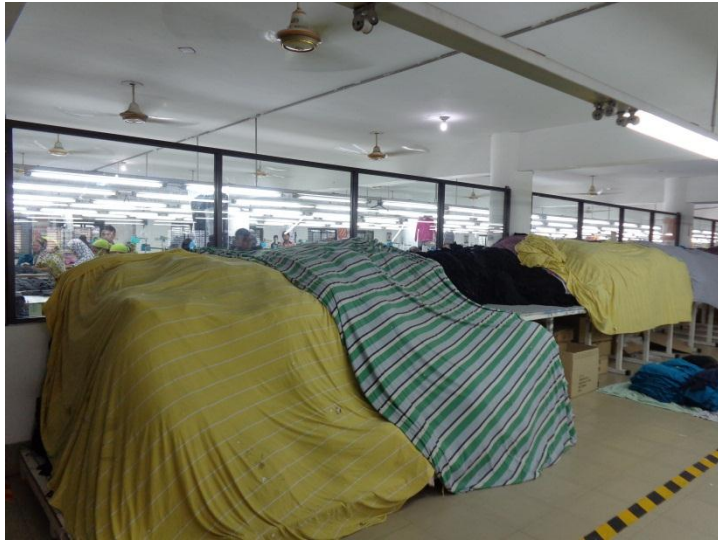
1<sup>st</sup> and 2<sup>nd</sup> floor levels

We believe that the intent of the original structural design was to use the main grid line beams to provide some form of lateral stability via moment frame action although no ductile detailing is provided on structural drawings.

However, in Building #1, there are beams in one direction at 1<sup>st</sup> and 2<sup>nd</sup> floor levels; in the short directions only.

We require that these items be investigated in a Detailed Engineering Assessment.

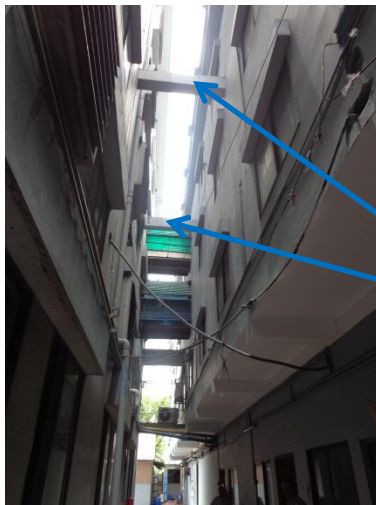
Tie beams

The two buildings are connected with tie beams. These are not shown on any structural drawings. Each building must be independently stable and these beams can not be used to transfer lateral load from one building to the other given they were not in the original design.

We require that these items be investigated in an Engineering Assessment

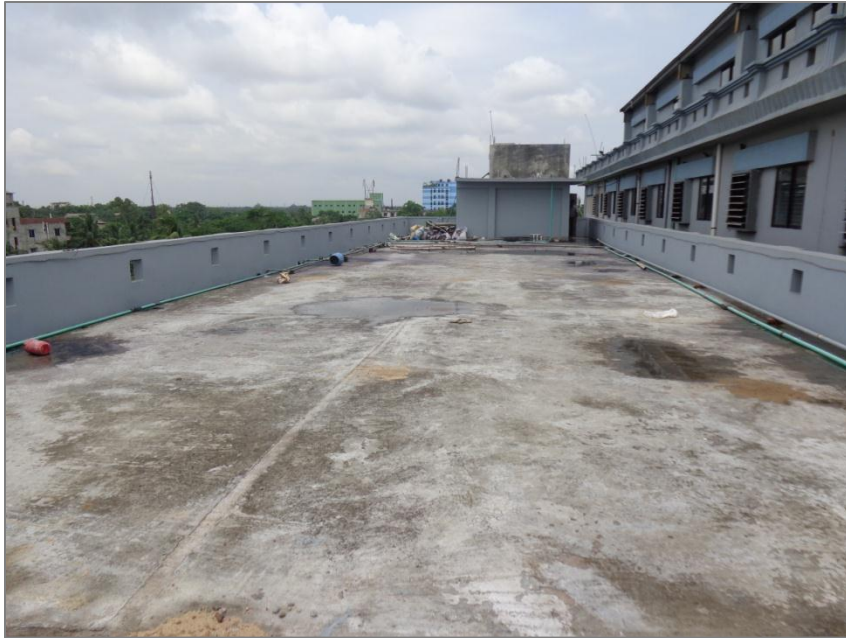
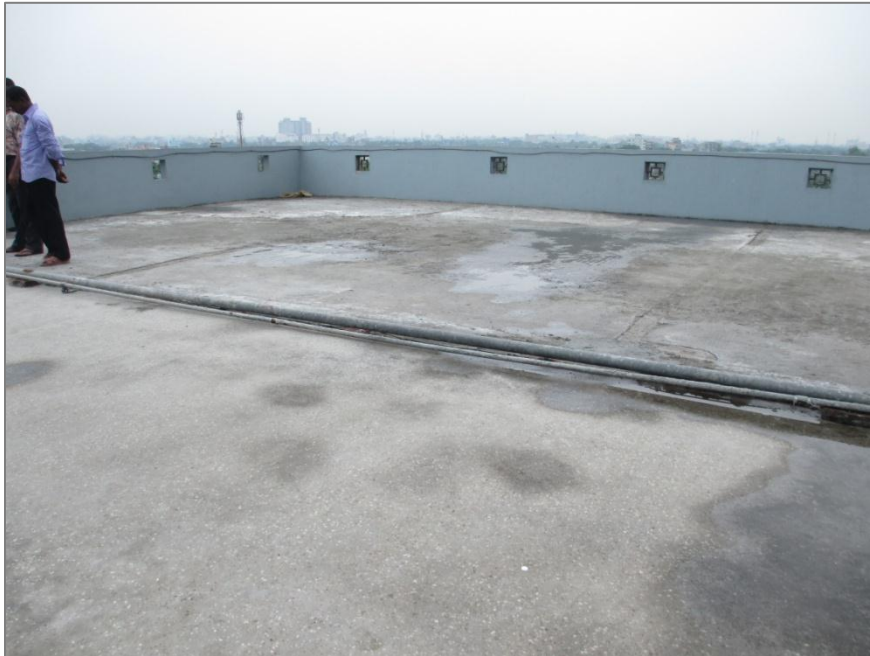
No waterproofing membrane was visible on the roof of either building. This means that any cracks in the surface finishes on the roof will allow water to seep into the concrete slab beneath the finishes, and cause long-term soaking of the slab. The same applies to the water tanks at roof level. To resolve this situation, a water proofing membrane should be applied on all the surface of the roof and the water tank.

| Item No. | Observation | Recommended Action Plan | Recommended Timeline |
|---|---|---|---|
| 16 | Priority 3 - Building #1 & #2 do not have any waterproofing membrane applied to the roof. | Cover the concrete roof with a suitable waterproofing membrane, e.g. waterproof screed. | 6-months |
