# Sakura Dyeing & Garments Ltd. (9876)

Kutubail, Fatullah, Naranganj

01.JUNE.2014

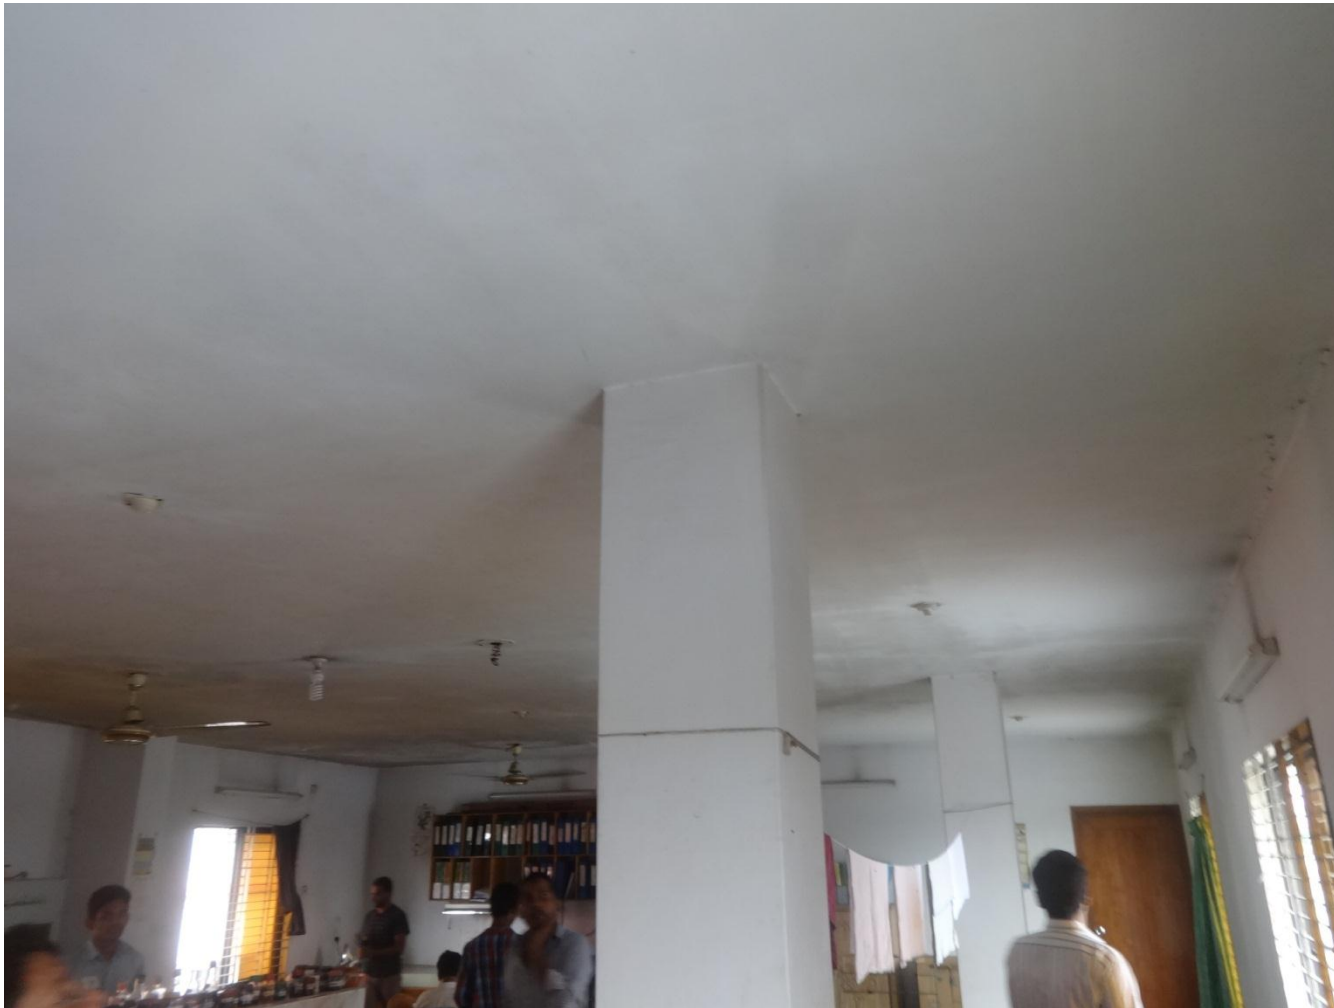
Lateral stability system in three-storey building seems insufficient, with only flat slab construction above 1<sup>st</sup> floor level and no reinforced core.

Left, the flat slab arrangement as witnessed in the three-storey building. The stair walls were scanned for reinforcement but it was determined that these were not reinforced shear walls.

This does not seem sufficient for lateral stability of the building, and the tie-detail between perimeter beams and rigid walls (on three sides only) may be critical.

| Item No. | Observation | Recommended Action Plan | Recommended Timeline |
|---|---|---|---|
| 1 | Priority 2 - Questionable lateral stability system in three-storey concrete building, with clarification also required for 'Dyeing Shed' and 'Boiler Room'. | Detailed Engineering Assessment required to determine capacity of three-storey building and adjacent 'shed' buildings against lateral loading. | 6-weeks |
| 2 | Priority 2 - Questionable lateral stability system in three-storey concrete building, with clarification also required for 'Dyeing Shed' and 'Boiler Room'. | Any amendments to the structure deemed necessary by the DEA to be implemented under Structural Engineer's supervision. | 6-months |

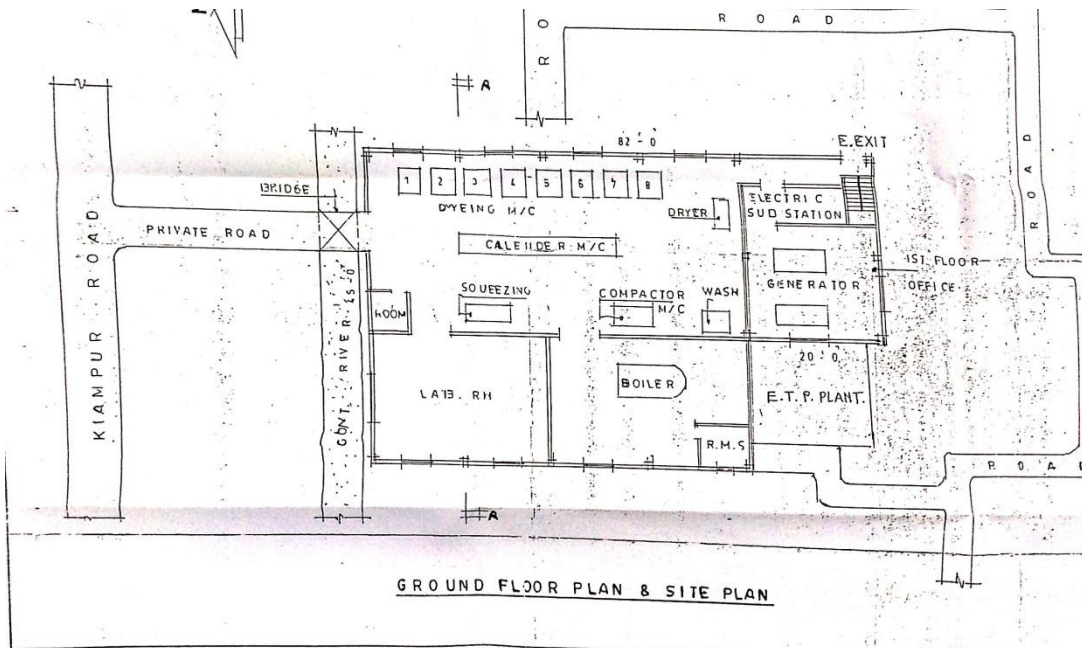
The column schedule to the right indicates a uniform column dimension for the full height of the building. In reality the columns were smaller at upper floor levels.

The drawing to the left is an indication of the level of information received for the three-storey building and associated steel/concrete sheds.

This level of information must be improved, with full structural drawings provided for all buildings on the site.

| Item No. | Observation | Recommended Action Plan | Recommended Timeline |
|---|---|---|---|
| 5 | Priority 3 - Some discrepancies between structural drawings and observed site conditions, with some drawings entirely absent. | Factory Engineer to survey actual site conditions and revise drawings to match.<br>Where drawings were not provided, original design drawings to be recovered or, if lost, as-built drawings to be produced. | 6-months |

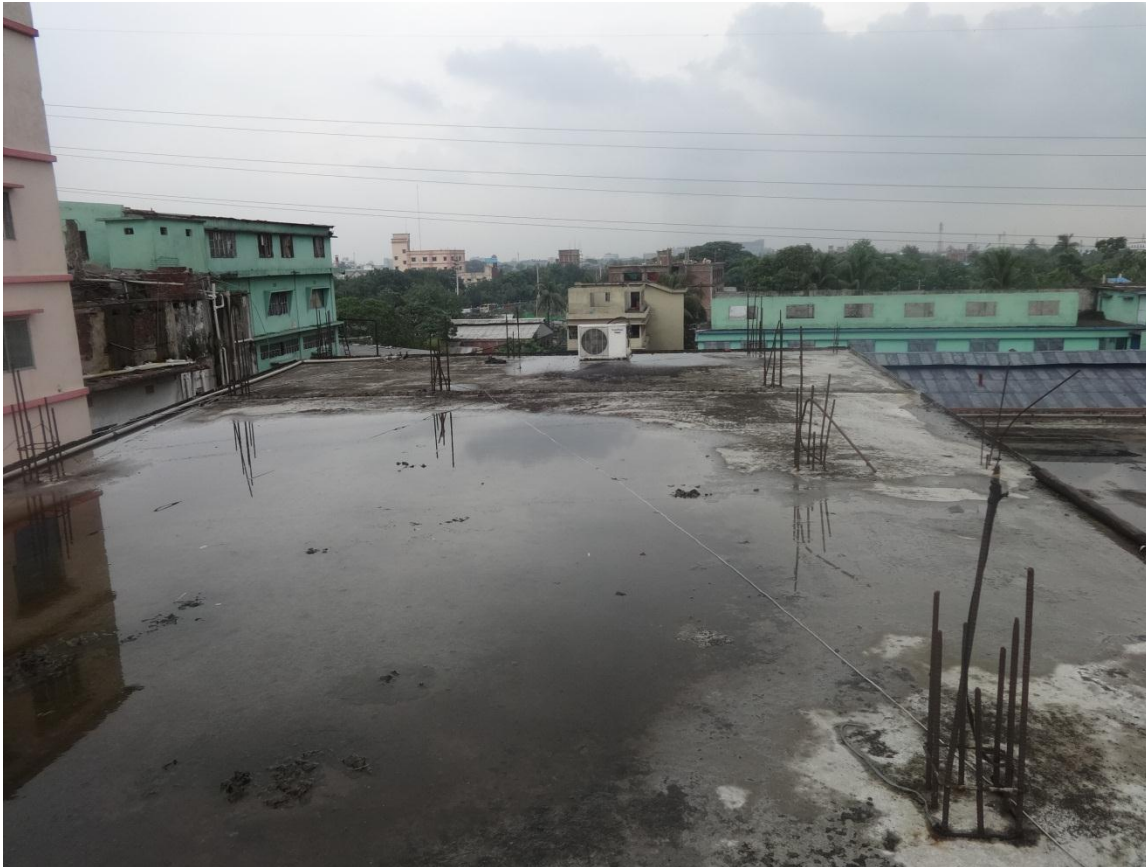
To the left is the roof level of the three-storey building, with protruding reinforcement above, as was observed on all concrete buildings.

This in itself does not raise any concerns, however it was stated that the foundations had been designed to withstand the load of a ten-storey building on the site of the existing six-storey building.

Given the questions that have already been raised about the suitability of the foundations under their existing loading conditions, it is recommended that these additional storeys are not constructed.

| Item No. | Observation | Recommended Action Plan | Recommended Timeline |
|---|---|---|---|
| 6 | Priority 3 - Suggestions of an upward extension but no structural design drawings seen. | Ideally, no upward extension to be added.<br>If planned, full structural design and drawings, as well as appropriate Building Permit, to be completed prior to any works commencing.<br>Note also that a back-check of the foundations must also be carried out. | 6-months |

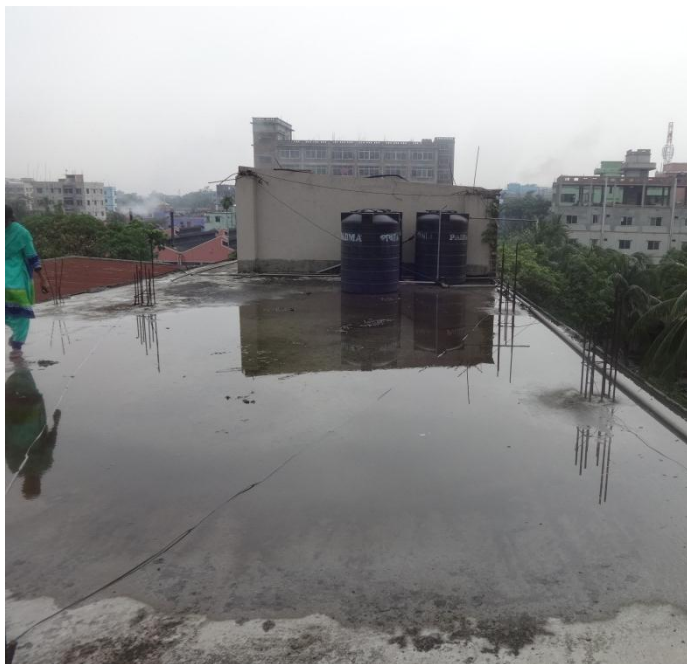
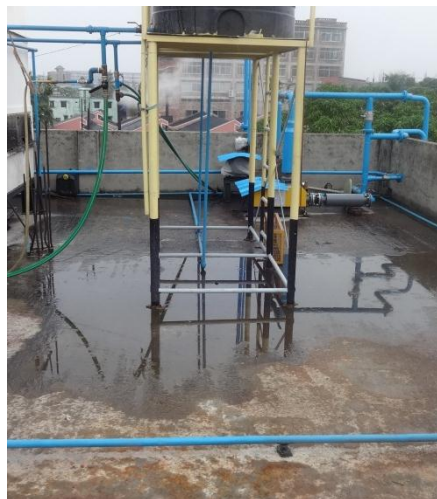
Ponding was observed on all concrete roof levels, with signs of water ingress inside the structure also visible in some locations.

The images to the left show instances of fairly extensive ponding on the three-storey building (left) and the ETP (right), as was also observed on the six-storey building.

To prevent this issue from getting worse, and potentially causing damage to structural elements, a waterproofing layer should be applied to roof level of all concrete buildings.

| Item No. | Observation | Recommended Action Plan | Recommended Timeline |
|---|---|---|---|
| 7 | Priority 3 - Extensive ponding on all concrete roofs, with some signs of water ingress within the building. | Waterproofing membrane to be applied to all concrete roof surfaces.<br>Factory Engineer to oversee installation, to ensure that excessive load is not added to the roof structure. | 6-months |

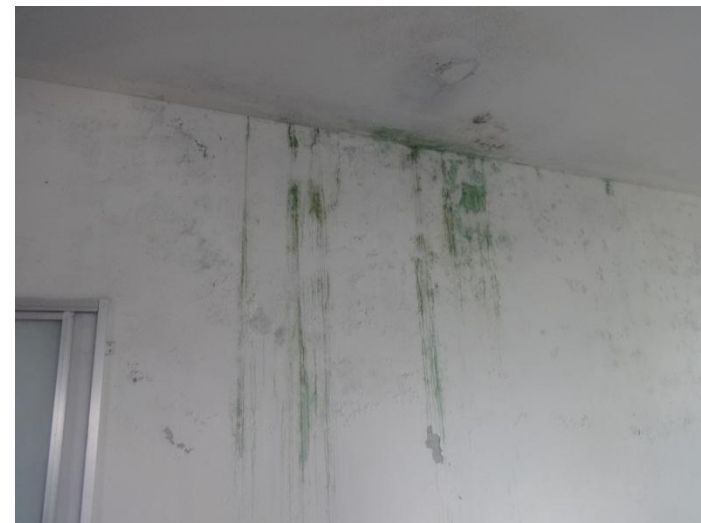
To the right is the worst instance of water ingress observed within the six-storey building.

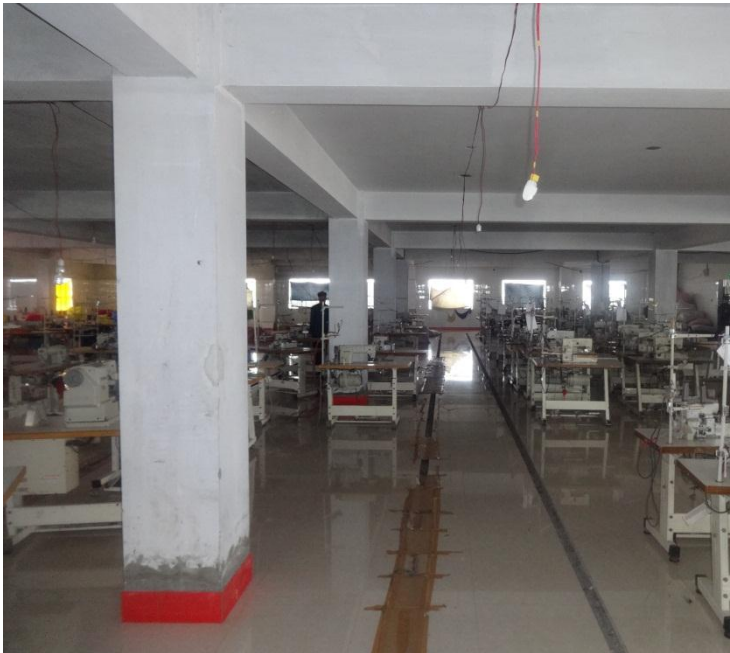
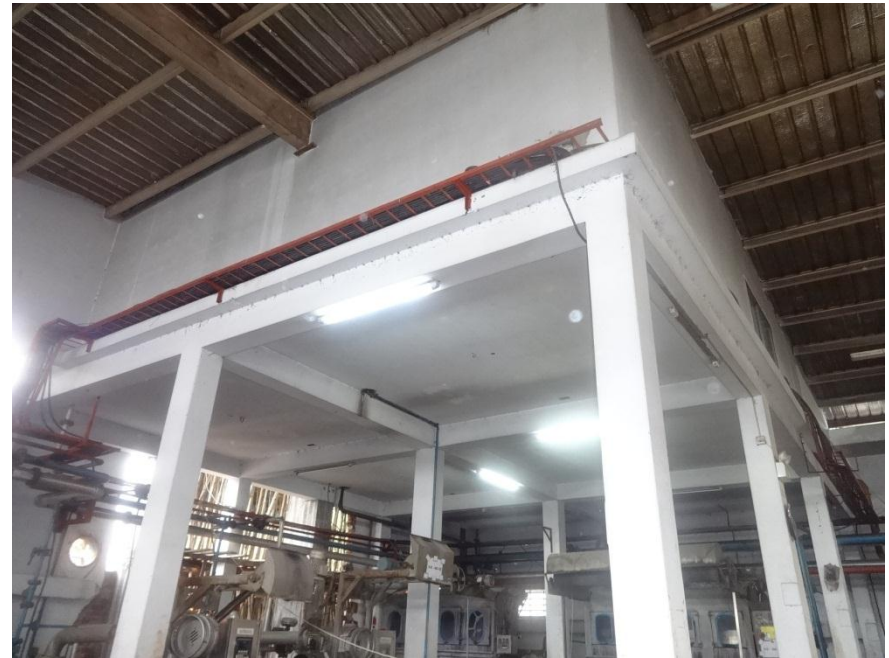
Factor of Safety of  $\sim 1.86$  from column load run-down, suggesting the need for some further investigation.

No visible signs of distress or structural damage were observed on any columns, meaning that this is not considered to be an urgent action.

Despite this, a Factor of Safety of less than 2 was calculated, meaning some further investigation is required.

Left, typical column arrangement in six-storey building. Right, slender columns supporting heavy loads from generators at 1<sup>st</sup> floor and roof level.

| Item No. | Observation | Recommended Action Plan | Recommended Timeline |
|---|---|---|---|
| 8 | Priority 3 - 'Green' Priority 3 result from column load run-down, requiring some further investigation. | Factory Engineer to review design, loads and column stresses in internal columns of three and six-storey buildings as well as two-storey Generator Building.<br>Verify insitu concrete stresses by 100mm dia. cores.<br>Produce and actively manage a loading plan for all floor plates within the factory, giving consideration to floor capacity and column capacity. | 6-months |

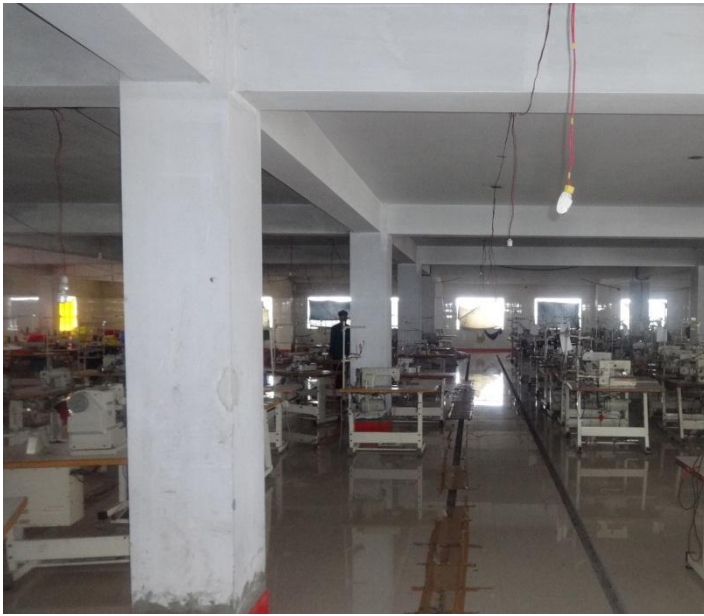
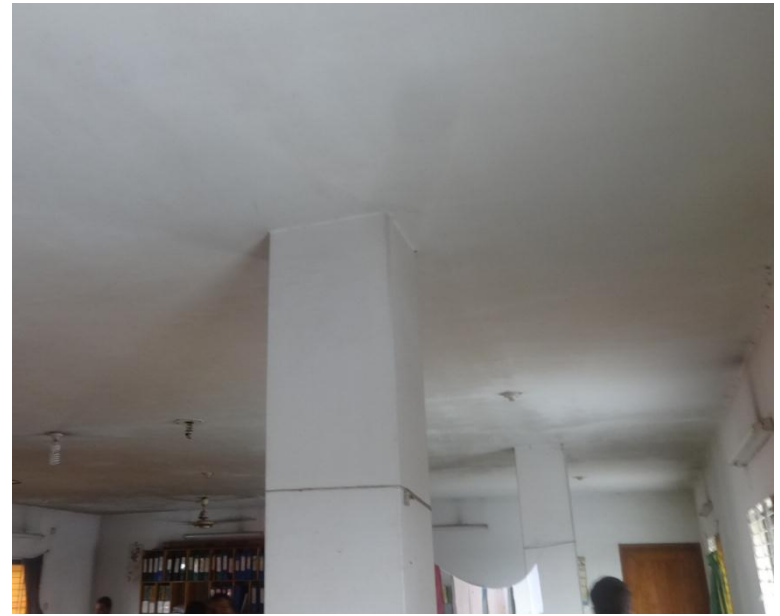
Above left is the typical beam-column arrangement observed in the six-storey building, gaining stability from moment connections. Above right is the flat slab construction present above 1<sup>st</sup> floor level in the three-storey building, with no apparent lateral stiffness other than in the perimeter walls which are immediately adjacent to the column lines on three sides.

We require that these items be investigated in a Detail Engineering Assessment

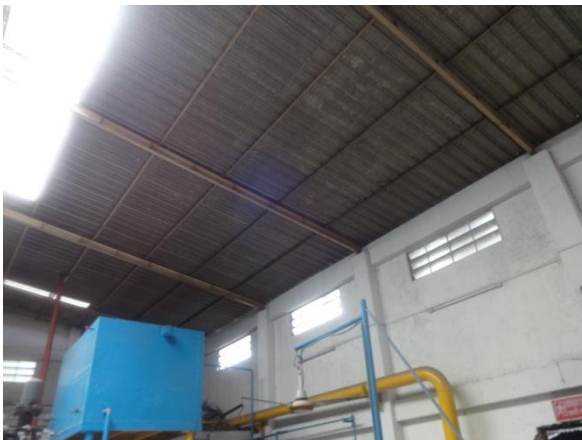
The 'Boiler Room', shown to the left, appears to have sufficient rigidity in its perimeter walls to withstand lateral loads, negating the need for diaphragm action in the roof.

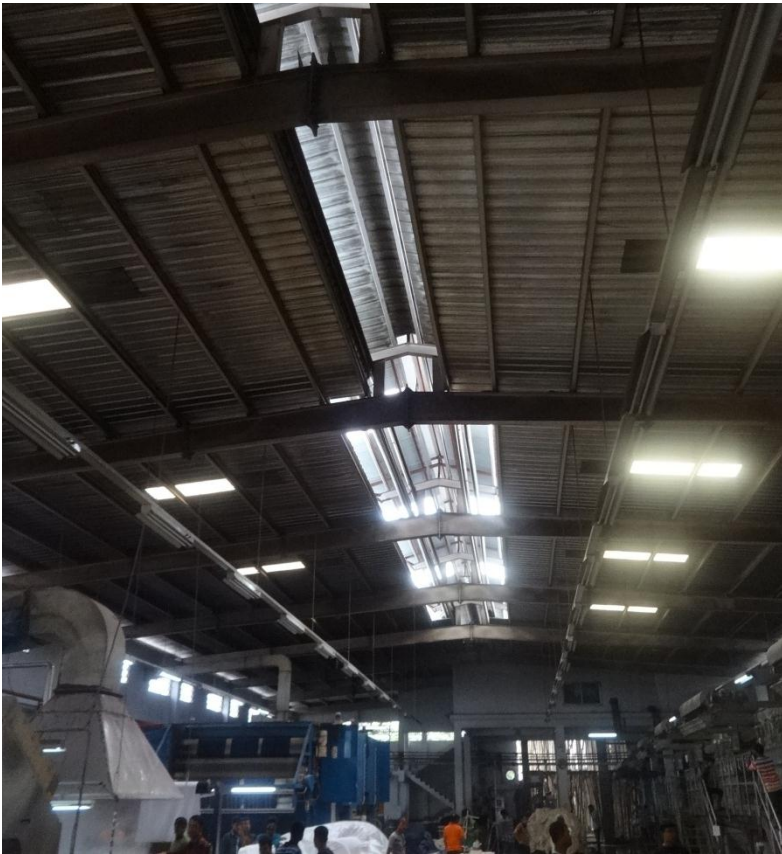
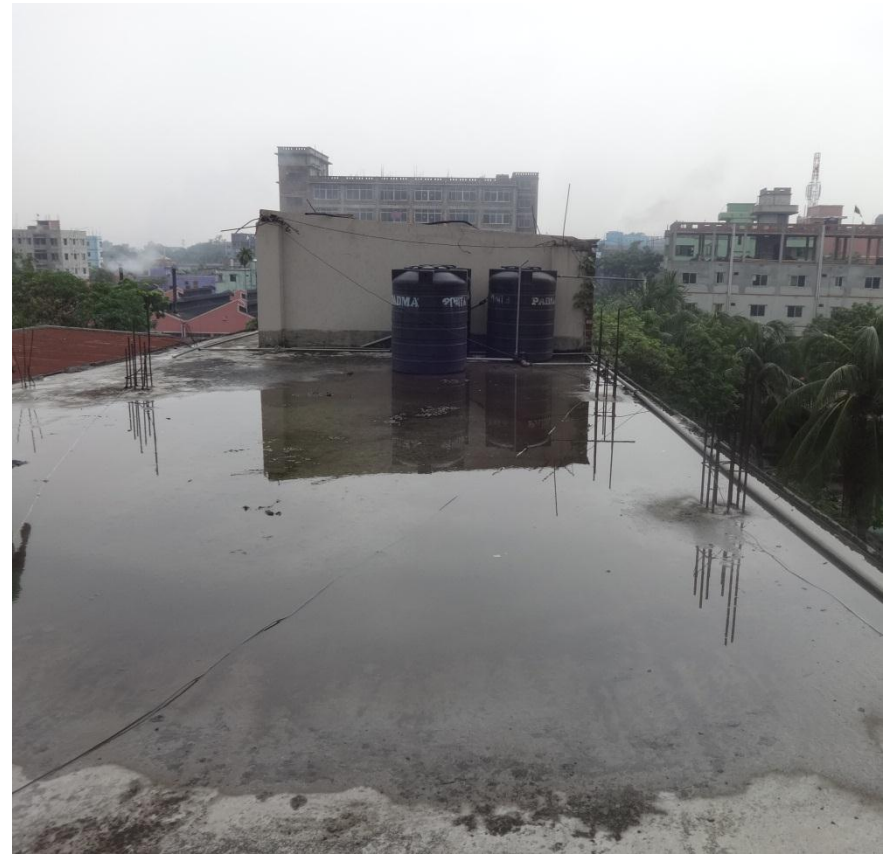
Several of the buildings on the site were steel-roofed, as shown to the left, and therefore caused no concerns. However, all concrete-roofed buildings showed signs of extensive ponding (right), and even signs of ingress within, in some locations.
