# Magpie Composite Textile Ltd. (9804)

02.JUN.2014

# Identified Priority 1 Concerns

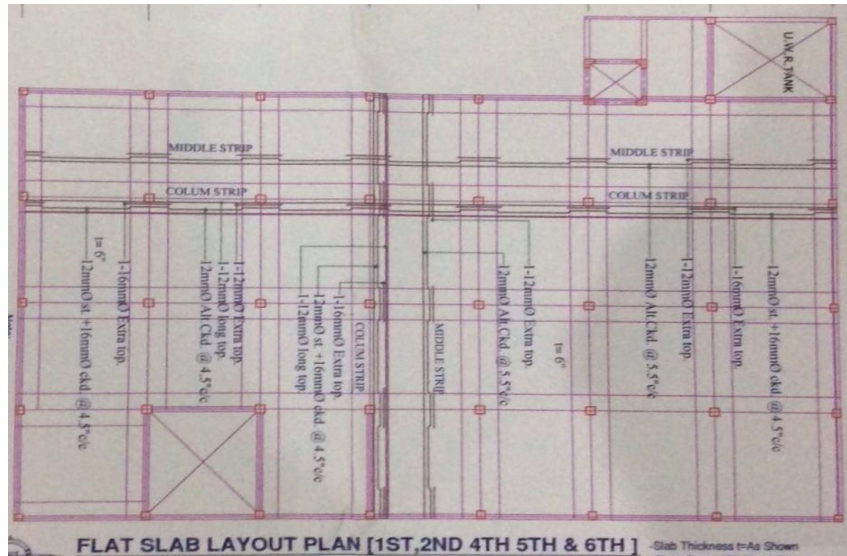
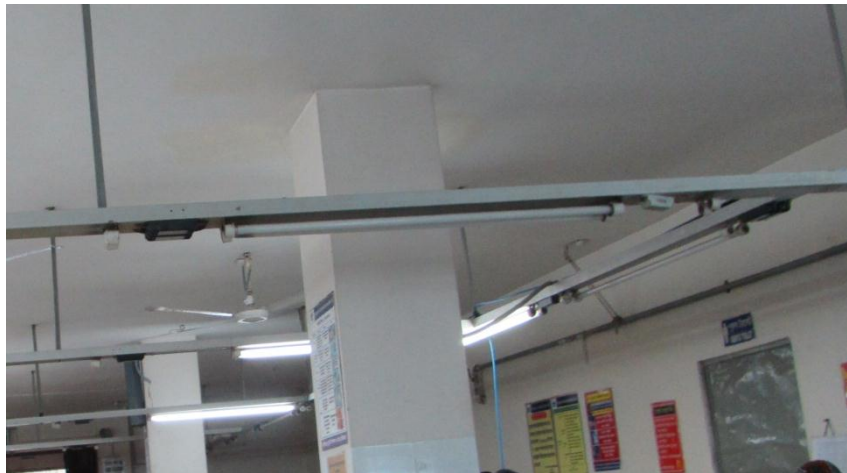
Main building

As per our calculation with the live load 3.5kPa for punching shear at the typical column, the shear stress at the first perimeter is higher than the design concrete shear stress. Based on the BNBC codes, the slab thickness should be increased, or shear links provided for slab. However, the drawings provided don't show shear links.

Furthermore, due to the lack of lateral stability system, the increase of un-balanced moments due to lateral loads need to be considered.

Nevertheless, it is assumed that the live load does not reach 3.5kPa under normal loading conditions, and so immediate danger is not imminent.

| Item No. | Observation | Recommended Action Plan | Recommended Timeline |
|---|---|---|---|
| 1 | 1st Priority 1 - The flat slab in the main building appears not to be sufficient to resist the punching shear forces. | Limit the average imposed load on the floor to a maximum of 1.5kPa (30 psf) | Immediate - Now |
| 2 | 1st Priority 1 - The flat slab in the main building appears not to be sufficient to resist the punching shear forces. | Carry out intrusive testing of the structure to determine the actual concrete strength, rebar strength and rebar layout | 6-weeks |
| 3 | 1st Priority 1 - The flat slab in the main building appears not to be sufficient to resist the punching shear forces. | Carry out full structural modelling of the building with respect to both gravity and lateral loads to assess the extent of modifications required to attain acceptable structural stability.<br>Carry out structural strengthening works as required | 6-months |

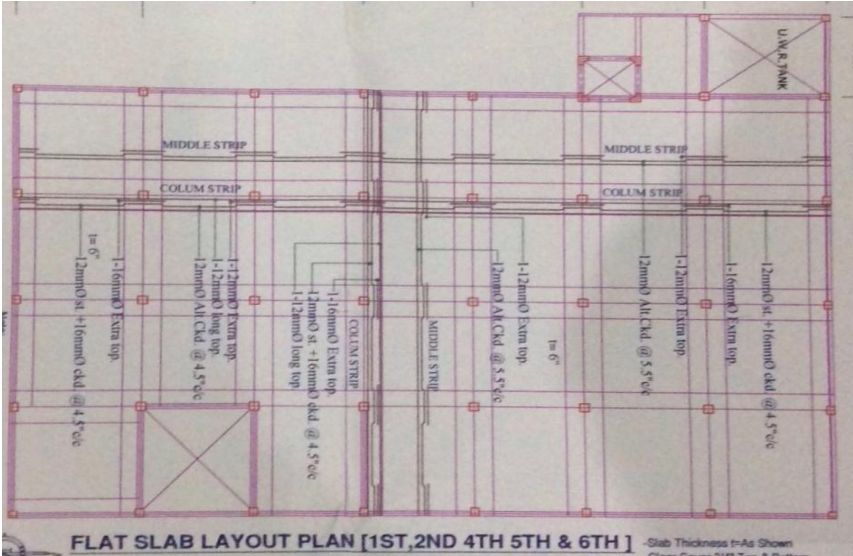
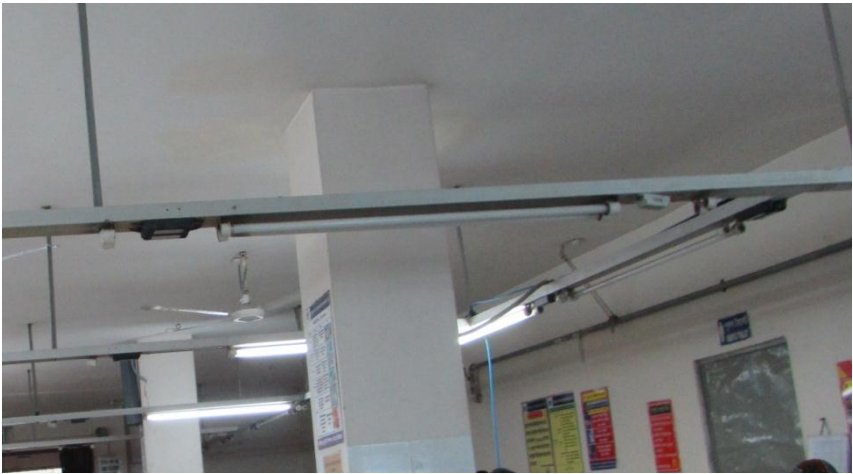
Main building

The span/depth ratio for flat slab which controls the limit of deflection for an RC element is defined apparently as  $L/30$ . The ratio for 6.1m span and 152.4mm thickness slab is 40 which was higher than ratio requirement.

Thinner flat slabs will lead to increased deflection in short-term and long-term and reduce the punching shear resistance as well.

The thin flat slab without a drop panels or shear reinforcement may not be able to resist punching shear loads in a seismic event which may cause the slab to collapse suddenly and potentially cause a subsequent total building collapse.

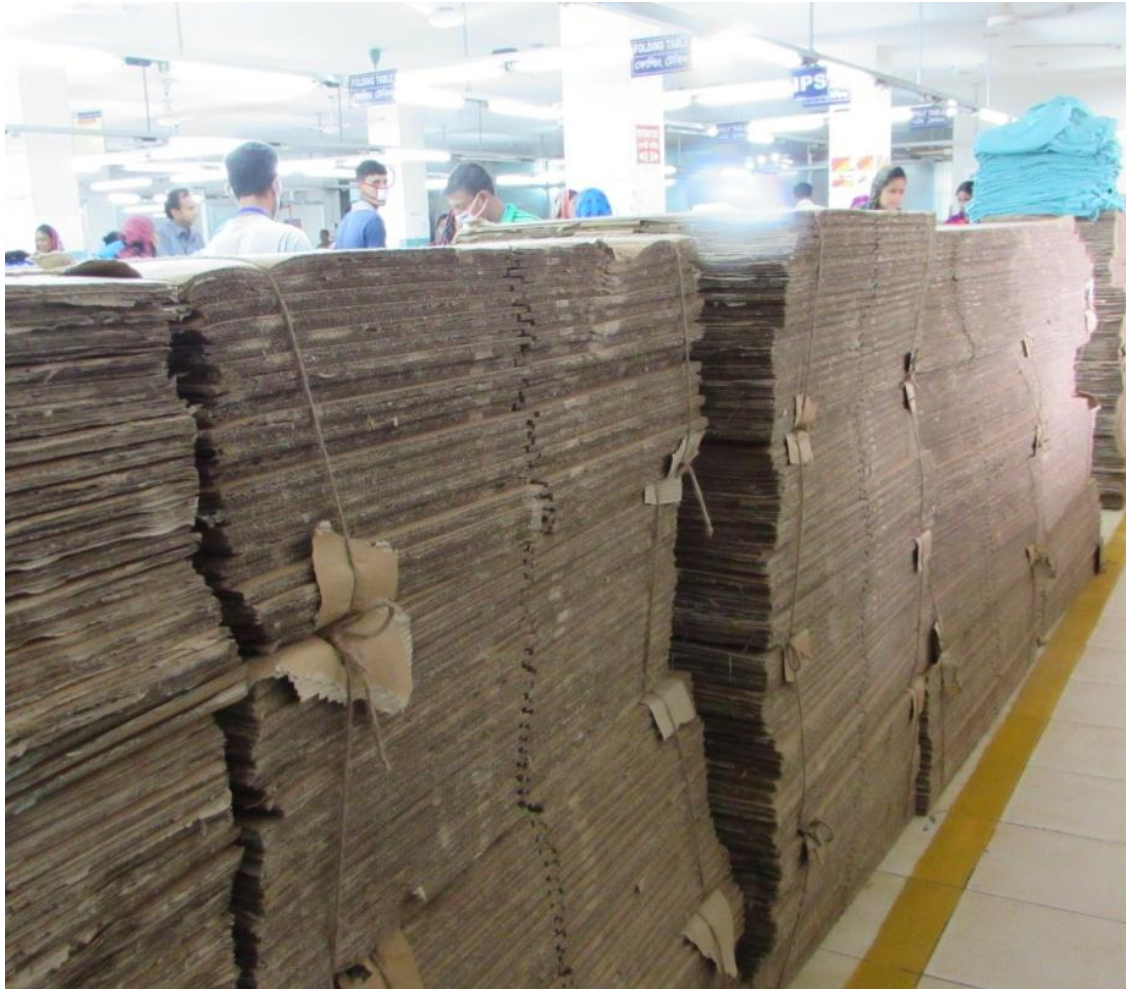
Main building

The load due to the storage of carton boxes on level 4 is higher than the design loading of 3.5 kPa (70psf). Each carton box package is estimated to be approximately 22kg with the dimension 0.6x0.4m and 4 layers, so the live load for this area is 3.7kPa (74psf) which is higher than the design loading 3.5kPa (70psf).

The localised live load is higher than the imposed load, the stacking of the boxes should be carefully monitored to ensure that there is no possibility of overloading should loading conditions change in future.

| Item No. | Observation | Recommended Action Plan | Recommended Timeline |
|---|---|---|---|
| 4 | 2nd Priority 1 - Loading intensity in the main building appears to be greater than what was the allowable load in some locations. | Immediately reduce stacking height of fabric bag to ensure total load does not exceed 1.5kPa (30 psf) | Immediate - Now |
| 5 | 2nd Priority 1 - Loading intensity in the main building appears to be greater than what was the allowable load in some locations. | Mark the maximum allowable height of fabric stacking to ensure full compliance<br>Develop floor loading plans and use them. | 6-weeks |
| 6 | 2nd Priority 1 - Loading intensity in the main building appears to be greater than what was the allowable load in some locations. | Ensure continued compliance to the loading intensity limitations on a long-term basis.<br>Maintain and enforce the loading plans. | 6-months |

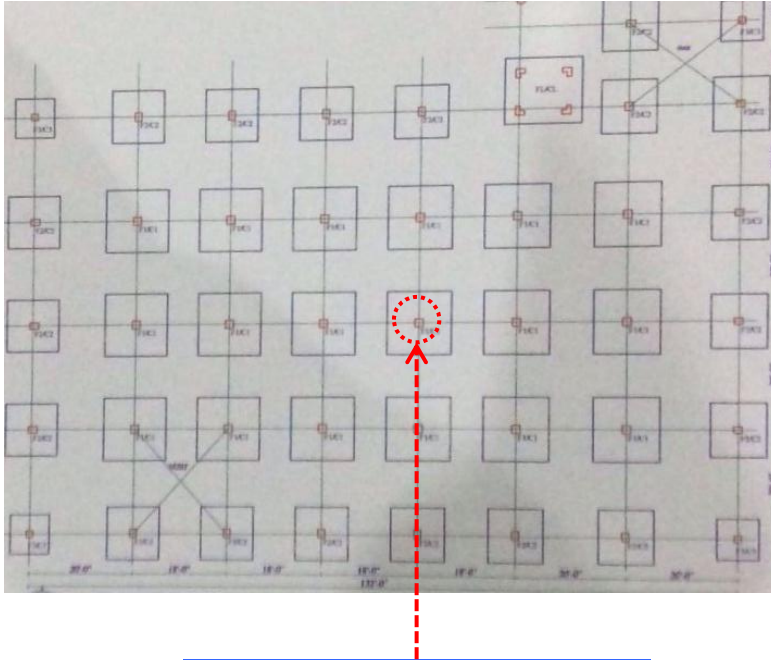
Column to be checked

Based on the load rundown analysis of the building with 7 floors as per Building permission drawing and existing building, it turns out to be YELLOW status for all checked columns that have similar loading condition and design. Which requires that all floor loadings must be carefully monitored and a provided loading plan must be strictly maintained.

| Item No. | Observation | Recommended Action Plan | Recommended Timeline |
|---|---|---|---|
| 7 | 1st Priority 2 - The typical columns in the main building have a low factor of safety with respect to their loading capacity with 7 floors. | Factory Engineer needs to review design, loads and columns stresses in areas identified above.<br>Verify in-situ concrete stresses either by 100mm dia. cores or existing cylinder strength data for the columns concerned. | 6-weeks |
| 8 | 1st Priority 2 - The typical columns in the main building have a low factor of safety with respect to their loading capacity with 7 floors. | Produce and actively manage a loading plan for all floor plates within the factory giving consideration to floor and column capacities. | 6-months |

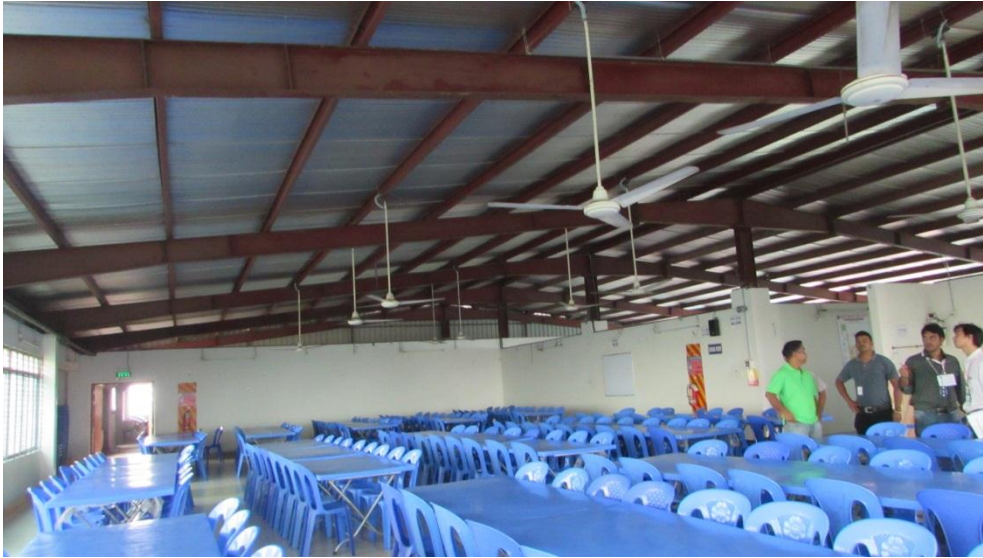
Main building

The rafter at this level are missing longitudinal bracing in the roof plane, across one or both end bays of the structure.

Tie rods should be provided in the middle of each purlin span to prevent buckling of the purlin.

| Item No. | Observation | Recommended Action Plan | Recommended Timeline |
|---|---|---|---|
| 9 | 1st Priority 3 - The rafter beams in the roof of main building are missing their longitudinal bracing in the roof. No tie rods have been provided for the purlins at the mid-span between trusses. | The bracing system needs to be provided in the longitudinal direction and a tie rod needs to be provided to the purlins at mid-span. | 6-months |

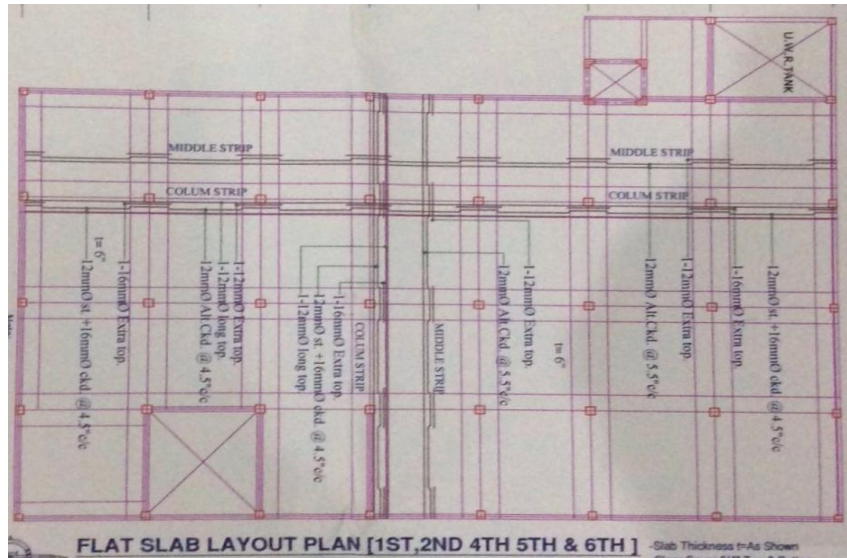
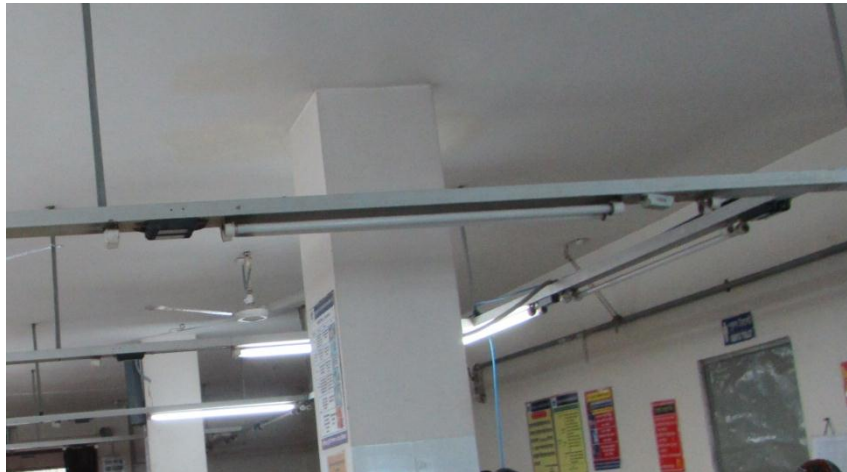
Dining room on roof floor

The overall structural arrangement does not appear to have any rational form of lateral stability system to resist wind or earthquake loads. A lateral load analysis is required to be carried out. Together with the very low factor of safety to resist punching shear, the building is at a very high risk of failure if a significant event occurs.

The design engineer needs to check the deflection and storey drift under lateral wind and seismic load.

We require that these items be investigated in a Detailed Engineering Assessment

| Item No. | Observation | Recommended Action Plan | Recommended Timeline |
|---|---|---|---|
| 10 | 2nd Priority 3 - No lateral load resistance system in the main building. | Building engineer to check and provide the solution for lateral resisting requirements of the structure. | 6-weeks |
| 11 | 2nd Priority 3 - No lateral load resistance system in the main building. | As per the results of structural analysis, the building needs to be revised to accord with BNBC building codes with regard to lateral stability. | 6-months |

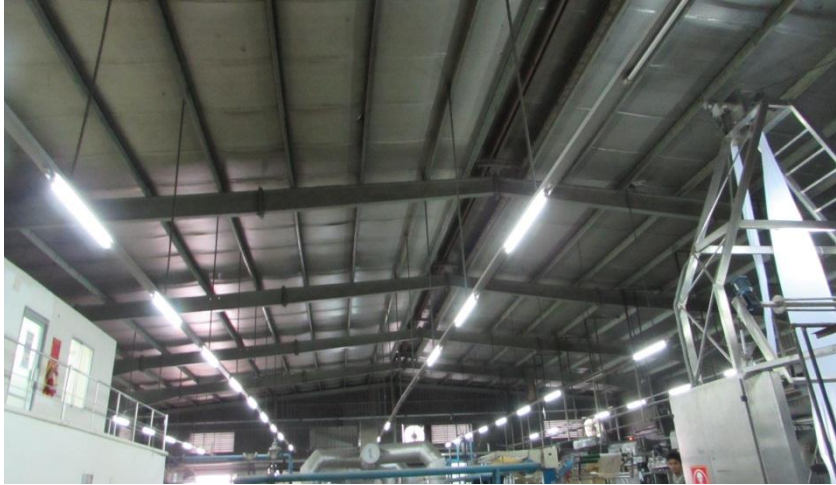
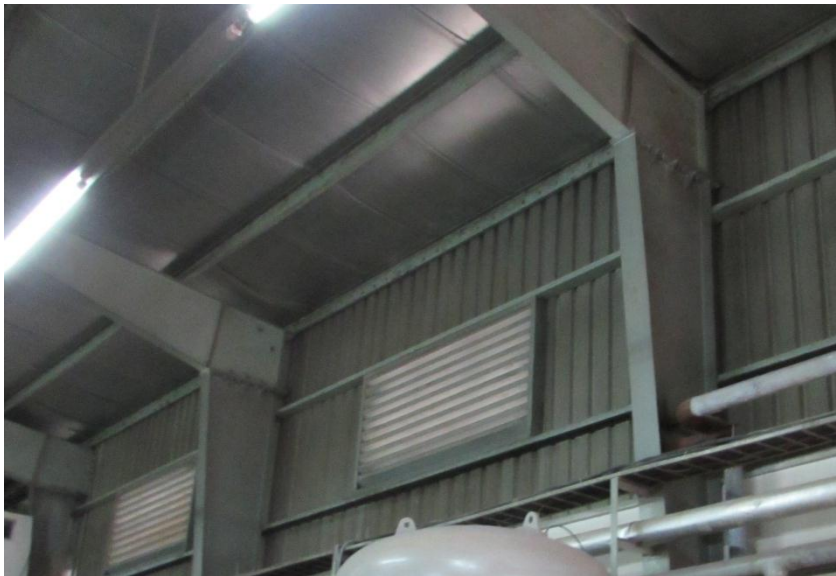
The building is a portal frame with moment connections to provide stability in-plan. The span is 24m with a 5.8m frame spacing in longitudinal direction.

The rafters are missing longitudinal bracing in the roof plane, across one or both end bays.

The steel columns are also missing vertical bracing in the elevations.

The roof purlins should also be provided with tie-rods at mid-span to help prevent buckling.

| Item No. | Observation | Recommended Action Plan | Recommended Timeline |
|---|---|---|---|
| 12 | 3rd Priority 3 - Dyeing section - The rafters are missing their longitudinal bracing in the roof. The steel columns are also missing the vertical bracing in the elevations. No tie rods have been provided for the purlins at their mid-span. | The bracing system need to be provided in the longitudinal direction in the roof and for the columns. The purlins need to provided with tie rods in their mid-span. | 6-months |

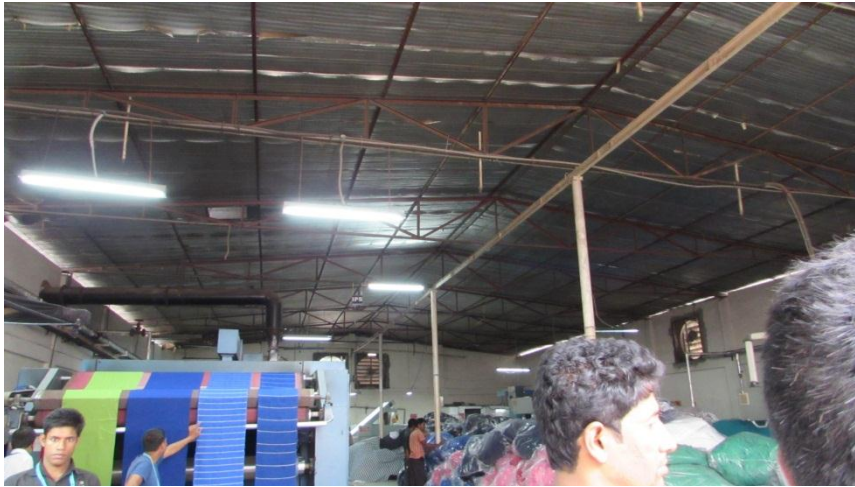
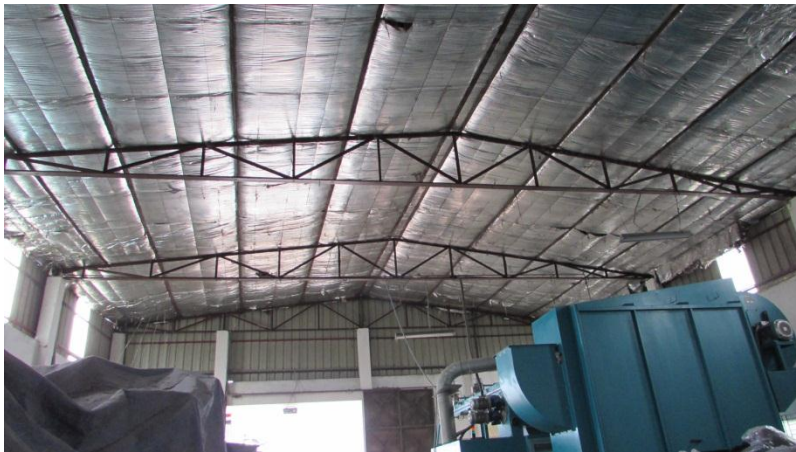
Dyeing  
finished  
section

Finished  
section

The steel trusses and beams are not longitudinally braced and the steel connections need to be reviewed and repaired properly according to the proper design detailing.

We require that these items be investigated in a Detailed Engineering Assessment

| Item No. | Observation | Recommended Action Plan | Recommended Timeline |
|---|---|---|---|
| 13 | 4th Priority 3 - The structure for the shed buildings needs to be reviewed for its lack of longitudinal bracing and the connections of steel structure needs to reviewed with proper design detailing. | The detailed design for the shed buildings needs be carry out to justify its structural stability under wind load. A bracing system needs to be provided in longitudinal direction. | 6-months |

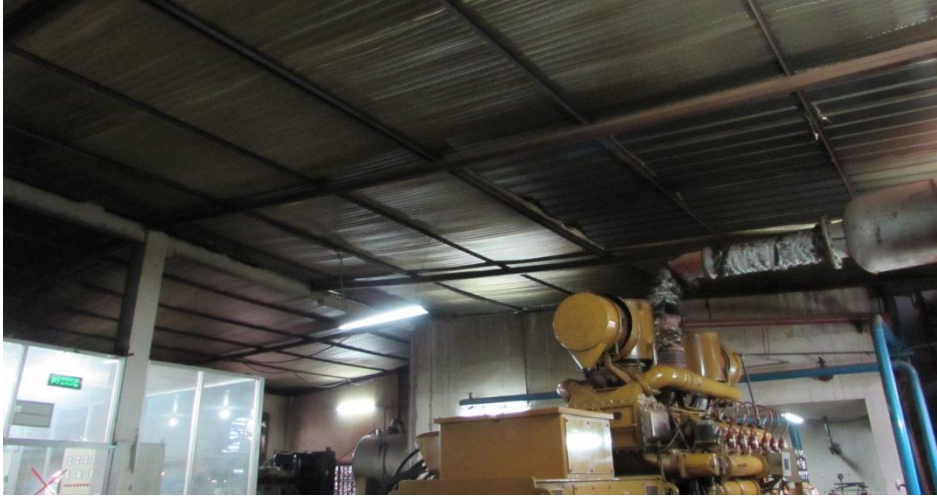
Generator room

This type of structural building appears to be a temporary structure.

The steel beams of the roof are very small with very simple connections and appear to be corroded and have excessive deflections.

We require that these items be investigated in a Detailed Engineering Assessment.
