Sams Fashion (10011)

Sams Socks

Keowa Pashim Khanda (Koroitola), Mawna, Sreepur, Gazipur

02.JUNE.2014

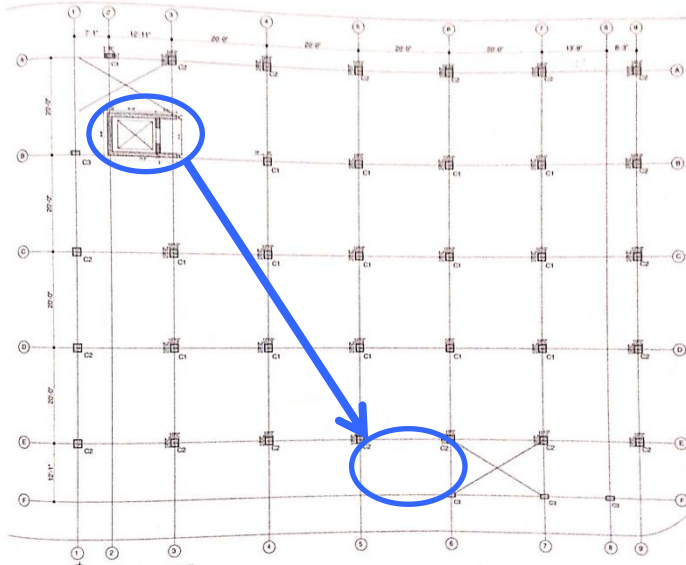
- Inconsistencies between the drawings and the actual as-built conditions of Building 1

We were informed that the shear wall will be constructed between grid line E-F/5-6 instead of grid line A'-B/2-3.

Item No.	Observation	Recommended Action Plan	Recommended Timeline
1	Priority 2 - Inconsistencies between the drawings and the actual as-built conditions of Building 1.	Factory Engineer to survey the actual conditions and revise the drawings. Factory Engineer to review design and lateral loads to confirm stability of this building under lateral loading.	6-weeks
2	Priority 2 - Inconsistencies between the drawings and the actual as-built conditions of Building 1.	Continue to implement load plan	6-months
3	Priority 2 - Overall stability system.	Request that an Engineering Assessment of the overall building to be carried out and in particular, stability and foundation aspects should be investigated in detail.	6-weeks
4	Priority 3 - Reinforcement left exposed at top level of Building 1.	Remove rust from rebar before further construction. For both durability and serviceability, rust proof paint or any appropriate methods is recommended.	6-months

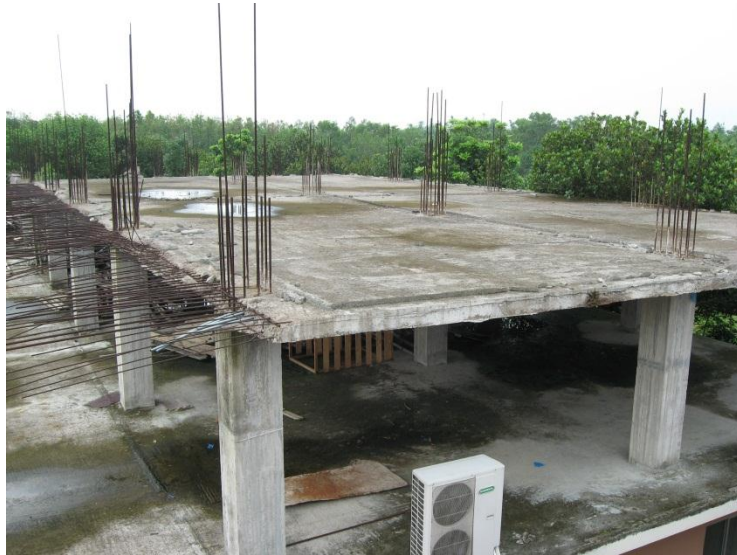
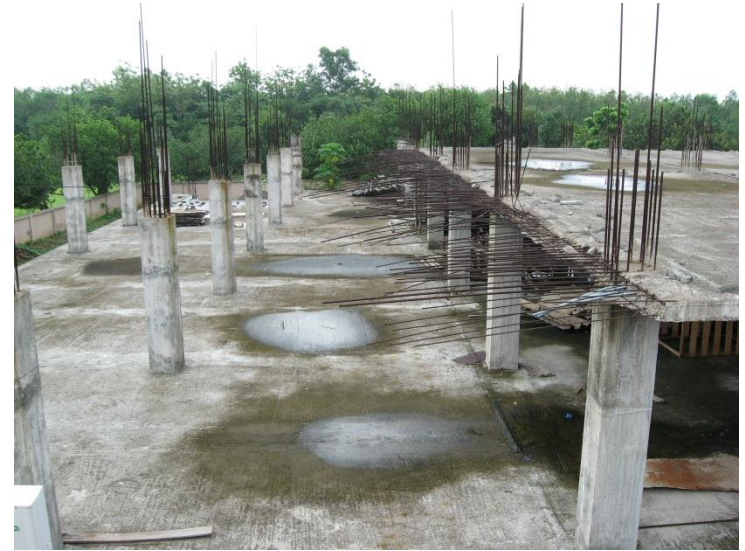
- Reinforcement left exposed at top level of Building 1

Reinforcement is left exposed at top level of Building 1.

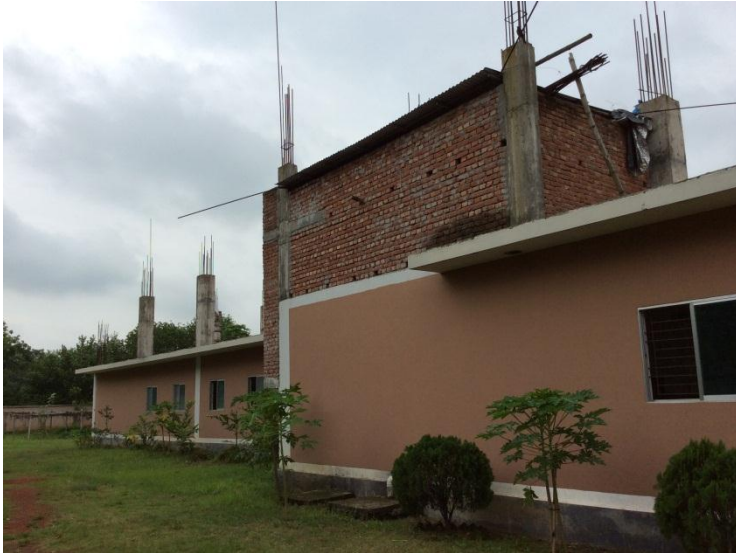
Concerns on the stability system for lateral loading. Shear wall of Building 1 was planned to be relocated. Stability of Building 2 was provided by brick bearing walls and slab action which lack of moment capacity in the connections between walls and slabs.

We require that these items be investigated in an Engineering Assessment.

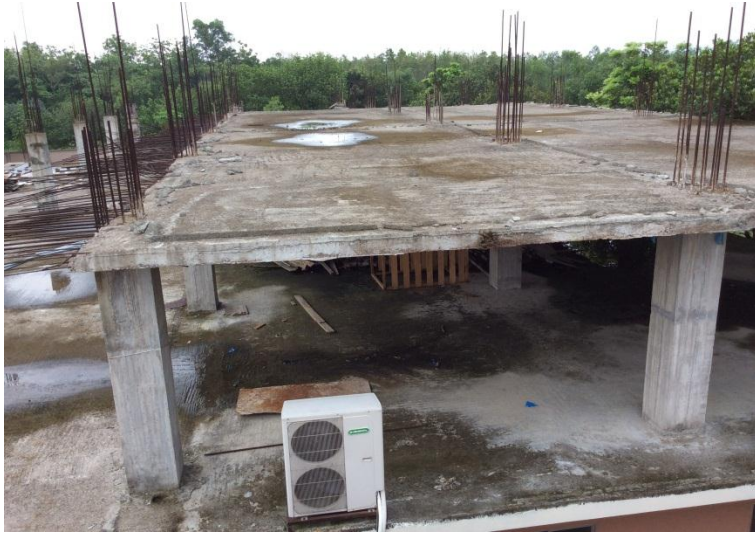
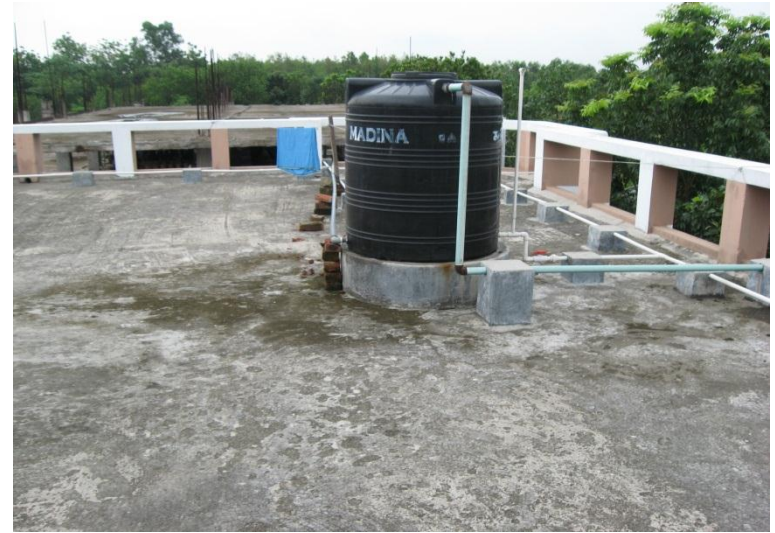
There is no distress due to water ingress found at top level. However, there is water ponding found after the rain. Waterproofing material should be applied.

5	Priority 3 - No waterproofing material applied at top level.	Factory Engineer to inspect water damaged structures and repair with a suitable method. Waterproofing on the roof slab is recommended. Moreover the slab drainage system should be investigated. Maintain standard of quality control.	6-months
