Sensible Fashion Pvt. Ltd. (11506)

North Masdair (malanchanagar), Fatullah, Narayangonj.

02.June.2014

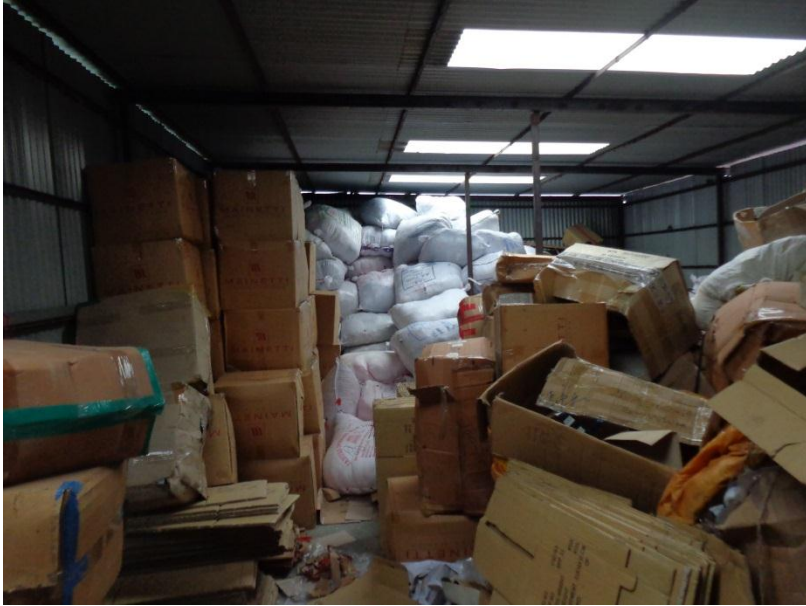
Generator Building

The second floor of the generator building was overloaded. In addition, storage loading was observed on the cantilevered portion of the slab of the main building.

Item No.	Observation	Recommended Action Plan	Recommended Timeline
1	Priority 1 - The second floor of the generator building was overloaded. In addition, storage loading was observed on the cantilevered portion of the slab of the main building.	Remove all loading on the 2nd floor of the generator building down to a maximum of 2.0 kPa (40 psf). Remove all loading on the cantilevered portion of slab of the main building down to a maximum of 2.0 kPa (40 psf).	Immediate - Now
2	Priority 1 - The second floor of the generator building was overloaded. In addition, storage loading was observed on the cantilevered portion of the slab of the main building.	Design Engineer to produce loading plans for all floors of the main building and generator building, based on the maximum load bearing capacity.	6-weeks
3	Priority 1 - The second floor of the generator building was overloaded. In addition, storage loading was observed on the cantilevered portion of the slab of the main building.	Post loading plans on each floor of main building and generator building and manage the load.	6-months

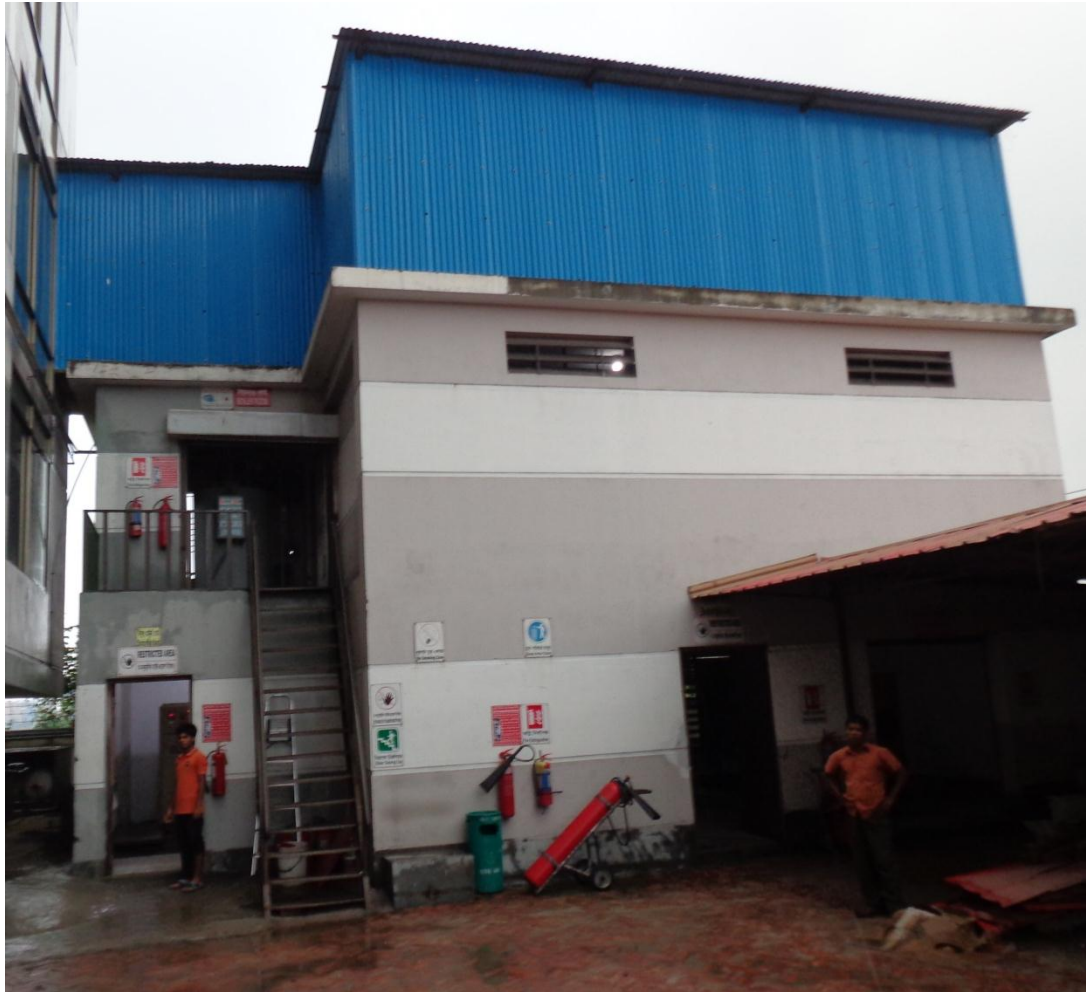
Structural Drawings for the generator building were incomplete.

4	Priority 2 - Structural Drawings for the generator building were incomplete.	Design Engineer to produce complete and accurate structural drawings for the generator building.	6-weeks
5	Priority 3 - The permit drawings indicate 7 storeys, however the structural drawings and soils report are only for 6 storeys.	If 6 storeys are intended, revise the architectural drawings to show only 6 storeys. If 7 storeys are desired, additional structural and soils investigations are required to determine feasibility, as well as revised reports and drawings.	6-months

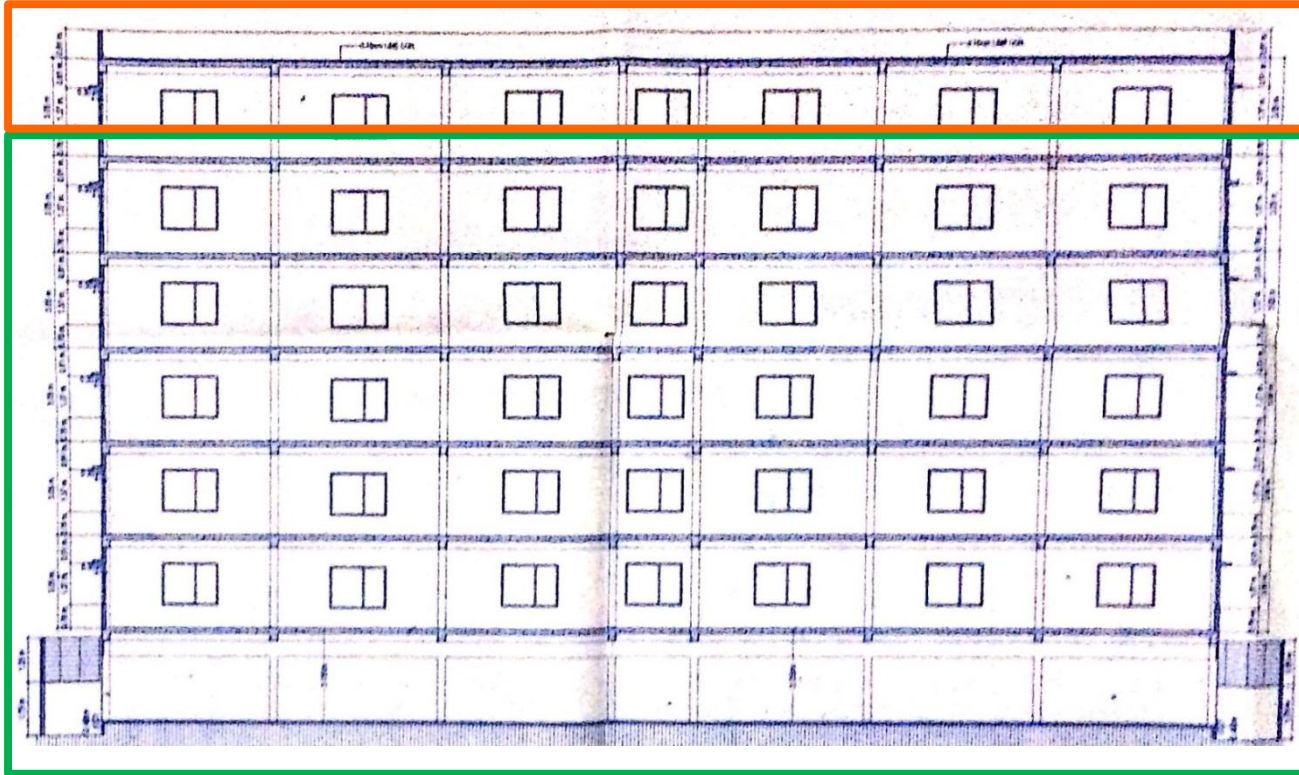
The permit drawings indicate 7 storeys, however the structural drawings and soils report are only for 6 storeys.

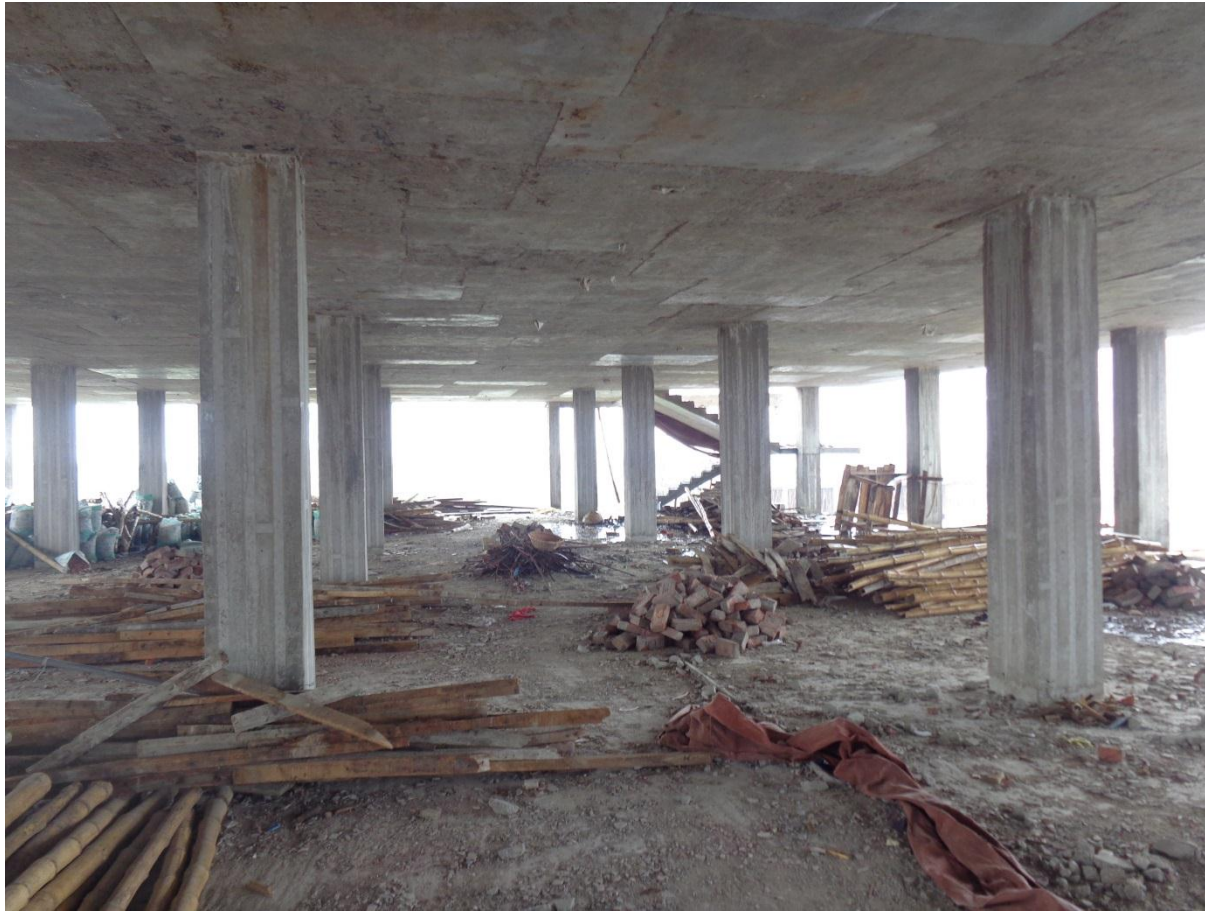
Overall Stability System

The building did not feature any core or shear walls. Stability was achieved through sway action between beams and columns and masonry infill walls.

We require that these items be investigated in an Engineering Assessment

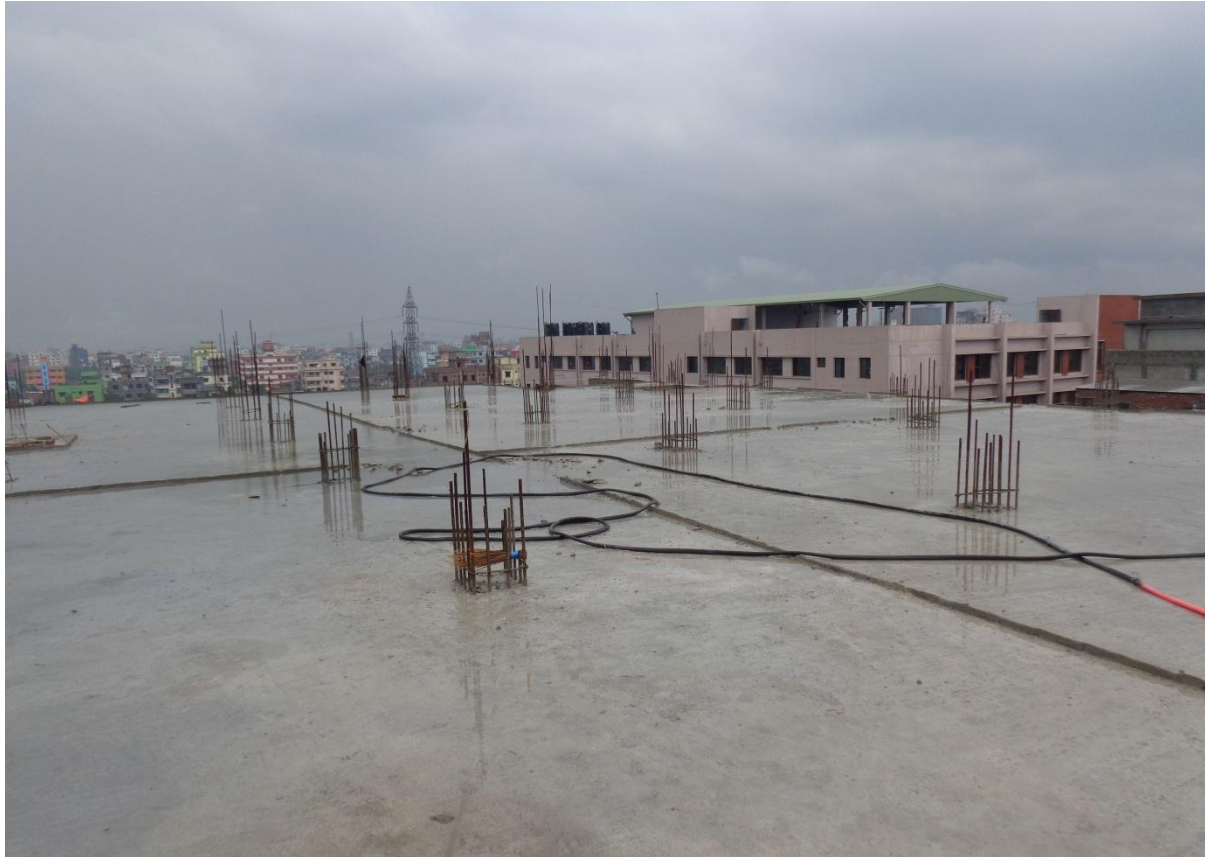
Water Ingress at Roof Level

No waterproofing membrane was visible on the roof of the building. This means that any cracks in the surface finishes on the roof will allow water to seep into the concrete slab beneath the finishes, and cause corrosion of the reinforcing steel.
