# Shomahar Sweaters Ltd. (10349)

A-99/1, Baktarpur, Kaliakoir, Gazipur.

03.June.2014

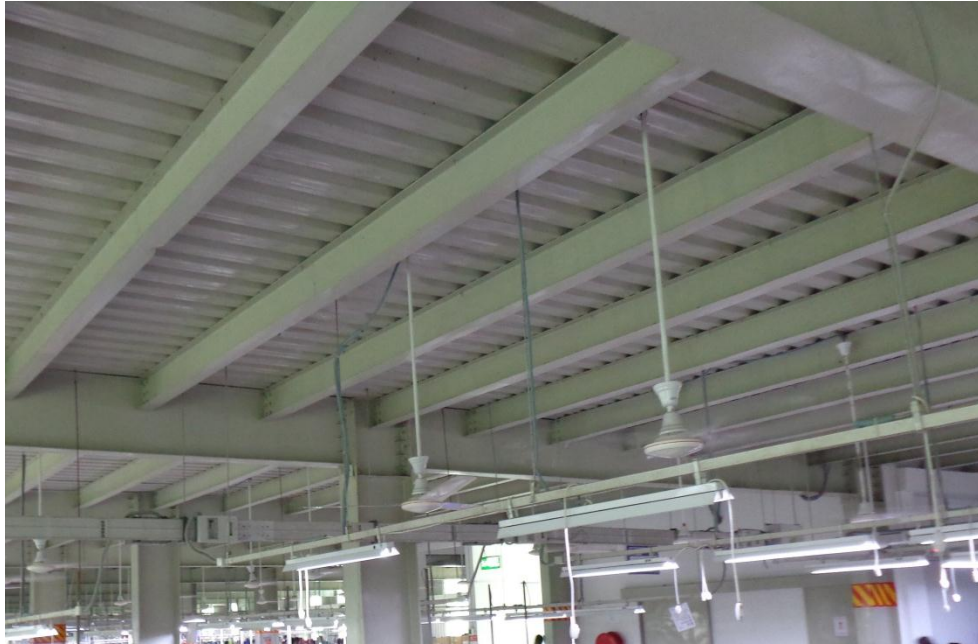
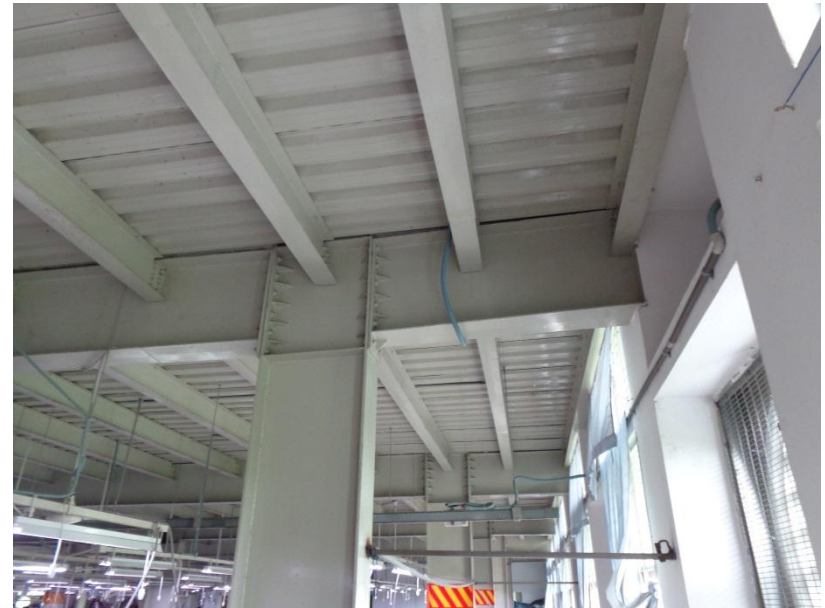
In addition, there is no lateral stability provided by the masonry infill walls due to their position (in front of the columns).

No lateral stability system was apparent in the North/South direction. Moment frame system was observed in the East/West direction.

| Item No. | Observation | Recommended Action Plan | Recommended Timeline |
|---|---|---|---|
| 1 | Priority 2 - No lateral stability system was apparent in the North/South direction. A moment frame system was observed in the East/West direction. | A Structural Engineer is to complete a Detailed Engineering Assessment of the lateral resisting system in both directions. | 6-weeks |
| 2 | Priority 2 - No lateral stability system was apparent in the North/South direction. A moment frame system was observed in the East/West direction. | Implement recommendations from DEA. | 6-months |

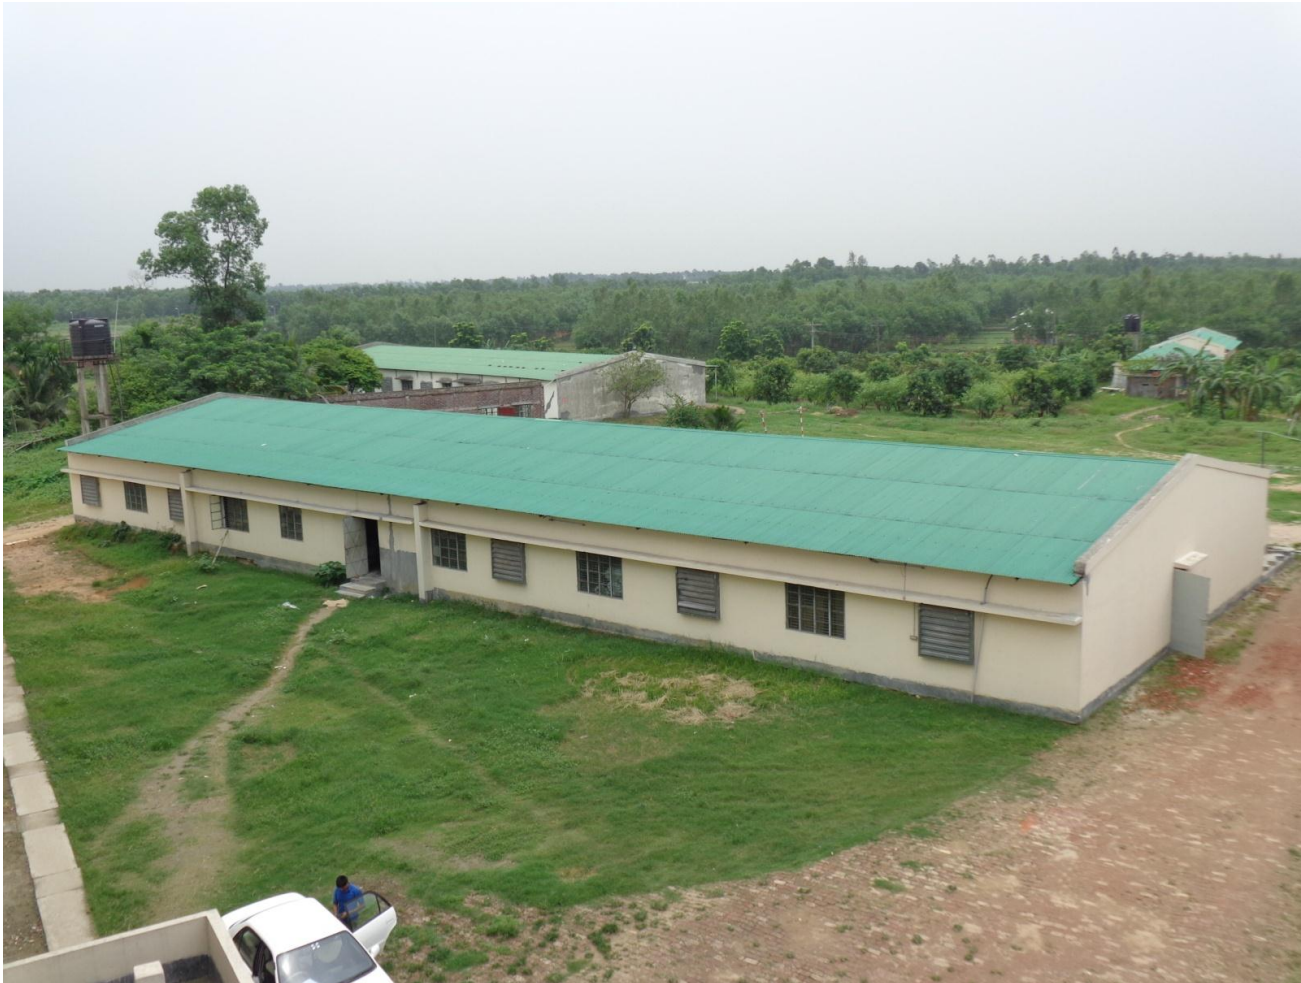
Structural drawings provided for the main building are inaccurate and incomplete. In addition, structural drawings were not available for the various ancillary buildings.

| Item No. | Observation | Recommended Action Plan | Recommended Timeline |
|---|---|---|---|
| 3 | Priority 2 - Structural drawings provided for the main building are inaccurate and incomplete. In addition, structural drawings were not available for the various ancillary buildings. | Structural Designer to review existing conditions and revise both sets of structural drawings to complete one full/accurate set of record drawings. | 6-weeks |
| 4 | Priority 2 - Structural drawings provided for the main building are inaccurate and incomplete. In addition, structural drawings were not available for the various ancillary buildings. | Structural Designer to assess any discrepancies between structural drawings and existing conditions. | 6-months |

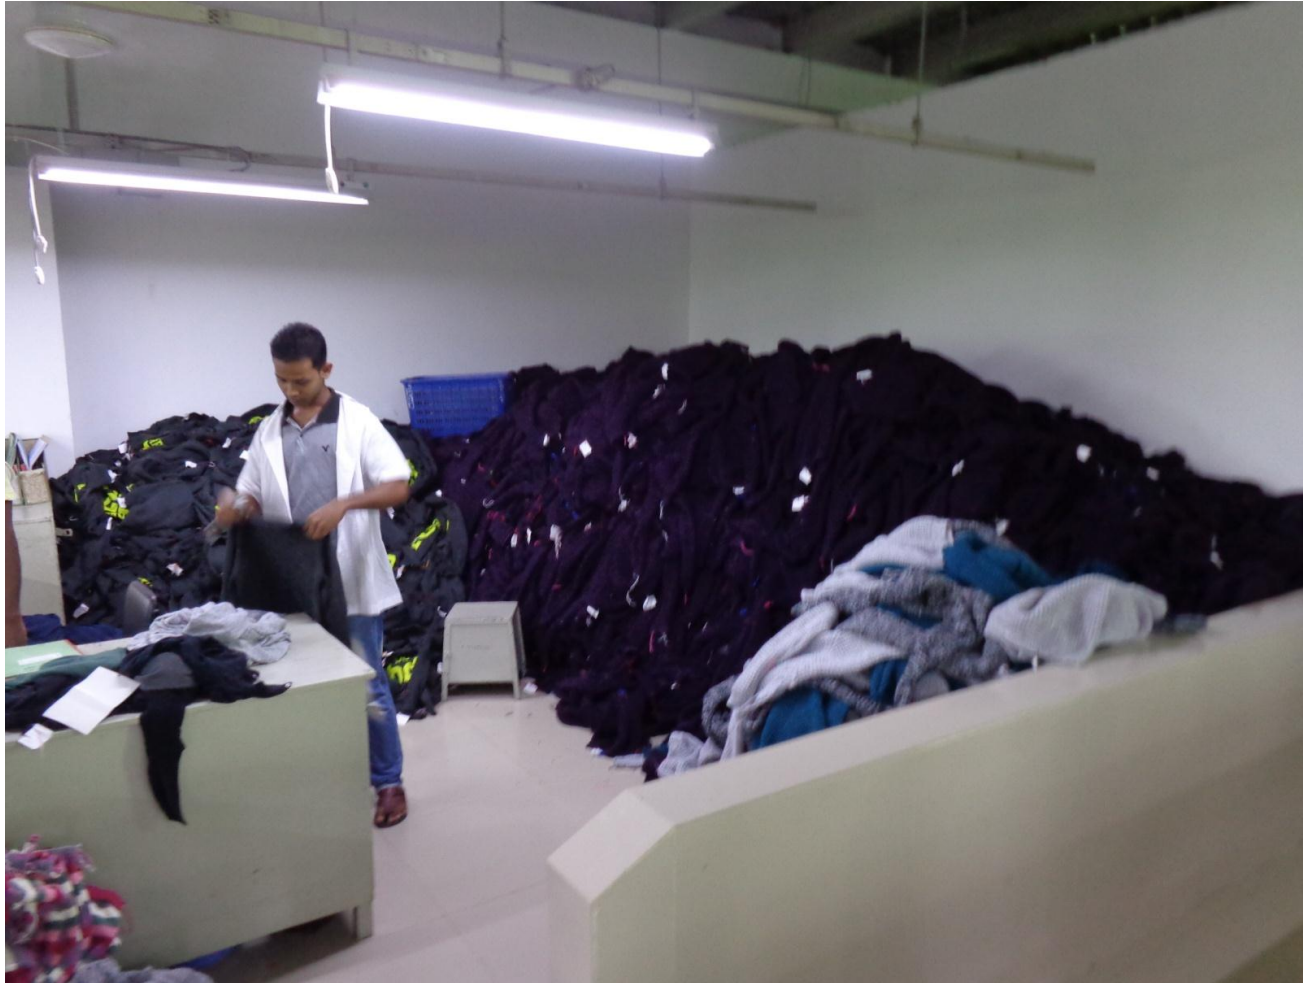
No loading plans  
were made  
available for the  
main building

| Item No. | Observation | Recommended Action Plan | Recommended Timeline |
|---|---|---|---|
| 9 | Priority 3 - No loading plans were made available for the main building. | Produce loading plans based on manufacturer's design parameters. | 6-weeks |
| 10 | Priority 3 - No loading plans were made available for the main building. | Post and manage loading plans. | 6-months |

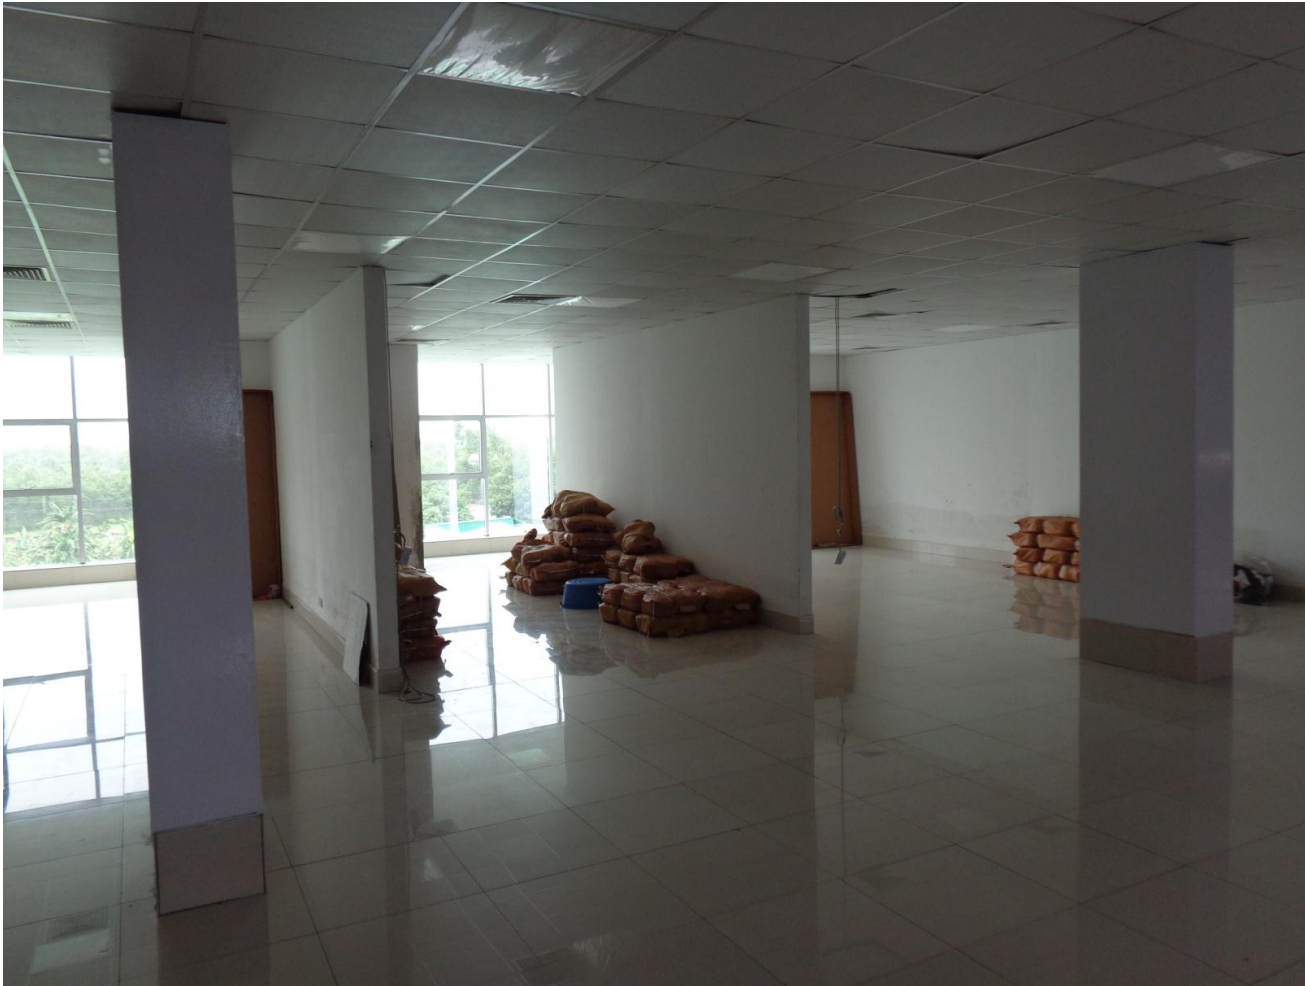
The building did not feature any core or shear walls. Stability was achieved through sway action between beams and columns and masonry infill walls.

We require that these items be investigated in a Detail Engineering Assessment

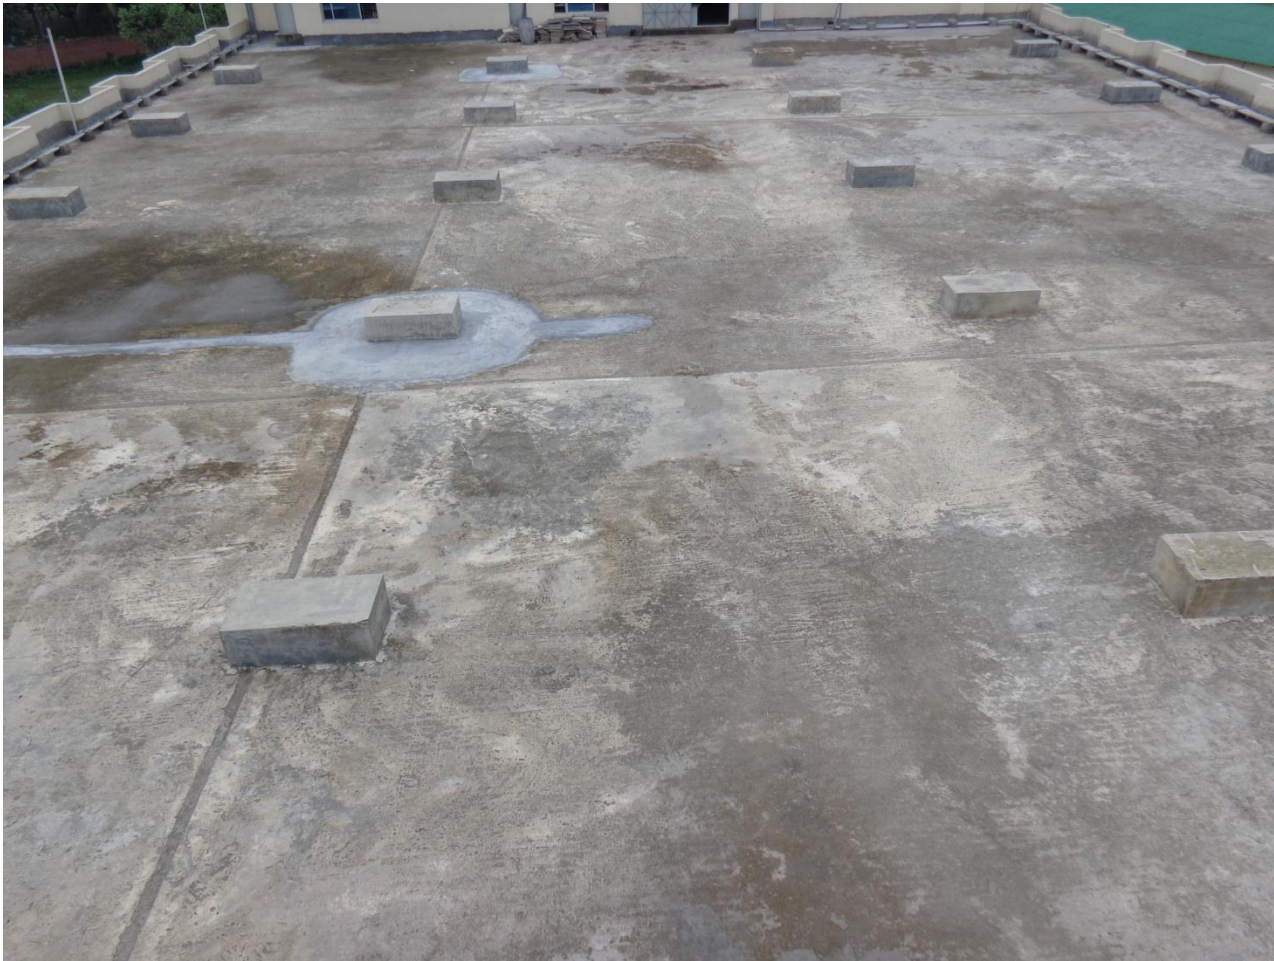
No waterproofing membrane was visible on the roof of the building. This means that any cracks in the surface finishes on the roof will allow water to seep into the concrete slab beneath the finishes, and cause corrosion of the reinforcing steel.
