# Sirajgonj Fashions Limited (UNIT 02)

101/1/A, Barabagh, Mirpur-2, Dhaka-1216

28<sup>th</sup> August 2017

# Observations

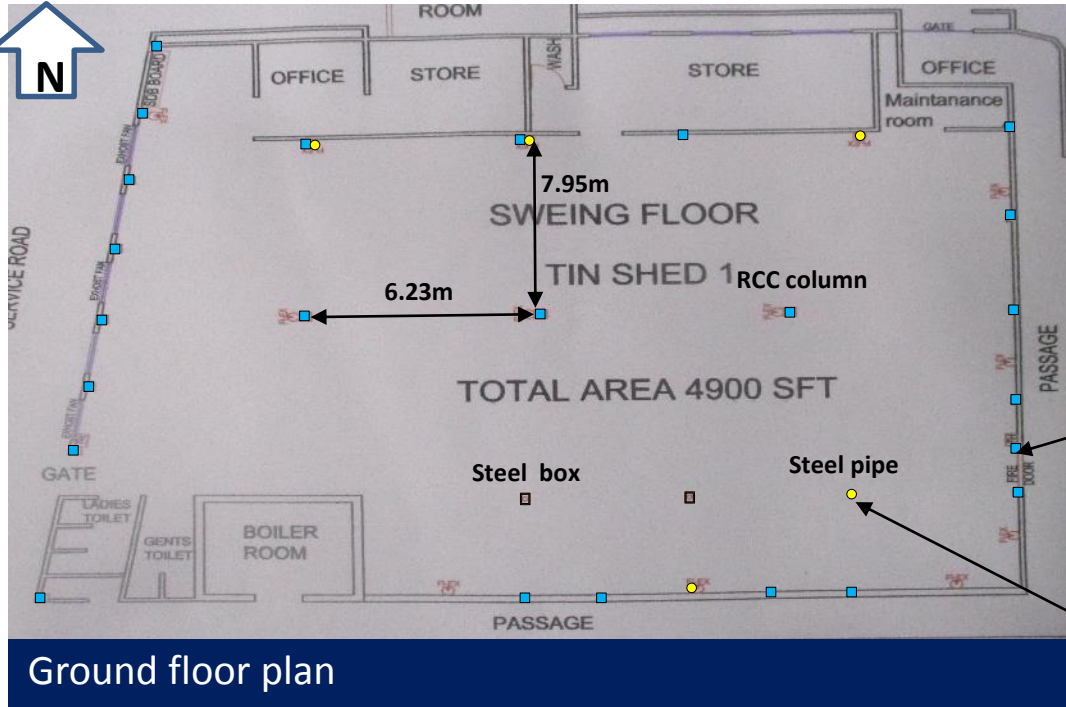
Ground floor plan

The lightweight shed was supported by truss and steel pipes. But details of framing and connection was not available in provided drawing.

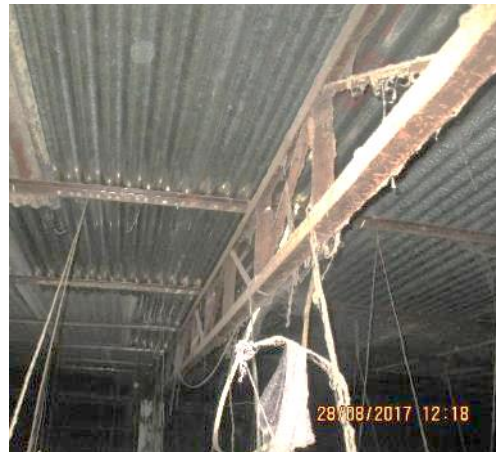
Steel roof truss

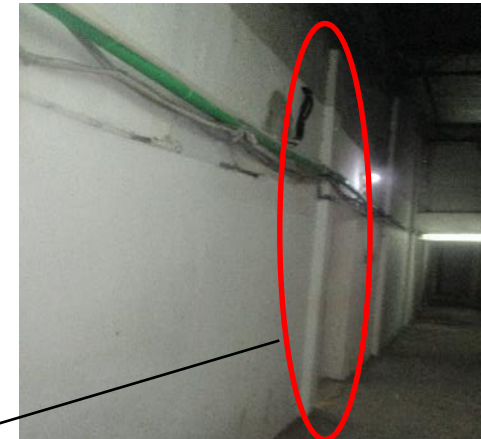
Peripheral RC column

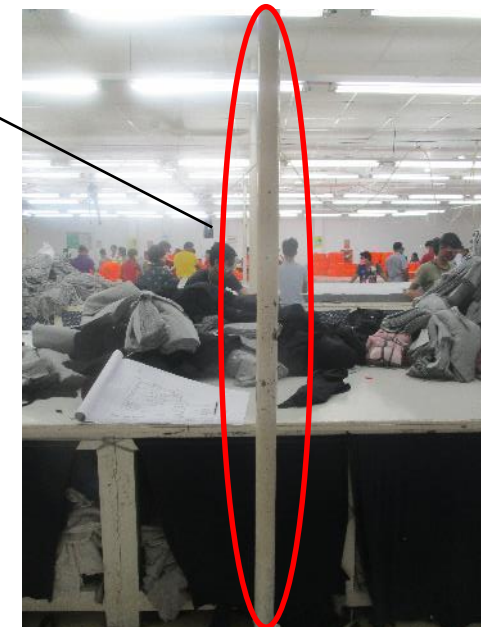
Steel pipe column

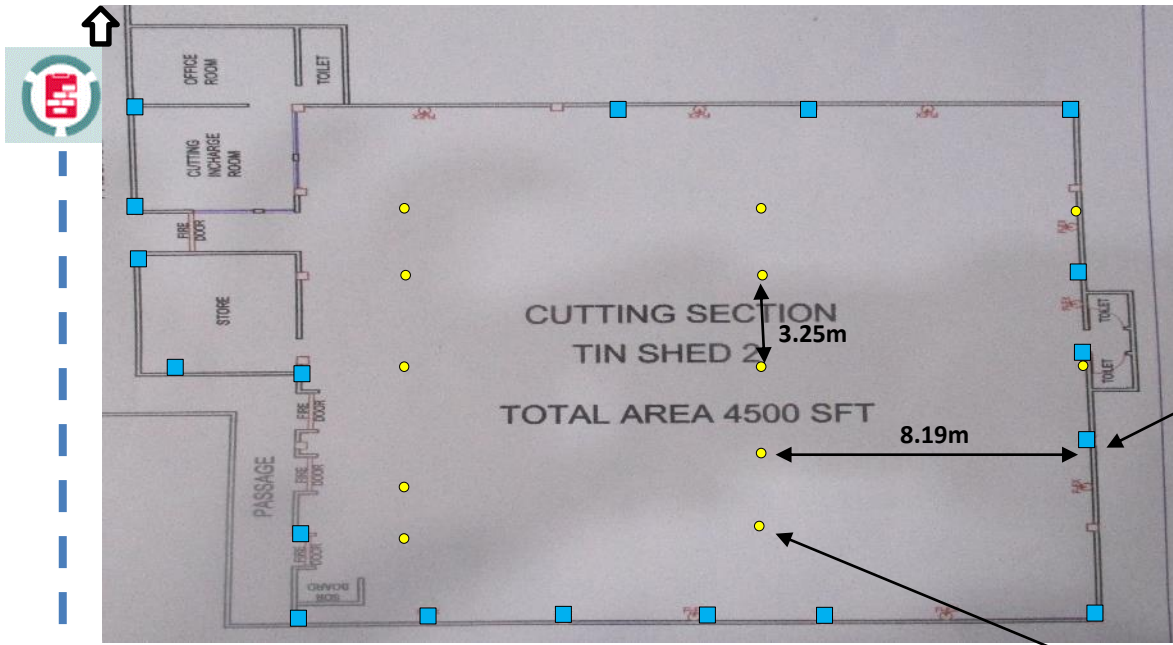
Ground floor plan

The lightweight shed was supported by truss and steel pipes. But details of framing and connection was not available in provided drawing.

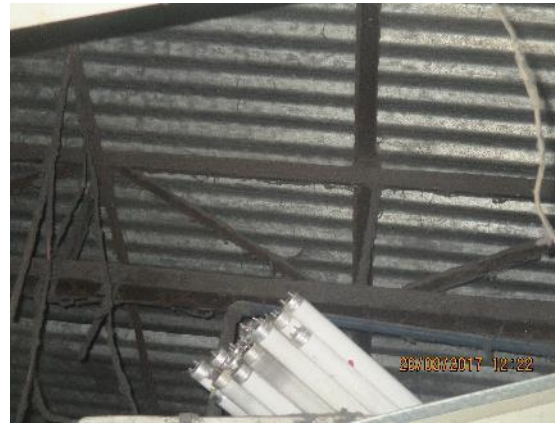
Steel truss frame

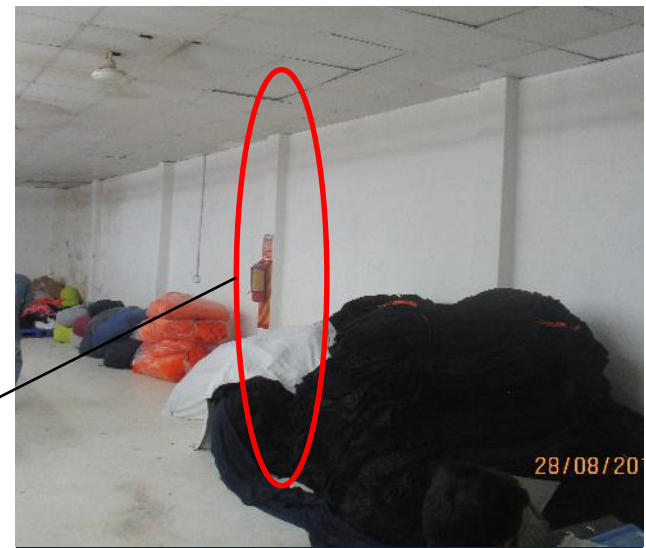
Peripheral RC column

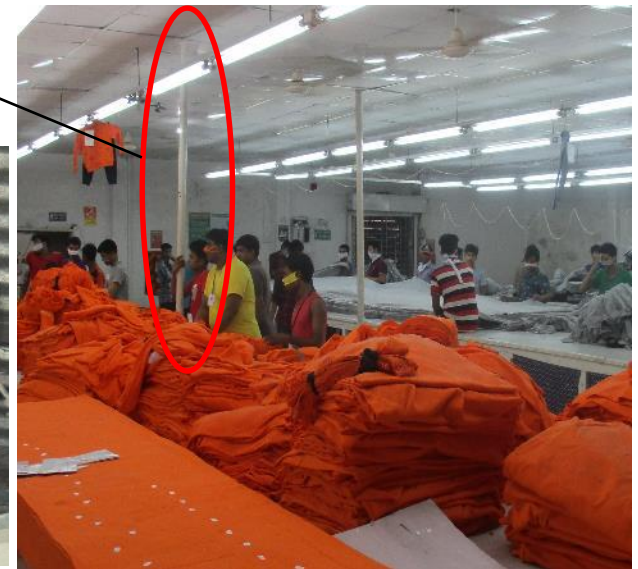
Steel pipe column

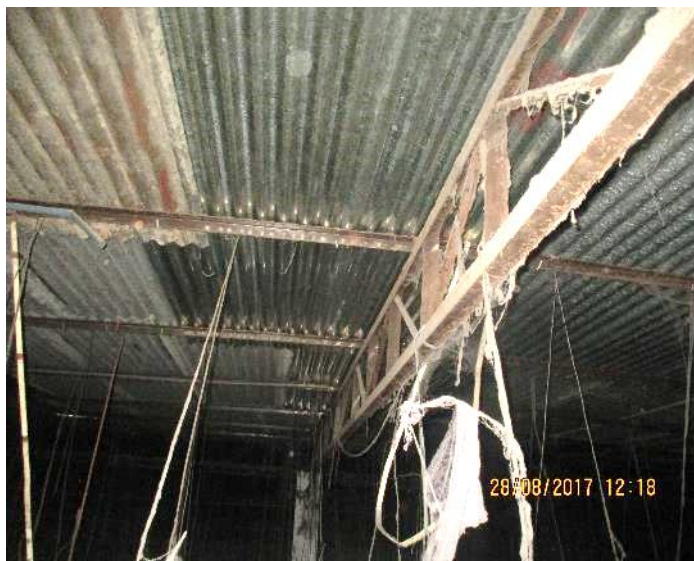
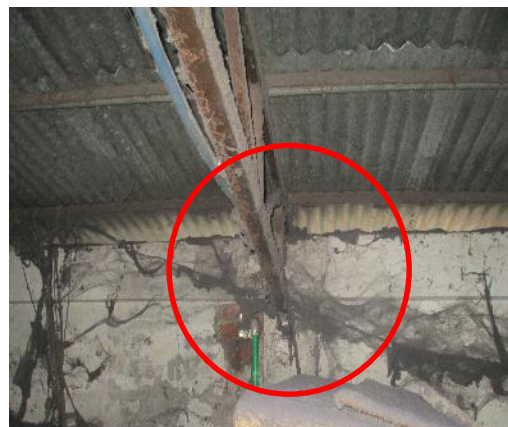
Steel truss frame of Sewing Shed

No connection detail was found in drawing. All members were connected by welding joint.

The connections of the truss & steel pipe are apparently non-engineered and the foundation type of the columns are not clear. Factory engineer to be checked the stability of the structures against uplift forces arise from lateral loading.

| Item No. | Observation | Recommended Action Plan | Recommended Timeline |
|---|---|---|---|
| 1 | Missing information in provided drawing | Building engineer to survey the whole building and produce as-built documentation including foundation detail reflecting the as constructed condition. | 6-weeks |
| 2 | Missing information in provided drawing | Building engineer to check the connections & stability system of the building against lateral load. | 6-weeks |
| 3 | Missing information in provided drawing | Carry out remedial works resulting from engineering assessment where necessary. | 6-months |

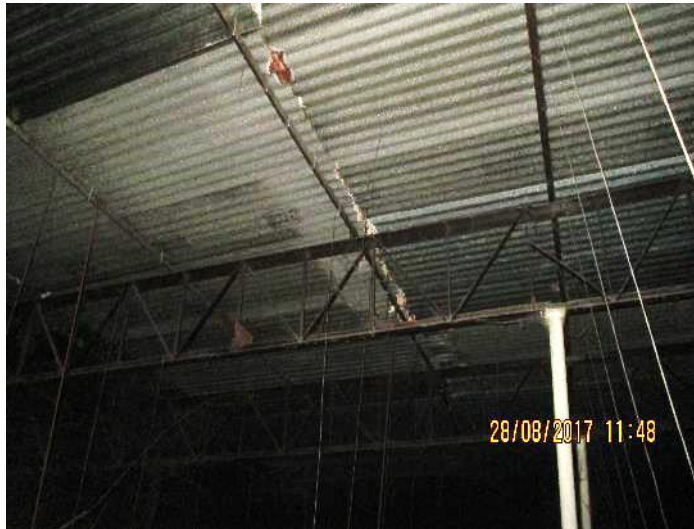
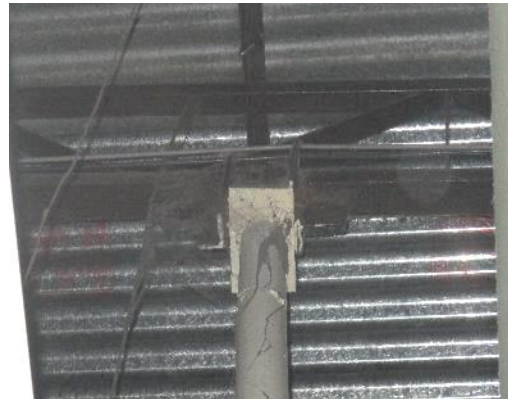
Steel truss frame of Cutting Shed

No connection detail was found in drawing. All members were connected by welding joint.

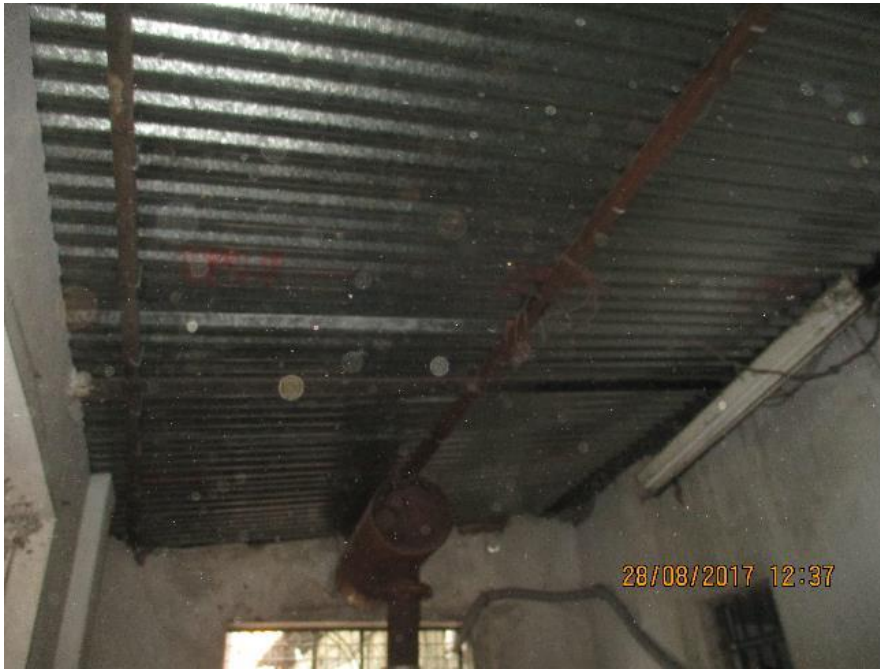
Roof system of the Generator shed

No detail drawing of the shed was found. Moreover, no defined stability system was observed during inspection.

Factory engineer to survey the building and prepare the as-built documentations.  
Stability of lightweight steel shed to be checked for uplift forces.

| Item No. | Observation | Recommended Action Plan | Recommended Timeline |
|---|---|---|---|
| 4 | Lack of as-built documentation | Building engineer to survey the whole building and produce as-built documentation reflecting the as constructed condition. | 6-weeks |
| 5 | Lack of as-built documentation | Building engineer to check the stability of lightweight steel shed for uplift forces. | 6-weeks |
| 6 | Lack of as-built documentation | Carry out remedial works resulting from engineering assessment where necessary. | 6-months |

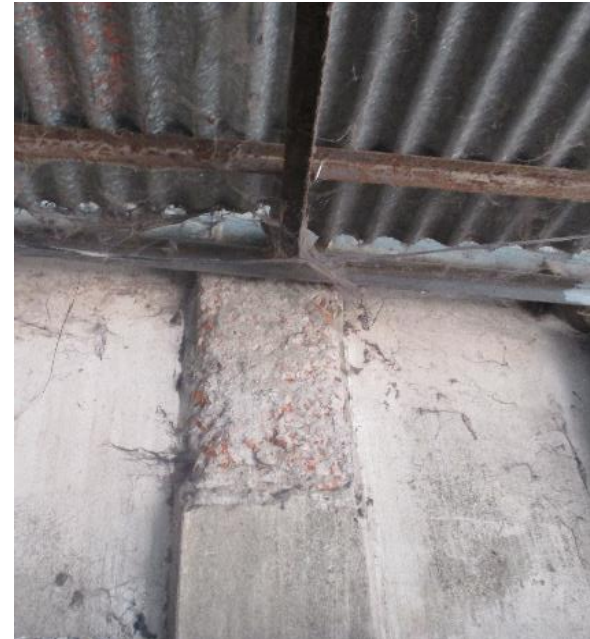
Connection between steel angle and RC column was not clear
