**SF Apparels Ltd. (10322)**  
**SF Fashion Wears Ltd. (10324)**  
**(Site also includes SF Washing Ltd.)**

Nayabari, Kanchpur, Sonargaon

03.JUNE.2014

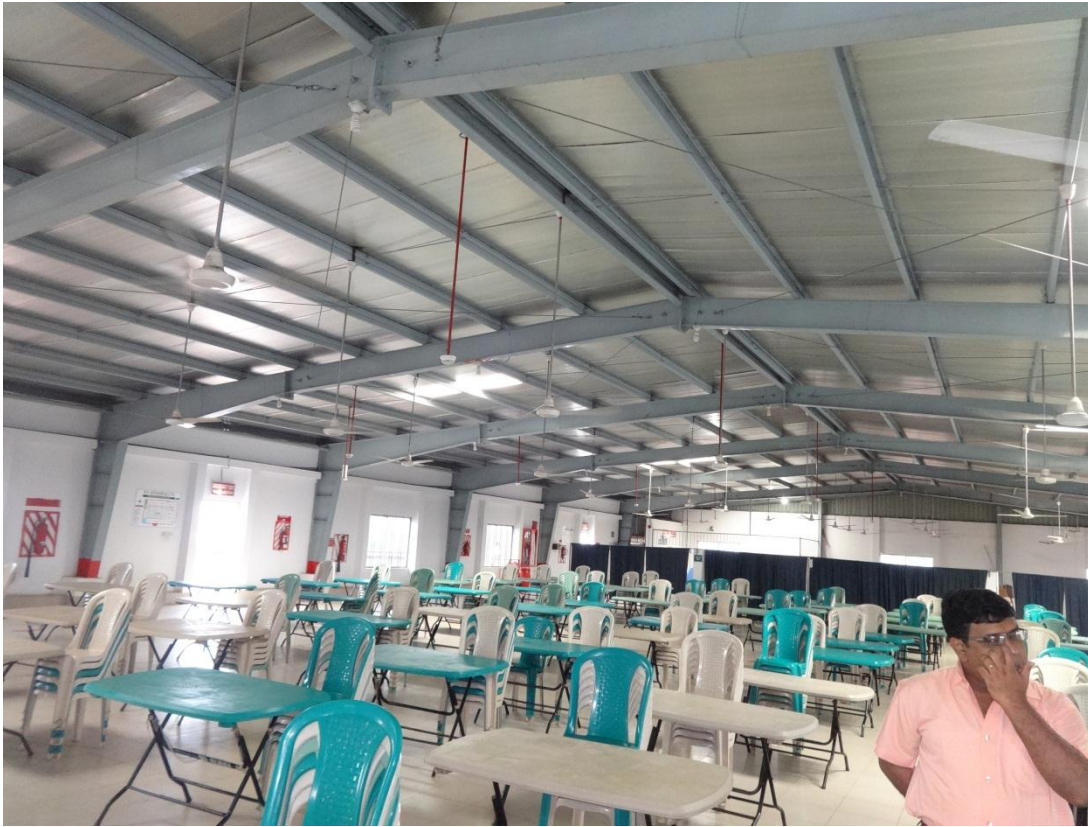
## 1<sup>st</sup> Priority 3 Concern

Some missing elements in steel shed over dining space, required to complete lateral stability system. Same deficiency noted in some areas of the SF Washing Ltd. sheds.

This image is from the steel dining shed, forming a 4<sup>th</sup> floor level over the main concrete factory building below. As can be seen here, there is sufficient horizontal bracing, but no vertical bracing. As the perimeter walls are not in the same plane as the columns to provide stability, vertical bracing should be provided.

Note also that some secondary structural elements, such as bottom flange restraint, were also missing.

The same deficiencies noted here, for the 4<sup>th</sup> floor dining space over the main factory building, were also observed in the 'Extension Shed' of the SF Washing Ltd. buildings.

| Item No. | Observation | Recommended Action Plan | Recommended Timeline |
|---|---|---|---|
| 1 | Priority 3 - Lateral stability system is thorough for most of the buildings, with some minor additions required to steel portions. | Cable cross-bracing to be extended down into the vertical plane (appropriate locations to be determined by Factory Engineer), for all steel structures lacking in this regard.<br>Purlin stays to be installed to provide bottom flange restraint, to Factory Engineer's specifications. | 6-months |

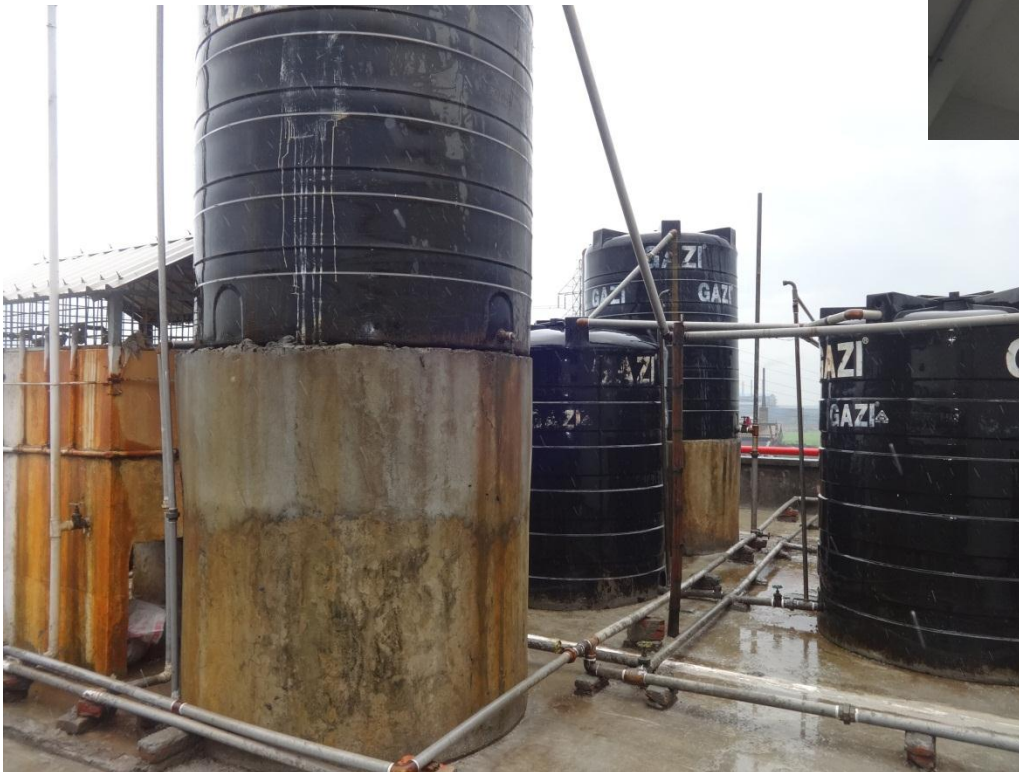
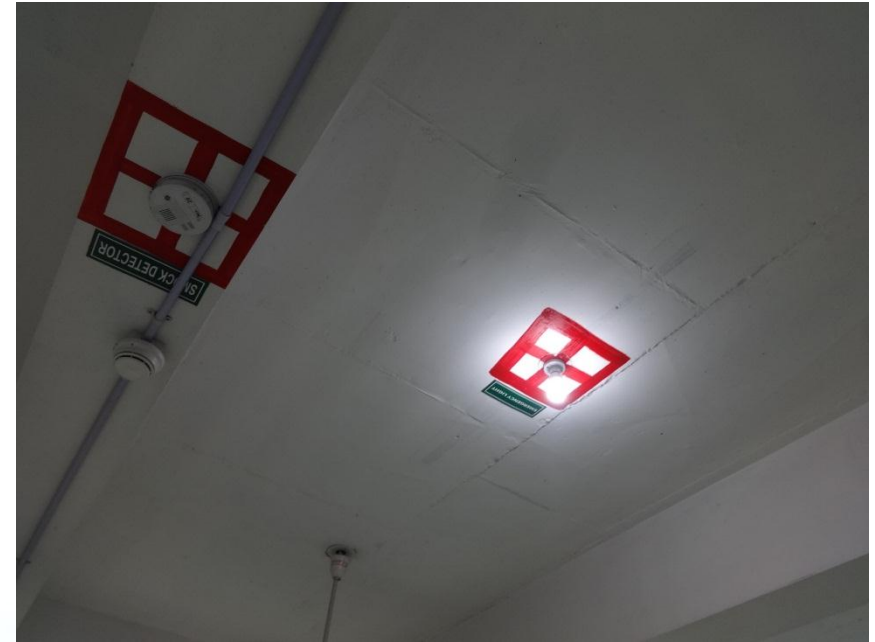
## 2<sup>nd</sup> Priority 3 Concern

Heavy water tanks at roof (4<sup>th</sup> floor) level. No distress was visible within, and columns have been checked, but further investigation into slab and beams may be pertinent.

Below are several large water tanks, located at the concrete roof level, outside the steel 4<sup>th</sup> floor level. Although no internal damage or distress was visible, a further check into the floor and column capacity is advised.

Above is the underside of the slab directly beneath the rooftop water tanks. The apparent 'joints' visible here are just the result of gaps in the formwork when placing concrete. No signs of distress were visible.

| Item No. | Observation | Recommended Action Plan | Recommended Timeline |
|---|---|---|---|
| 2 | Priority 3 - Heavy water tanks at roof level, requiring a capacity check of the supporting structure. | Factory Engineer to produce calculations confirming the capacity of structural elements (primary beams, secondary beams and slabs, as well as columns), under the loading of the rooftop water tanks. | 6-months |

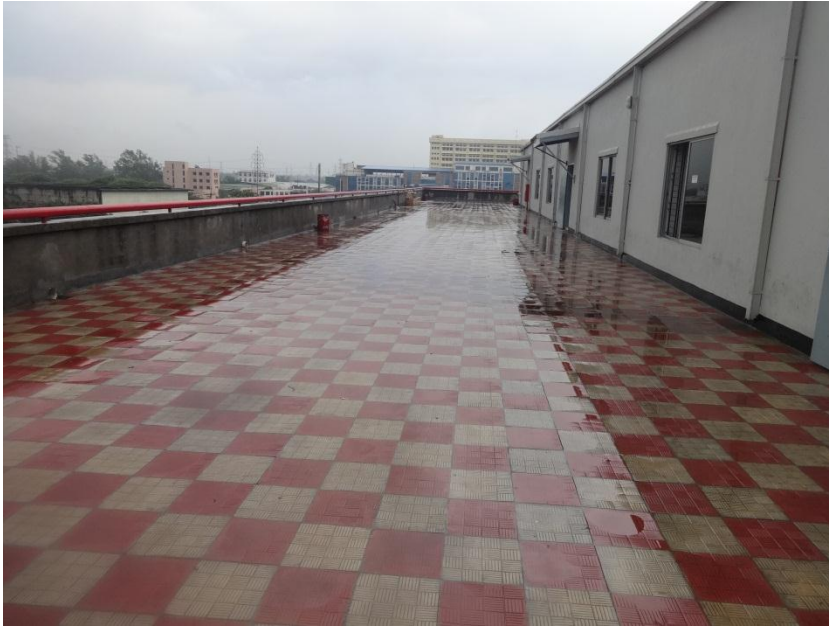
Tiled portion of the concrete roof, providing a waterproof layer over the concrete deck.

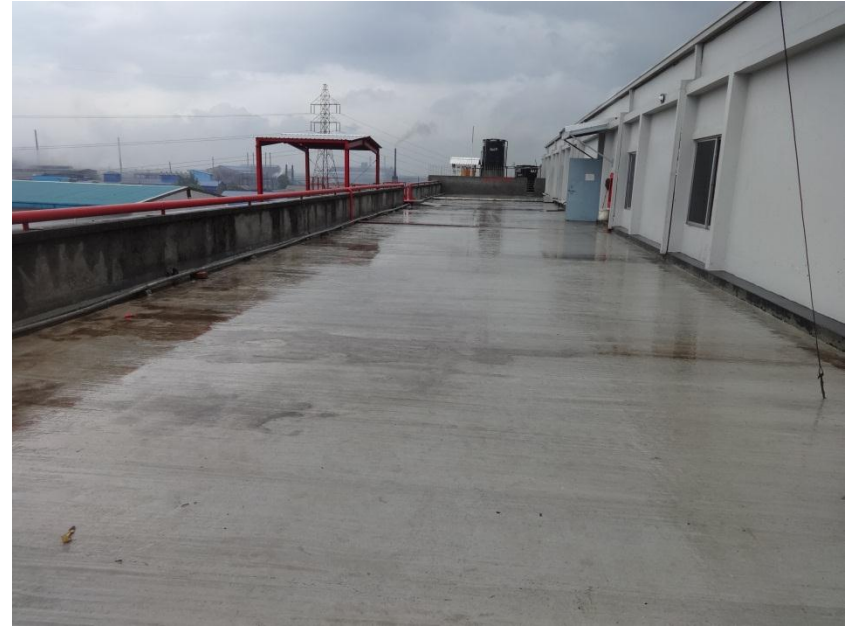
Waterproofing layer at the concrete roof level, external to the 4<sup>th</sup> floor dining space, is not fully comprehensive across the floor area.

This area, on the West side of the roof, is sloped for drainage, but does not have a waterproofing membrane.

This concrete roof area, surrounding the steel 4<sup>th</sup> floor level, appears well constructed, with a suitable slope and ample drainage routes. Most of the roof is also tiled for waterproofing, so it would seem sensible to complete this arrangement for the remainder of this currently unprotected level.

| Item No. | Observation | Recommended Action Plan | Recommended Timeline |
|---|---|---|---|
| 3 | Priority 3 - Waterproofing solution at concrete roof level is appropriate for most of the plan area, with only some small areas un-protected. | Waterproofing membrane to be applied to any exposed concrete areas of roof.<br>Existence of sufficient roof slope and drainage routes to be confirmed. | 6-months |

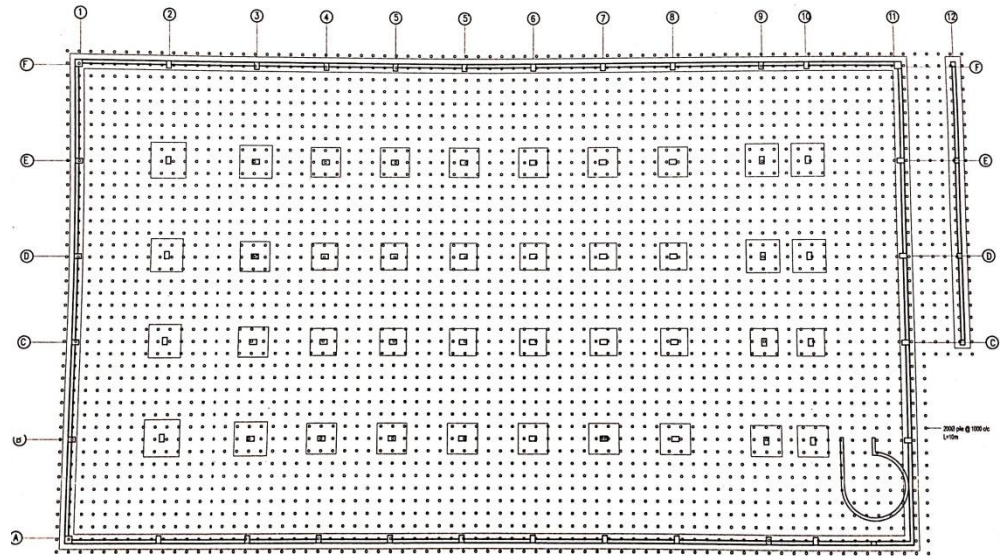
SAND PILE LAYOUT

Discrepancy between pile foundations suggested in Soil Report, and pad foundations on improved ground shown in As-Built drawings.

The extract from the Soil Test Report, shown to the left, clearly states a requirement for RC pile foundations.

Above is a structural As-Built drawing showing sand pile ground improvement and individual pad foundations.

There is no reason why this alternative solution should not work, however due to the deviation from Soil Report advice, it is requested that justification for the foundation solution is provided.

| Item No. | Observation | Recommended Action Plan | Recommended Timeline |
|---|---|---|---|
| 4 | Priority 3 - Foundation solution applied seems to differ from that suggested in Soil Test Report. Capacity to be confirmed. | Ground bearing capacity of improved ground, strengthened by sand piles, to be established (either by existing Soil Test or calculations, or new Site Investigation).<br>Pressure exerted under installed pad foundations to be calculated following load run-down, and compared with bearing capacity established from previous point. | 6-months |

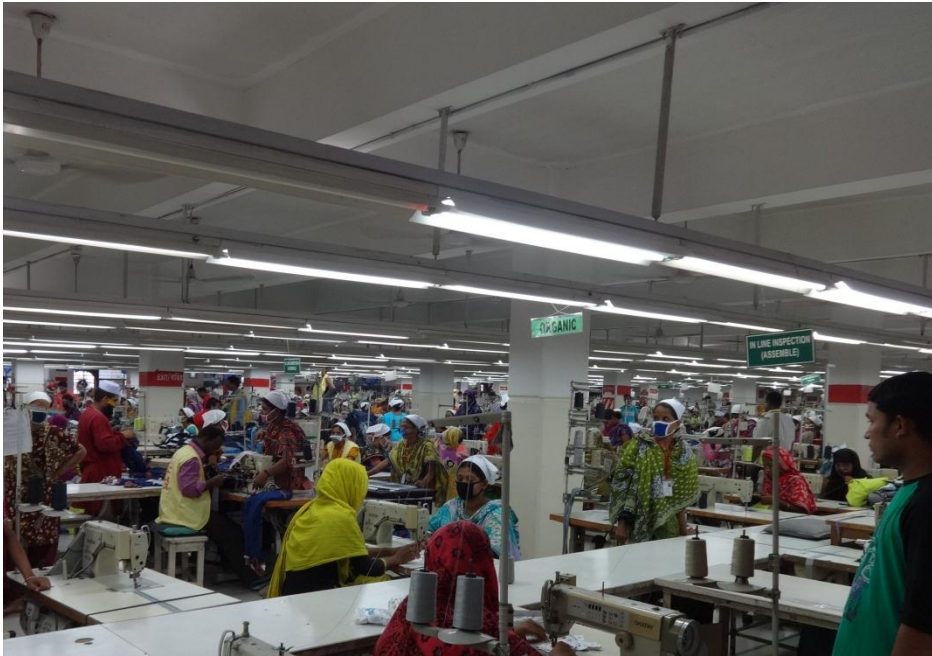
## 5<sup>th</sup> Priority 3 Concern

Factor of Safety around 1.86 from column load run-down.  
'Green' rating, requiring only some further investigation.

These images show the fairly regular column grid apparent across the building. For the column load run-down, the largest bay in the column grid was located and measured-up.

No significant concerns were raised through this calculation, however the resulting Factor of Safety was low enough to warrant a certain level of further investigation.

| Item No. | Observation | Recommended Action Plan | Recommended Timeline |
|---|---|---|---|
| 5 | Priority 3 - Potential for over-stress in internal columns. Further investigation required. | Factory Engineer to review design, loads and column stresses for internal columns.<br>Verify in-situ concrete stresses by 100mm dia. cores from 4 columns.<br>Produce and actively manage a loading plan for all floor plates within the factory, giving consideration to floor capacity and column capacity. | 6-months |

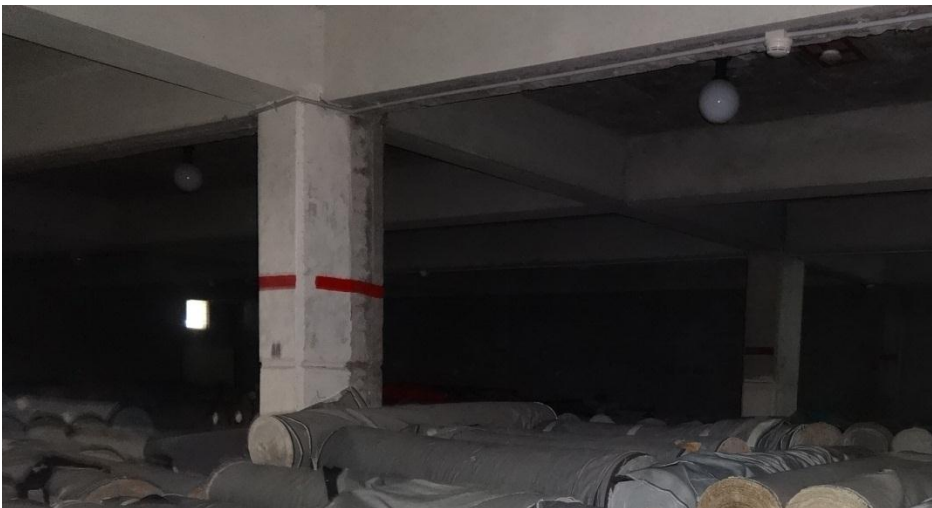
After Ferros scanning and measuring, it appeared that the columns had been constructed as shown in the drawings.

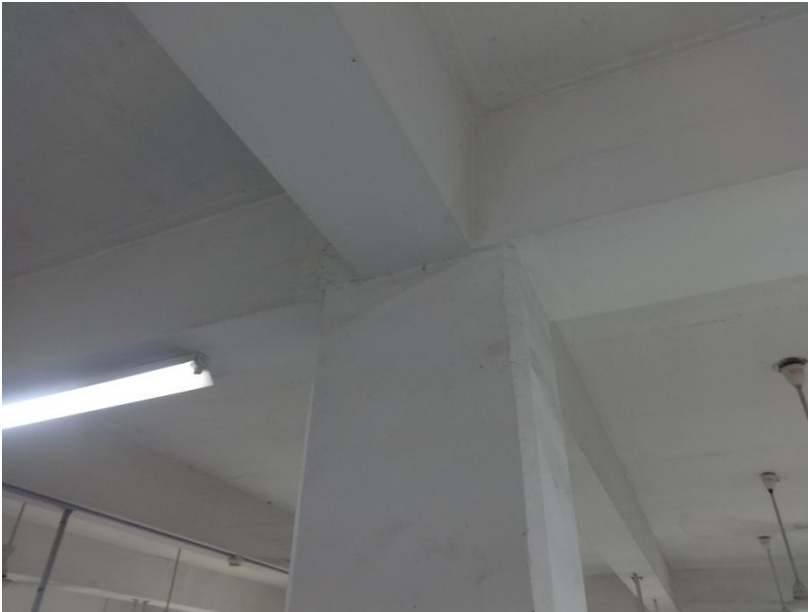
The concrete building had ample lateral stability, with both the reinforced concrete core shown to the right, and rigid beam-column connections throughout the structure.

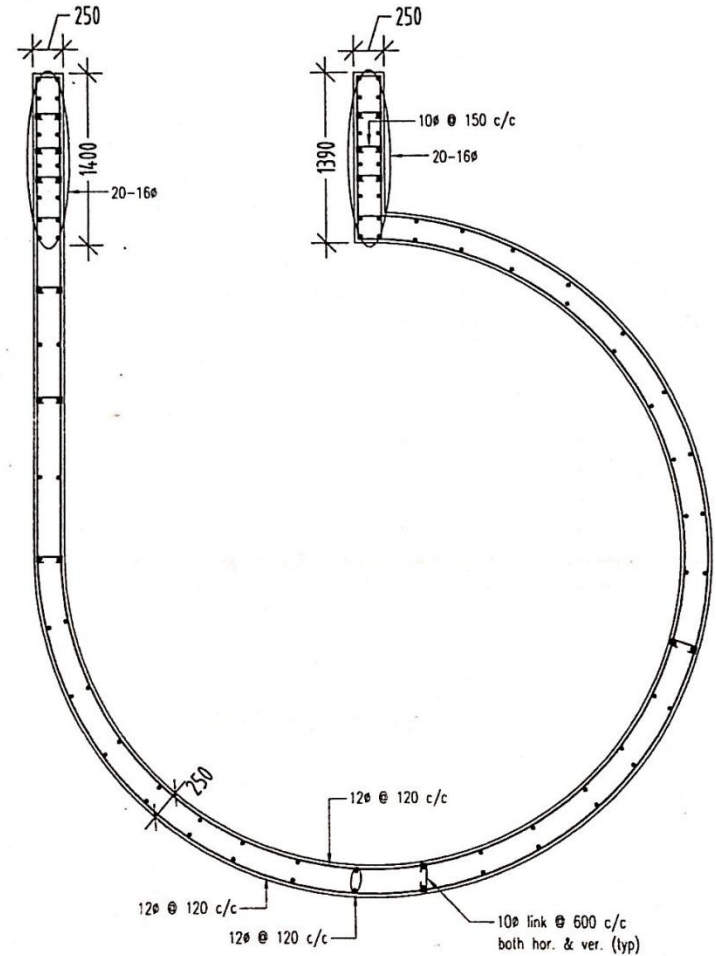
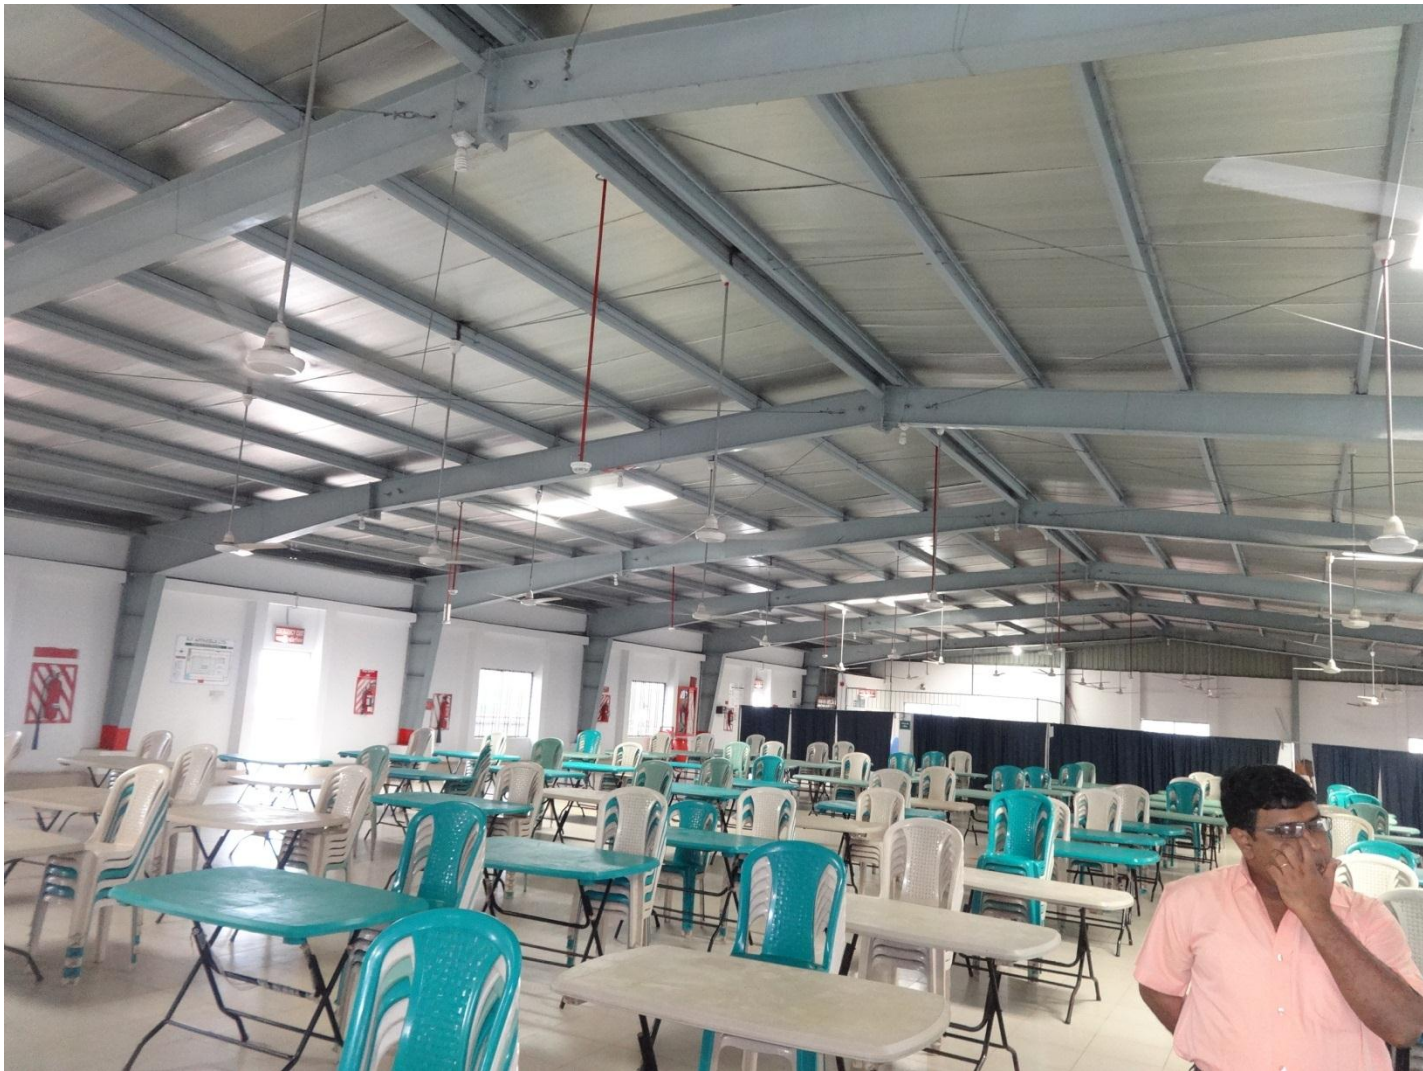
Steel roof over the 4<sup>th</sup> floor dining space on the main building, as indicative of the other steel buildings on the site also. Ample horizontal bracing evident, but none in the vertical plane.

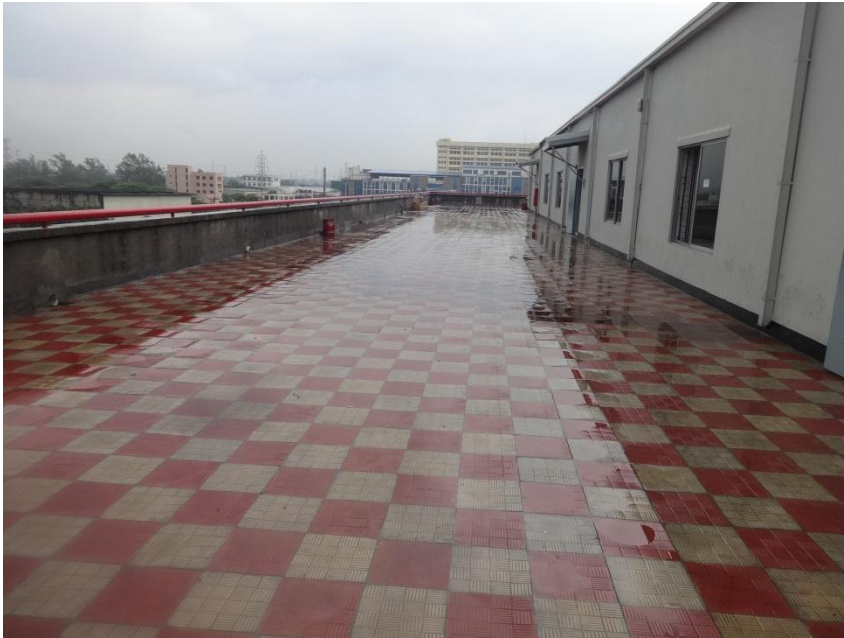
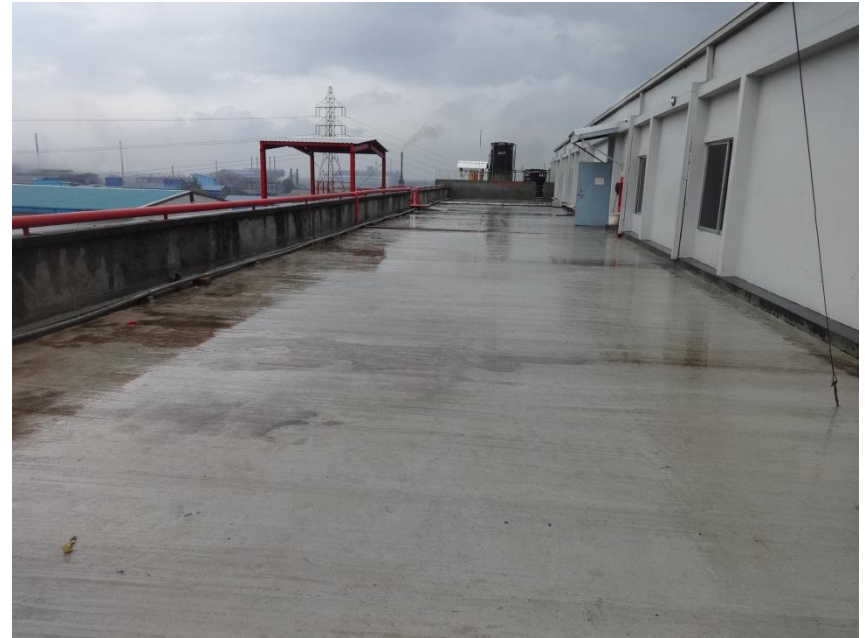
Images showing the external roof space around the 4<sup>th</sup> floor dining area. Left; a tiled surface with apparently sufficient slope and drainage, as was observed across most of this roof level. Right; a small area of this roof level which had no waterproofing membrane, leaving exposed concrete/screed susceptible to water ingress.

As covered in the Priority Actions section of the report, provided there is a suitable slope on this roof, the simple addition of a waterproof membrane will be sufficient to prevent any future issues of water ingress.
