# SF Sweaters Ltd. (9879)

South Salna, Salna Bazar, Gazipur.

04.June.2014

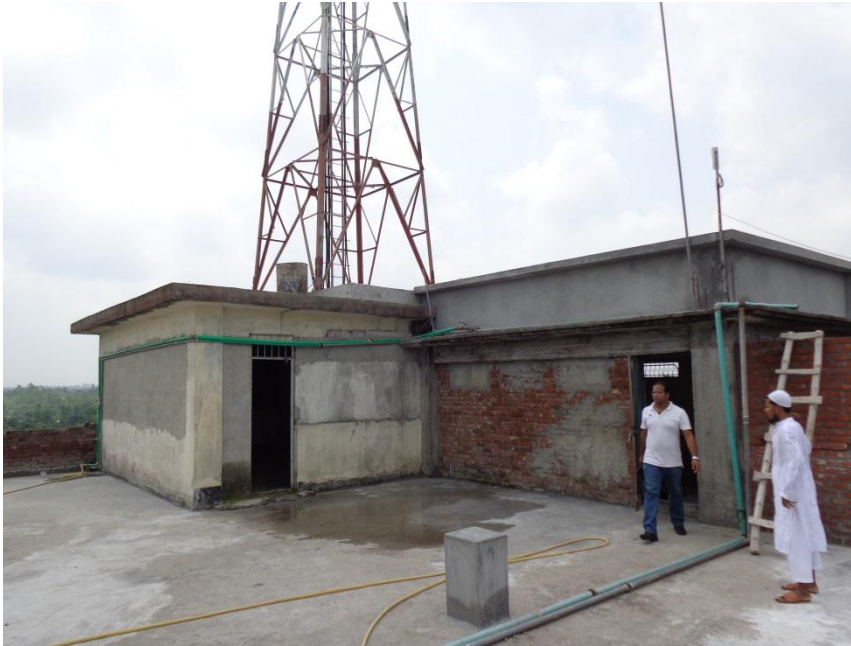
Critical Column at Original Building

The critical columns in both the original building and the extension portion are overstressed. Three separate critical columns were examined, and all three were found to be overstressed. In addition, if the roof of the extension portion is completed, some columns will become critically overstressed.

| Item No. | Observation | Recommended Action Plan | Recommended Timeline |
|---|---|---|---|
| 1 | 1st Priority 1 - The critical columns in both the original building and the extension are overstressed. | Stop all further construction.<br>Reduce all loading, on all floors, for both the original building and the extension down to a maximum of 2.0 kPa (40 psf). | Immediate - Now |
| 2 | 1st Priority 1 - The critical columns in both the original building and the extension are overstressed. | A Detailed Engineering Assessment is required to determine the concrete strength and load bearing capacity for the entire building (both original and extension portion). | 6-weeks |
| 3 | 1st Priority 1 - The critical columns in both the original building and the extension are overstressed. | Complete and Implement any recommendations from the DEA. | 6-months |

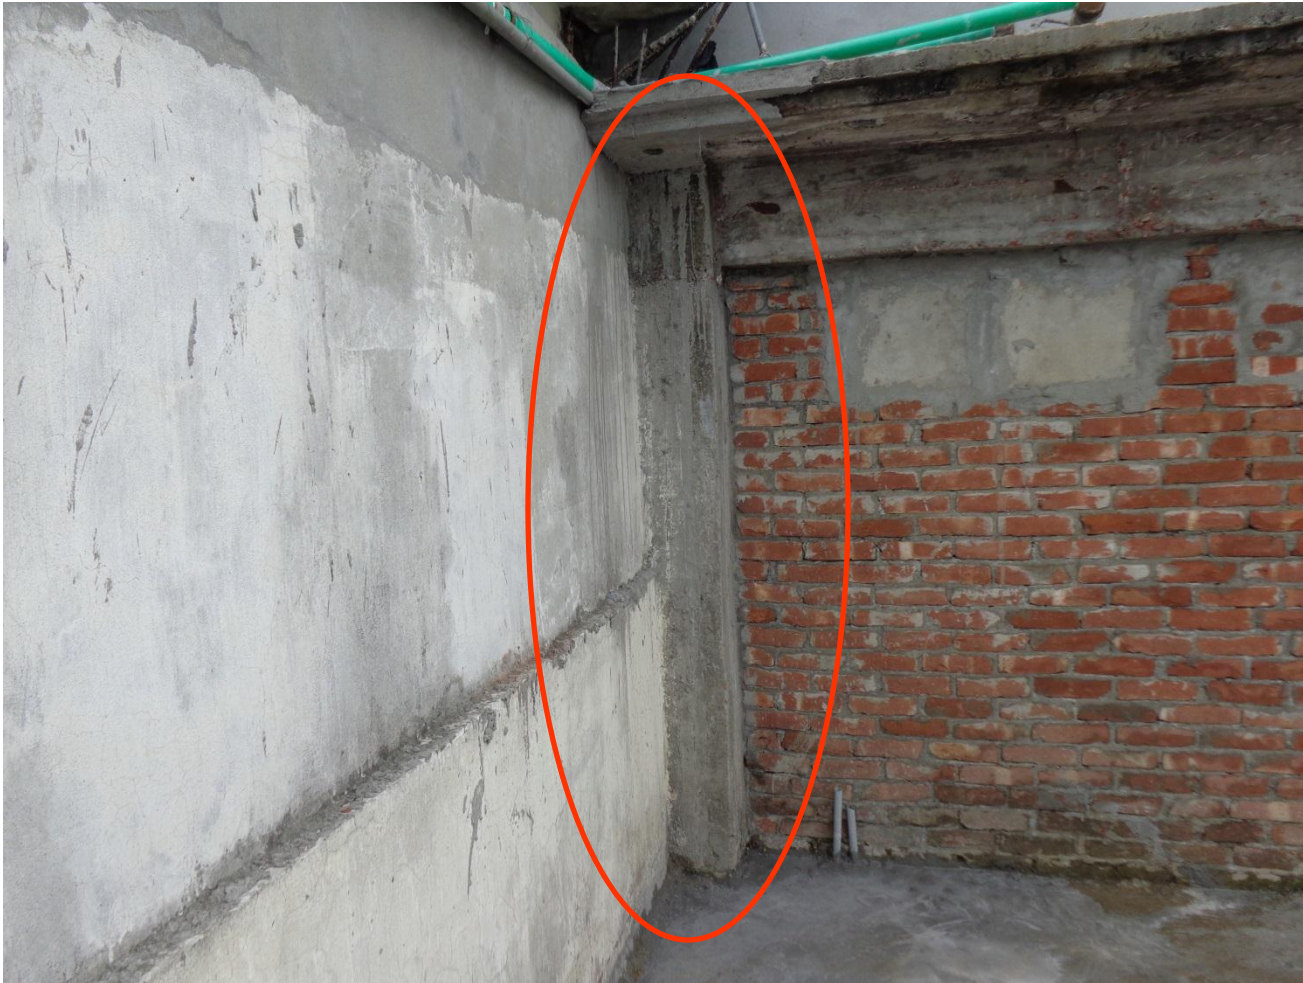
A column was added at the roof to support a newly constructed water tank, however this column is supported only by the beam below and is not shown on the structural drawings.

| Item No. | Observation | Recommended Action Plan | Recommended Timeline |
|---|---|---|---|
| 4 | 2nd Priority 1 - A column was added at the roof to support a newly constructed water tank, however this column is supported by the beam below and is not shown on the structural drawings. | Empty water in tank down to minimum volume required to meet fire code and regulations.<br>Temporarily prop column between two beams to help transfer load across roof beam and 5th floor beam. | Immediate - Now |
| 5 | 2nd Priority 1 - A column was added at the roof to support a newly constructed water tank, however this column is supported by the beam below and is not shown on the structural drawings. | A Detailed Engineering Assessment is required to determine the capacity of the roof beam supporting the concentrated column load. | 6-weeks |
| 6 | 2nd Priority 1 - A column was added at the roof to support a newly constructed water tank, however this column is supported by the beam below and is not shown on the structural drawings. | Implement any recommendations from DEA. | 6-months |

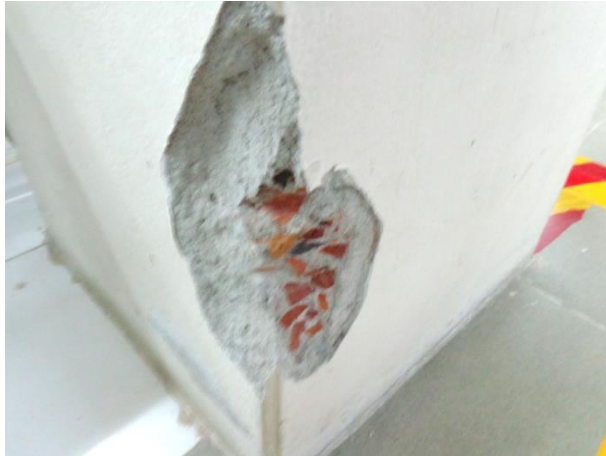
Brick not Stone Aggregate

The structural drawings do not match the following existing conditions:

| Item No. | Observation | Recommended Action Plan | Recommended Timeline |
|---|---|---|---|
| 7 | 1st Priority 2 - The structural drawings do not match the existing conditions. Column size and reinforcing, joint details, grid spacing, beam size, concrete type and reinforcing grade all differ on site from the as-built structural drawings. | Structural Engineer to review existing conditions and revise drawings to match as-built conditions. | 6-weeks |

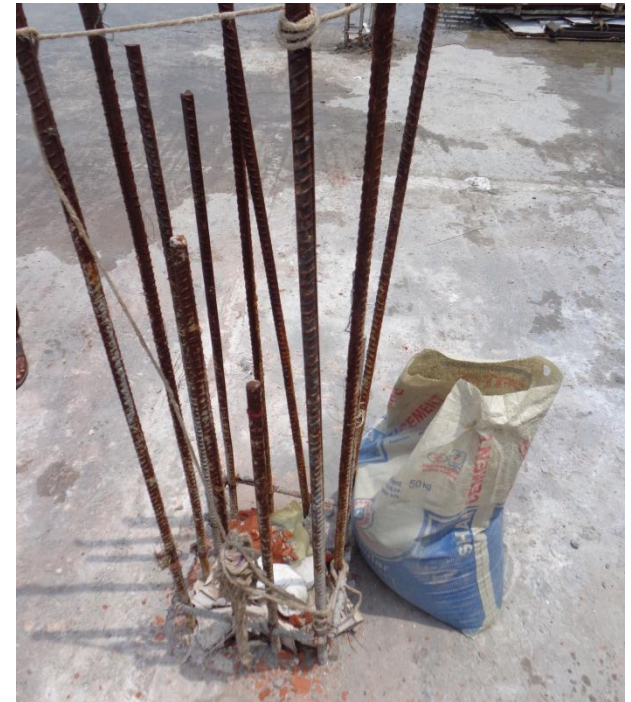
15"x13" column not 20"x12"

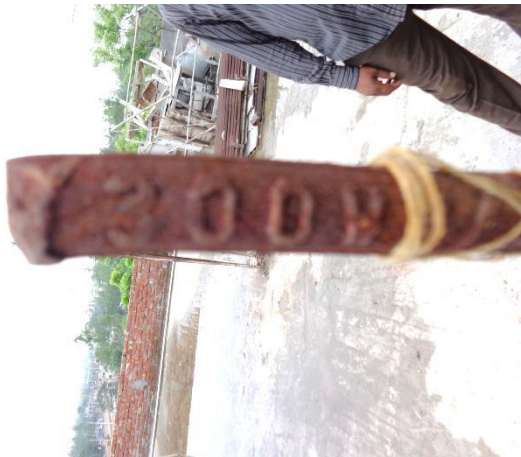
40 not 60 Grade Reinforcing

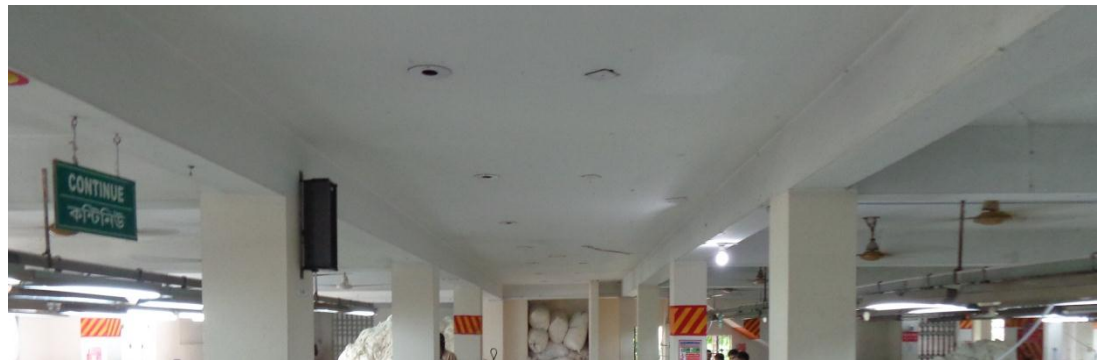
No Beams across Joint

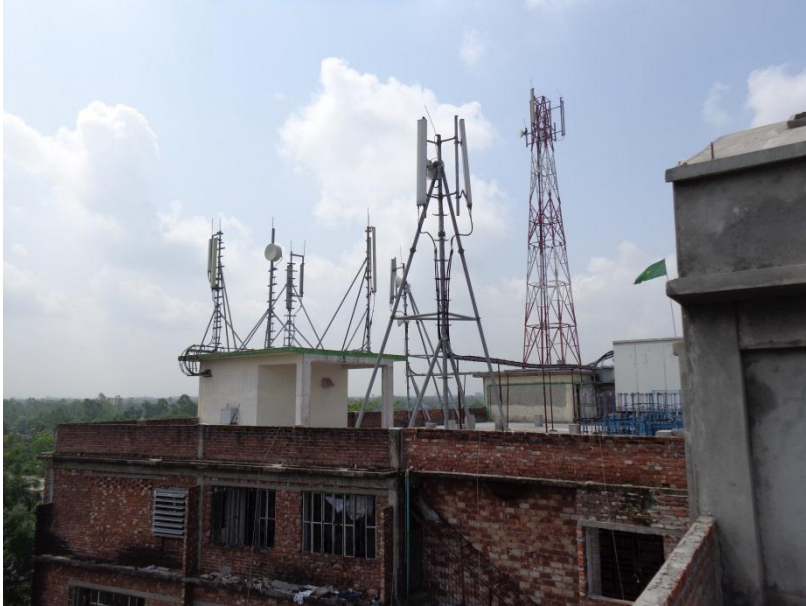
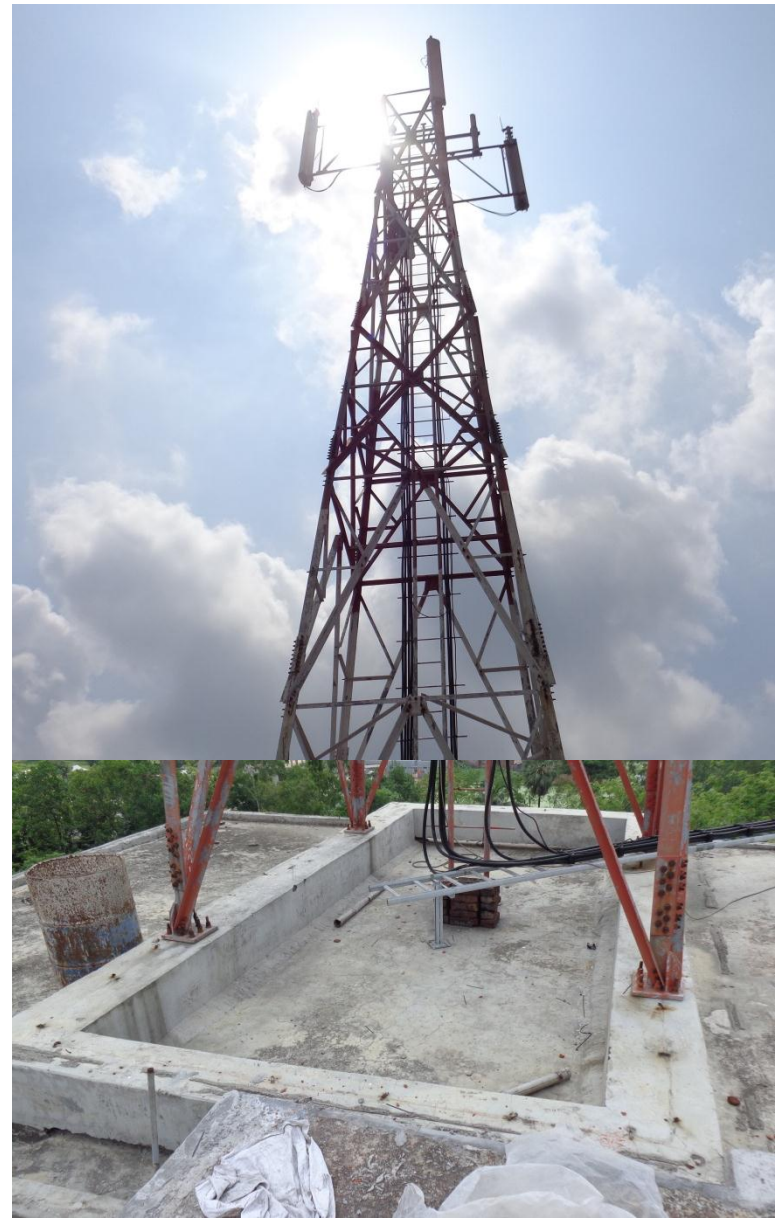
No structural drawings or details exists for the mobile towers and additional rooms on the roof.

| Item No. | Observation | Recommended Action Plan | Recommended Timeline |
|---|---|---|---|
| 8 | 2nd Priority 2 - No structural drawings or details exist for the mobile towers and additional rooms on the roof. | Detailed Engineering Assessment is required to assess the impact of added loading from all towers and additional structures on the roof. | 6-weeks |
| 9 | 2nd Priority 2 - No structural drawings or details exist for the mobile towers and additional rooms on the roof. | Implement any recommendations from DEA. | 6-months |

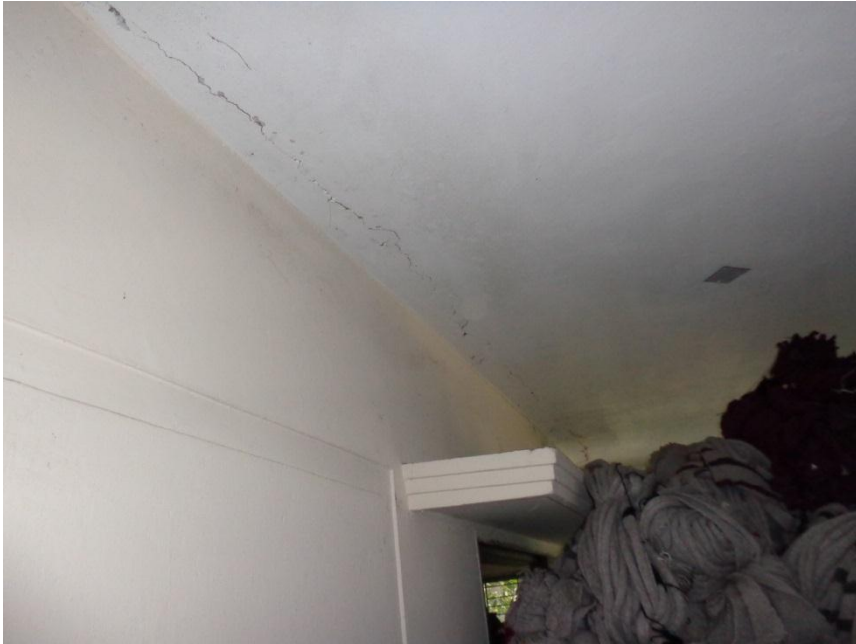
Medium Crack along Joint

A crack has developed on all floors at the joint between the extension and the original building. In some areas this crack has been plastered over. No movement joint is apparent between the two cantilevered slabs. In addition, the structural as-built drawings indicate beams across the joint, however these beams are not present.

| Item No. | Observation | Recommended Action Plan | Recommended Timeline |
|---|---|---|---|
| 10 | 3rd Priority 2 - A crack has developed on all floors at the joint between the extension and the original building. | Detailed Engineering Assessment is required for the joint (or lack there of) between the two phases of construction. | 6-weeks |
| 11 | 3rd Priority 2 - A crack has developed on all floors at the joint between the extension and the original building. | Implement any recommendations from DEA. | 6-months |

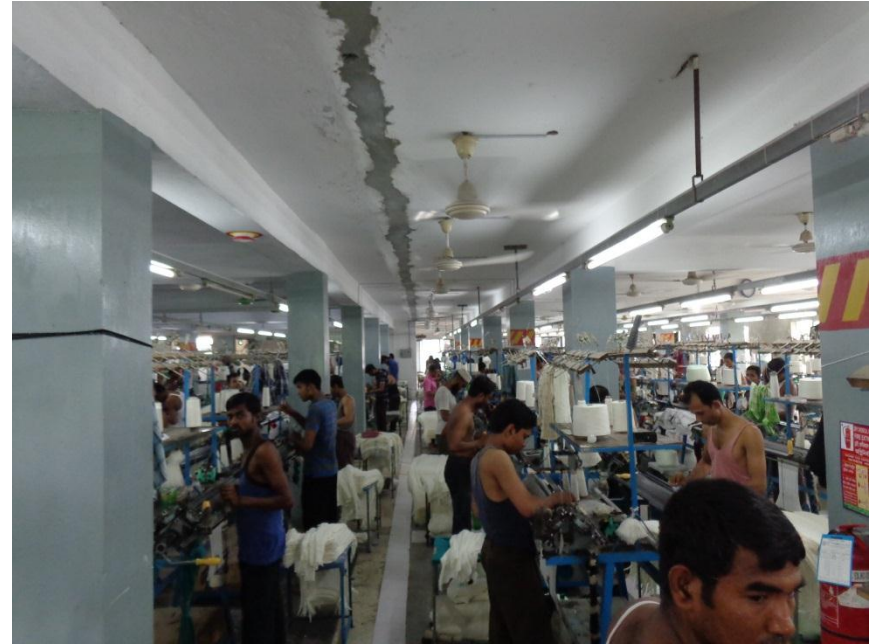
Plaster Repair along Joint

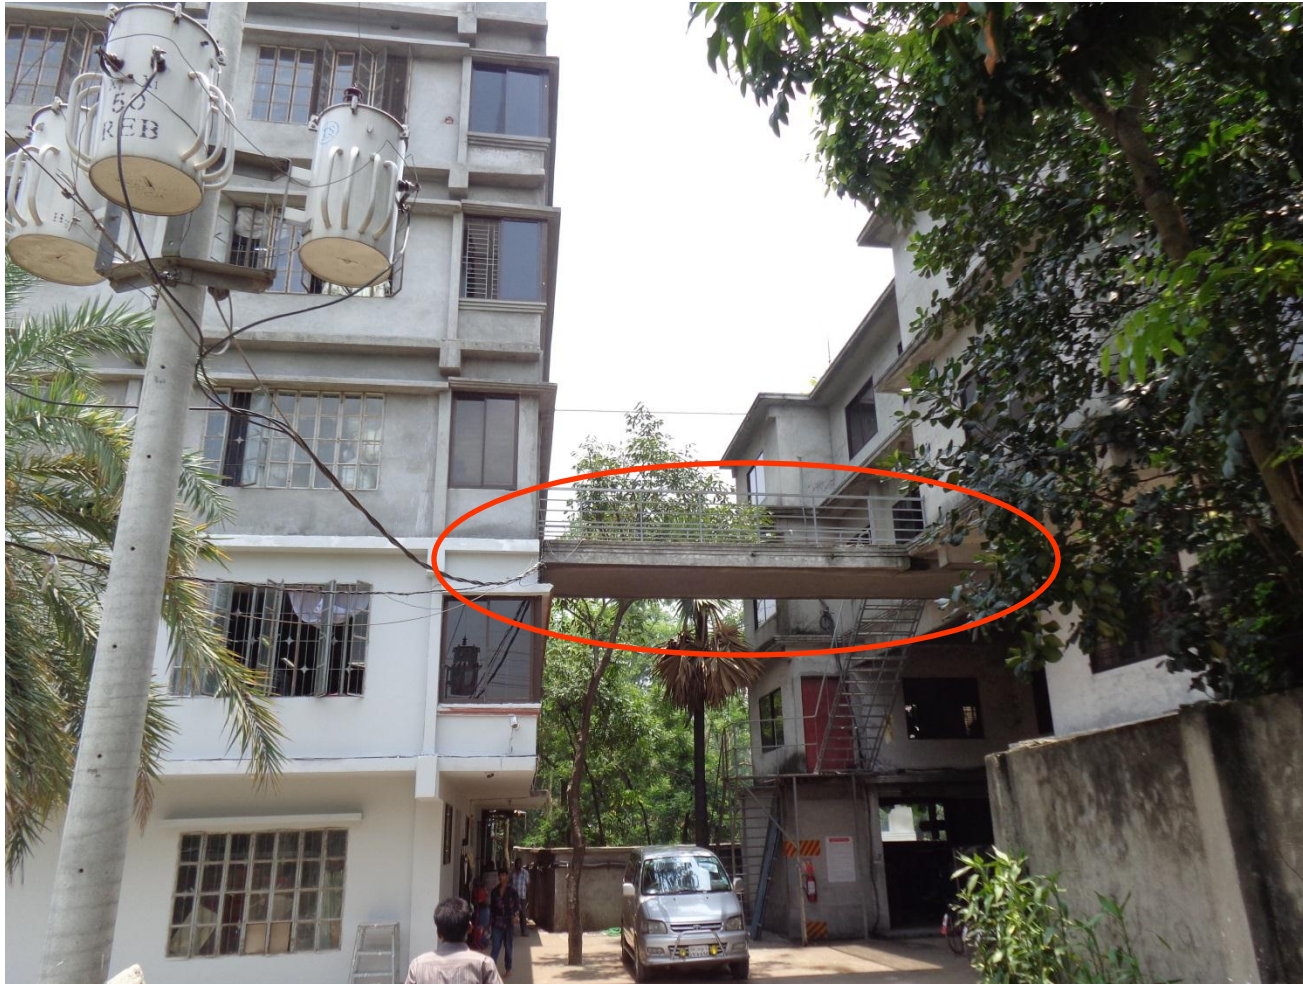
A concrete link between the original building and an adjacent building exists on the 3rd level, however no drawings were made available for this.

| Item No. | Observation | Recommended Action Plan | Recommended Timeline |
|---|---|---|---|
| 12 | 4th Priority 2 - A concrete link between the original building and an adjacent building exists on the 3rd level, however no drawings were made available. | Detailed Engineering Assessment is required for the concrete link between the two buildings. | 6-weeks |
| 13 | 4th Priority 2 - A concrete link between the original building and an adjacent building exists on the 3rd level, however no drawings were made available. | Implement any recommendations from DEA. | 6-months |

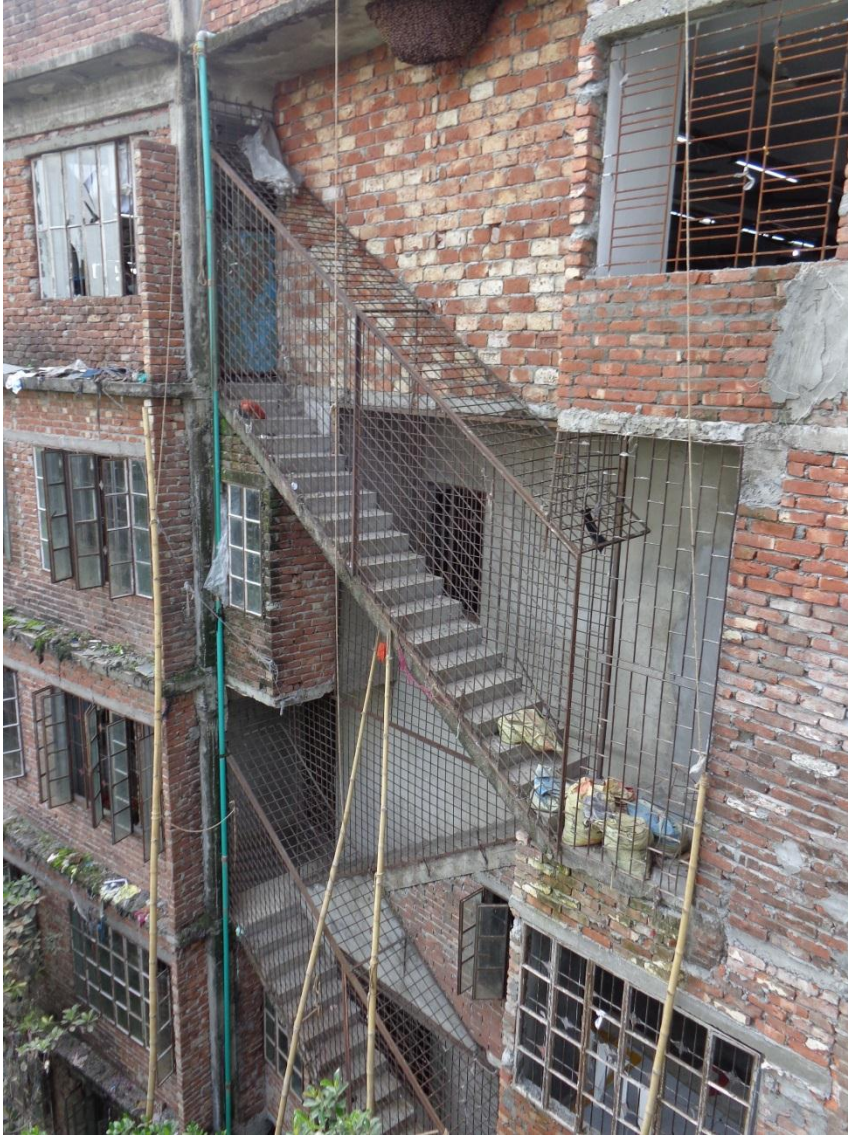
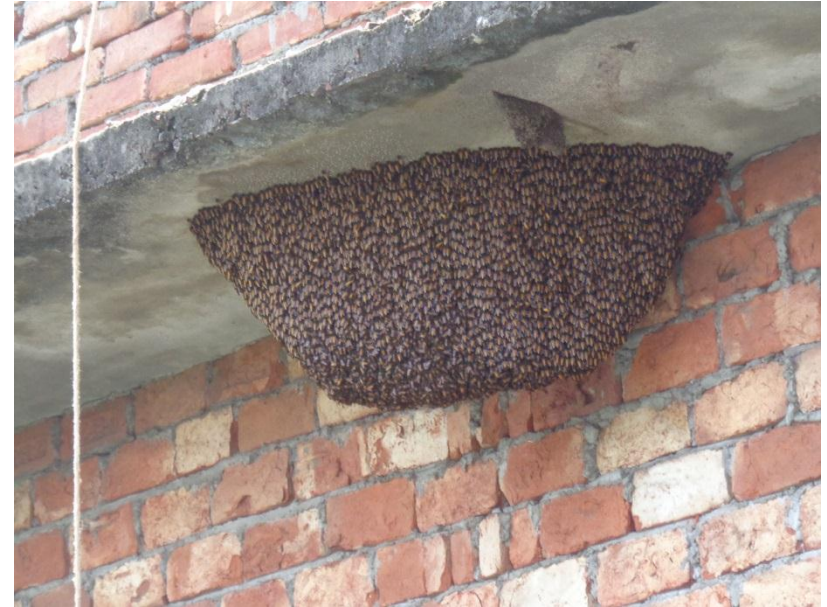
The decommissioned concrete stairs along the outside of the original building appear deficient. In addition, a large beehive is present at the 5th level.

| Item No. | Observation | Recommended Action Plan | Recommended Timeline |
|---|---|---|---|
| 14 | 5th Priority 2 - The decommissioned concrete stairs along the outside of the original building appears deficient. | Detailed Engineering Assessment is required for the concrete stairs. | 6-weeks |
| 15 | 5th Priority 2 - The decommissioned concrete stairs along the outside of the original building appears deficient. | Implement any recommendations from DEA. | 6-months |

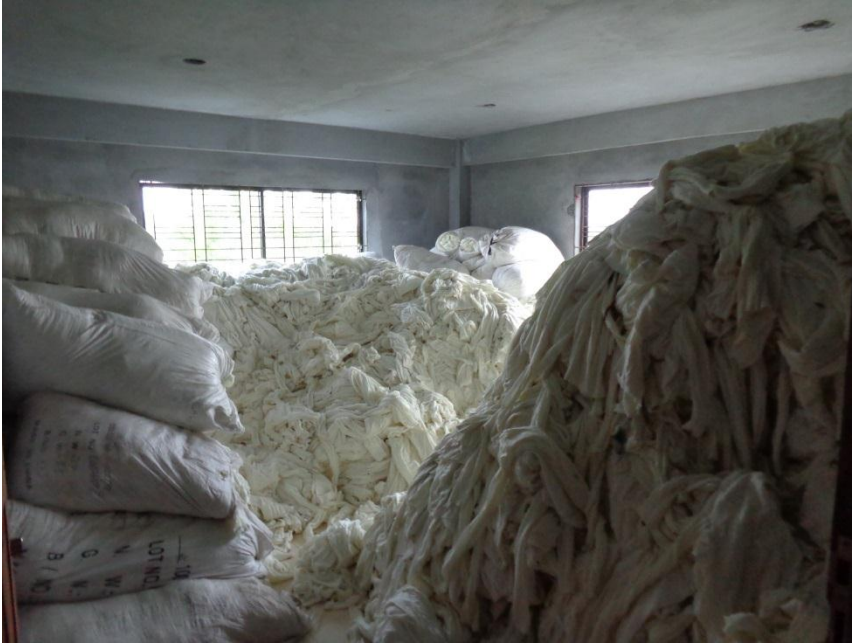
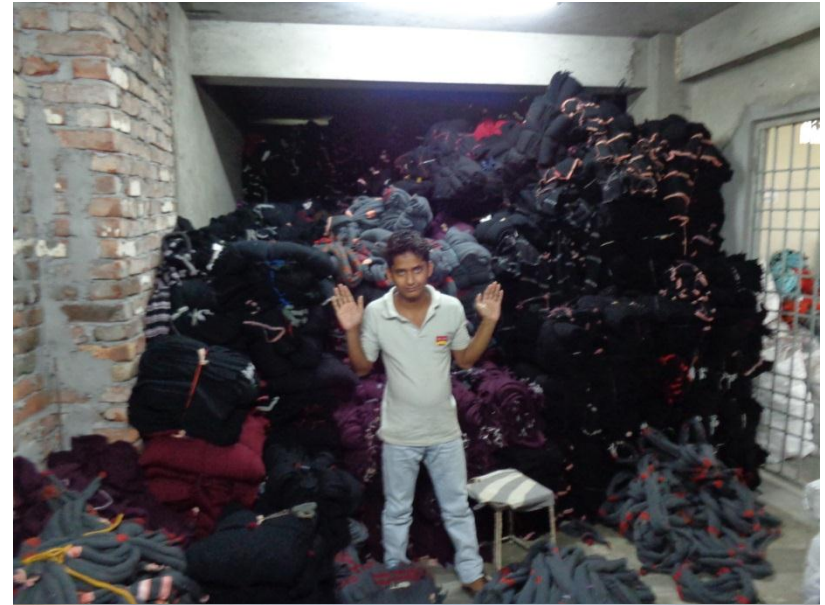
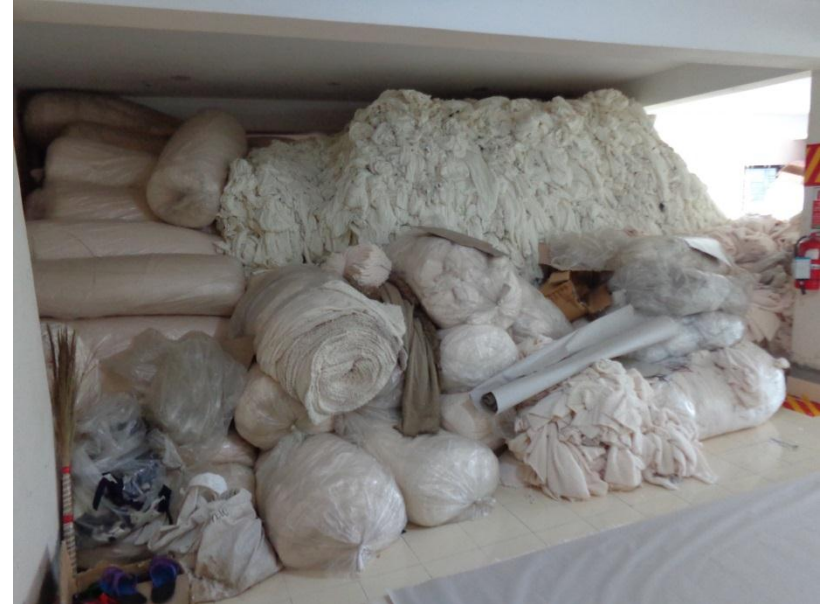
No loading plans were made available and high storage loading was observed on nearly all the floors.

| Item No. | Observation | Recommended Action Plan | Recommended Timeline |
|---|---|---|---|
| 16 | 1st Priority 3 - No loading plans were made available and storage loading was observed on nearly all of the floors. | Structural Engineer to provide loading plans based on capacity for each floor of the entire building.<br>Post and manage loading on all floors. | 6-months |

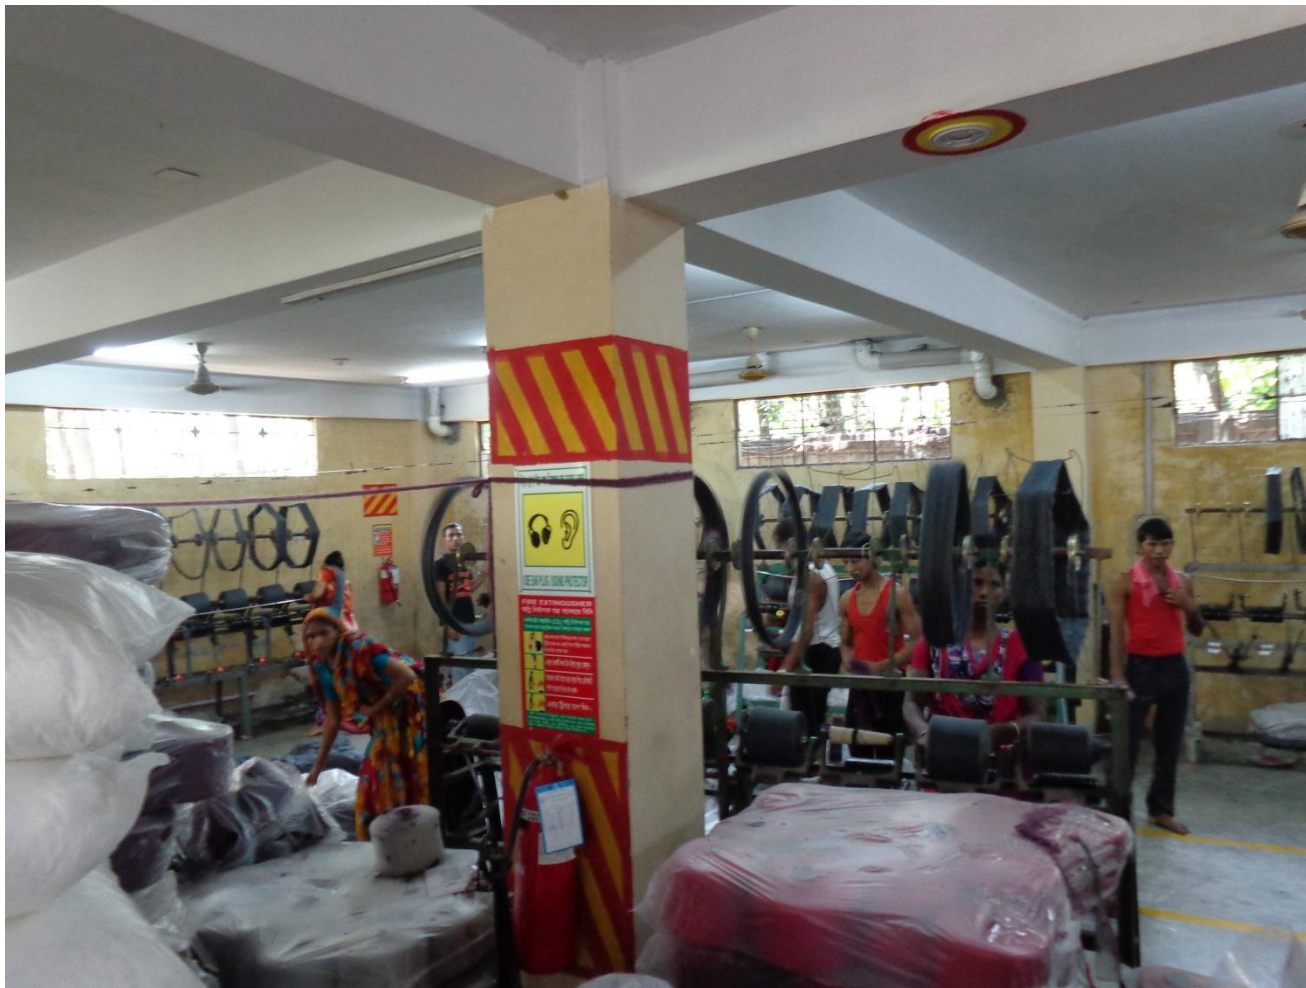
The building did not feature any core or shear walls. Stability was achieved through sway action between beams and columns and masonry infill walls.

We require that these items be investigated in a Detail Engineering Assessment

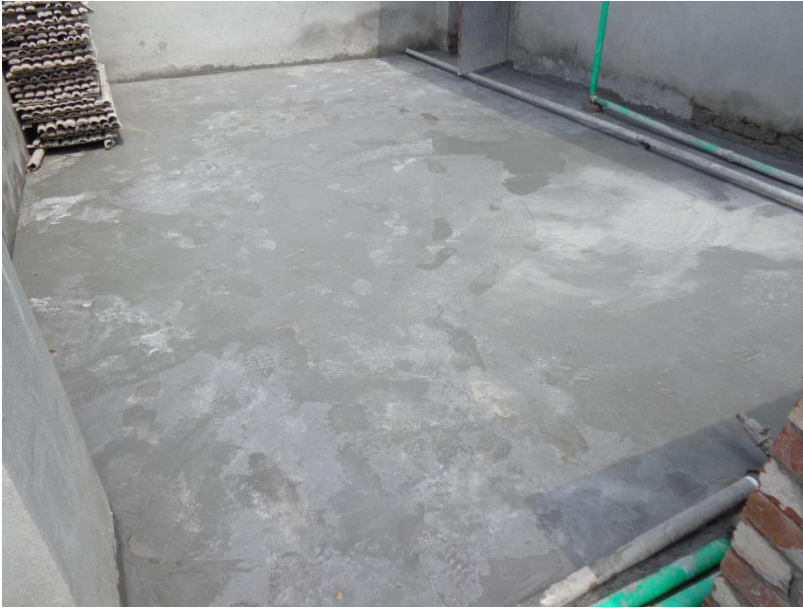
A waterproofing membrane was visible on the roof of the building, but only for a small portion. Waterproofing should extend across the entire roof in order to limit infiltration of water and corrosion of the reinforcing steel.
