# Ananta Garments Ltd

# Ananta Sportswear Ltd

Nischintapur, Ashulia, DEPZ Road, Savar  
23.92703N, 90.30931E)

22 March 2014

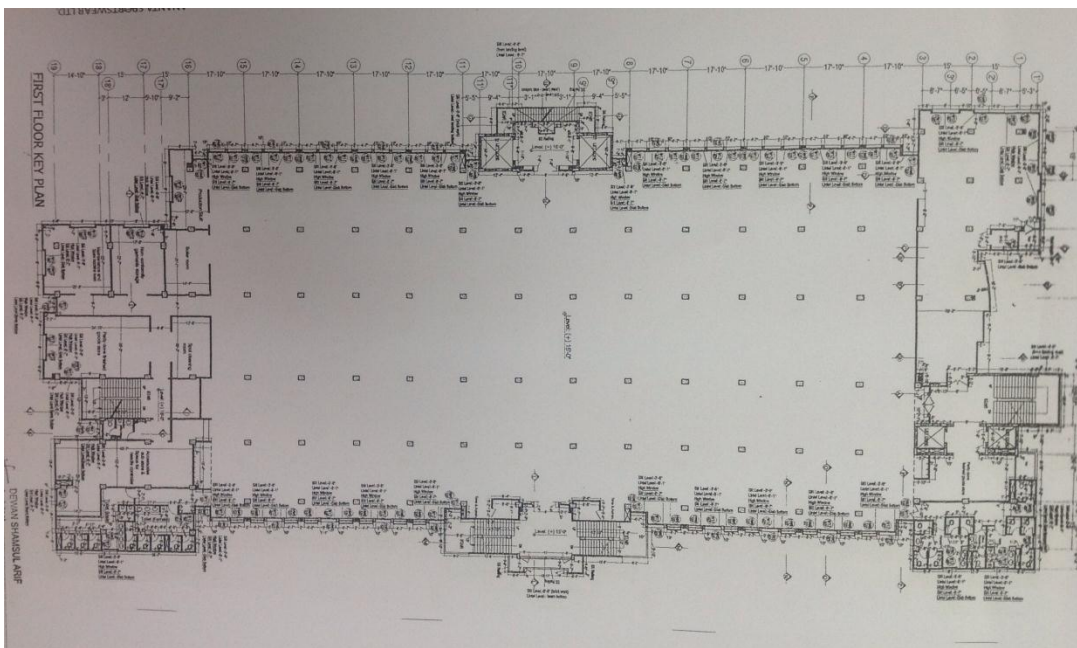
Typical Column Layout

**Columns appear to be stressed in excess of normal design limits – Building Engineer to verify concrete stresses and in-situ concrete strength**

Cursory calculations indicate that the working stress of columns at Ground Floor level are at a high level.

Building Engineer to check that columns have been designed to accommodate loads.

| Item No. | Observation | Recommended Action Plan | Priority |
|---|---|---|---|
| 1 | Columns appear to be stressed in excess of normal design limits – Building Engineer to verify concrete stresses and in-situ concrete strength. | Factory Engineer to review design, loads and columns stresses. | 6-weeks |
| 2 | Columns appear to be stressed in excess of normal design limits – Building Engineer to verify concrete stresses and in-situ concrete strength. | Verify insitu concrete stresses either by 100mm diameter cores or existing cylinder strength data for cores from 4 columns. | 6-weeks |

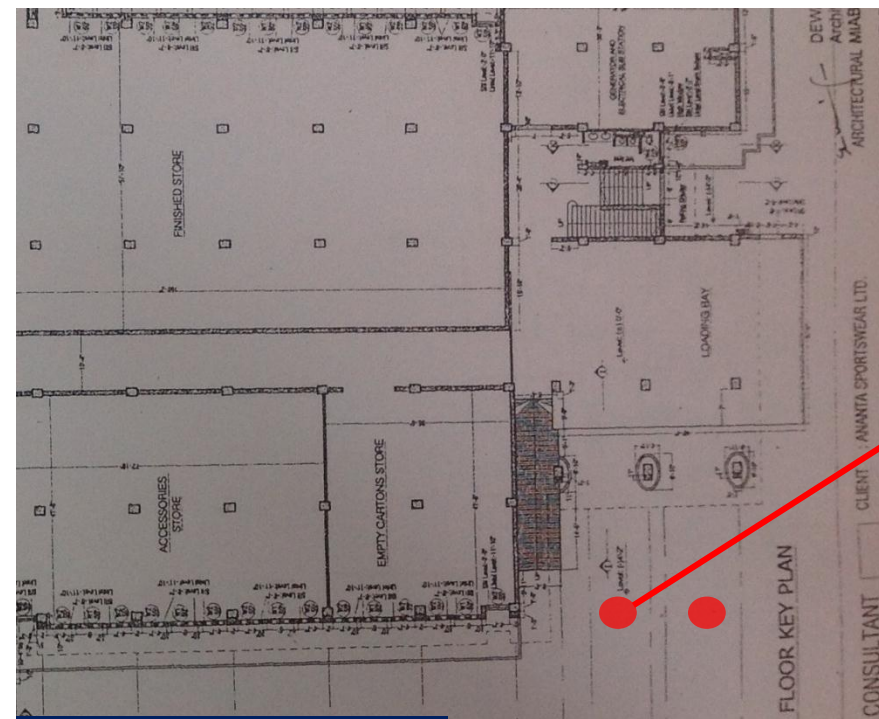
Ground Floor Plan

**The columns at the delivery entrance to the Building are at risk of being accidentally struck by a vehicle. More substantial Column protection barriers need to be provided**

2 no. columns at the delivery entrance to the Building are at risk of being accidentally struck by a vehicle.

Building Engineer to check that the columns have been adequately designed for impact loading, and to ensure protection currently provided for impact loading is adequate.

| Item No. | Observation | Recommended Action Plan | Priority |
|---|---|---|---|
| 4 | The columns at the delivery entrance to the Building are at risk of being accidentally struck by a vehicle. More substantial Column protection barriers need to be provided. | Building Engineer to check that the columns have been adequately designed for impact loading | 6-weeks |
| 5 | The columns at the delivery entrance to the Building are at risk of being accidentally struck by a vehicle. More substantial Column protection barriers need to be provided. | Suitable column protection barriers to be designed and constructed. | 6-weeks |

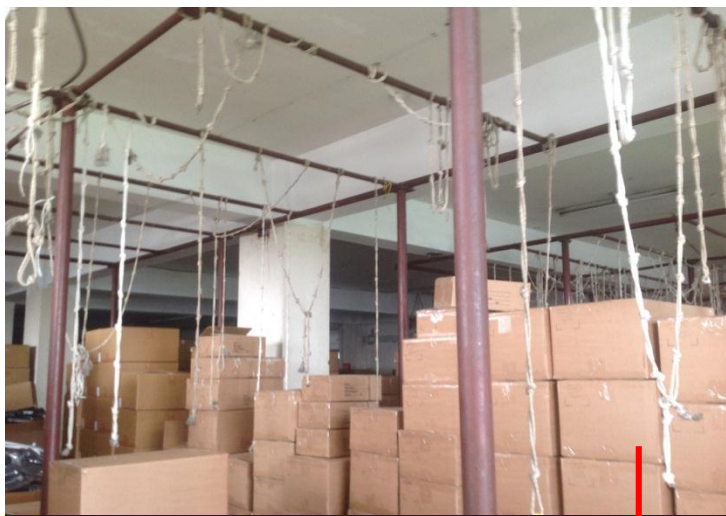
2<sup>nd</sup> Floor Storage Area

**Design Check required for the storage areas as indicated to confirm the capacity of the floor structure**

The Storage area to the Second Floor includes distributed loading due to stacking of boxed garments and point loading due to a hanging frame. The Storage area to the First Floor , directly below, includes loading hung from Second Floor slab.

Building Engineer to check that the floor structure has been adequately designed to carry these loads.

| Item No. | Observation | Recommended Action Plan | Priority |
|---|---|---|---|
| 6 | Design Check required for the storage areas as indicated to confirm the capacity of the floor structure. | The extent of storage areas and the weight are to be surveyed. The capacity of the floor structure is to be assessed to confirm that the structure is designed to carry these loads. | 6-weeks |

| Item No. | Observation | Recommended Action Plan | Priority |
|---|---|---|---|
| 7 | Design Check required for the storage areas as indicated to confirm the capacity of the floor structure. | Produce and actively manage a loading plan for all floor plates within the factory giving consideration to floor capacity and column capacity. Loading plans to be put on each factory floor. | 6-weeks |

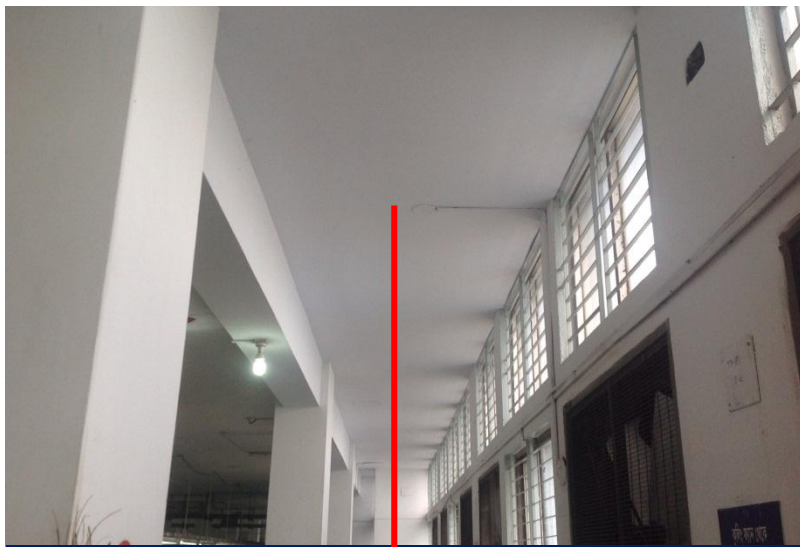
2m cantilevering slab (no down-stand beams)

**Design check required for the floor cantilevers at the suspended floor levels to confirm their load capacity to support floor and façade loading**

There is a slab cantilever to the North and South elevations of the Building above First Floor level.

Building Engineer to check that all the floor cantilevers at the suspended floor levels have the capacity to support the floor and façade loading.

| Item No. | Observation | Recommended Action Plan | Priority |
|---|---|---|---|
| 9 | Design check required for the floor cantilevers at the suspended floor levels to confirm their load capacity to support floor and façade loading. | Building Engineer to confirm the capacity of the slab to support the combination of the floor loading and the façade loading. | 6-months |

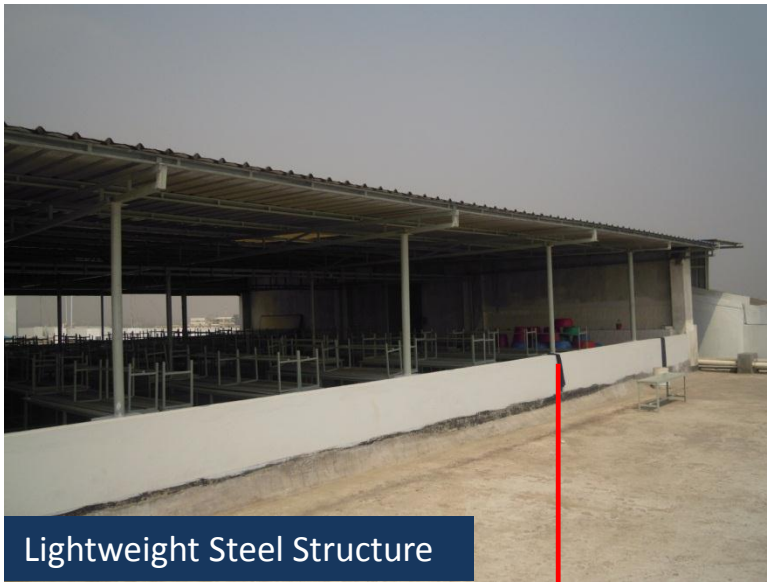
Lightweight Steel Structure

**Design Check required for the light steel roof structures as indicated.**

Capacity of Lightweight structure at Roof level to resist lateral loading (wind ) to be checked.  
All connections to be included in this check.

| Item No. | Observation | Recommended Action Plan | Priority |
|---|---|---|---|
| 10 | Design Check required for the light steel roof structures as indicated. | Building Engineer to provide detailed calculations for the single storey structures and the associated light steel roofs. These should confirm their ability to withstand all wind loading pressure, suctions and uplift forces. | 6-months |

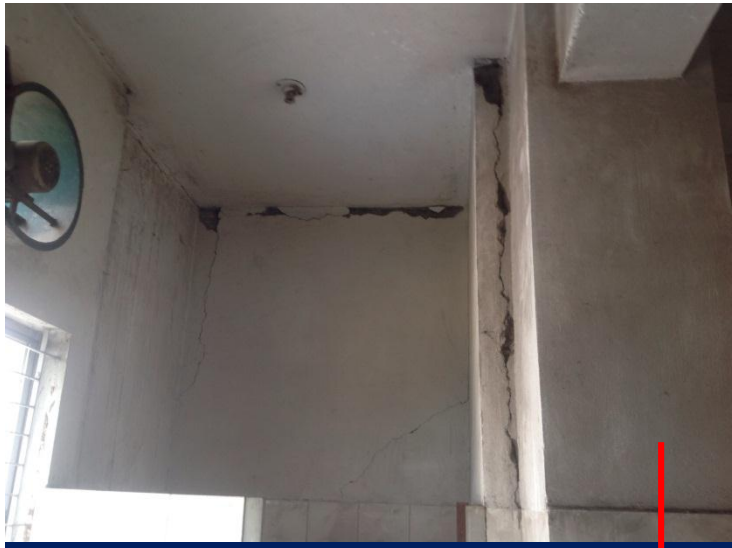
**Building Engineer to investigate the cause  
of the local wall cracking at 8<sup>th</sup> floor level  
as indicated**

Cracking to walls at 8<sup>th</sup> Floor level North-East corner.  
Building Engineer to investigate.

| Item No. | Observation | Recommended Action Plan | Priority |
|---|---|---|---|
| 11 | Building Engineer to investigate the cause of the local wall cracking at 8th floor level as indicated. | Building Engineer to organise exploratory opening up works to identify the cause. Remedial works to be carried out as appropriate. | 6-months |

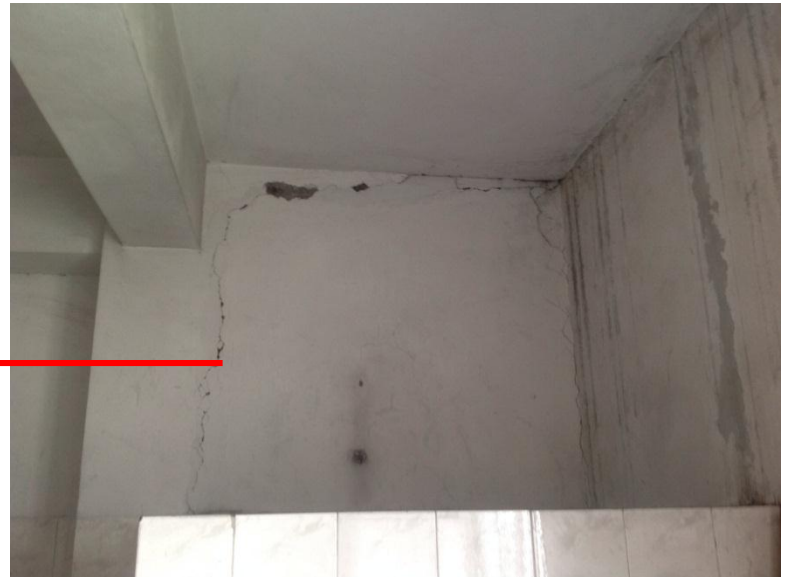
Cracking to 8<sup>th</sup> Floor Washroom
