# FIRE SAFETY INSPECTION REPORT

**UTAH KNITTING AND DYEING LTD.  
BOKRAN MONIPUR, HOTAPARA, GAZIPUR**

**ACCORD**  
on Fire and Building Safety in Bangladesh

May 6, 2014

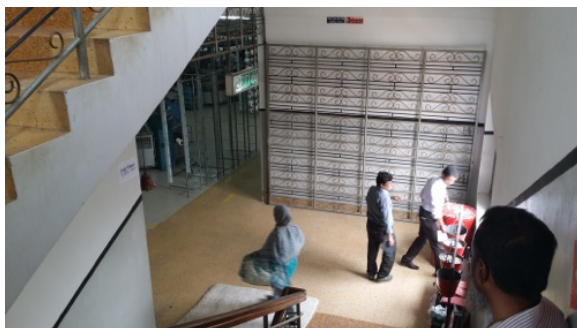
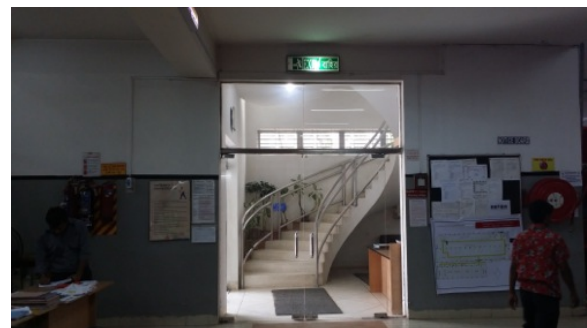
| No. | Category | Finding | Recommendation | Remediation Timeframe |
|---|---|---|---|---|
| F-1 | Fire Rated Construction | The exit stairs are not separated from work areas, and other spaces on each floor by fire-rated construction. This was reflected throughout the building on all floors. | <p>Provide minimum 1.5-hr fire rated doors and seal all unprotected openings to separate the exit stairs from work areas and other building spaces on all floor levels. Ensure that the fire doors are self-closing and positive latching and that they are provided with fire exit (panic) hardware where serving production floors.</p> <p>If fire doors are required to be held open for functional reasons, provide automatic-closing devices tied to the fire alarm system.</p> | Within 3 months |

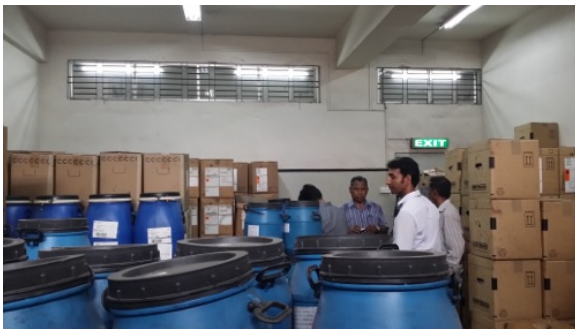
| F-2 | Fire Rated Construction | Hazardous materials / flammable liquid storage area, located on the ground floor adjacent to the north stairwell is not separated by fire-rated construction (openings, non-rated doors, and penetrations). | Separate the hazardous materials / flammable liquid storage room by a minimum 2-hr fire-rated construction. Seal and/or protected all openings to maintain the required fire separations. | Within 3 months |

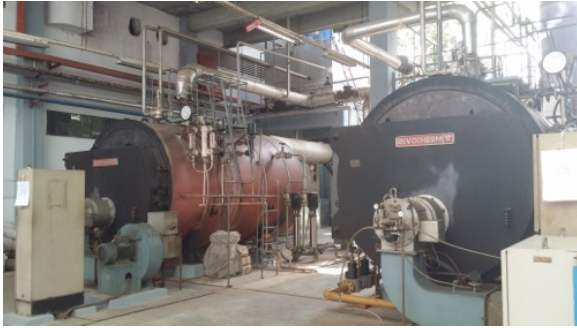
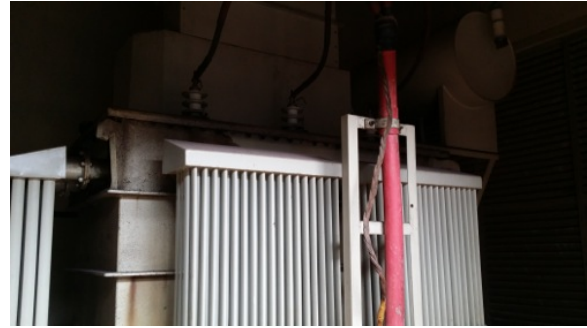
| F-3 | Fire Rated Construction | The boiler, and transformer room located on the ground floor, is not separated by fire-rated construction, openings, non-rated doors, and penetrations. | Separate the boiler, and transformer room by a minimum 2-hr fire-rated construction. Seal and/or protected all openings to maintain the required fire separations | Within 3 months |

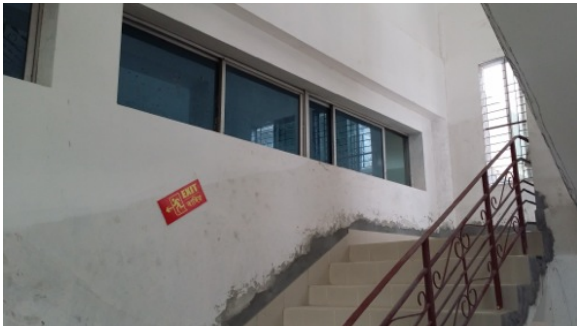
| F-4 | Fire Rated Construction | Unsealed penetrations and openings are located on all floors in the east and west exit stair enclosures. | Seal all penetrations and openings in exit stair enclosure walls to maintain the fire separation. | Within 3 months |

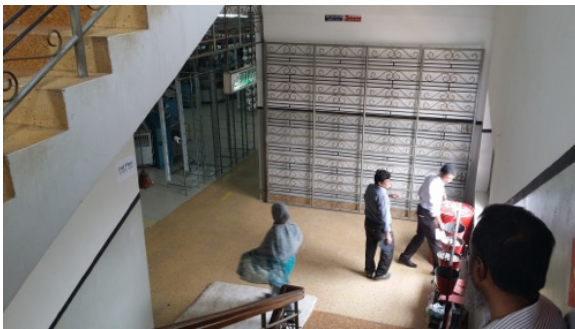
| F-5 | Egress | Egress doors / gates with locking features are provided at building exits, exit stairs, along egress routes, and exit discharge. This was reflected throughout the building on all floors. | Remove locking features from all egress doors / gates.<br><br>If locks are required for security reasons, utilize special door locking features complying with NFPA 101. | Immediate |

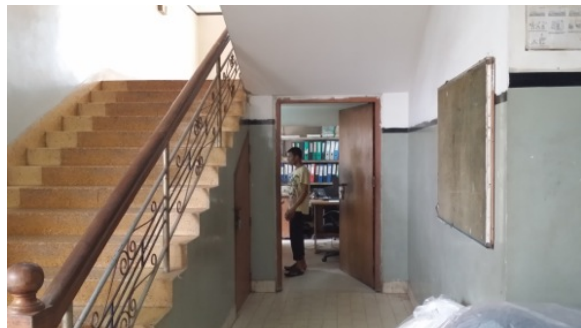
| F-6 | Egress | Storage areas were located in all exit stairwells on the ground floor, underneath the stairs. | Remove all storage from exit stairs and egress paths. | Immediate |

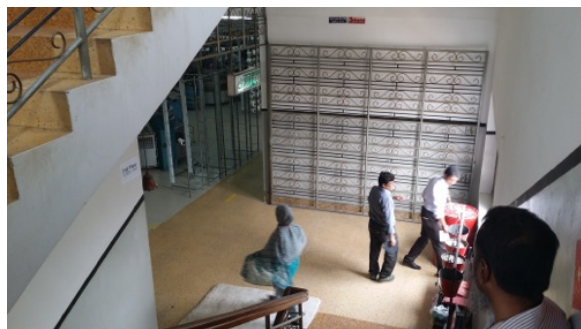
| F-7 | Egress | Collapsible gates / sliding doors are provided at building exits, exit stairs, along egress routes, and exit discharge. This was reflected throughout the building on all floors. | Replace all gates / sliding doors along the means of egress with side-hinged, swinging egress doors.<br><br>If locks are required for security reasons, utilize special door locking features complying with NFPA 101. | Within 1 month |

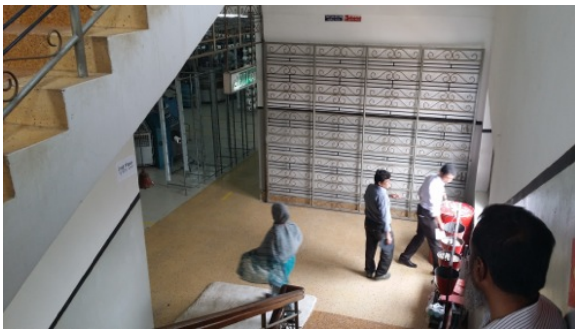
| F-8 | Egress | Exit stair door does not swing in the direction of egress travel. Egress doors were of collapsible gates / sliding doors and were not capable of having a swing. | Replace all gates / sliding doors along the means of egress with side-hinged, swinging egress doors. Modify the egress door to swing in the direction of egress travel. | Within 3 months |

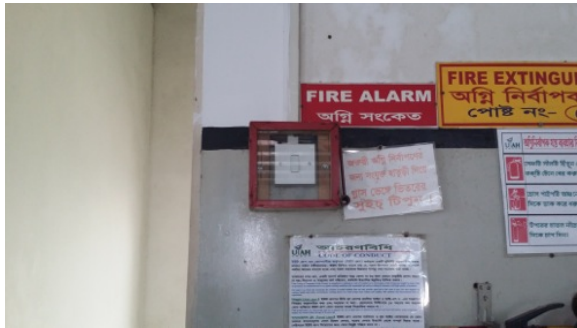
| F-9 | Fire Protection | The fire alarm system is antiquated, not a listed system, and does not provide alarm and notification features consistent with acceptable standards. | Replace the fire alarm system with a new, listed addressable fire alarm system in accordance with NFPA 72. | Design within 4 months, install within 9 months |

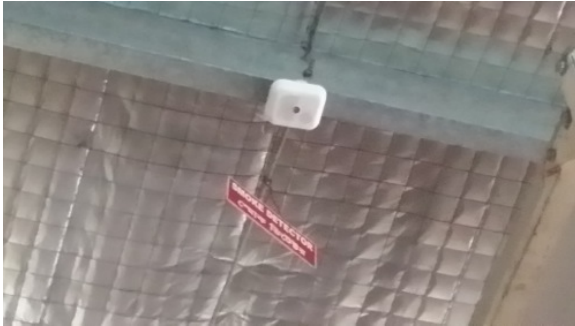
| F-11 | Fire Protection | The building is equipped with single-station smoke alarms. Smoke alarm activation sounds only a local alarm and does not provide automatic fire alarm notification of occupants. | Replace the single-station smoke alarms. Provide automatic smoke detection throughout the building in accordance with NFPA 72. | Within 6 months |

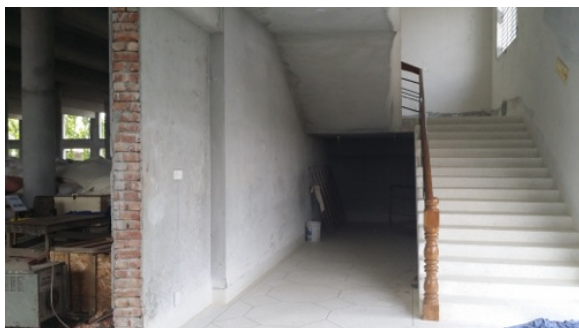
| No. | Category | Finding | Recommendation | Remediation<br>Timeframe |
|---|---|---|---|---|
| F-1 | Fire Rated<br>Construction | The exit stairs are not separated from work areas, and other spaces on each floor by fire-rated construction. This was reflected throughout the building on all floors. | <p>Provide minimum 1.5-hr fire rated doors and seal all unprotected openings to separate the exit stairs from work areas and other building spaces on all floor levels. Ensure that the fire doors are self-closing and positive latching and that they are provided with fire exit (panic) hardware where serving production floors.</p> <p>If fire doors are required to be held open for functional reasons, provide automatic-closing devices tied to the fire alarm system.</p> | Within 3 months |

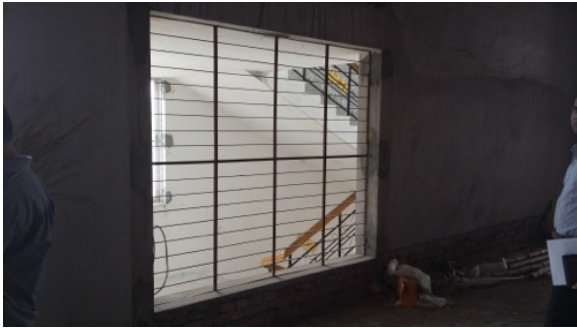
| F-2 | Fire Rated Construction | Unsealed window penetrations and openings are located in west, and east exit stair enclosures. This was reflected on all floors. | Seal all penetrations and openings in exit stair enclosure walls to maintain the fire separation. | Within 3 months |

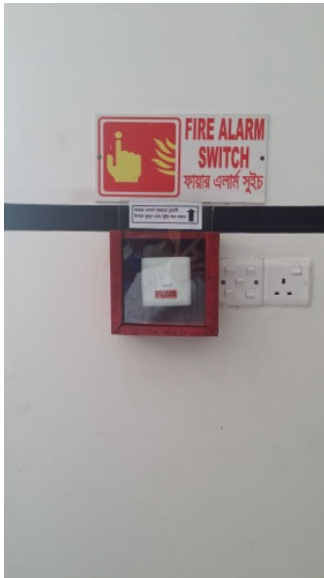
| F-3 | Fire Protection | The fire alarm system is antiquated, not a listed system, and does not provide alarm and notification features consistent with acceptable standards. | Replace the fire alarm system with a new, listed addressable fire alarm system in accordance with NFPA 72. | Design within 4 months, install within 9 months |

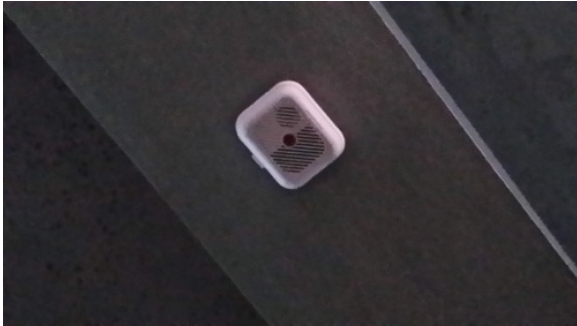
| F-6 | Fire Protection | The building is equipped with single-station smoke alarms. Smoke alarm activation sounds only a local alarm and does not provide automatic fire alarm notification of occupants. | Replace the single-station smoke alarms. Provide automatic smoke detection throughout the building in accordance with NFPA 72. | Within 6 months |
