Dress World Ltd. (10218)
Neo Fashion Ltd. (10159)
Vertex Wear Ltd. (9632)

Varari, Rajfulbaria, Tetuljhora, Savar
(+23.803761N, 90.131126E)
08.June.2014

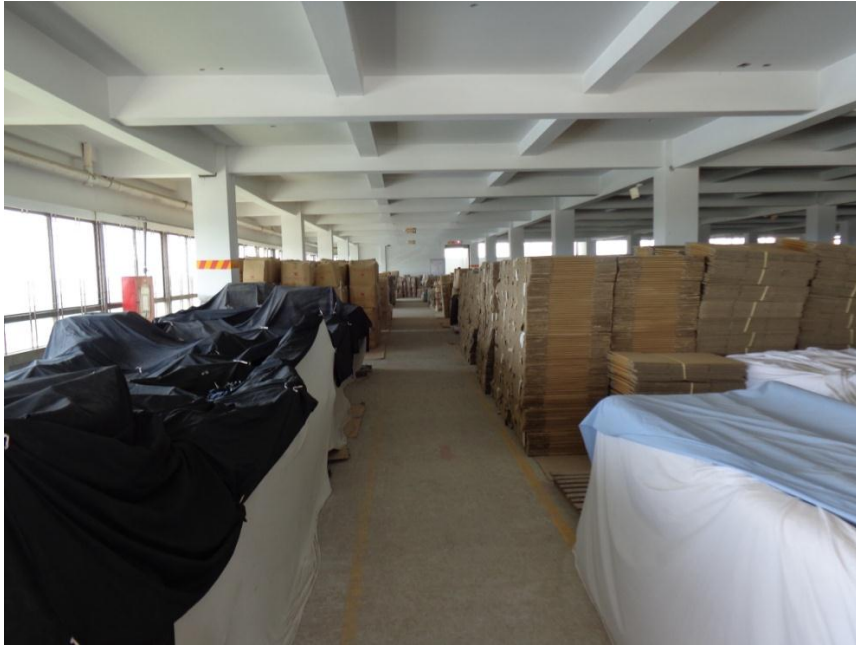
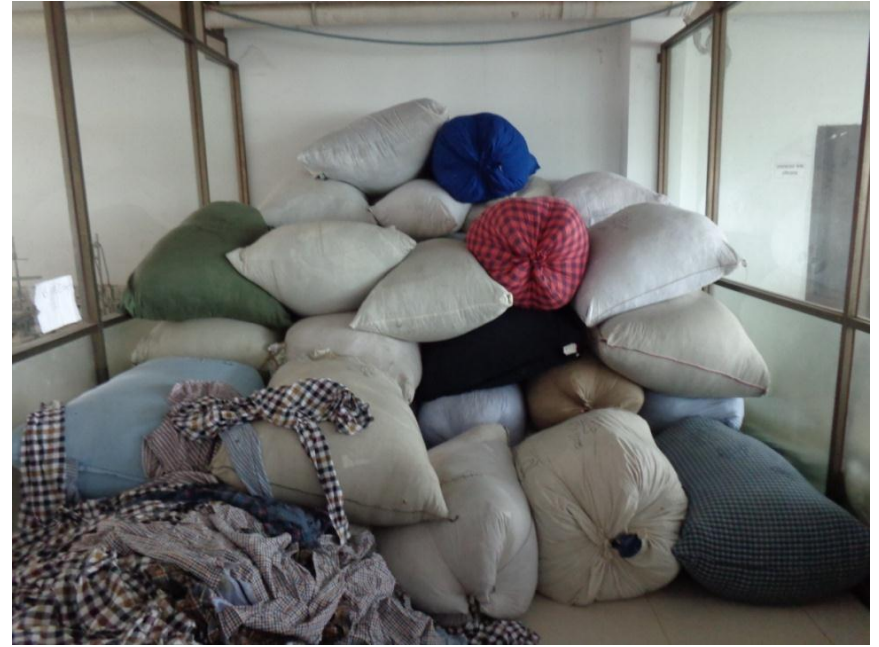
1st Priority 2 Concern

No loading plans were made available and storage loading was observed on the 6th floor of the main factory building.

Although column markings indicating a maximum allowable stacking height were observed, it appears the markings were made without consideration for the maximum allowable live load.

Item No.	Observation	Recommended Action Plan	Recommended Timeline
1	Priority 2 - No loading plans were made available and storage loading was observed on the 6th floor of the main factory building.	Structural Design Engineer to provide loading plans based on bearing capacity of each floor for all buildings.	6-weeks
2	Priority 2 - No loading plans were made available and storage loading was observed on the 6th floor of the main factory building.	Post loading plans on each floor and manage accordingly.	6-months
3	1st Priority 3 - Structural drawings were not made available for some of the ancillary buildings. In addition, some omissions or inaccuracies in the structural drawings existed for the main factory building.	Factory Engineer to review existing conditions for all buildings and revise structural drawings.	6-months
4	2nd Priority 3 - The masonry façade for the main factory building exhibited cracking, due to either the separation joint or corrosion of the reinforcing steel.	A Detailed Engineering Assessment is required for the cracked masonry façade.	6-months

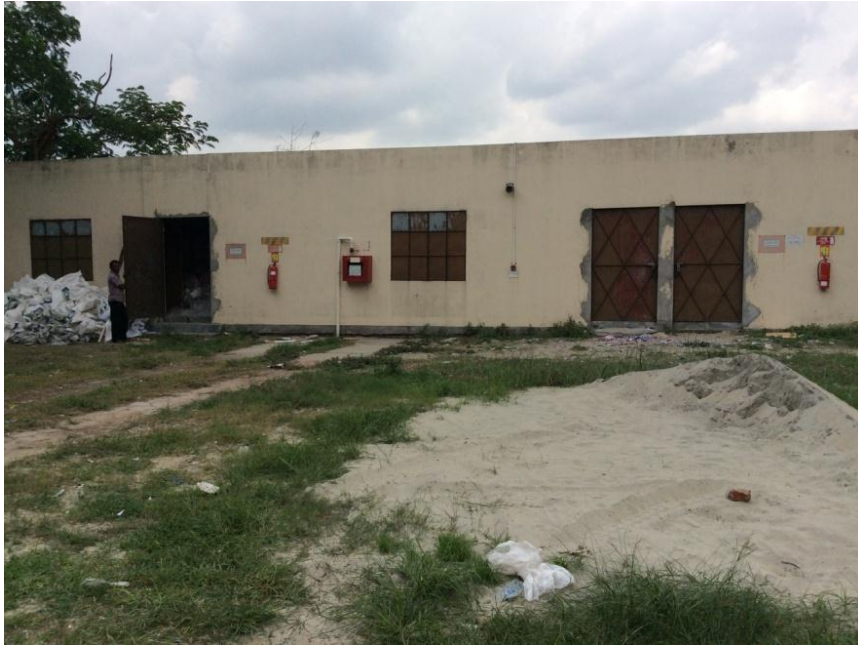
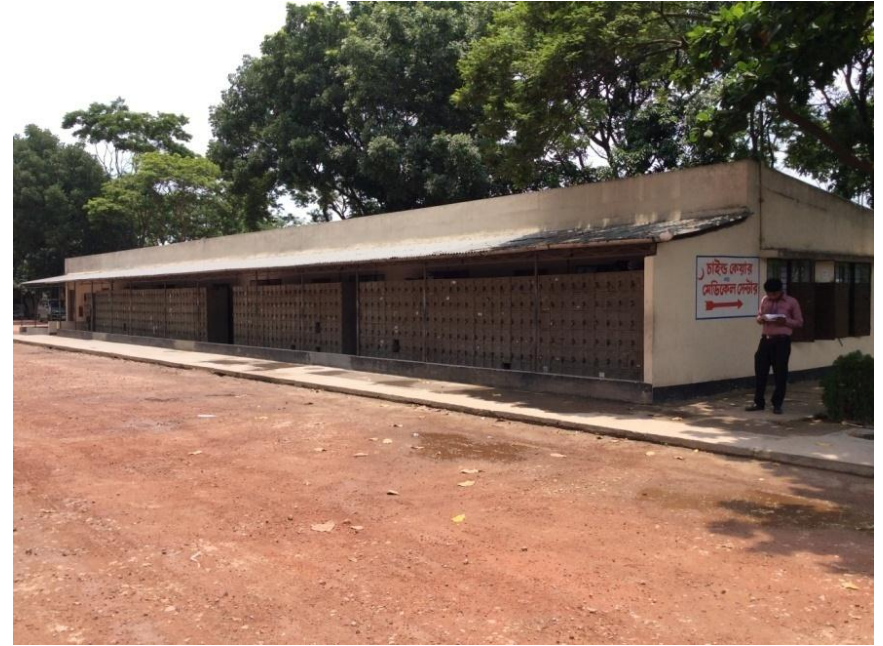
1st Priority 3 Concern

Structural drawings were not made available for some of the ancillary buildings. In addition, some omissions or inaccuracies in the structural drawings existed for the main factory building.

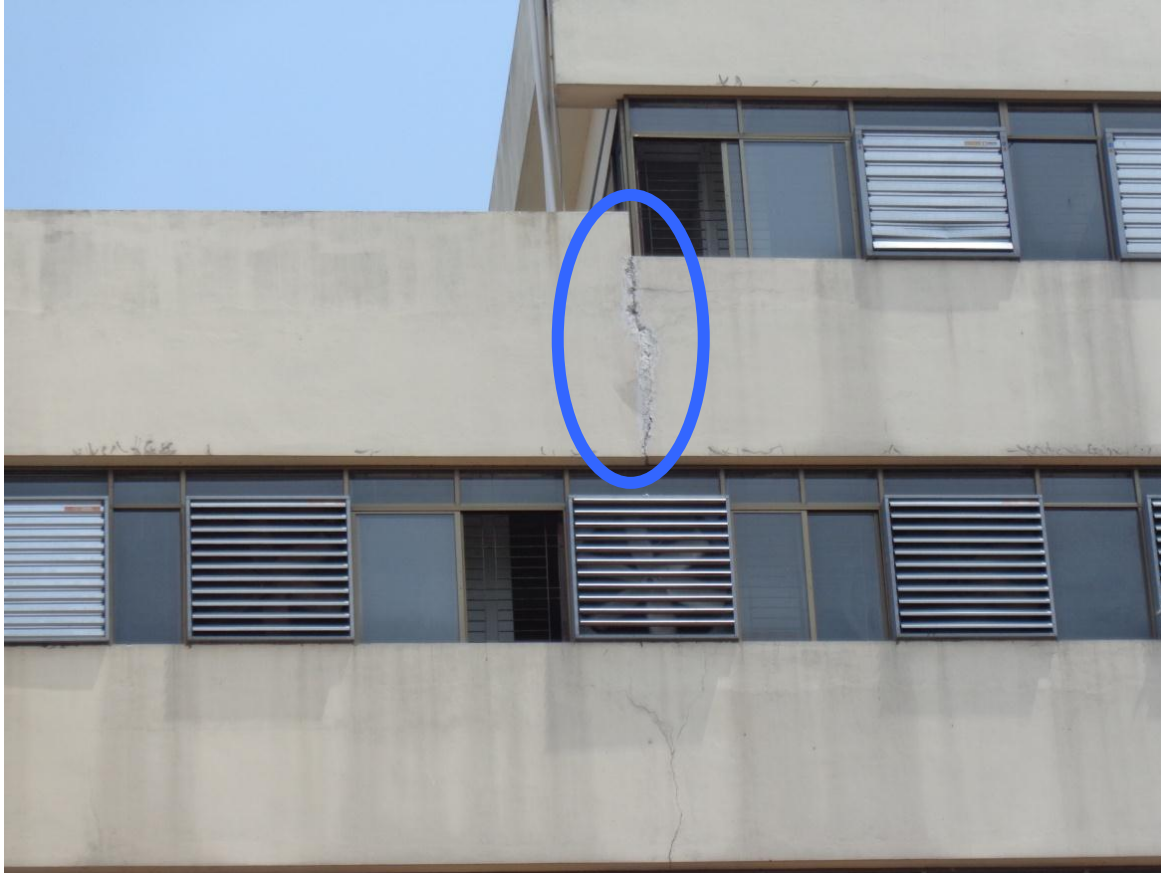
2nd Priority 3 Concern

The masonry façade for the main factory building exhibited cracking, due to either the separation joint or corrosion of the reinforcing steel

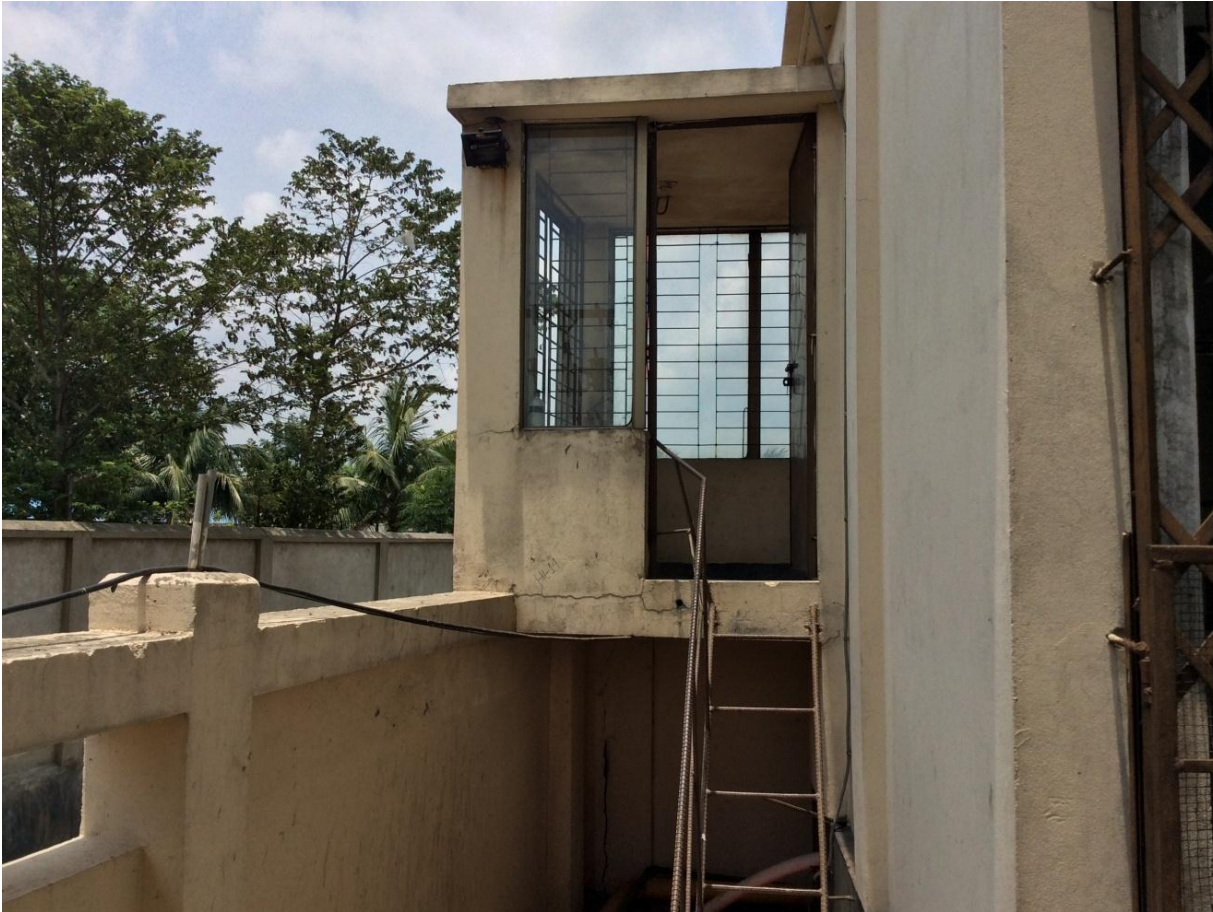
3rd Priority 3 Concern

The concrete slab of the security post was bearing directly on the perimeter beam of the masonry boundary wall.

5	3rd Priority 3 - The concrete slab of the security post was bearing directly on the perimeter beam of the masonry boundary wall.	A Detailed Engineering Assessment is required for the security post.	6-months
6	4th Priority 3 - Large deflection was noted in the steel roof purlins of the wastage shed.	A Detailed Engineering Assessment is required for the steel roof of the wastage shed.	6-months

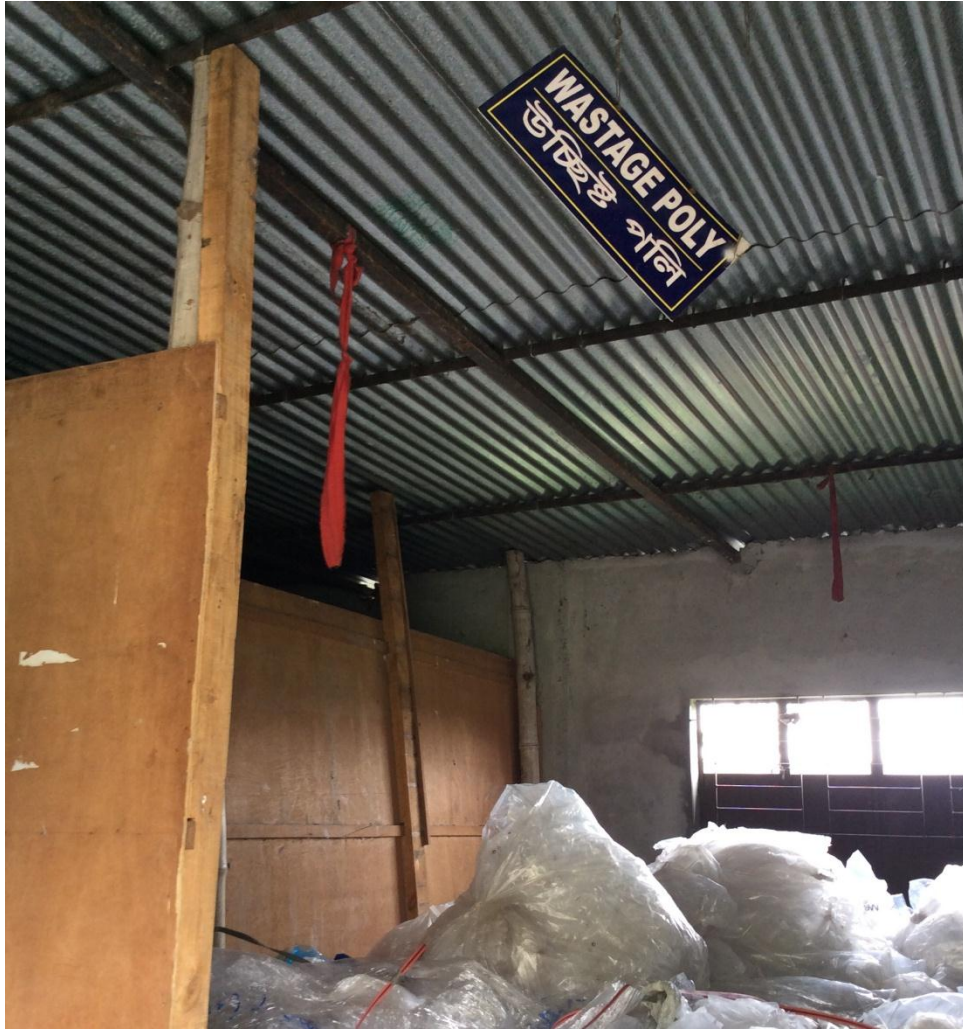
4th Priority 3 Concern

Large deflection was noted in the steel roof purlins of the wastage shed.

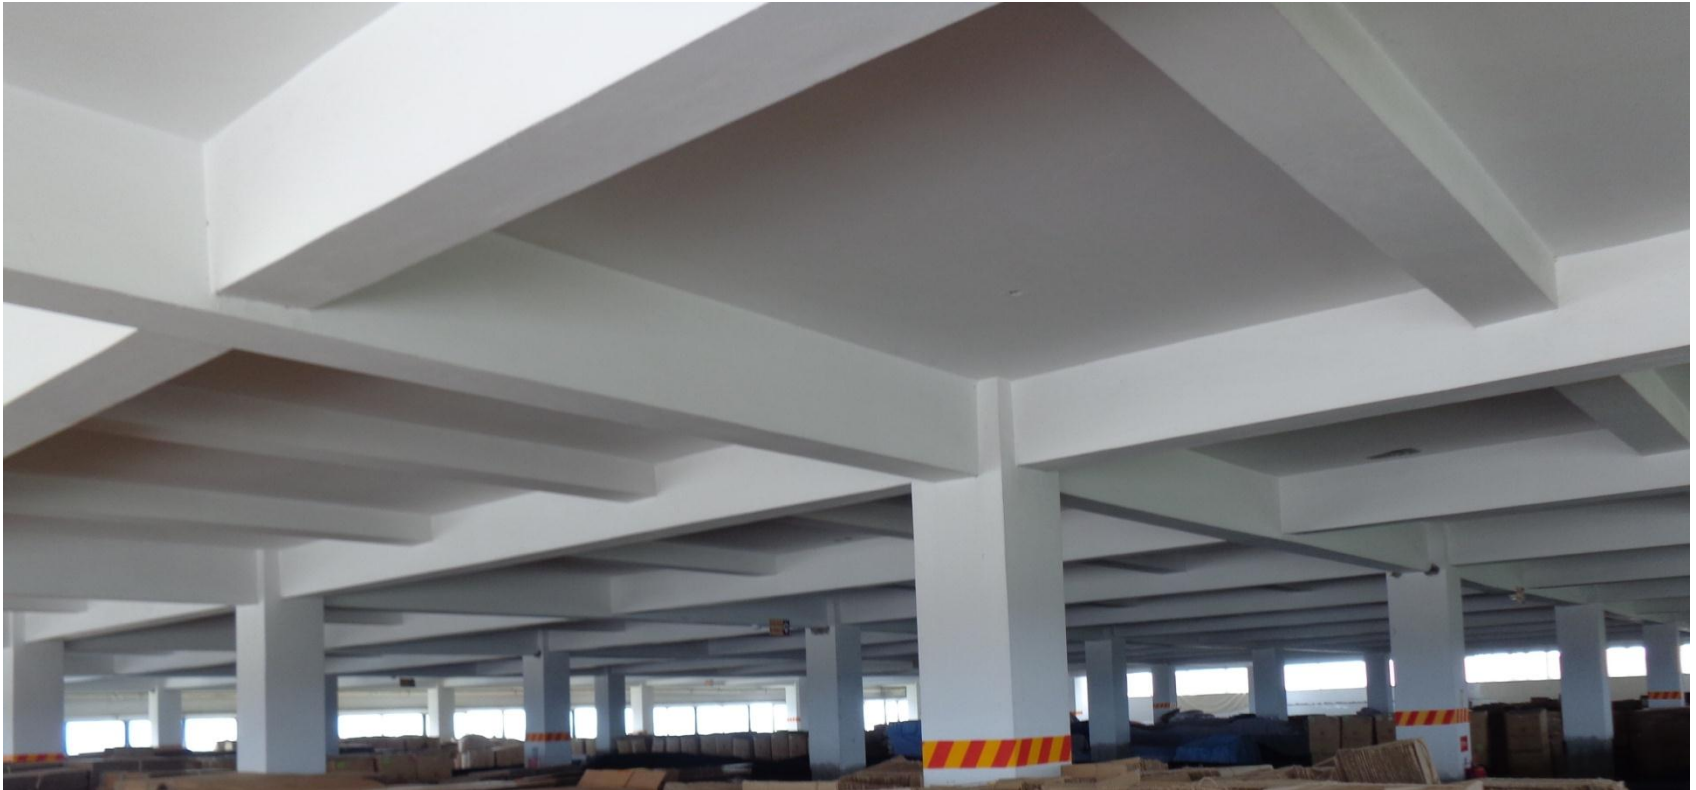
Overall Stability System

The building did feature lift core or shear walls. Stability was achieved through sway action between beams and columns and masonry infill walls.

We require that these items be investigated in a Detail Engineering Assessment

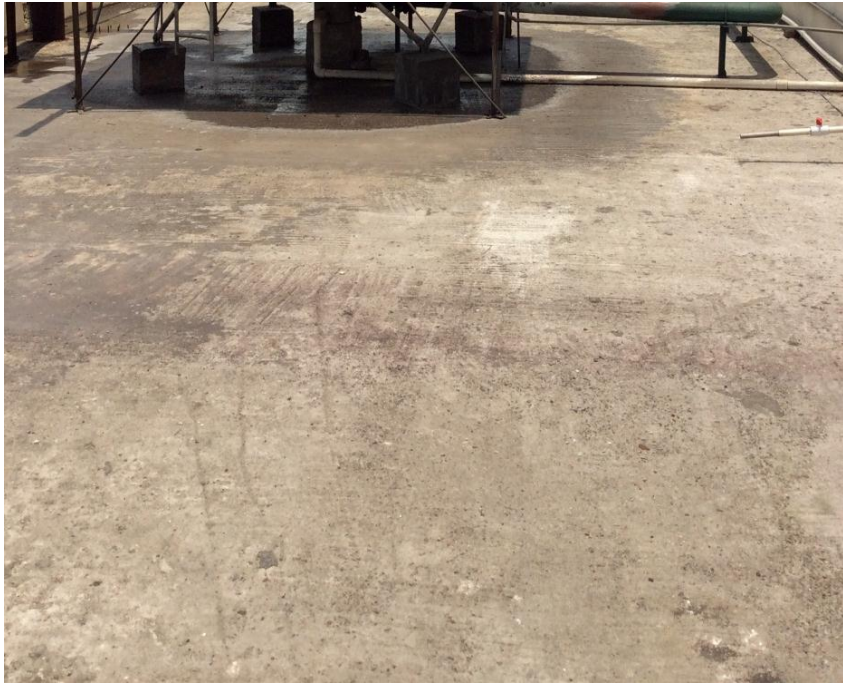
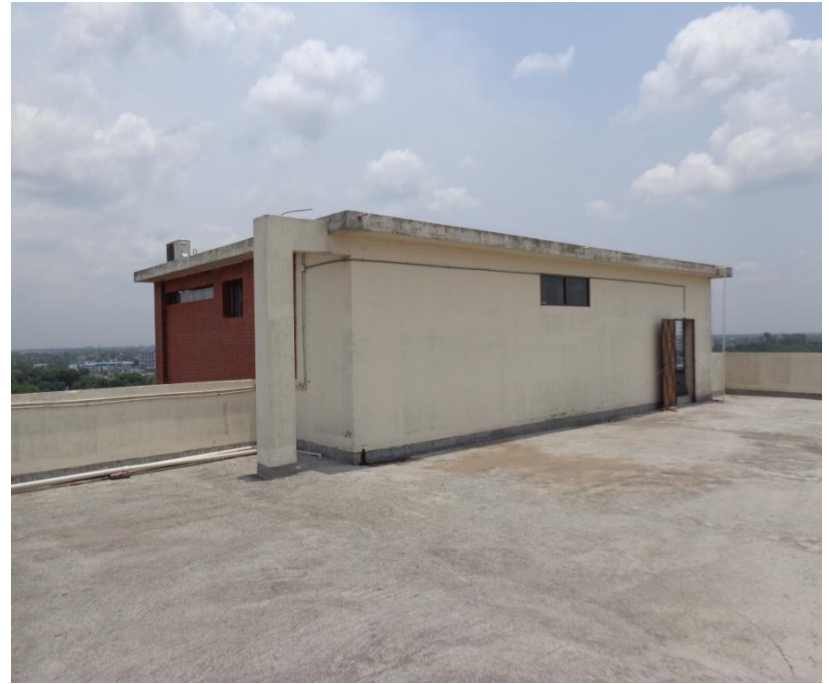
Water Ingress at Roof Level

No waterproofing membrane was visible on the roof of the building. This means that any cracks in the surface finishes on the roof will allow water to seep into the concrete slab beneath the finishes, and cause corrosion of the reinforcing steel.
