# Aman Winter Wears Ltd. (11333)

Nazimnagar, Hemayetpur, Savar.

09.June.2014

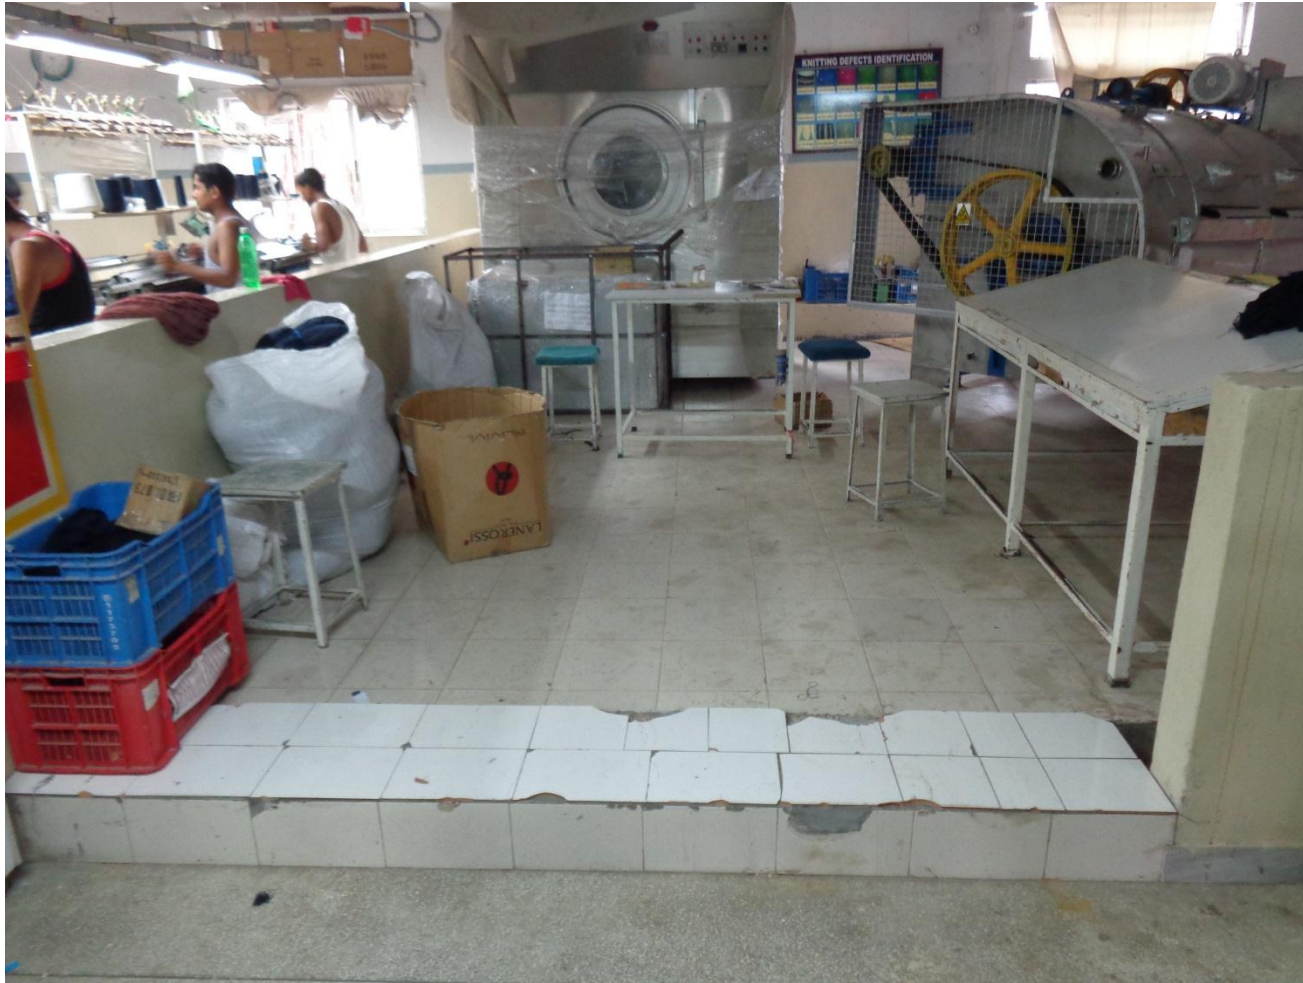
## 1<sup>st</sup> Priority 1 Concern

Large washing machines were observed on the ground floor (structural due to presence of basement). In addition, a 6" platform was also observed in the same washing area.

| Item No. | Observation | Recommended Action Plan | Recommended Timeline |
|---|---|---|---|
| 1 | Priority 1 - Large washing machines were observed on the ground floor (structural due to presence of basement). In addition, a 6" platform was also observed in the same washing area. | A Detailed Engineering Assessment is required to determine load bearing capacity of ground floor in vicinity of washing platform and machines. | Immediate – Now |
| 2 | Priority 1 - Large washing machines were observed on the ground floor (structural due to presence of basement). In addition, a 6" platform was also observed in the same washing area. | Implement any recommendations from DEA. | 6-weeks |

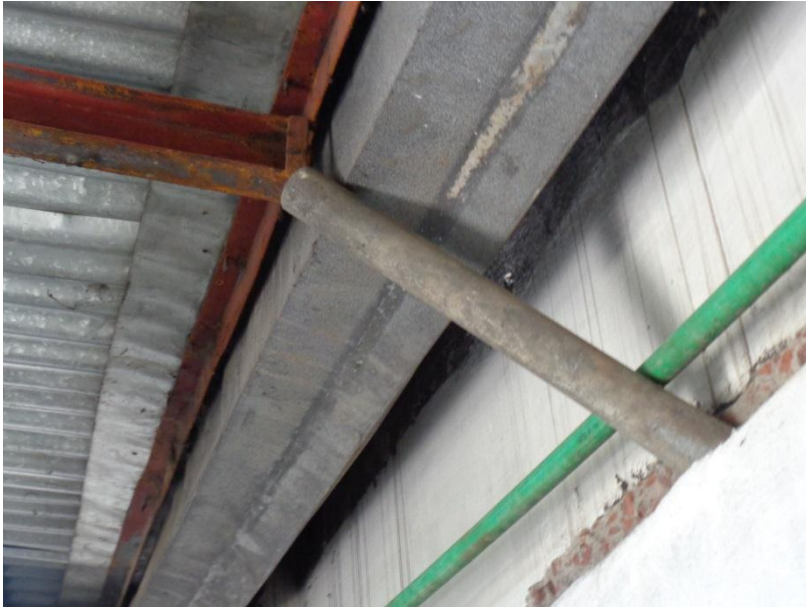
## 1<sup>st</sup> Priority 2 Concern

Poor steel detailing was observed for the various steel roofs. Poor connection bearing details were observed at the generator/ childcare/doctor's building (top left). Steel posts were bearing directly on the 3<sup>rd</sup> floor slab (top right). Poor bearing support and damaged masonry at generator shed (bottom left).

| Item No. | Observation | Recommended Action Plan | Recommended Timeline |
|---|---|---|---|
| 3 | 1st Priority 2 - Poor steel detailing was observed for the various steel roofs. | Detailed Engineering Assessments are required for various steel roofs. | 6-weeks |
| 4 | 1st Priority 2 - Poor steel detailing was observed for the various steel roofs. | Implement any recommendations from DEAs. | 6-months |

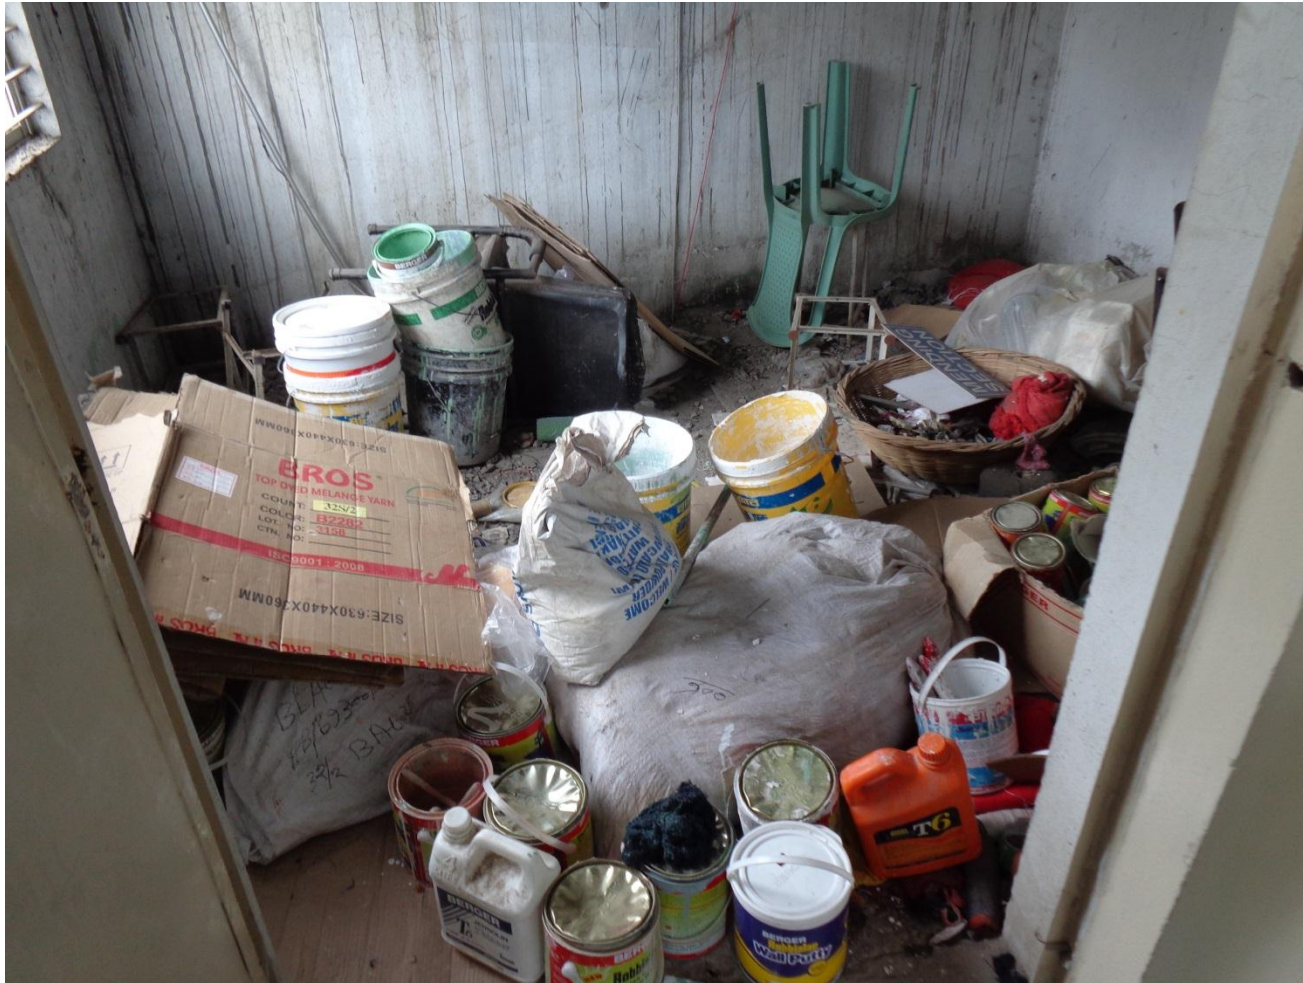
## 2<sup>nd</sup> Priority 2 Concern

A wooden platform was observed in the lift core, at the 2nd floor. The space was only used for storage, however the type of construction and load capacity is unknown.

| Item No. | Observation | Recommended Action Plan | Recommended Timeline |
|---|---|---|---|
| 5 | 2nd Priority 2 - A wooden platform was observed in the lift core, at the 2nd floor. | A Detailed Engineering Assessment is required for the wooden platform in the lift core. | 6-weeks |
| 6 | 2nd Priority 2 - A wooden platform was observed in the lift core, at the 2nd floor. | Implement any recommendations from DEA. | 6-months |

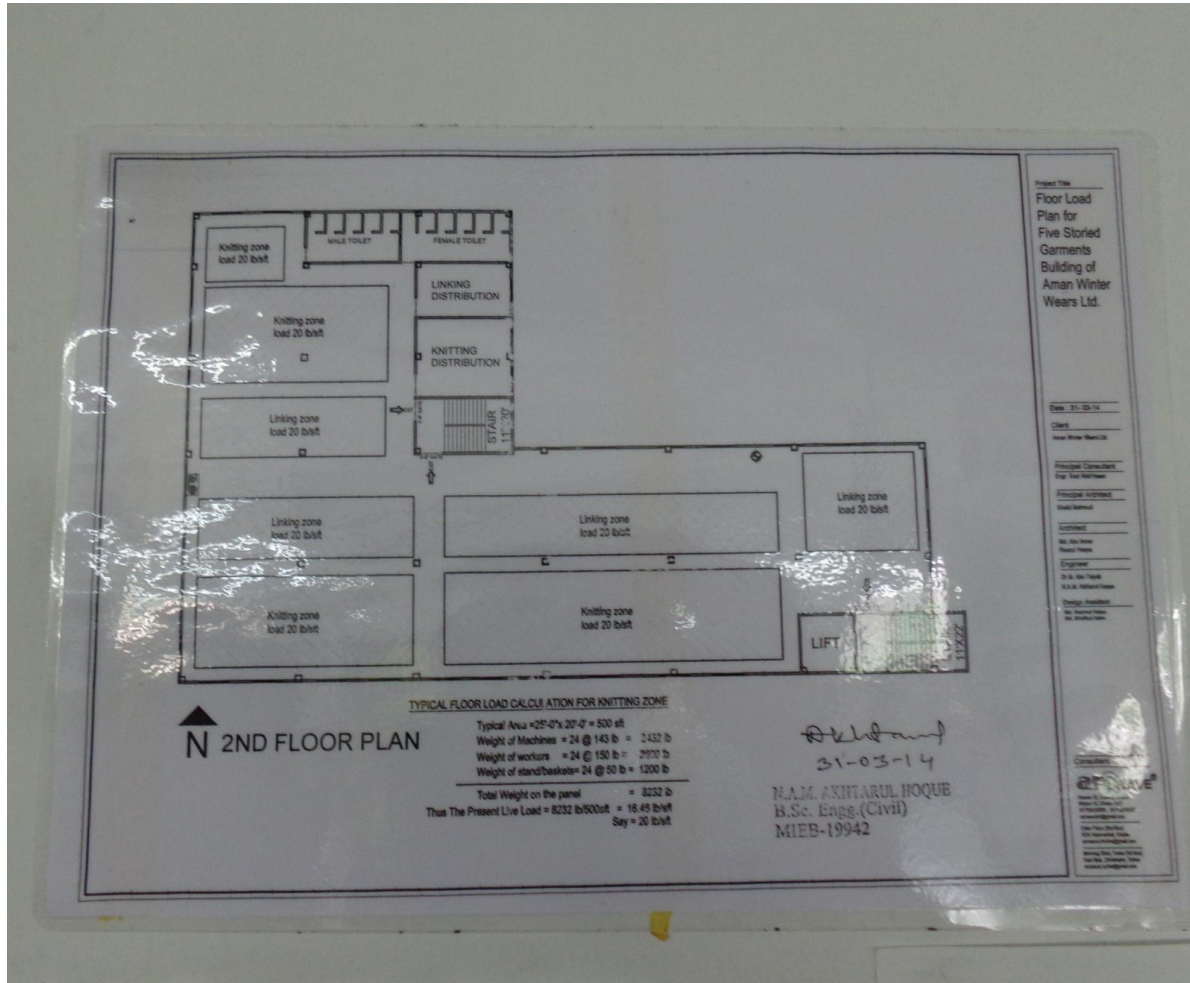
## 1<sup>st</sup> Priority 3 Concern

Loading plans were posted, however they represent current loading conditions and not ultimate floor capacity. This could limit future floor use.

| Item No. | Observation | Recommended Action Plan | Recommended Timeline |
|---|---|---|---|
| 7 | Priority 3 - Incorrect loading plans were posted. | Structural Engineer to assess load bearing capacity of each floor for the main building and provide correct loading plans.<br>Post loading plans at each floor of the main building and manage load. | 6-months |

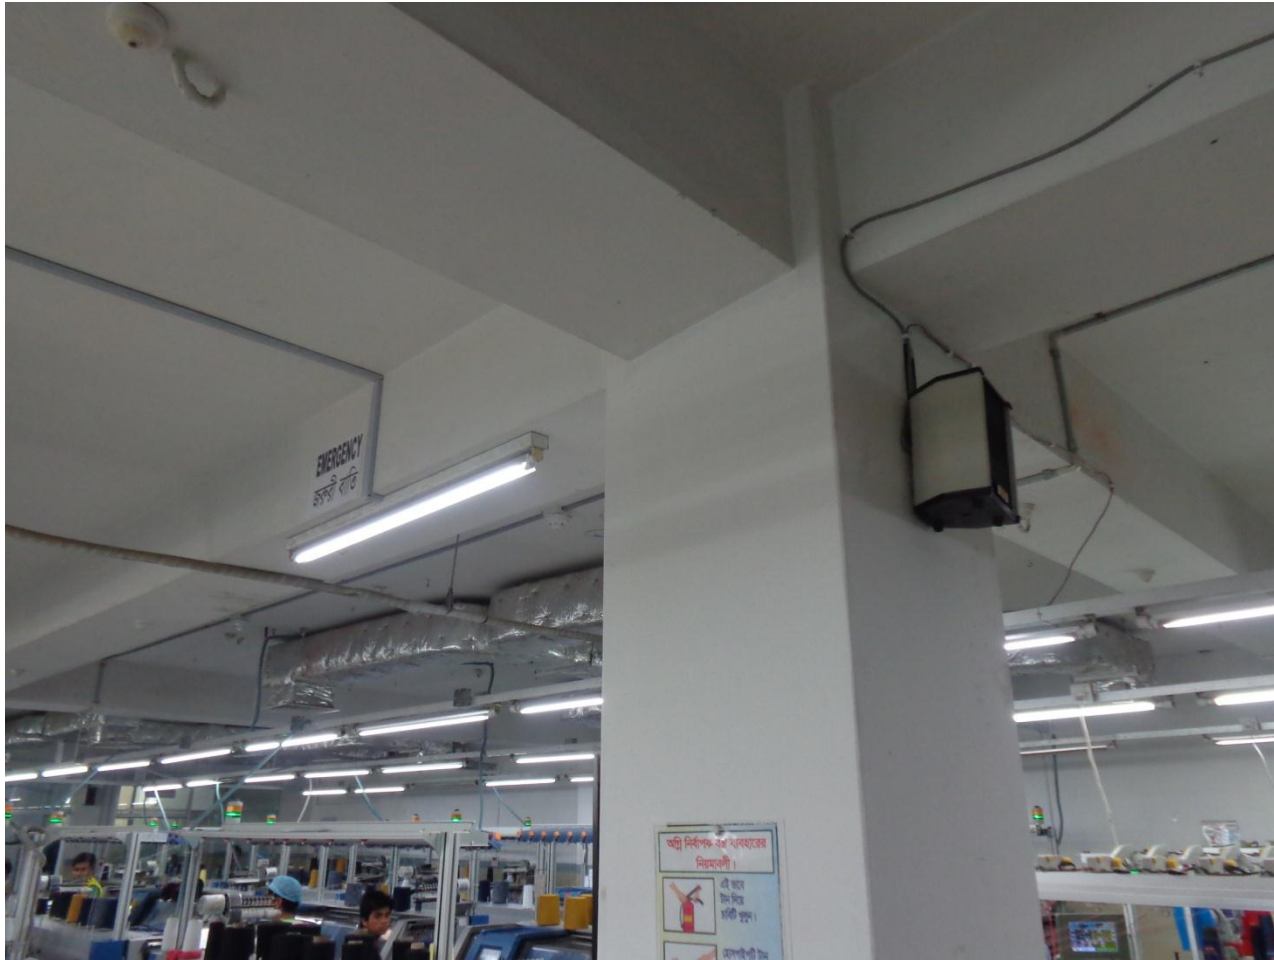
# Overall Stability System

The building did not feature any core or shear walls. Stability was achieved through sway action between beams and columns and masonry infill walls.

We require that these items be investigated in a Detail Engineering Assessment

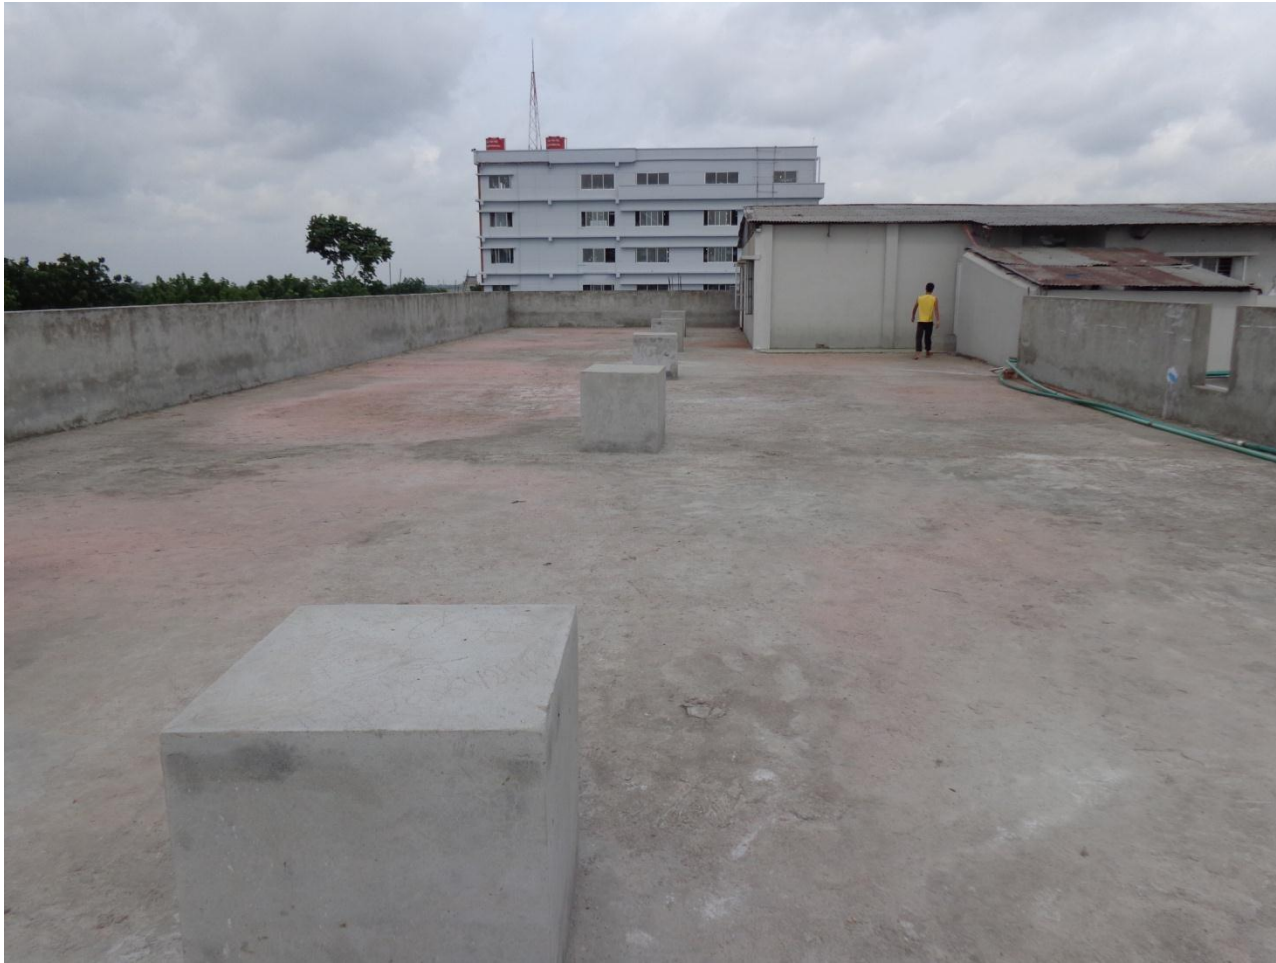
# Water Ingress at Roof Level

No waterproofing membrane was visible on the roof of the building. This means that any cracks in the surface finishes on the roof will allow water to seep into the concrete slab beneath the finishes, and cause corrosion of the reinforcing steel.
