Aman Fashions & Designs Ltd. (10602)

Nalam, Mirzanagar, Ashulia, Savar

10.06.2014

Identified Priority 2 Concerns

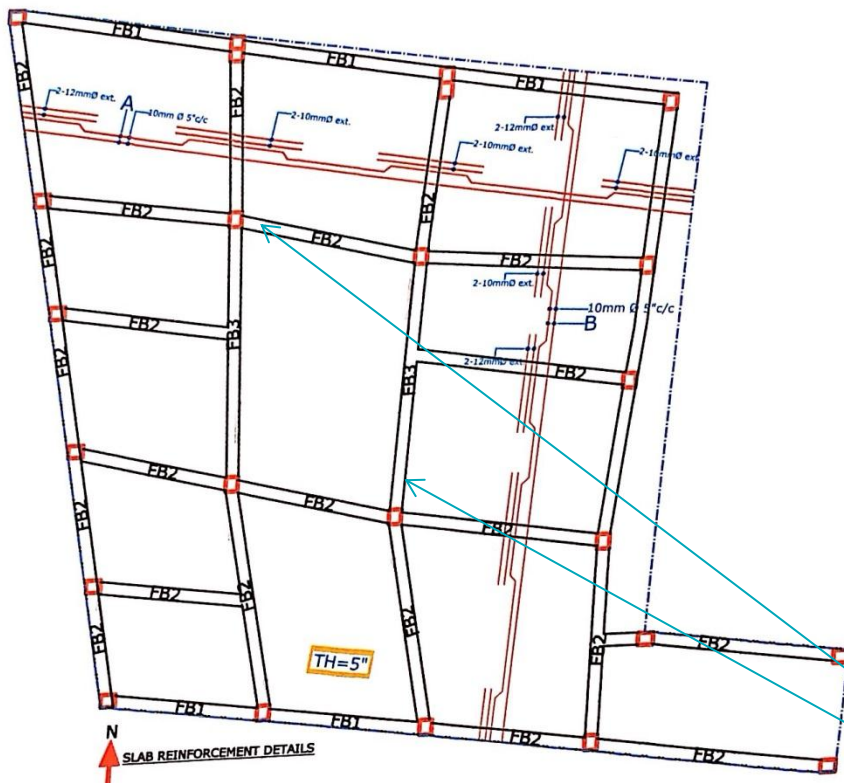
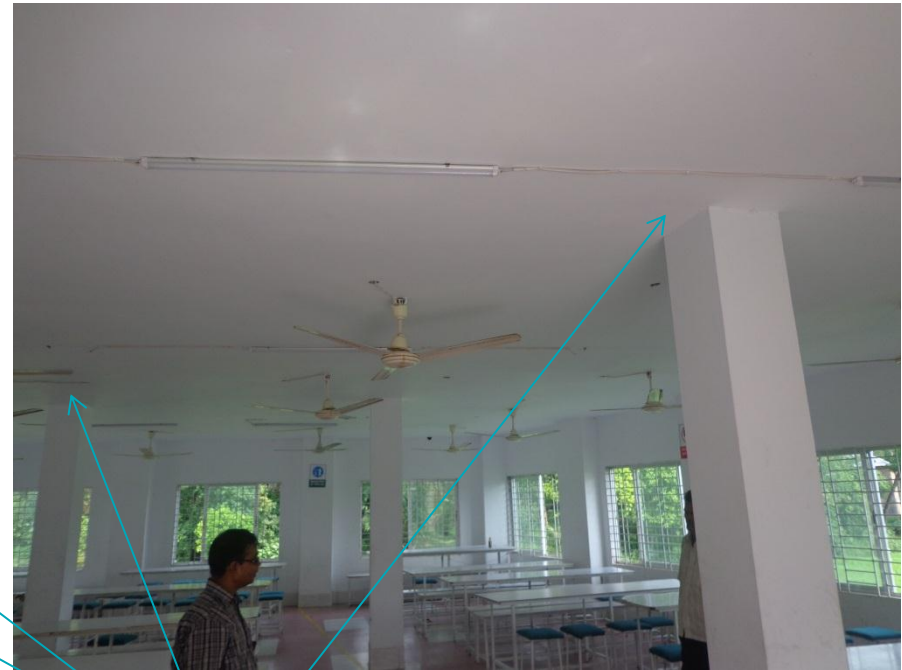
Structural drawing of dining building does not match the actual site condition.

The drawings show slab on beams but actually there are no beams so flat slab.

Item No.	Observation	Recommended Action Plan	Recommended Timeline
1	Priority 2 - The structural drawing of the Dining building did not match the actual site condition.	Factory Engineer to survey the actual conditions and revise the drawings. Factory Engineer to review design, loads and columns stresses to confirm suitability for loads applied.	6-weeks
2	Priority 2 - No vertical cross bracing provide at steel shed; Overall stability system of Industrial Shed, Dining Building.	Carry out a Detail Engineering Assessment both on the steel shed and Dining building to verify lateral stability against wind and seismic loading. It is anticipated that vertical cross bracing must be added in the Shed.	6-weeks
3	Priority 2 - No vertical cross bracing provide at steel shed; Overall stability system of Industrial Shed, Dining Building.	Carry out Detailed Engineering Assessment recommendations.	6-months
4	Priority 2 - Reinforcement is left exposed at roof level of Dining Building.	The Factory Engineer is to carry out an assessment for both durability and serviceability.	6-weeks

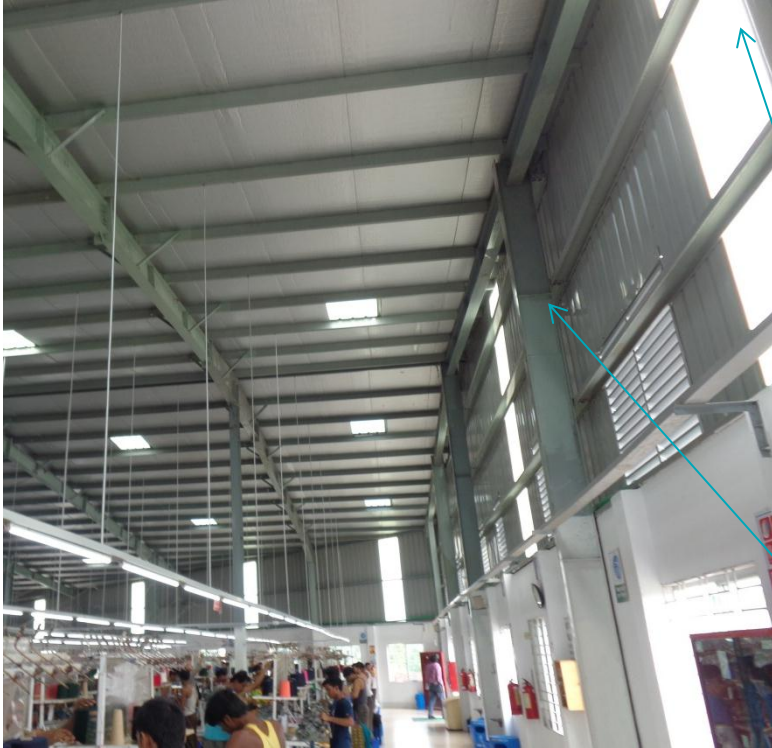
No vertical cross bracing provided at Industrial steel shed.

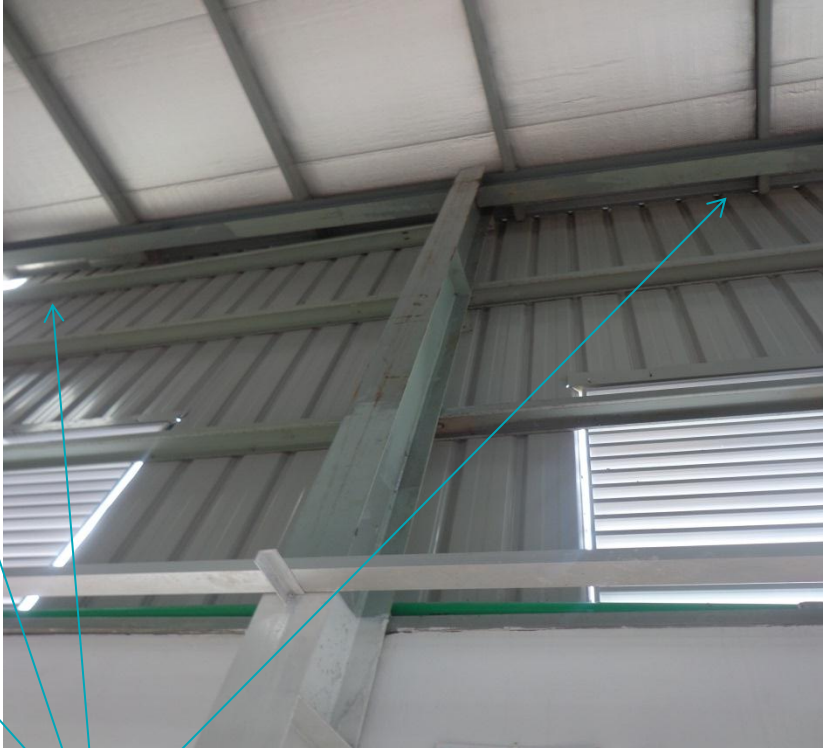
No cross bracing provide to resist lateral load due to wind pressure.

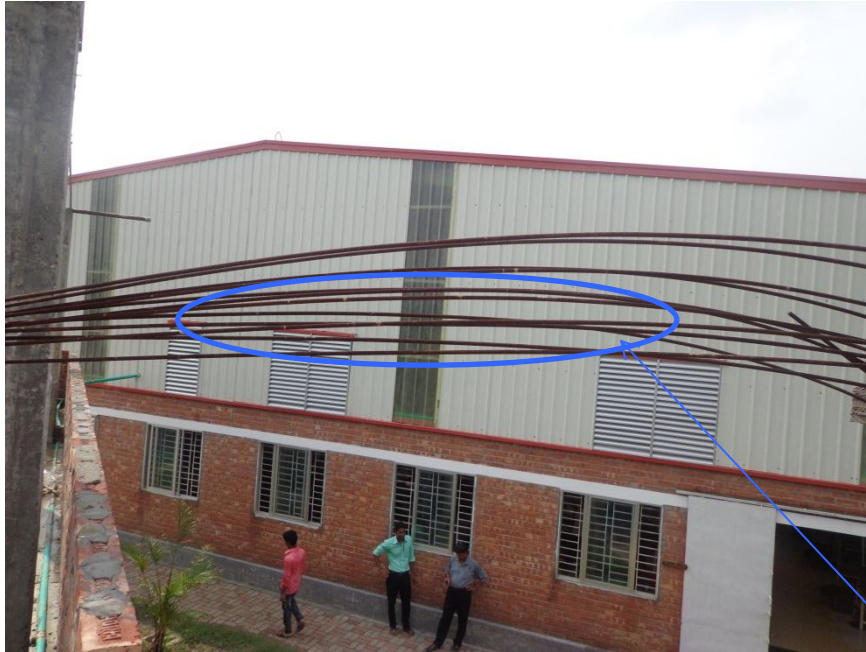
Reinforcement is left exposed at roof level of Dining Building.

5	Priority 2 - Reinforcement is left exposed at roof level of Dining Building.	If deemed necessary by Factory Engineer, carry out any remedial works recommended. For both durability and serviceability, rust proof paint or any appropriate methods is recommended.	6-months

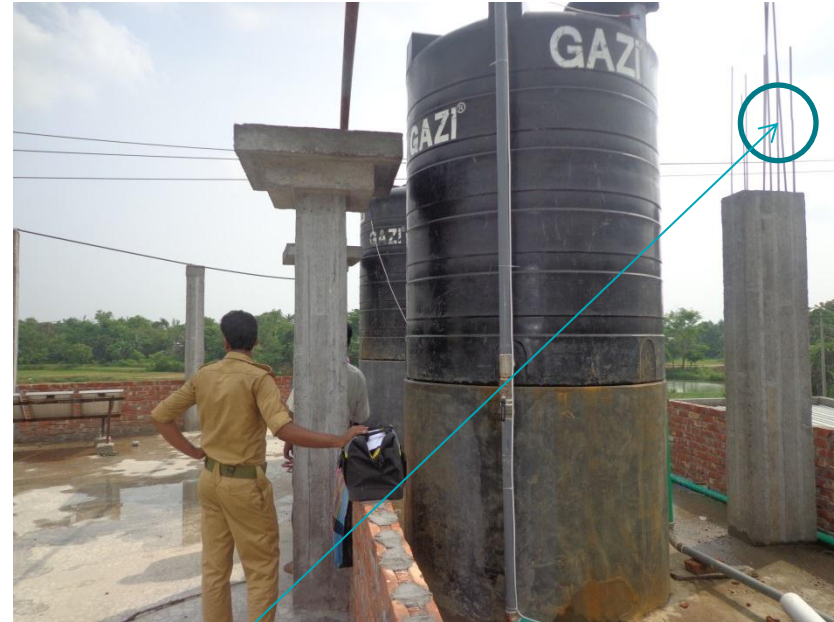
Reinforcement is left exposed

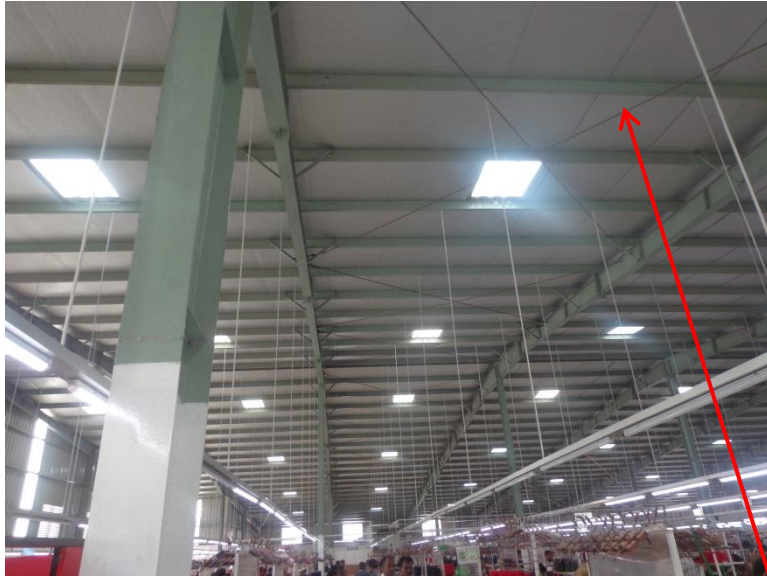
Industrial Steel Shed.

In the Steel shed, the structure should be detailed for adequate lateral restraints for beams and purlins. The shed had horizontal steel bar bracing for the roof diaphragm, but no lateral bracing for vertical component.

No vertical cross bracing at any walls to resist lateral load.

We require that this item be investigated in a Detail Engineering Assessment

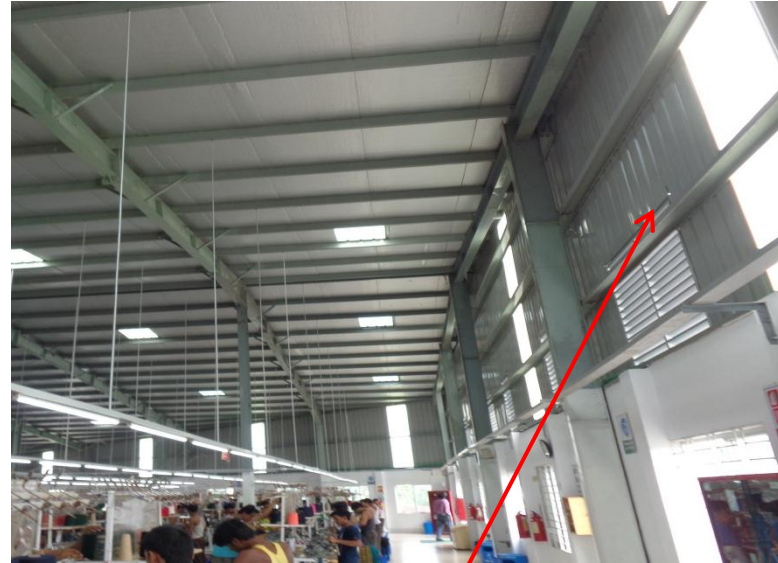
Presence of horizontal steel bar bracing for the roof diaphragm.

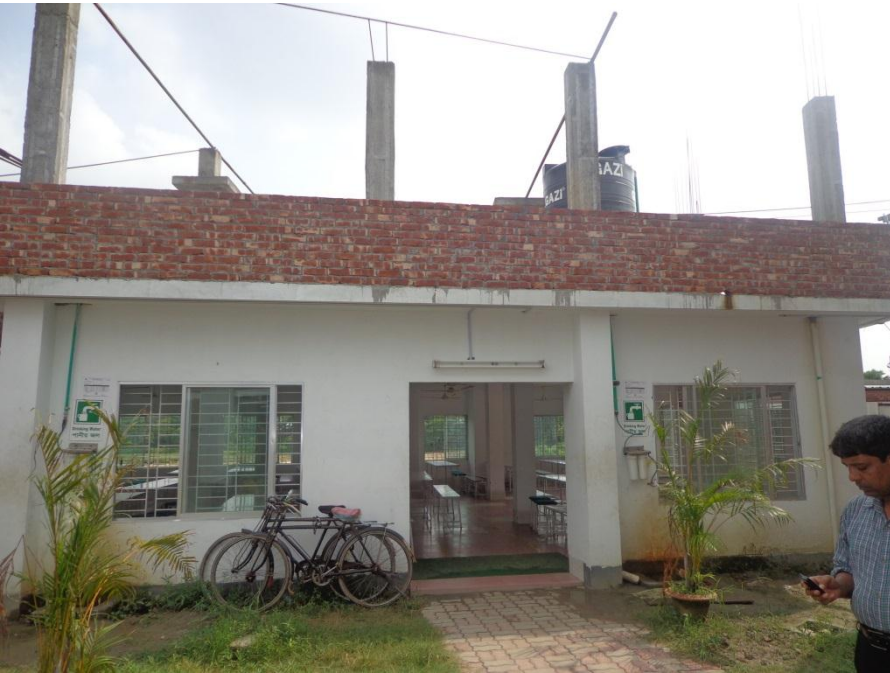
Dining Building

Concerns on the stability system for seismic loading. Façade brickwork walls lack of moment capacity in the connections between columns and Slab.

We require that these items be investigated in a Detail Engineering Assessment.

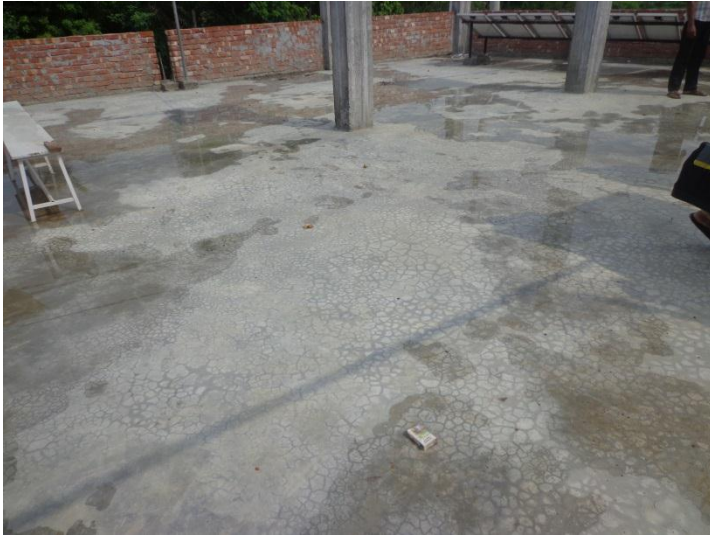
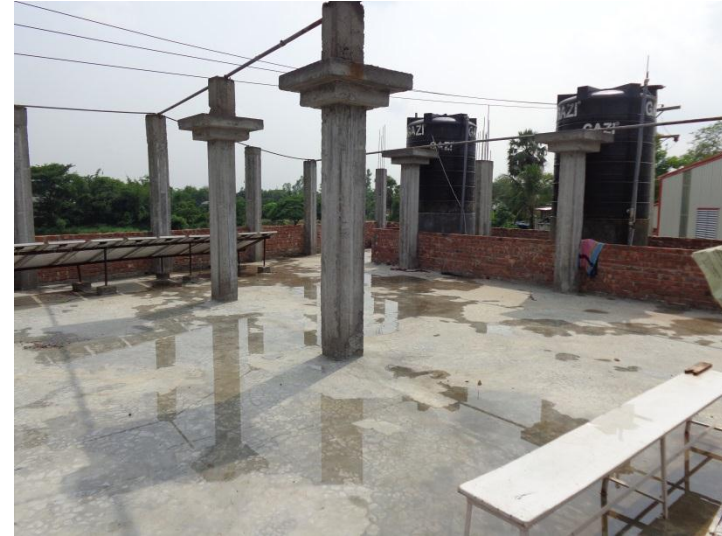
Water Ingress

There is water ponding on the roof slab of the Dinning building.

No waterproofing membrane was visible on the roof of the building. This means that any cracks in the surface finishes on the roof will allow water to seep into the concrete slab beneath the finishes, and cause corrosion of the reinforcing steel.
