Alliance Stitch Ltd. (9556)

DEPZ, Ganakbari, Savar.
(+23.950920N, 90.271744E)

11.June.2014

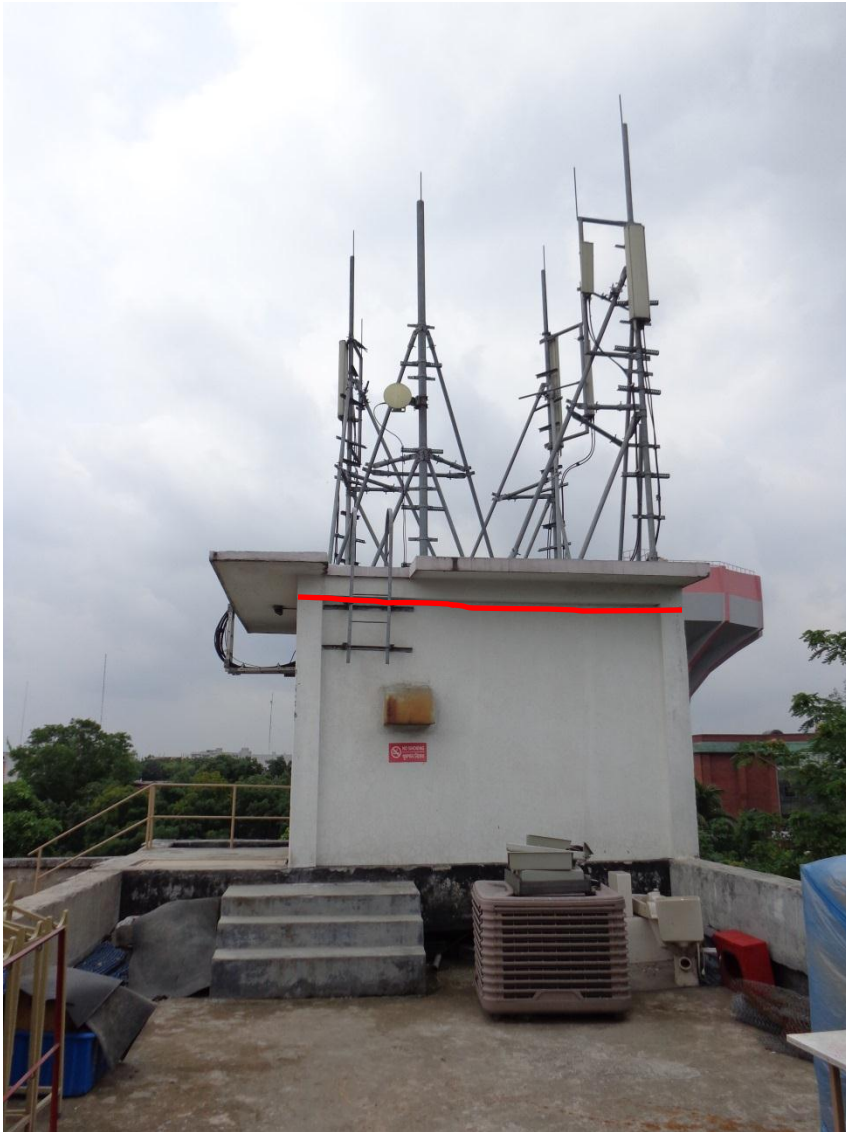
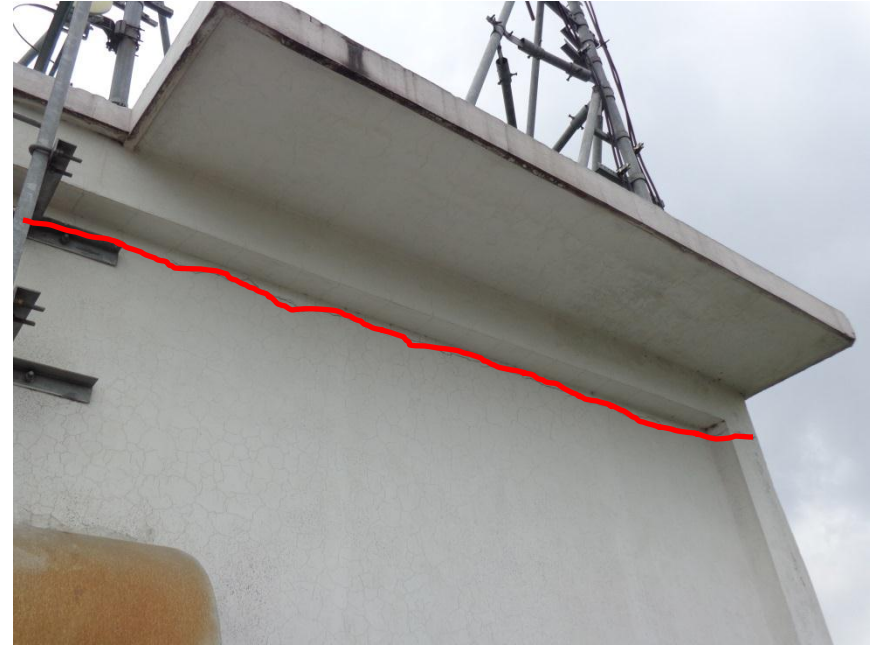
1st Priority 2 Concern

A medium, horizontal crack was observed in the masonry wall and concrete columns of the TV antenna room on the roof. This masonry and concrete crack could be the result of uplift or overturning forces applied to the TV antenna room on the roof.

- ITEM 1: (1st Priority 2) A medium, horizontal crack was observed in the masonry wall and concrete columns of the TV antenna room on the roof.**
- ITEM 2: (2nd Priority 2) Concrete spalling, cracking, and deterioration was observed in several areas. The deterioration is more severe at the link between the two buildings, where maintenance and repair has been neglected.**
- ITEM 3: (1st Priority 3) No structural drawings were made available for the TV antenna room, the lift room, the concrete corridors between adjacent buildings, the access ramp, and the steel canteen roof.**
- ITEM 4: (2nd Priority 3) No loading plans were made available.**

Item No.	Observation	Recommended Action Plan	Recommended Timeline
1	1st Priority 2 - A medium, horizontal crack was observed in the masonry wall and concrete columns of the TV antenna room on the roof.	A Detailed Engineering Assessment is required to determine the cause and extent of this cracking.	6-weeks
2	1st Priority 2 - A medium, horizontal crack was observed in the masonry wall and concrete columns of the TV antenna room on the roof.	Implement any recommendations from the DEA.	6-months
3	2nd Priority 2 - Concrete spalling, cracking, and deterioration was observed in several areas. The deterioration is more severe at the link between the two buildings, where maintenance and repair has been neglected.	All deteriorated concrete needs to be repaired to prevent further damage and falling concrete. An Engineering Assessment is required to determine the cause and extent of the damaged lintel and warping of windows in the link.	6-weeks

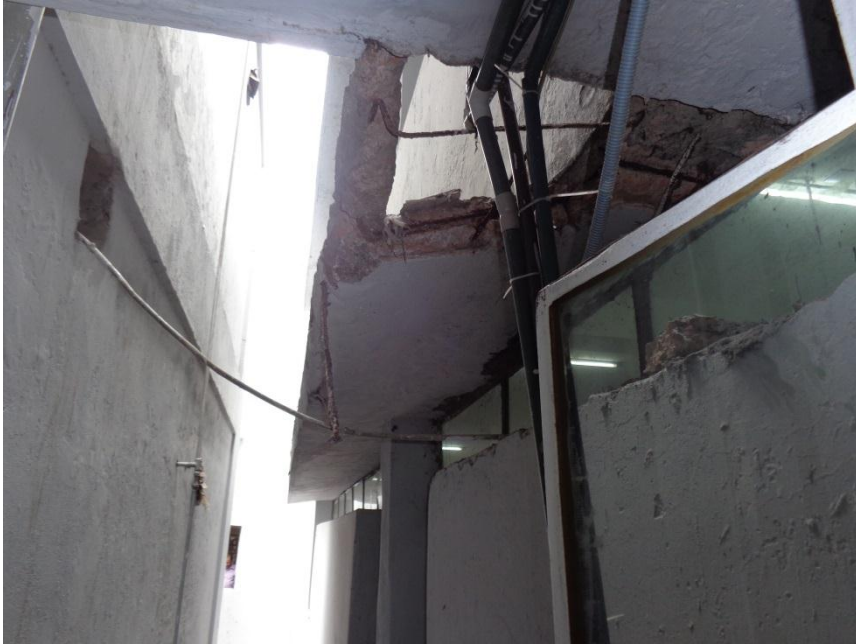
Concrete spalling of awning along exterior corridor wall between adjacent buildings observed at the 1st and 2nd storey.

4	2nd Priority 2 - Concrete spalling, cracking, and deterioration was observed in several areas. The deterioration is more severe at the link between the two buildings, where maintenance and repair has been neglected.	Concrete tests should be carried out to determine the current concrete strength. Implement any recommendations from EA.	6-months
5	1st Priority 3 - No structural drawings were made available for the TV antenna room, the lift room, the concrete corridors between adjacent buildings, the access ramp, and the steel canteen roof.	Structural Engineer to provide drawings reflecting existing conditions.	6-months
6	2nd Priority 3 - No loading plans were made available.	Structural Design Engineer to provide loading plans based on capacity, not current loading. Post and manage loading plans.	6-months

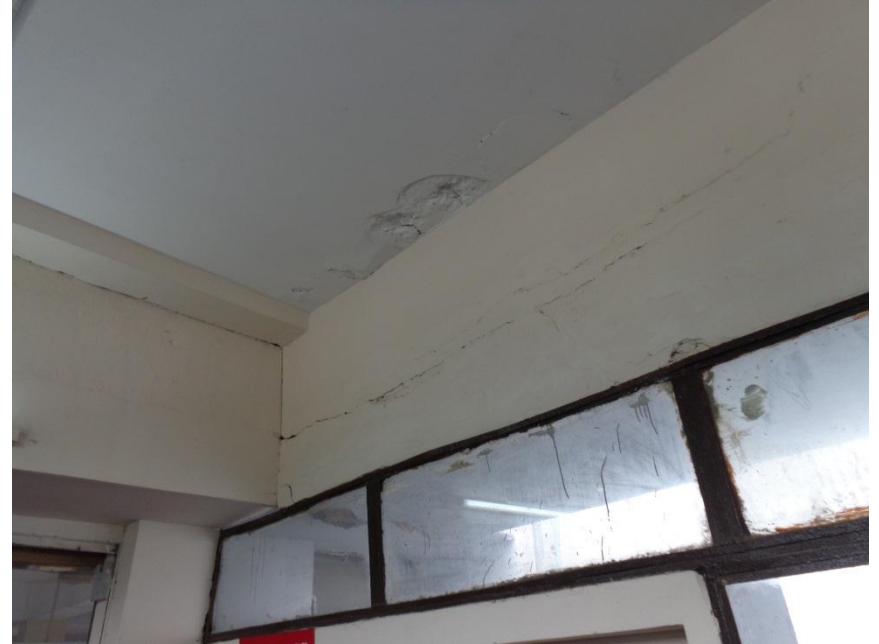
Cracking in masonry and/or concrete lintel causing windows and walls to warp.

Concrete spalling (top left), cracking (top right), and general deterioration was observed in several areas. The deterioration is more severe at the link between the two buildings, where maintenance and repair has been neglected. In addition, the concrete appeared weak when probed. At the time of our inspection, plaster and masonry repairs had been carried out quite recently, prohibiting observation of the extent of the damaged concrete.

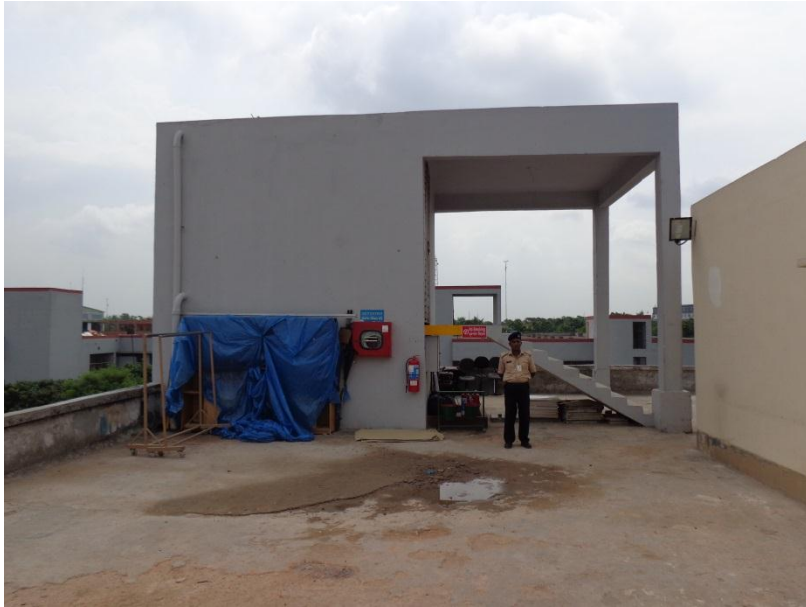
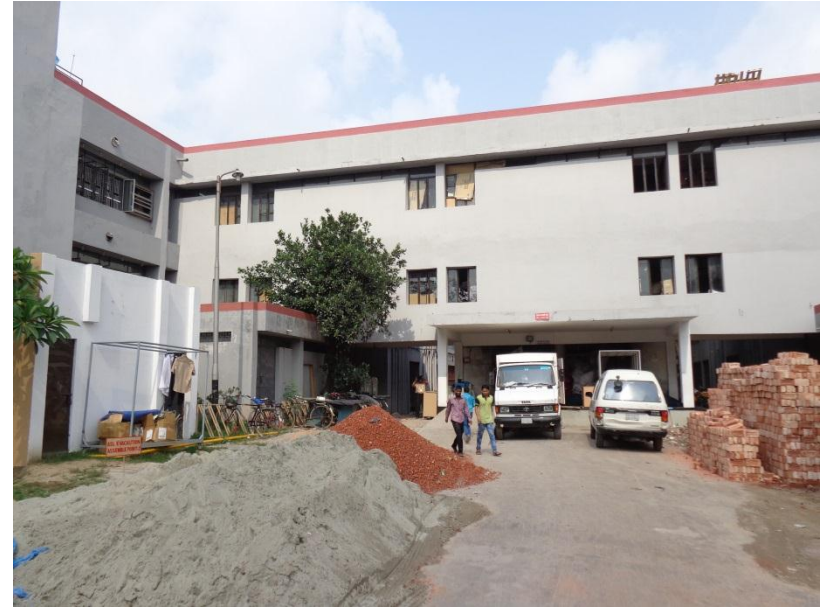
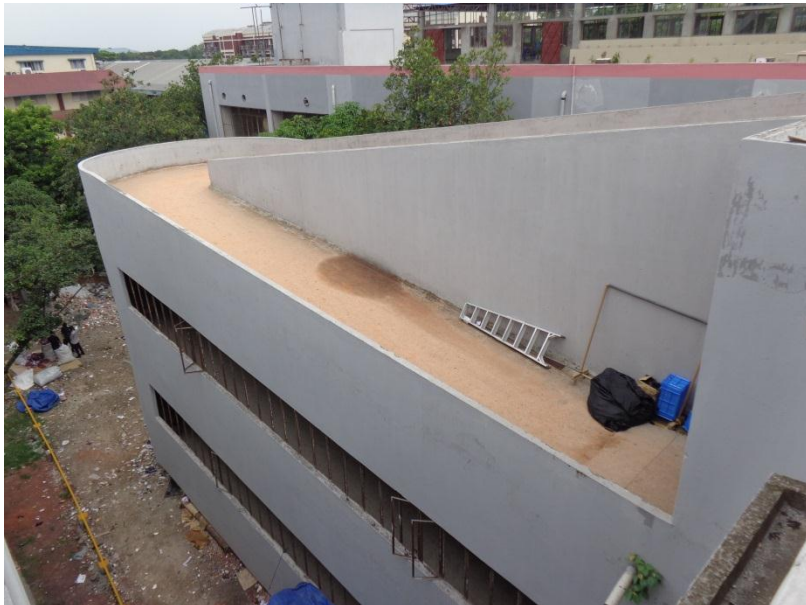
1st Priority 3 Concern

No structural drawings were made available for the TV antenna room, the lift room (top left), the concrete corridors between adjacent buildings (top right), the access ramp (bottom left), and the steel canteen roof.

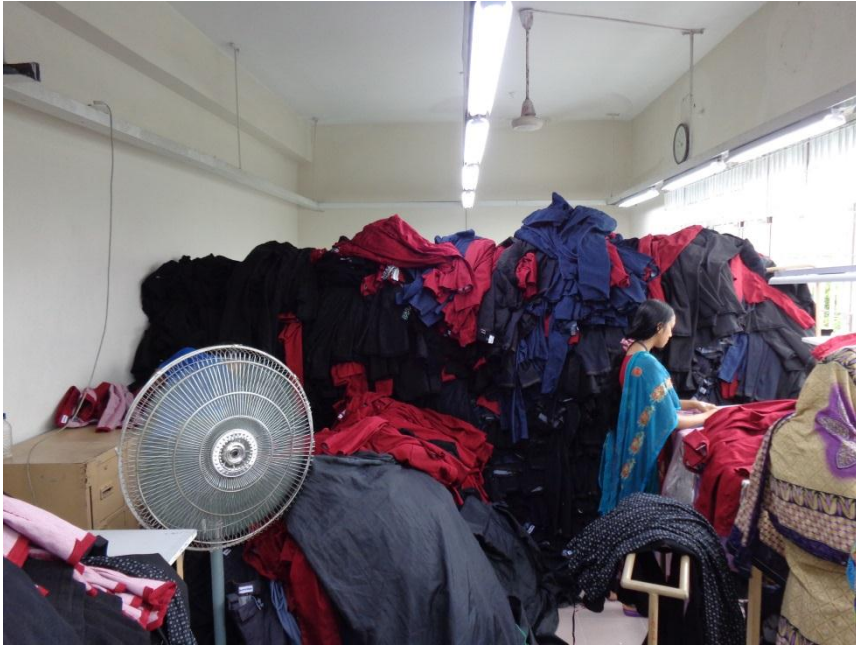
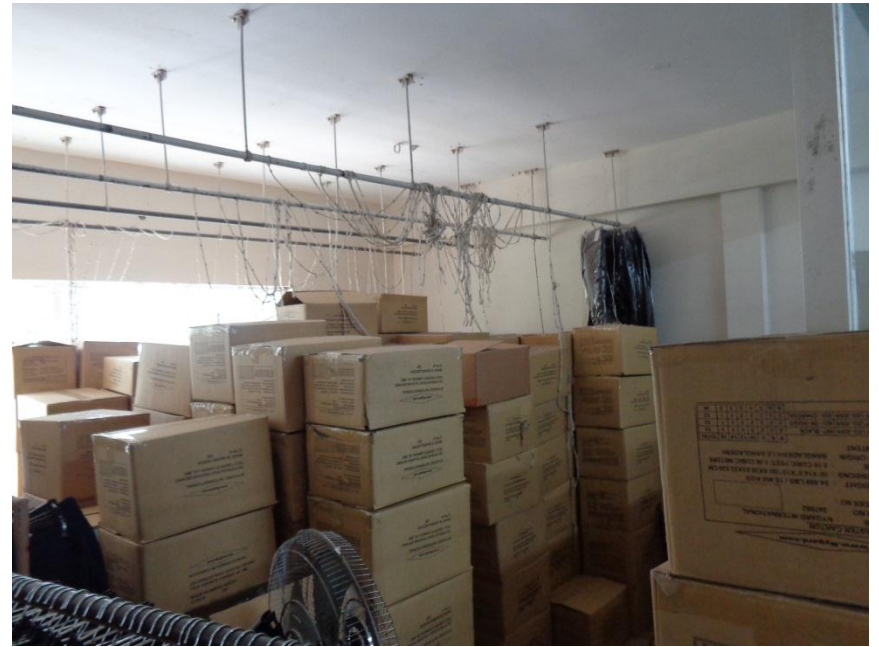
2nd Priority 3 Concern

No loading plans were made available, and stockpiling (top left) and packing (bottom right) areas were observed.

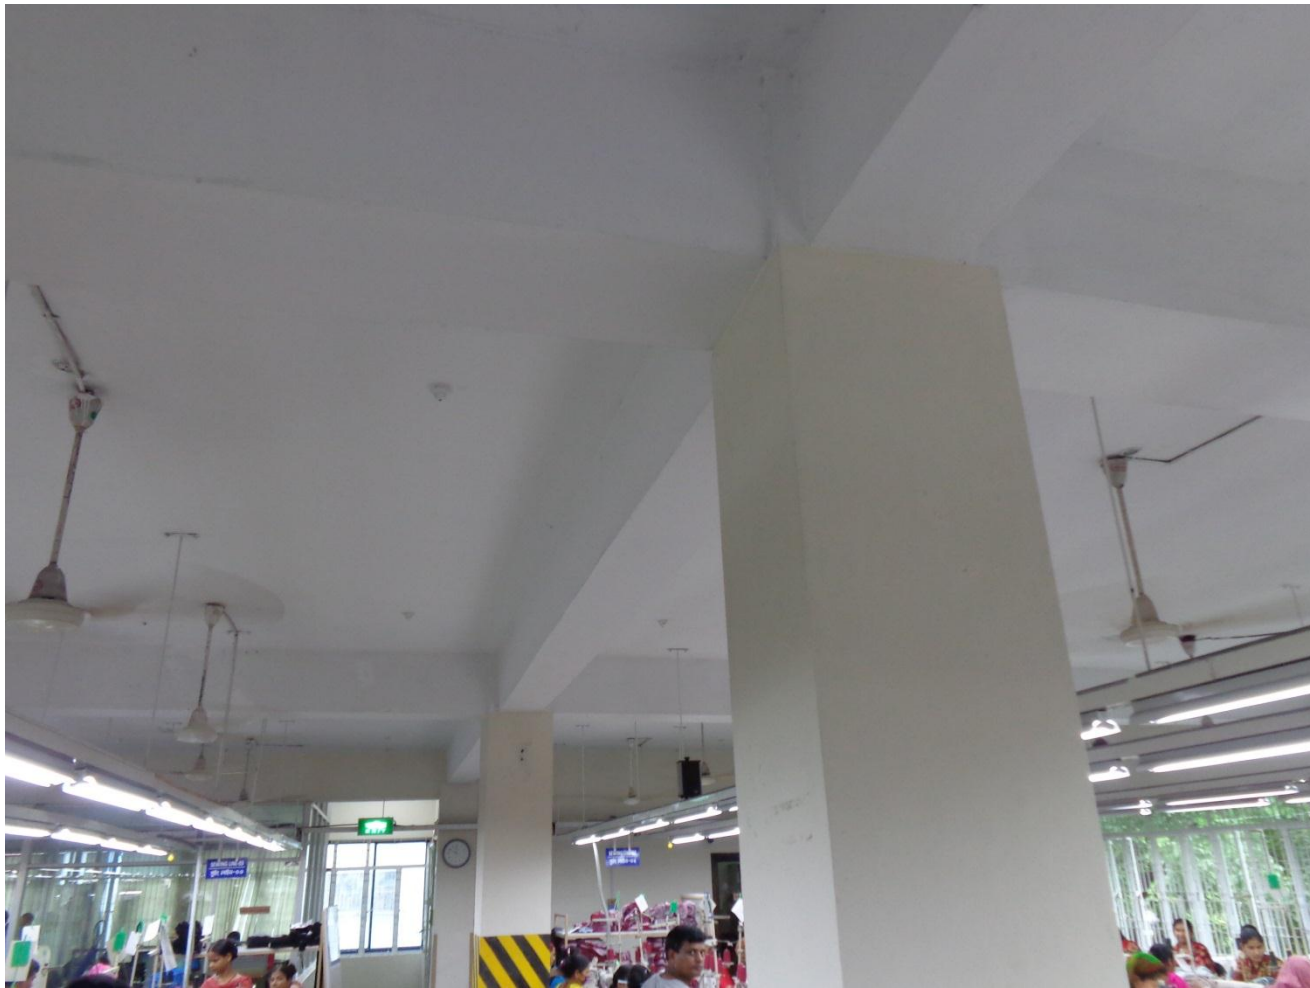
Overall Stability System

The building did not feature any core or shear walls. Stability was achieved through sway action between beams and columns and masonry infill walls.

We require that these items be investigated in a Detail Engineering Assessment

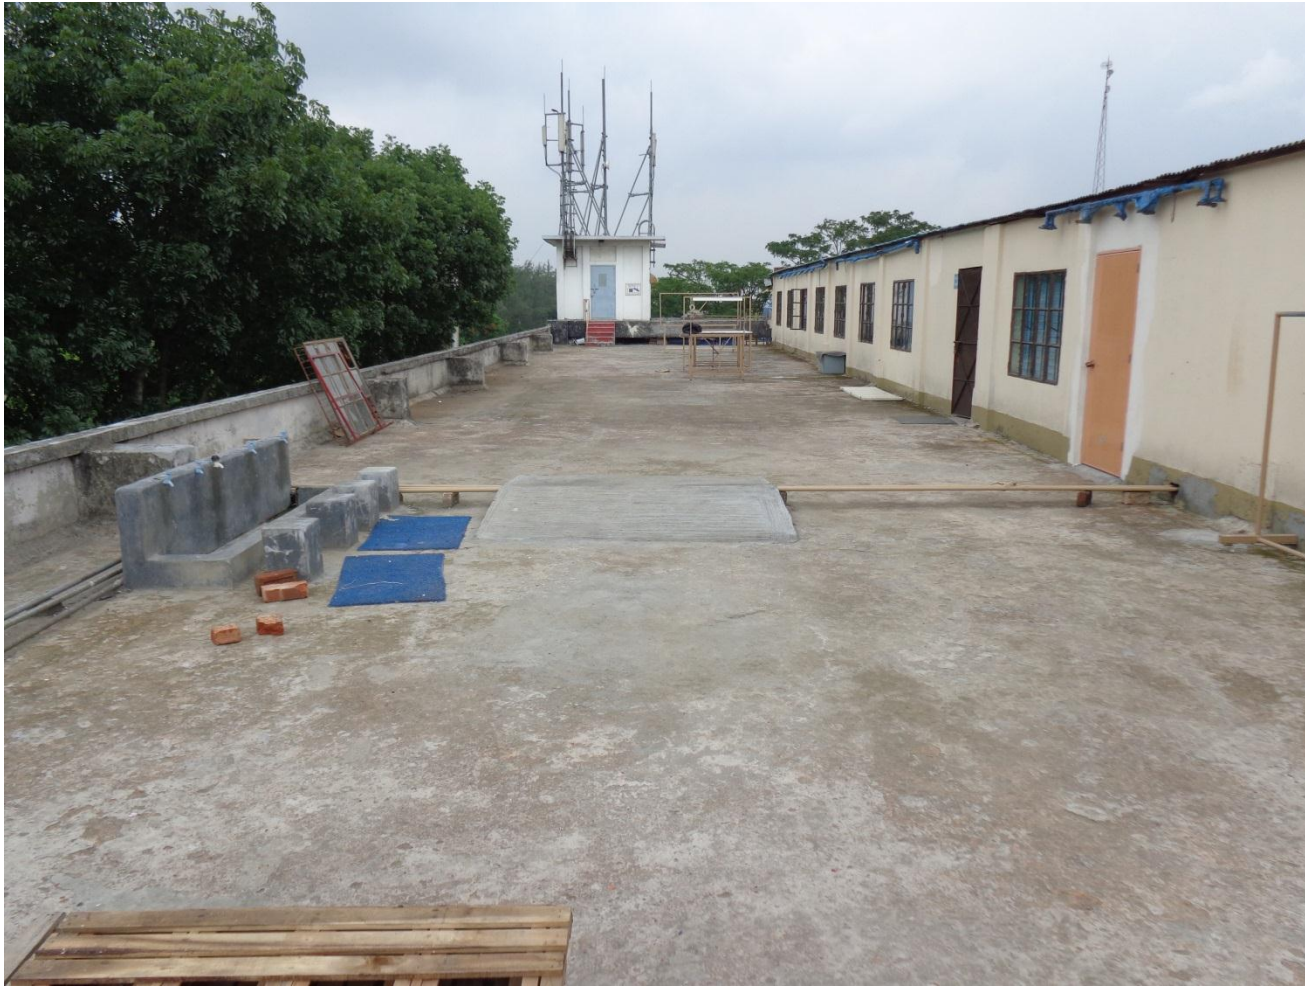
Water Ingress at Roof Level

No waterproofing membrane was visible on the roof of the building. This means that any cracks in the surface finishes on the roof will allow water to seep into the concrete slab beneath the finishes, and cause corrosion of the reinforcing steel.
