# Global Attire Ltd (11253)

Khejurtek, Mirzanagar, Pathalia, Ashulia, Savar

17.June.2014

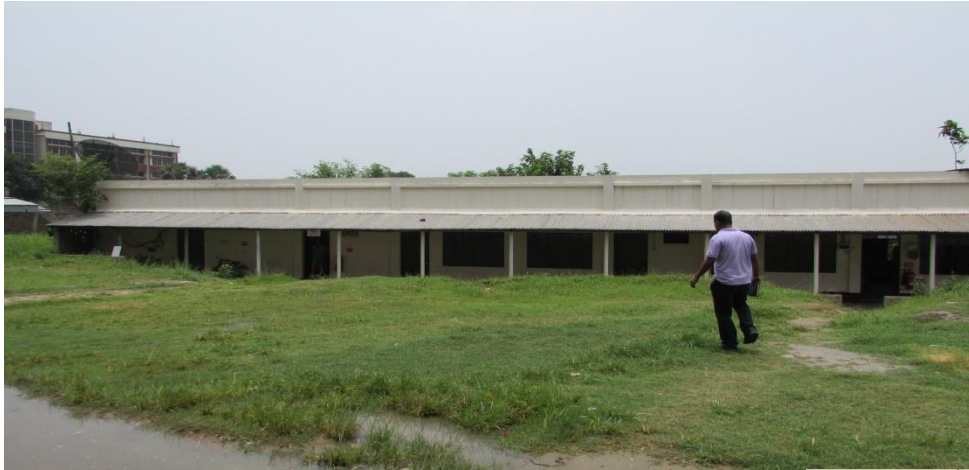
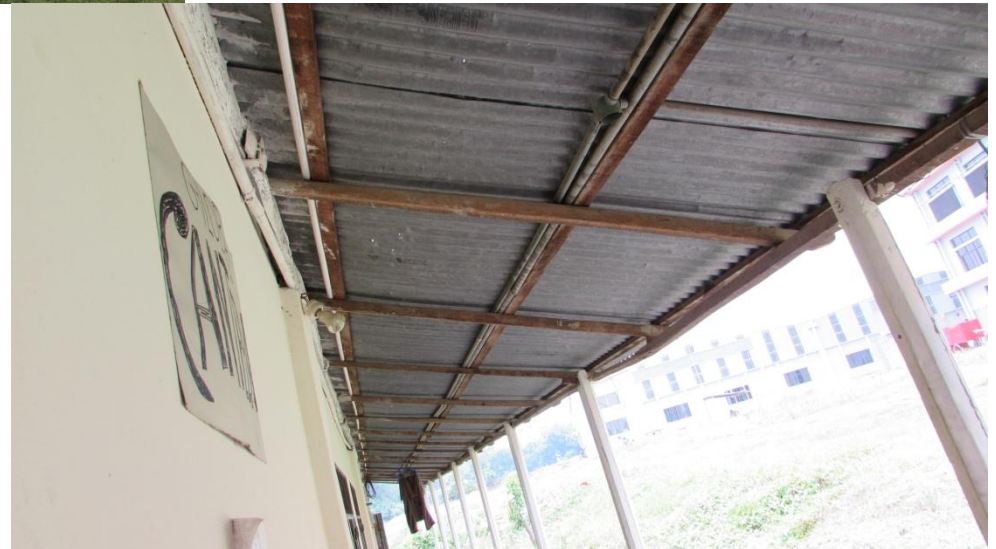
The canteen shed consists of a wooden frame which appears to be weak and inadequate. In strong winds it may not be stable. Moreover, in emergency fire conditions a wooden frame is not appropriate.

**Weak wooden frame for canteen shed**

**ITEM 1: 1<sup>st</sup> Priority 3-** Weak wooden framing for canteen shed .

| Item No. | Observation | Recommended Action Plan | Recommended Timeline |
|---|---|---|---|
| 1 | 1st Priority 3 - Weak wooden framing for canteen shed . | Remove wooden frame from canteen shed and replace with steel framing. | 6-months |

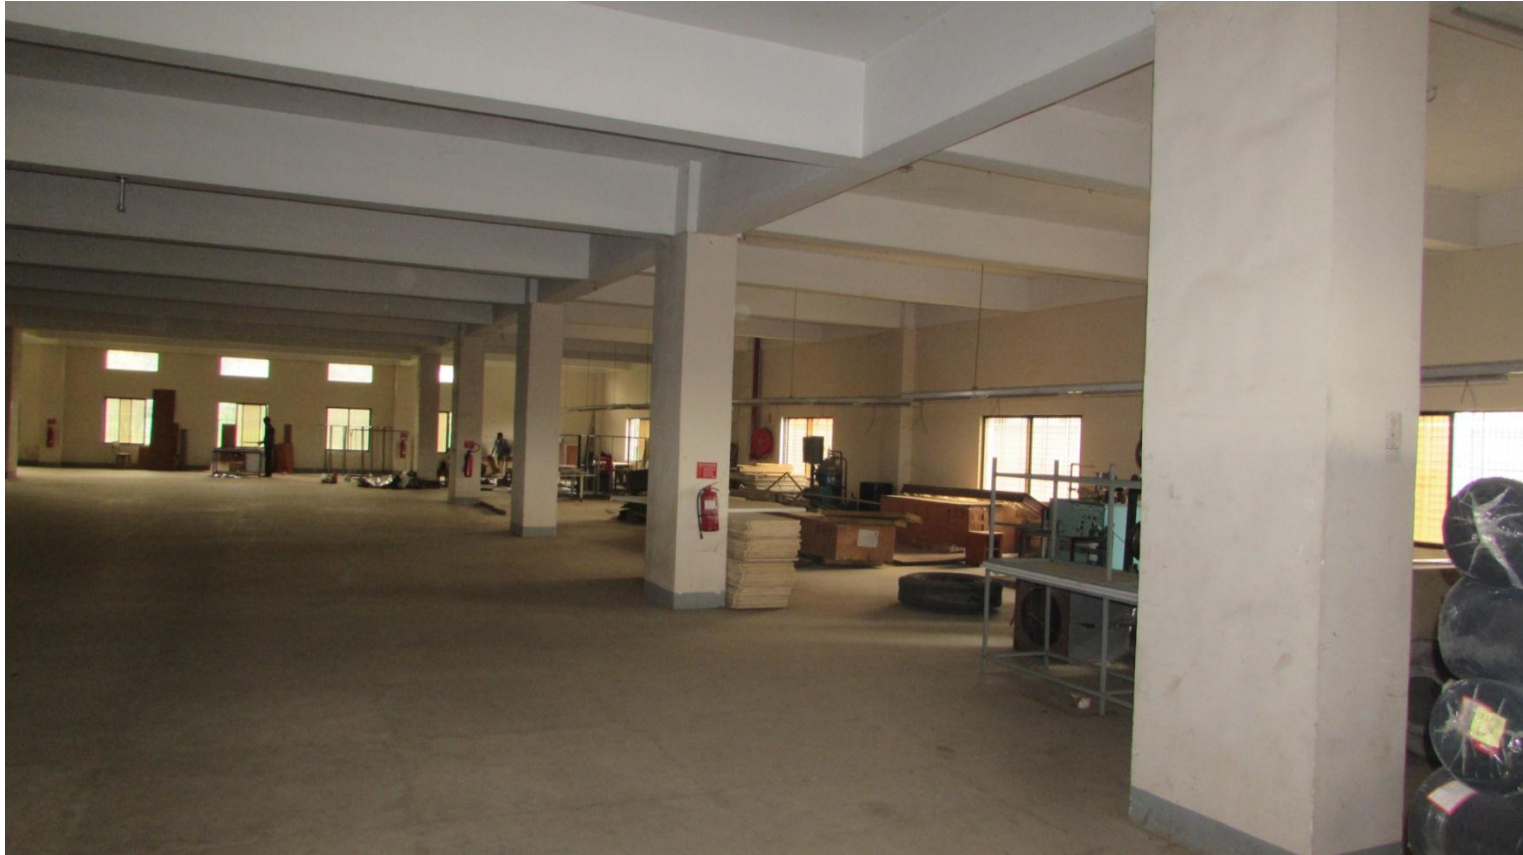
The building does not feature reinforced concrete lift core or shear walls. Stability may be achieved through sway action between beams and columns and masonry infill walls.

We require that this item be investigated in an Engineering Assessment

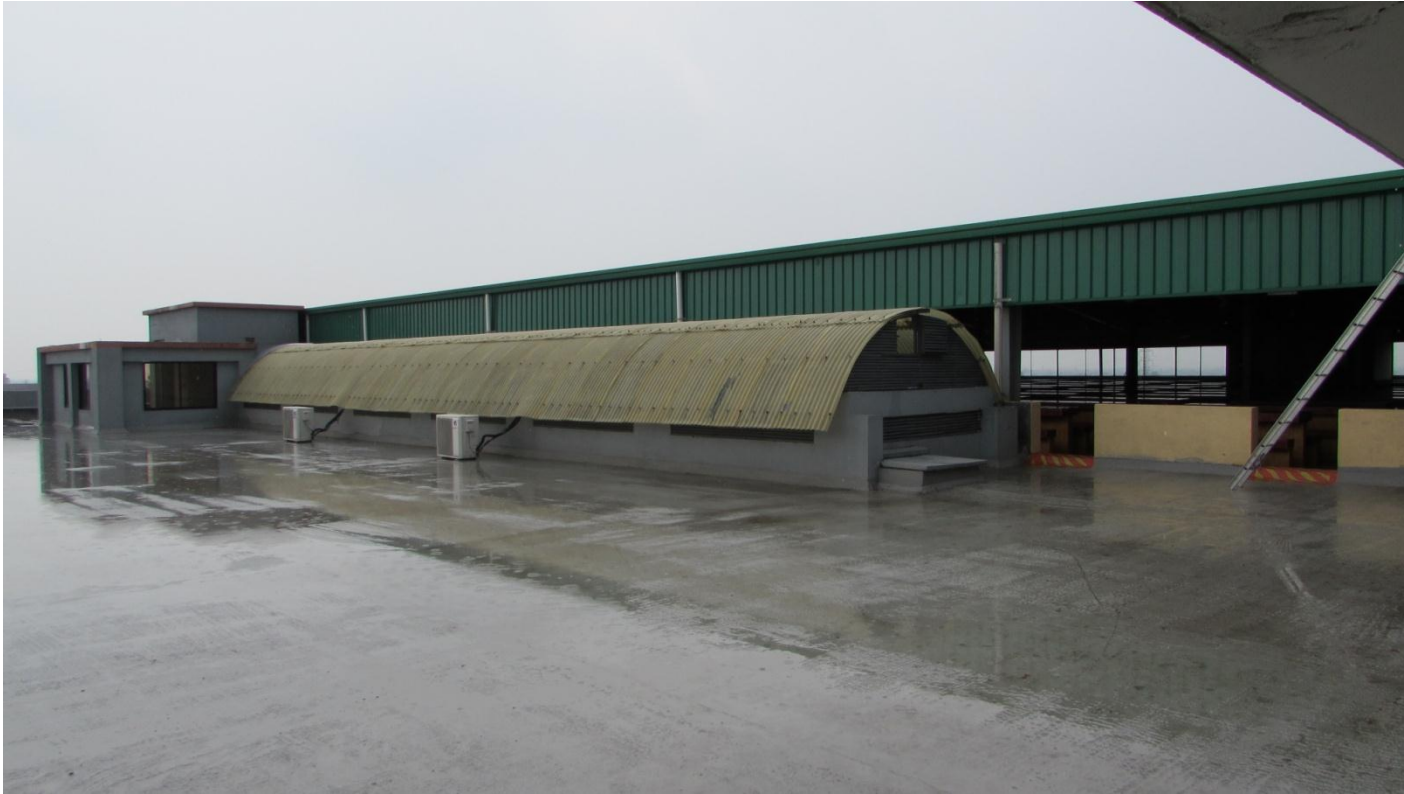
No waterproofing membrane was visible on the roof of the building. This means that any cracks in the surface finishes on the roof will allow water to seep into the concrete slab beneath the finishes, and cause corrosion of the reinforcing steel.

**ITEM 2: 2<sup>nd</sup> Priority 3-** Water proofing material has not been applied on roof floor.

| Item No. | Observation | Recommended Action Plan | Recommended Timeline |
|---|---|---|---|
| 2 | 2nd Priority 3 - Water proofing material has not been applied on roof floor. | For both durability and serviceability, waterproofing on the roof slab is required.<br>Waterproofing should be applied immediately, also the roof slab drainage system should be investigated and improved if necessary. | 6-months |
