# Apparels Village Ltd. (11547)

Plot-37, Village:Khagan, Union Parishad: Birulia, Upozilla: Savar, Dist: Dhaka, Bangladesh

18.JUNE.2014

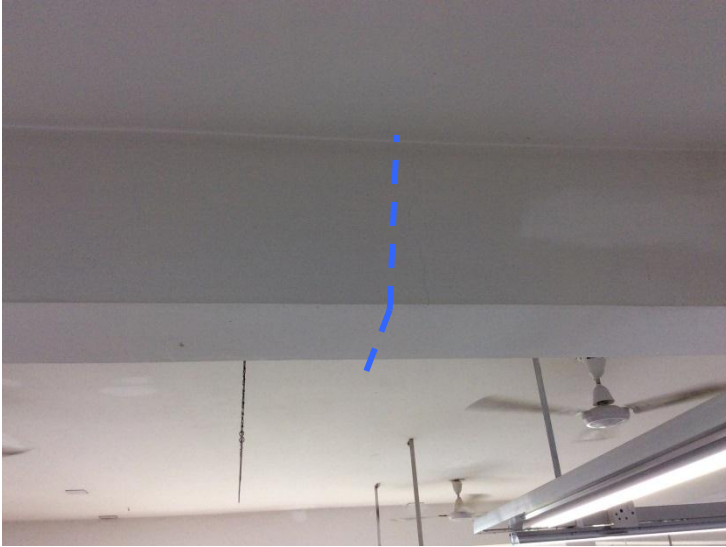
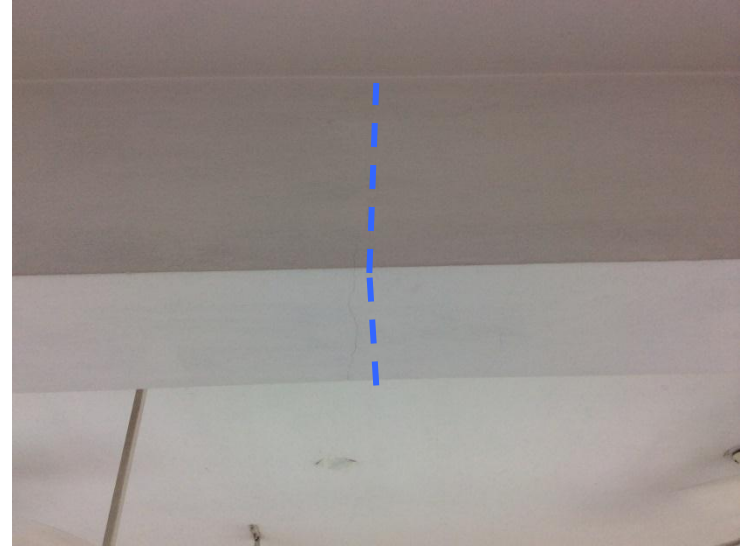
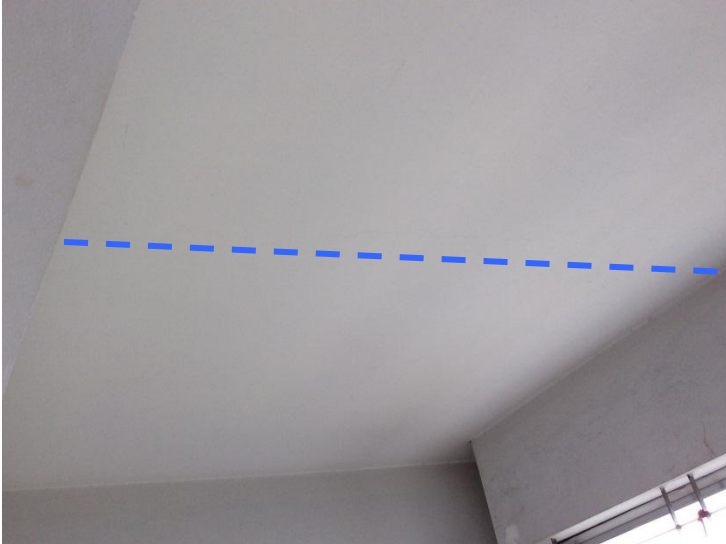
Cracks on beams and slab soffits of Building 1. The cause of cracks should be investigated by appropriate methods.

| Item No. | Observation | Recommended Action Plan | Recommended Timeline |
|---|---|---|---|
| 1 | Priority 2 - Cracks on beams and slab soffits of Building 1. | The Factory Engineer to investigate the cause of cracks by appropriate methods.<br>The distress found is to be suitably rectified and then repaired. | 6-weeks |
| 2 | Priority 2 - Cracks on beams and slab soffits of Building 1. | Create loading plans for each floor level.<br>Maintain standards of quality control to ensure that loading plan is correctly followed so that problems do not arise in the future.<br>Maintain and enforce the loading plans. | 6-months |

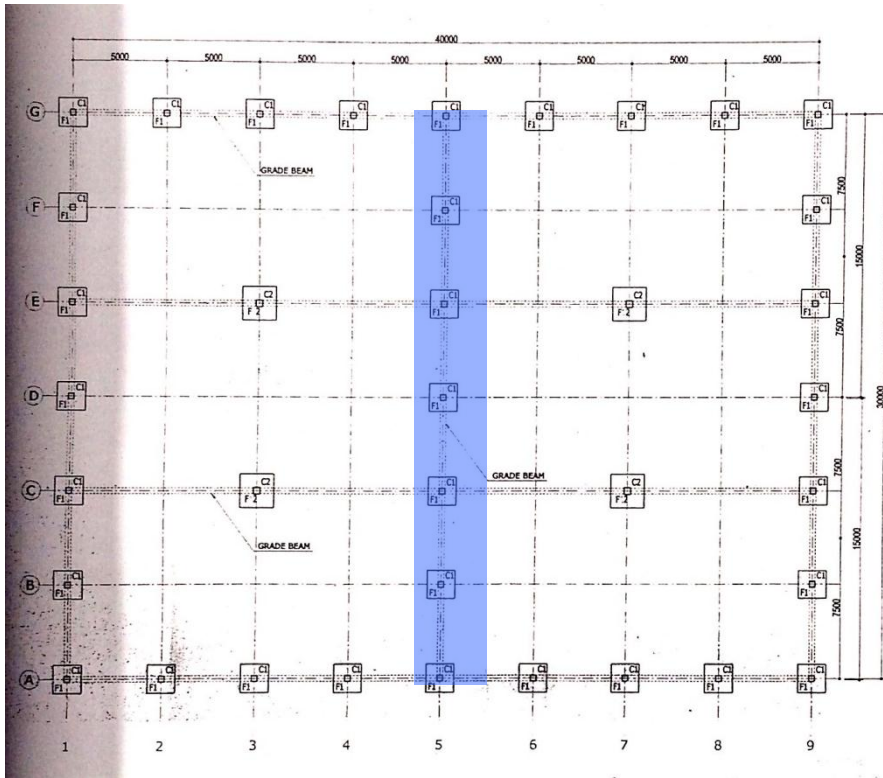
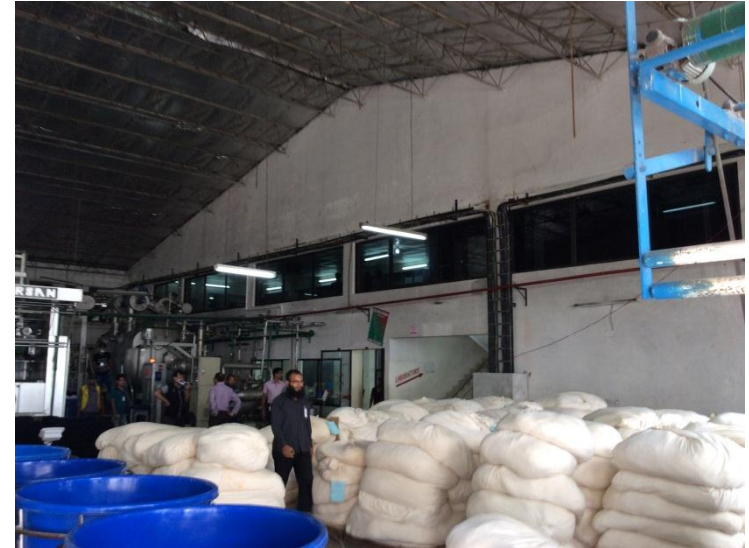
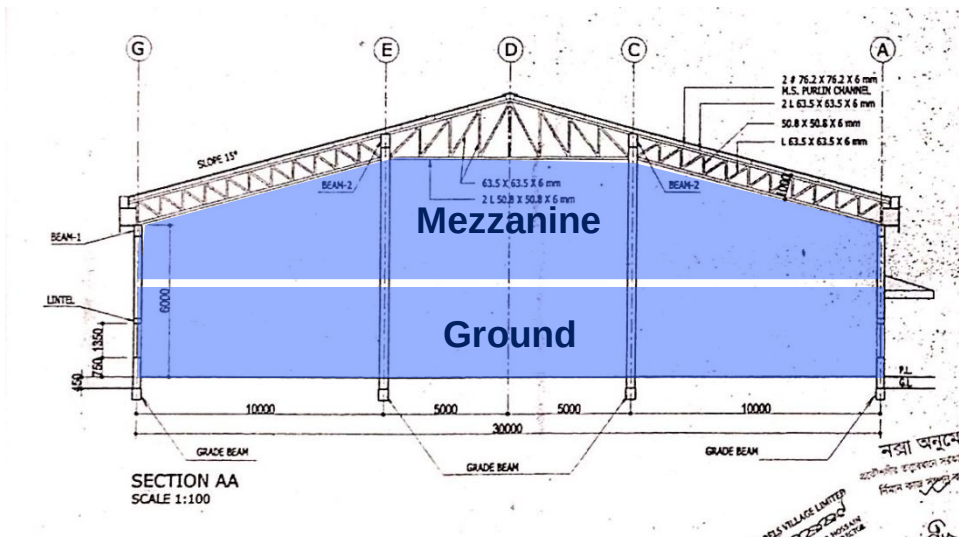
A mezzanine was added at the middle of Shed 3. This floor is used for offices and a laboratory. The drawings should be updated as early as possible.

| Item No. | Observation | Recommended Action Plan | Recommended Timeline |
|---|---|---|---|
| 3 | Priority 2 - Inadequacies between the drawings of Shed 3 and the actual as-built conditions. | Factory Engineer to survey the actual conditions and revise the drawings.<br>Any results of the DEA which affect the structure should be taken on board. | 6-weeks |
| 4 | Priority 2 - Inadequacies between the drawings of Shed 3 and the actual as-built conditions. | Continue to implement load plan | 6-months |

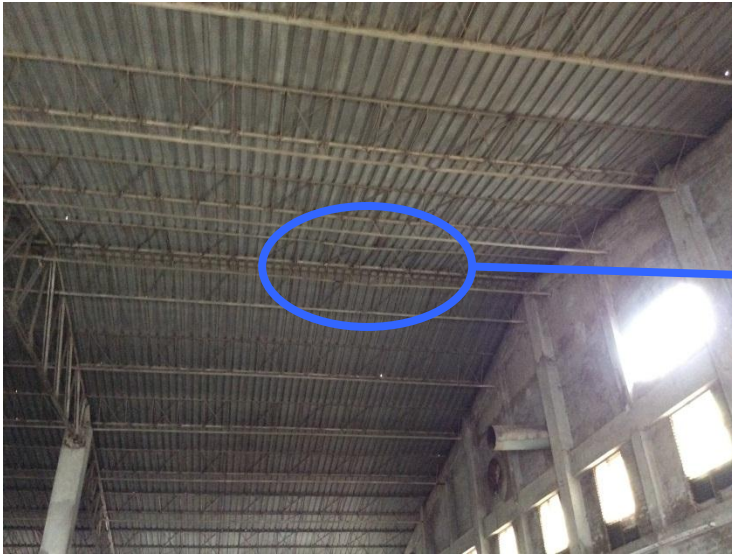
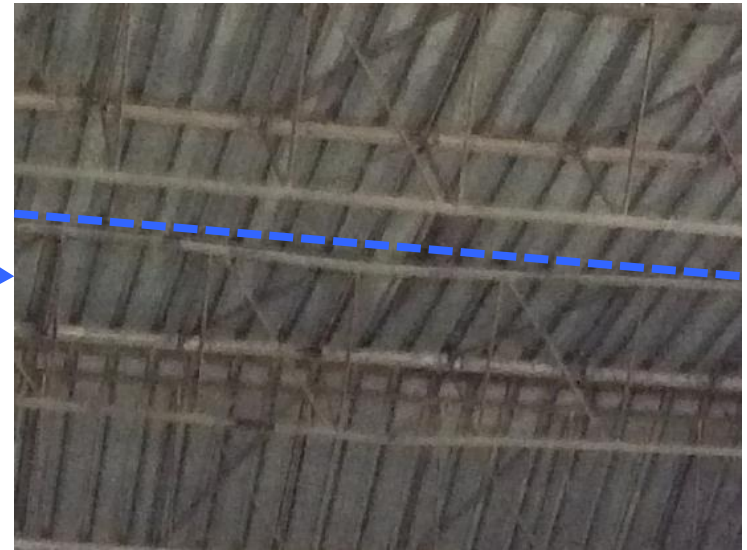
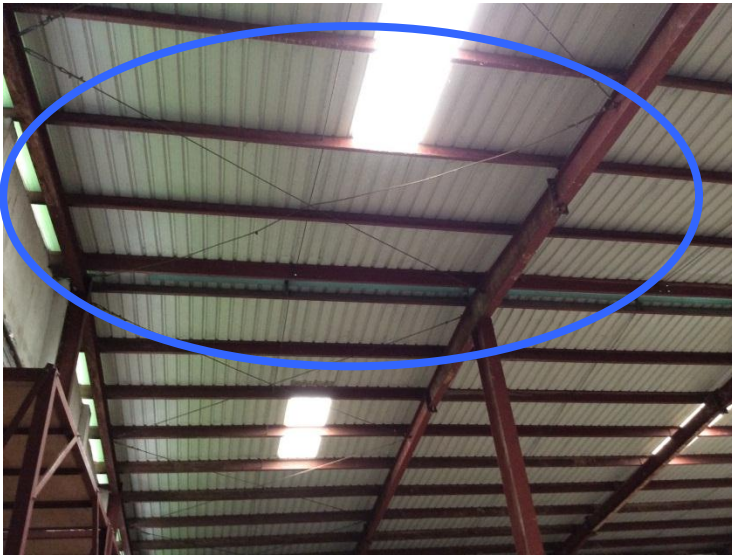
Deflection of structural steel elements supporting lightweight roof was noted at Shed 3. And loose roof bracing rods were noted in Shed 4.

| Item No. | Observation | Recommended Action Plan | Recommended Timeline |
|---|---|---|---|
| 5 | Priority 2 - Structural steel elements supporting the roof of Shed 3 and the roof bracing rods of Shed 4 to be checked. | Factory Engineer to inspect items in the area identified above and repair with a suitable methods. | 6-weeks |

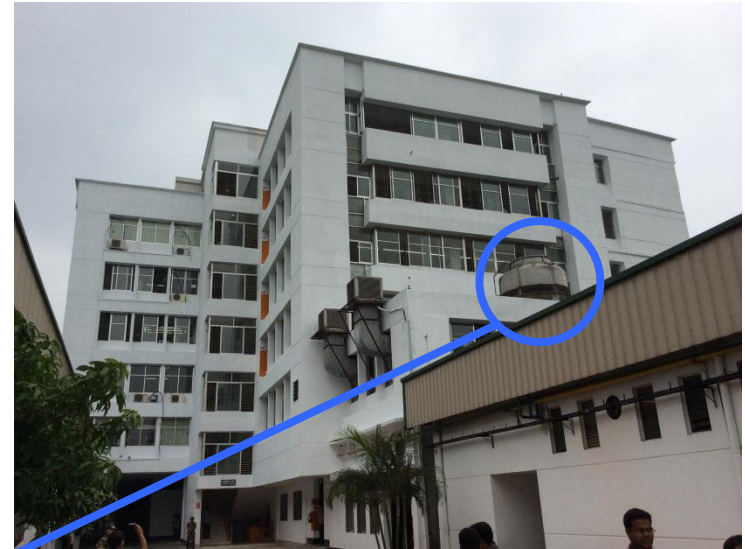
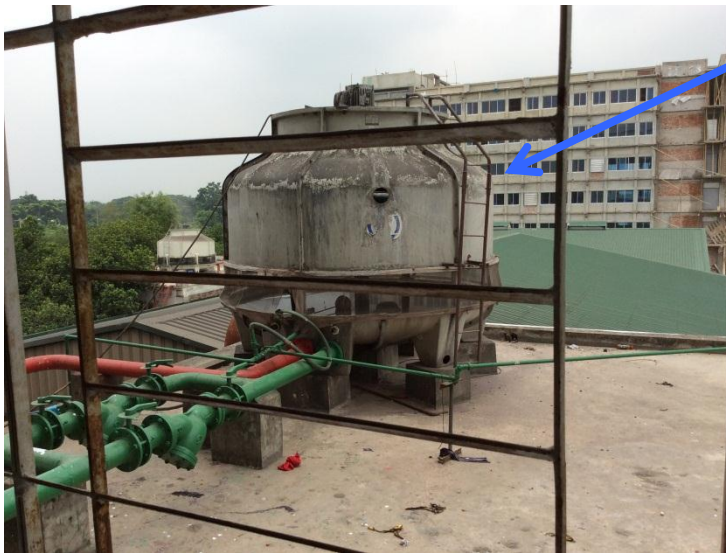
There are concerns with a section of roof slab of Building 1, a section that was supporting a cooling tower. A capacity check of the roof slab and related elements should be carried out.

| Item No. | Observation | Recommended Action Plan | Recommended Timeline |
|---|---|---|---|
| 6 | Priority 2 - Capacity check of roof slab of Building 1 supporting cooling tower. | Factory Engineer to review design, loads and related elements in area identified above to confirm capacity for these items. | 6-weeks |

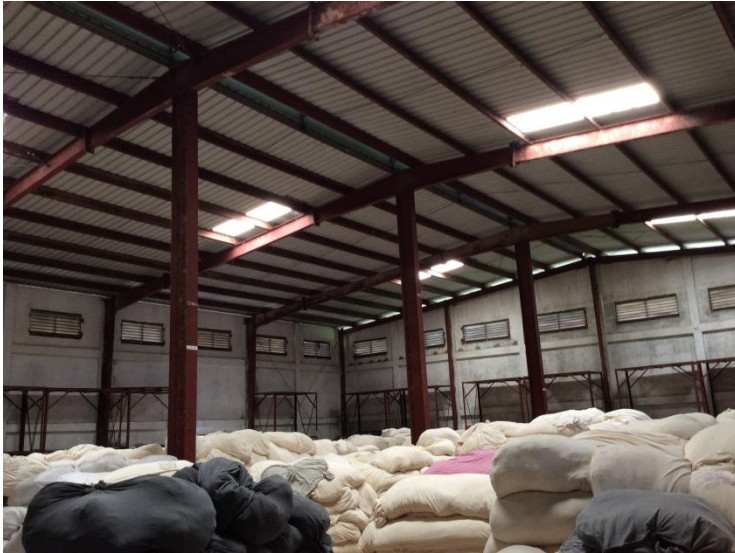
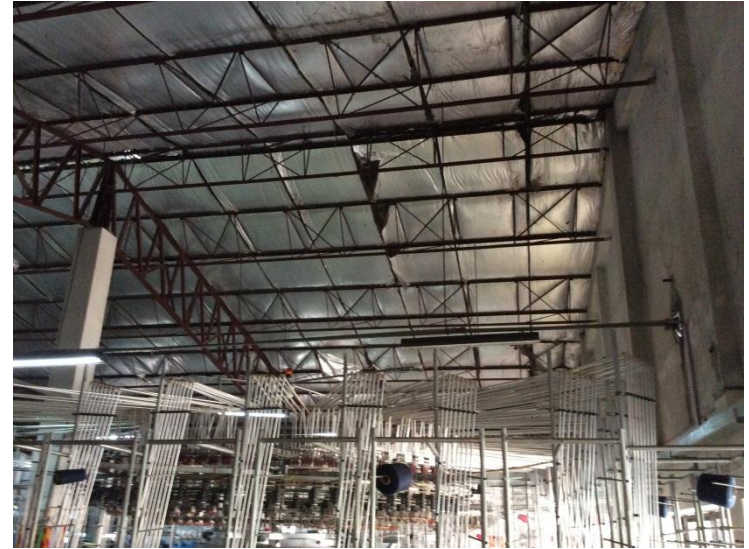
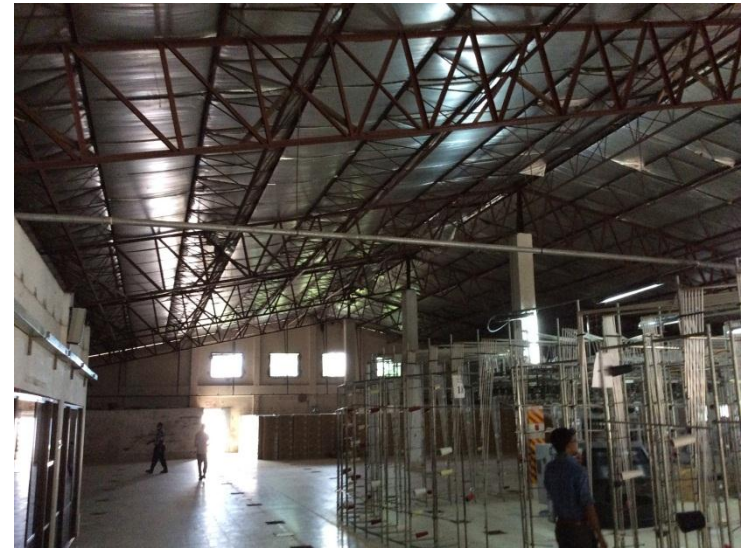
No fireproofing material was noted on structural steel elements of Shed 1, Shed 2, Shed 3, Shed 4 and Shed 5 (if required).

| Item No. | Observation | Recommended Action Plan | Recommended Timeline |
|---|---|---|---|
| 9 | Priority 3 - No fireproofing material applied for structural steel elements of Shed 1, Shed 2, Shed 3, Shed 4 and Shed 5 (if required). | Fireproofing material for structural steel element is recommended as suggested in BNBC Codes. | 6-weeks |
| 10 | Priority 3 - No fireproofing material applied for structural steel elements of Shed 1, Shed 2, Shed 3, Shed 4 and Shed 5 (if required). | Maintain standard of quality control and protection of the fire protection. | 6-months |

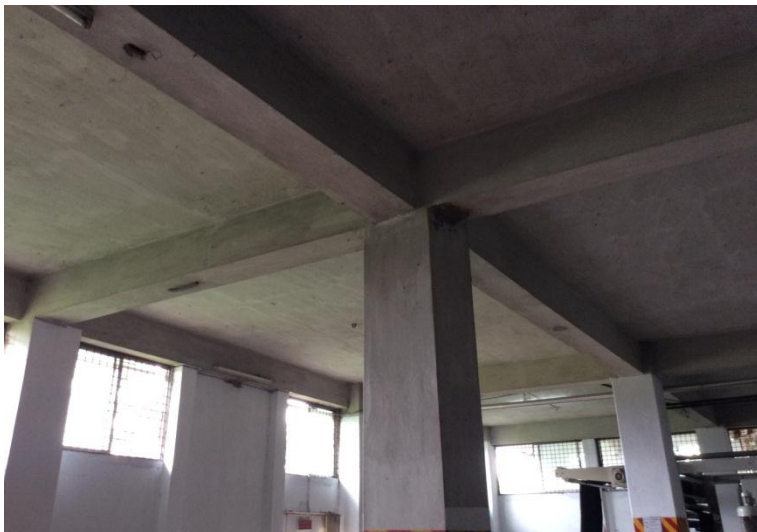
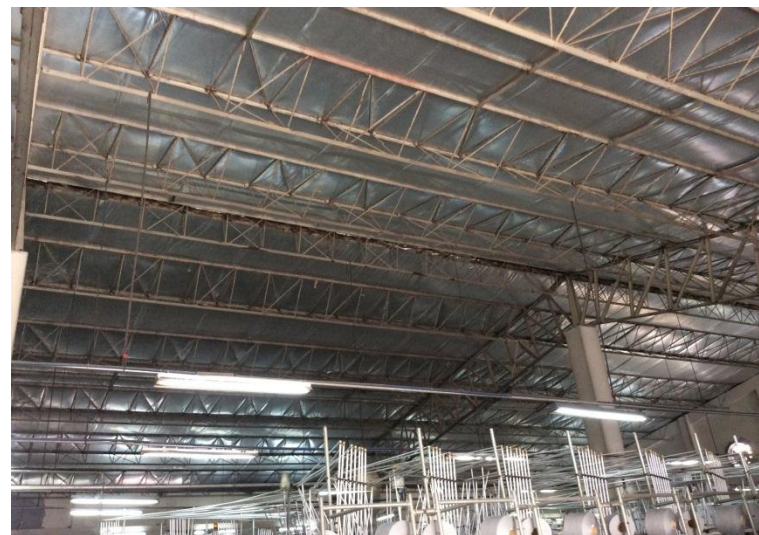
Concerns on the stability system for lateral loading. The lateral loading resistance of the RC buildings is provided by moment frame action without any shear walls. Façade brickwork walls lack moment capacity due to their poor connections between columns and beams.

Concerns on the stability system for lateral loading as well as uplift due to wind for roof. Structural steel elements lack moment capacity in the connections.

We require that these items be investigated in a Detailed Engineering Assessment.

| Item No. | Observation | Recommended Action Plan | Recommended Timeline |
|---|---|---|---|
| 7 | Priority 2 - Overall stability system. | Request that a Detailed Engineering Assessment of the overall building to be carried out and in particular, stability and foundation aspects should be investigated in detail. | 6-weeks |

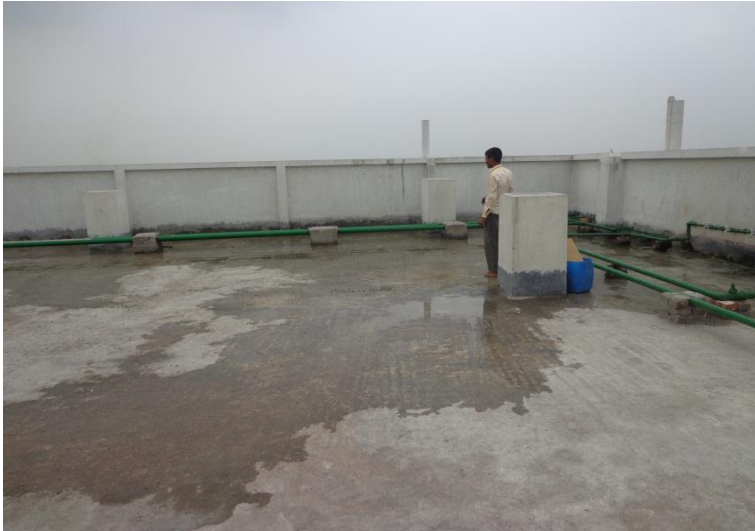
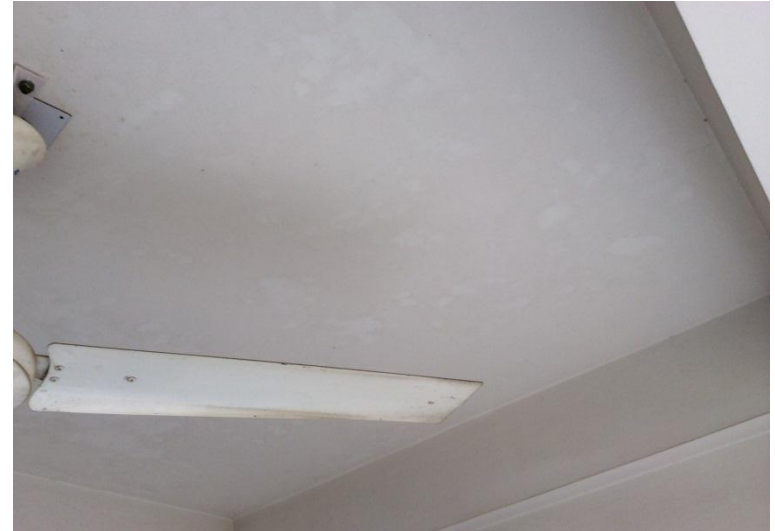
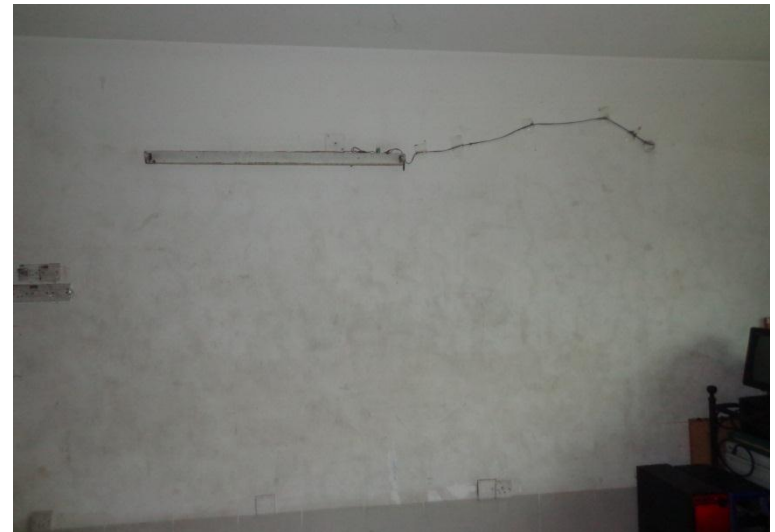
Water distress was noted on slabs and walls of Building 2. And water ponding was found on the roof slab of Building 1.

| Item No. | Observation | Recommended Action Plan | Recommended Timeline |
|---|---|---|---|
| 8 | Priority 3 - Distress due to water ingress of Building 1 and Building 2. | Factory Engineer to inspect water damaged structures and repair with a suitable methods. | 6-months |
