# Masco Industries Ltd Unit 2

221 – 223 Khartail, Shataish Road, Tongi, Gazipur, Dhaka  
(+ 23.921041N,90.386399E)

12 December 2013

# **Building Observations Garment Factory**

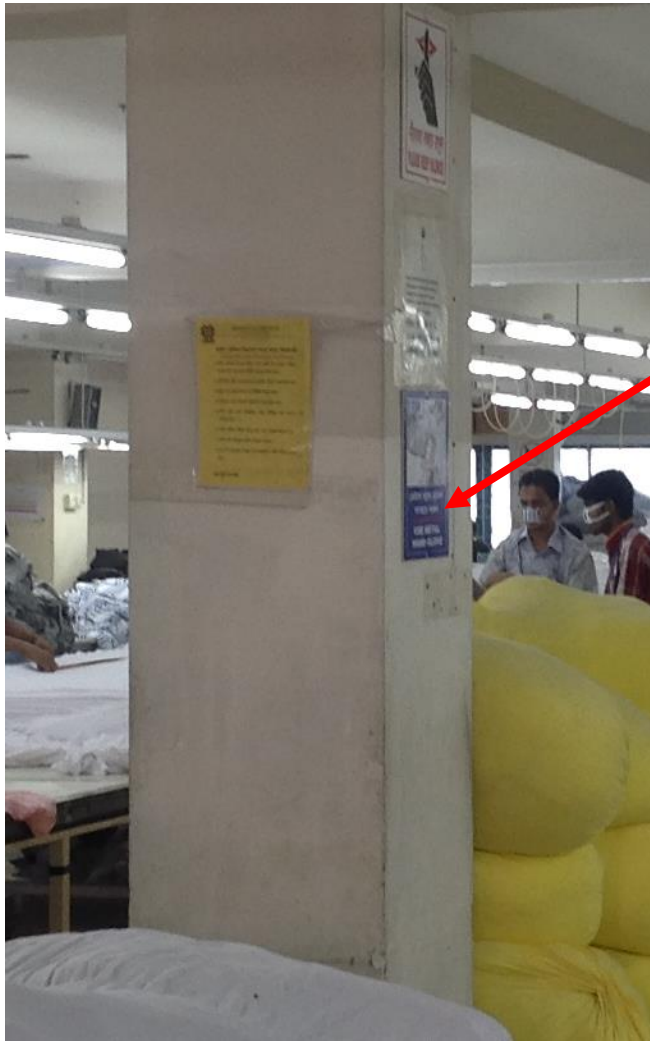
**Columns appear to be stressed in excess of  
normal design limits**

Cursory calculations indicate that column size appears to be smaller than required by code for the applied dead and live load, assuming typical concrete strength

Building Engineer to perform detailed calculations and concrete tests to prove column size and (if required) :

- Reduce loads by preparation of allowable floor loading plans
- Carry out strengthening works

| Item No. | Observation | Recommended Action Plan | Recommended Timeline |
|---|---|---|---|
| 1 | <b>Garment Factory</b> - Columns, within the 9 storey factory, appear to be stressed in excess of normal design limits | All loads, including equipment, garments and personnel, at each floor level, except ground floor, are to be reduced to 2.0kN/m <sup>2</sup> pending completion of this design check. (equivalent 1 to 1.2m high of loose stacked garments or packed boxes) | <b>Immediate - Now</b> |
| 2 | <b>Garment Factory</b> - Columns, within the 9 storey factory, appear to be stressed in excess of normal design limits | Detail Engineering Assessment of as built structure to be commenced as per attached scope. | <b>Immediate - Now</b> |
| 3 | <b>Garment Factory</b> - Columns, within the 9 storey factory, appear to be stressed in excess of normal design limits | Verify insitu concrete strengths and existing reinforcement for all columns | <b>Immediate - Now</b> |

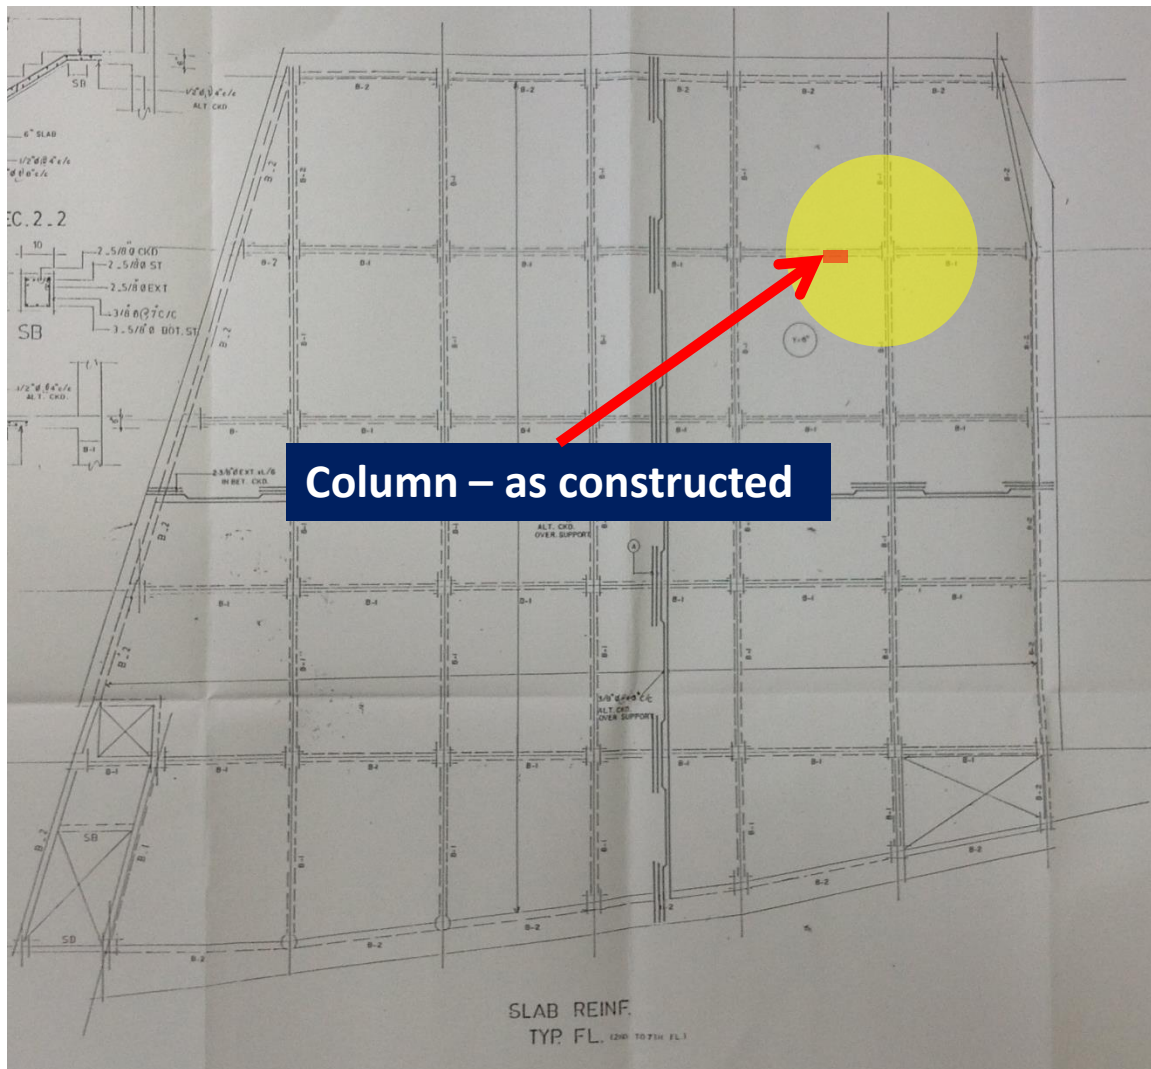
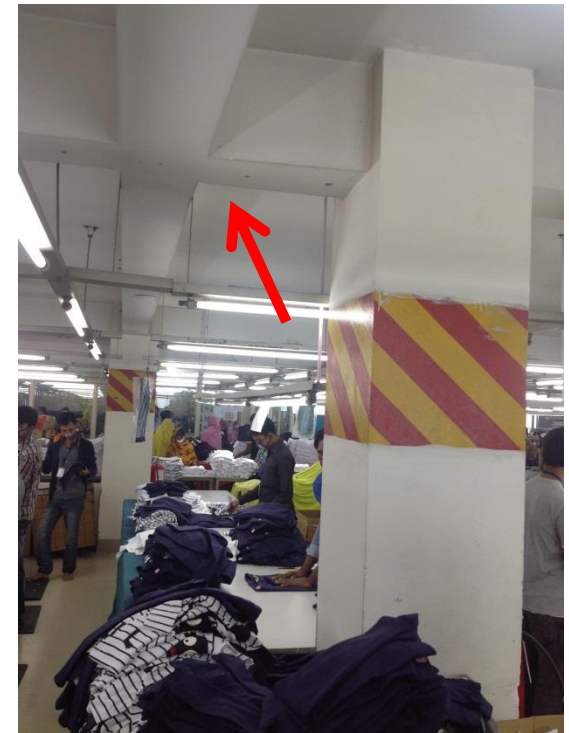
Column at South West of building

**Column at South West of building plan is not  
constructed at the location shown on the  
structural drawings**

The column is not constructed in the center of two beams

| Item No. | Observation | Recommended Action Plan | Recommended Timeline |
|---|---|---|---|
| 7 | <b>Garment Factory</b> - Column at south west of building plan is not constructed at the location shown on the structural drawings | Building Engineer to survey column locations and compare with structural drawings to identify this and any other discrepancies in column locations between the design and as- built structure. (refer to item 1 – Detail Engineering Assessment) | <b>6-weeks</b> |
| 8 | <b>Garment Factory</b> - Column at south west of building plan is not constructed at the location shown on the structural drawings | Building Engineer to review the design calculations and confirm that the design corresponds with the as-built structure. | <b>6-months</b> |
| 9 | <b>Garment Factory</b> - Column at south west of building plan is not constructed at the location shown on the structural drawings | Layout and structural drawings to be updated | <b>6-months</b> |

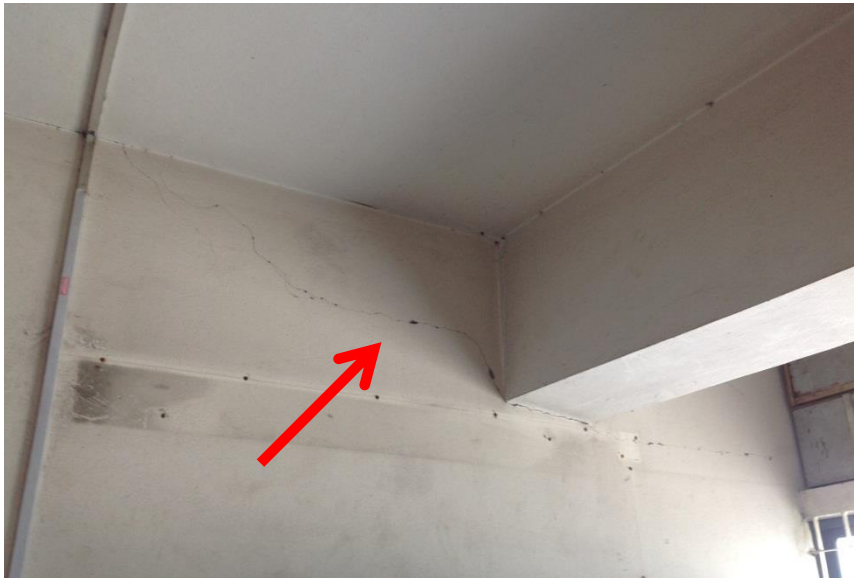
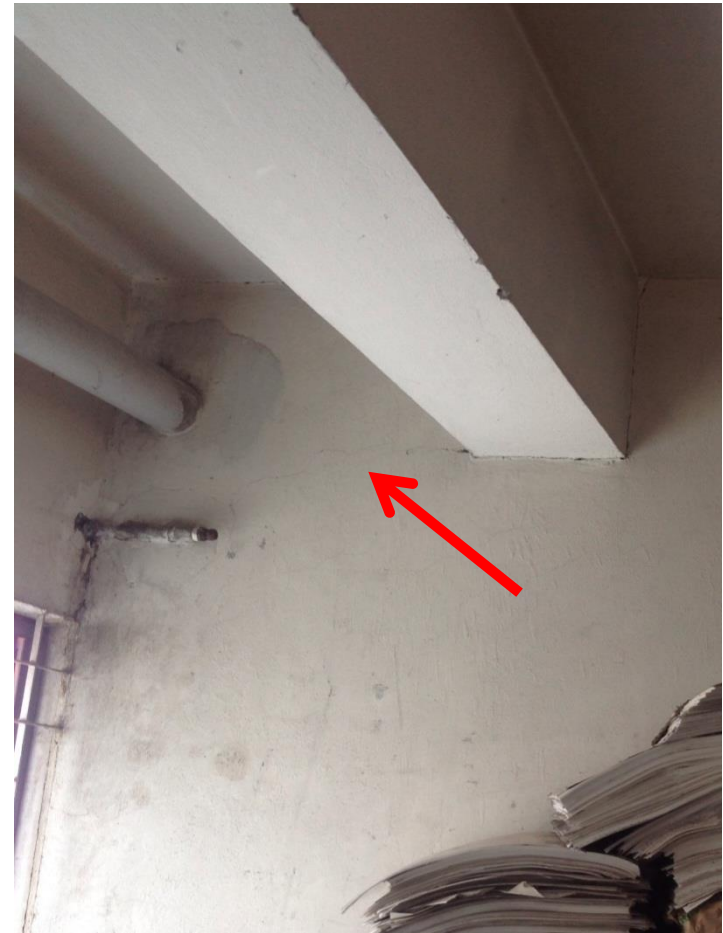
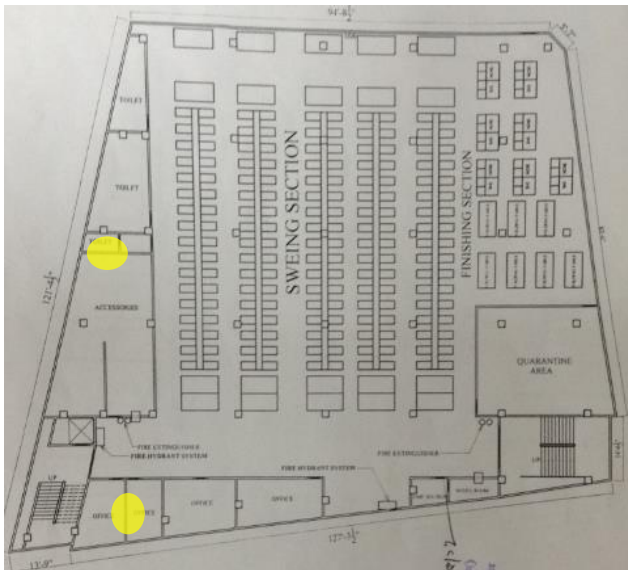
**Brick wall on 7<sup>th</sup> floor**

# **Cracking in internal brick wall on 7<sup>th</sup> and 5<sup>th</sup> floors at interface points with reinforced concrete beams above**

**Cracking in internal brick wall at points highlighted in yellow on 7<sup>th</sup> floor**

| Item No. | Observation | Recommended Action Plan | Recommended Timeline |
|---|---|---|---|
| 12 | <b>Garment Factory</b> - Cracking in internal brick wall on 7th and 5th floors at interface points with reinforced concrete beams above | Sections of plaster finish to wall to be removed and extent of crack to be reviewed by Building Engineer | <b>6-months</b> |

| Item No. | Observation | Recommended Action Plan | Recommended Timeline |
|---|---|---|---|
| 13 | <b>Garment Factory</b> - Cracking in internal brick wall on 7th and 5th floors at interface points with reinforced concrete beams above | Building Engineer to confirm that wall and floor slab structure above act separately | 6-months |
| 14 | <b>Garment Factory</b> - Cracking in internal brick wall on 7th and 5th floors at interface points with reinforced concrete beams above | Remedial works to be completed including isolation of structure from brick wall | 6-months |

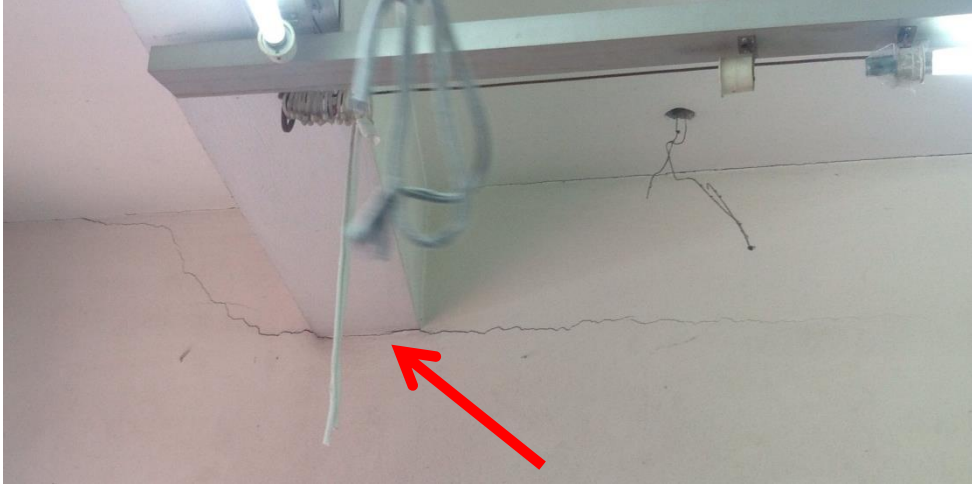
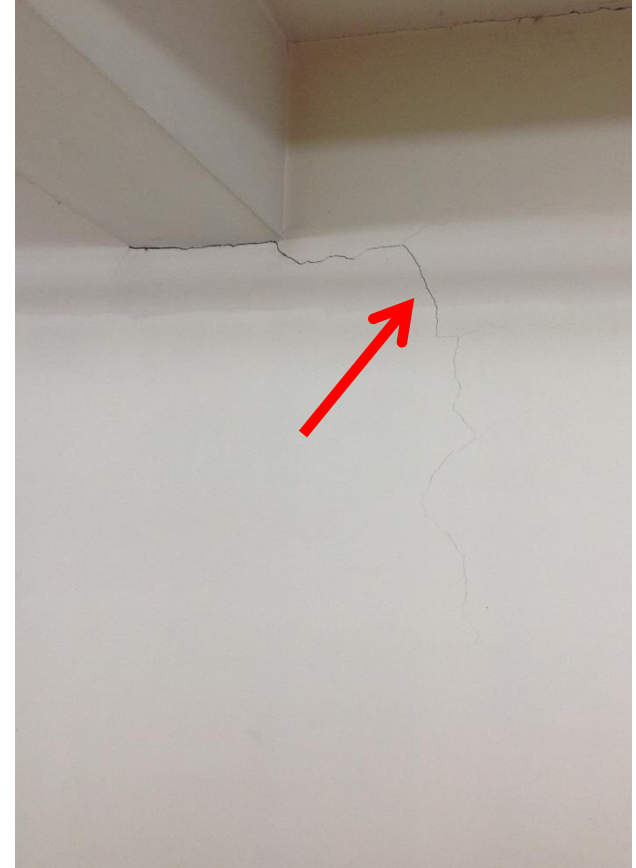
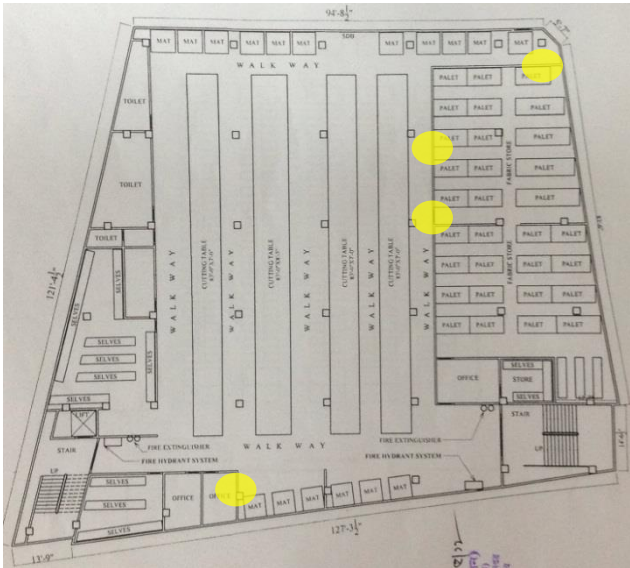
**Brick wall on 5<sup>th</sup> floor**

**Cracking pattern to internal brick wall at points highlighted in yellow on 5<sup>th</sup> floor**

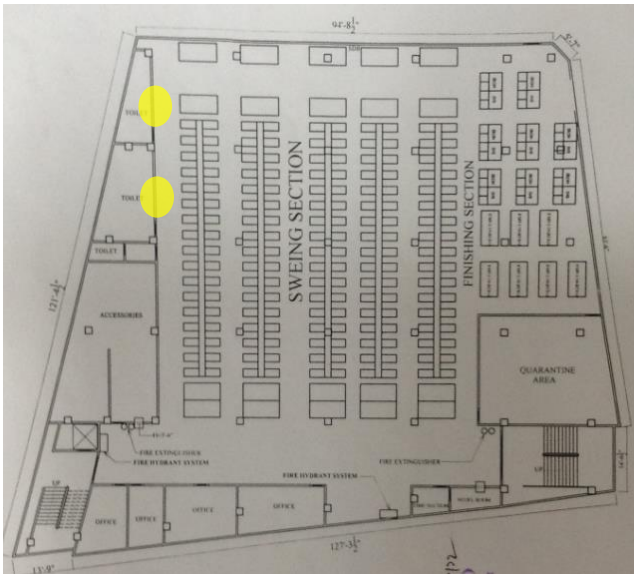
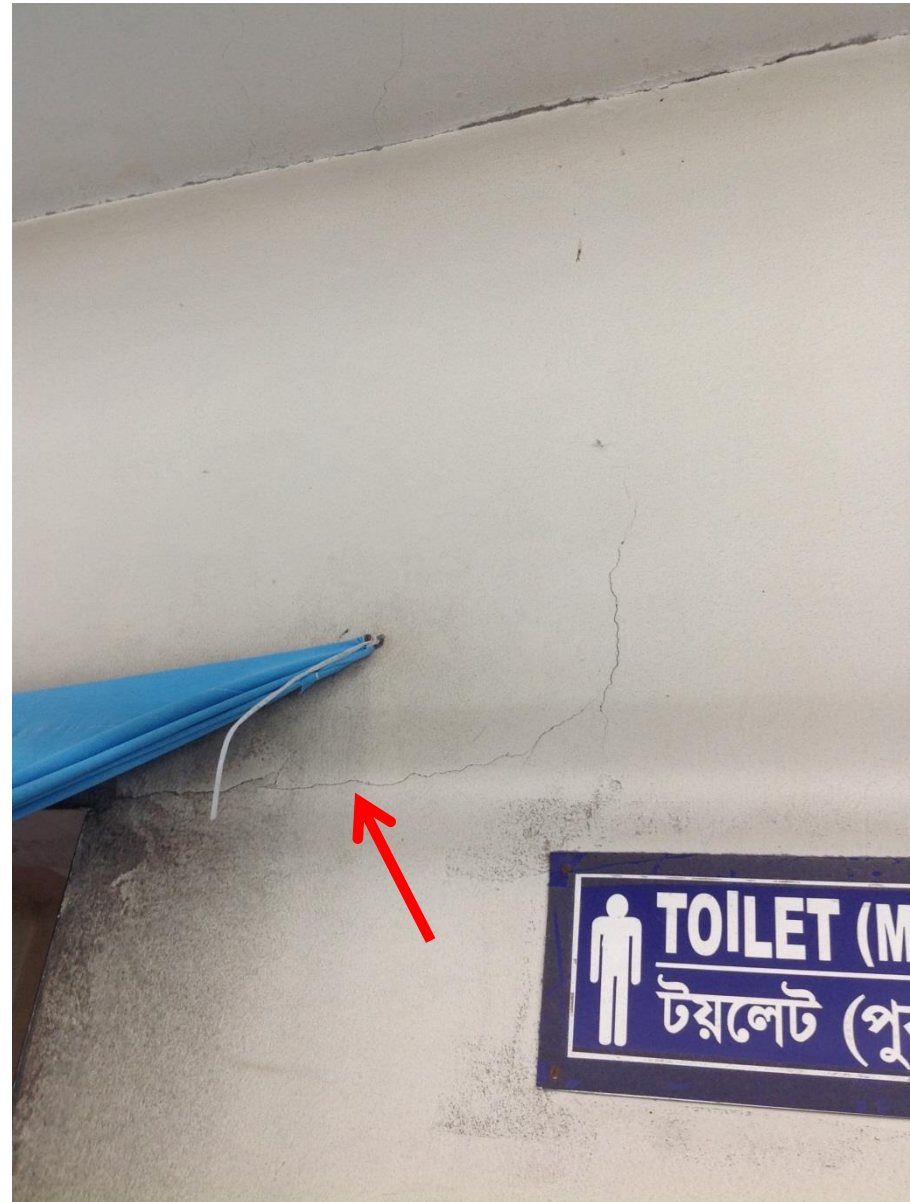
**Brick wall on 6<sup>th</sup> floor**

**Cracking to internal brick wall  
at points highlighted in yellow  
on 6<sup>th</sup> floor**

| Item No. | Observation | Recommended Action Plan | Recommended Timeline |
|---|---|---|---|
| 15 | <b>Garment Factory</b> - Cracking in internal brick wall on ground floor and 6th floor | Sections of plaster finish to wall to be removed, extent and cause of crack to be reviewed by Building Engineer | 6-months |
| 16 | <b>Garment Factory</b> - Cracking in internal brick wall on ground floor and 6th floor | Remedial works to be completed including isolation of structure from brick wall | 6-months |

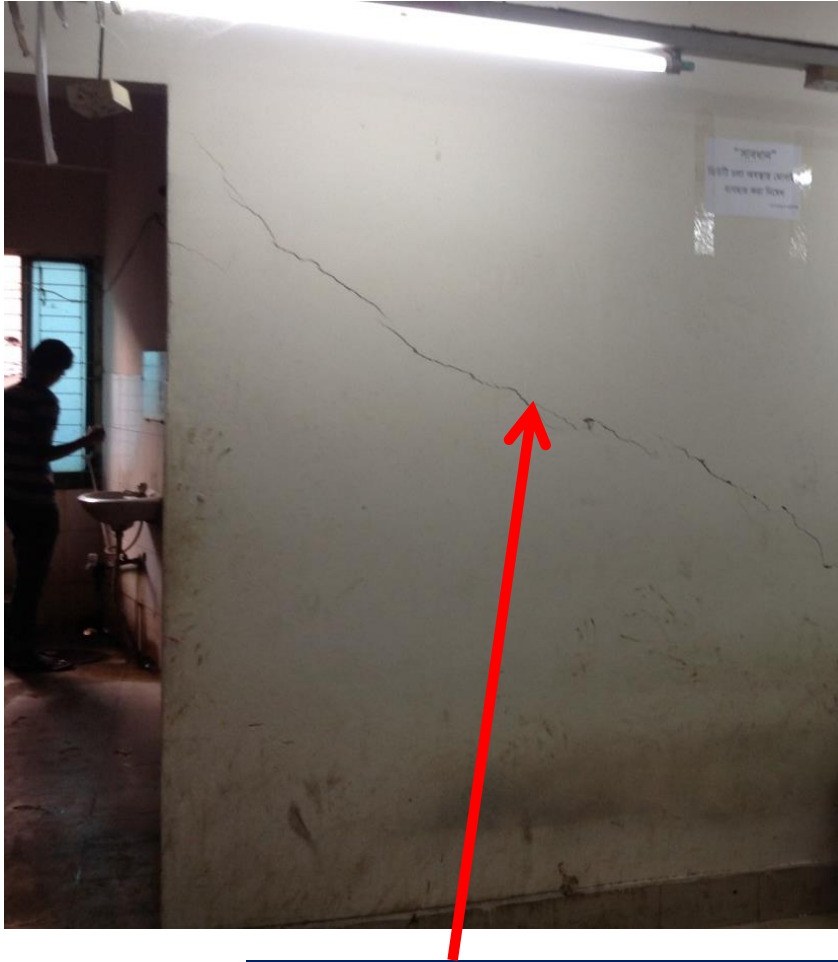
**Brick wall on ground floor**

**Cracking to internal brick wall  
on ground floor**

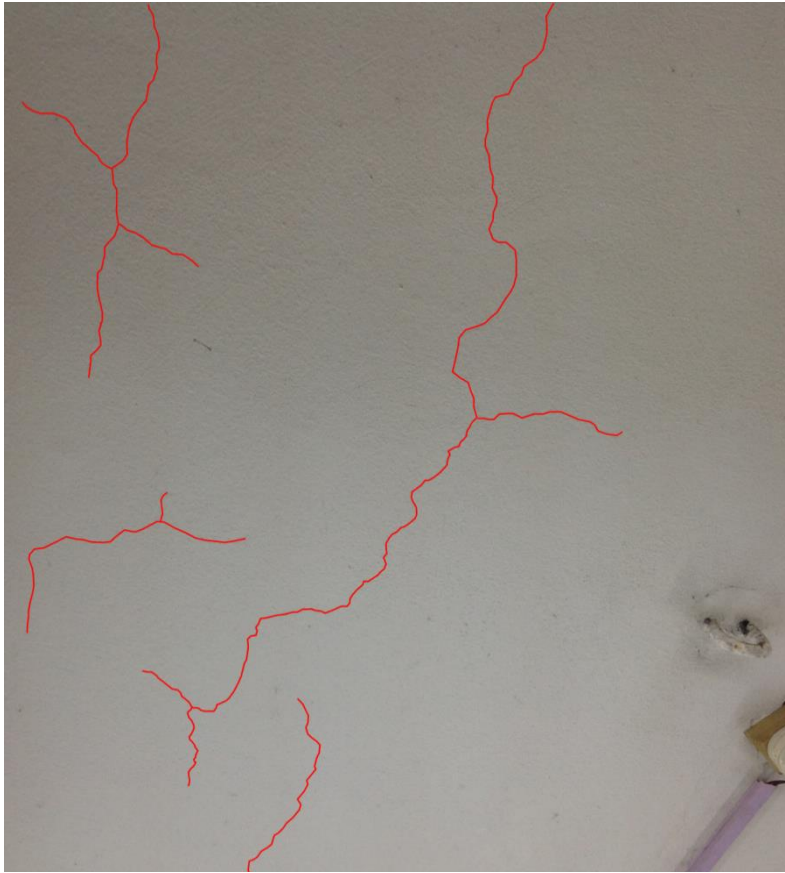
**Crack in slab – u/side 8<sup>th</sup> floor**

| Item No. | Observation | Recommended Action Plan | Recommended Timeline |
|---|---|---|---|
| 17 | <b>Garment Factory</b> - Cracking to concrete beams and slabs on the underside of 4th, 5th, 6th, 7th and 8th floors | Sections of plaster finish to beams and slabs to be removed to investigate if cracks penetrate the building structure. | 6-months |
| 18 | <b>Garment Factory</b> - Cracking to concrete beams and slabs on the underside of 4th, 5th, 6th, 7th and 8th floors | Building Engineer to carry out design check on beams and slab to confirm that these cracks are non-structural. (refer to item 1 – Detail Engineering Assessment) | 6-months |

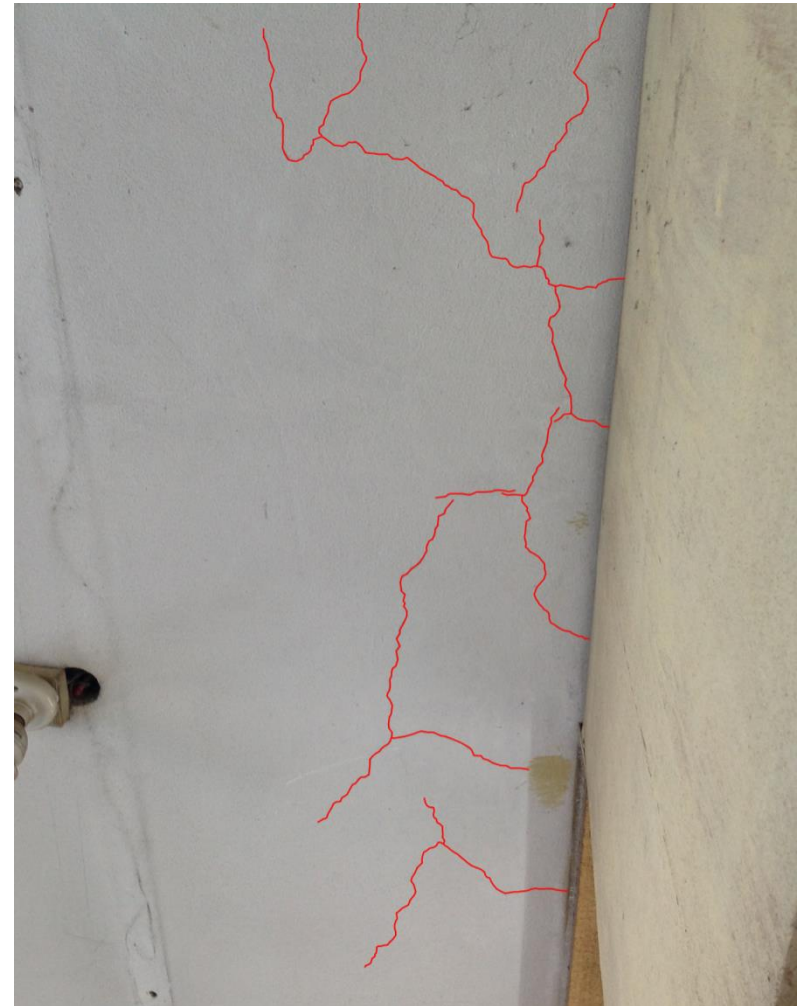
**Crack in slab – u/side 5<sup>th</sup> floor**

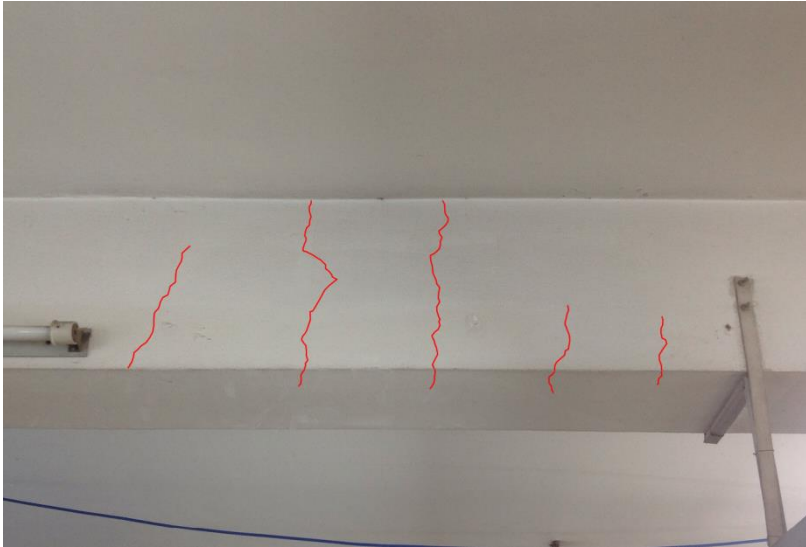
**Crack in beam – u/side 4<sup>th</sup> floor**

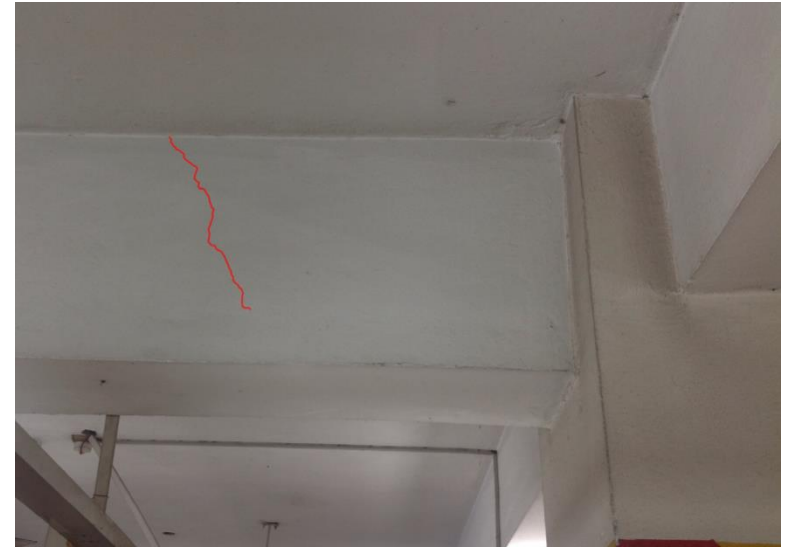
**Crack in beam – u/side 8<sup>th</sup> floor**

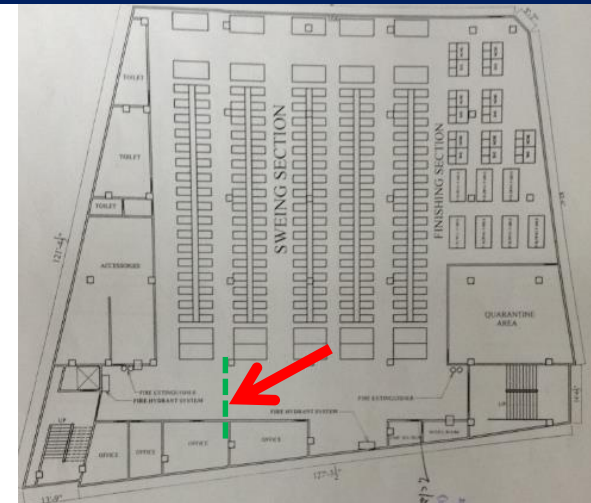
## Crack in beams

**Cracking pattern to concrete beams on the underside of 4<sup>th</sup>, 5<sup>th</sup>, 6<sup>th</sup>, 7<sup>th</sup> and 8<sup>th</sup> floor slabs**

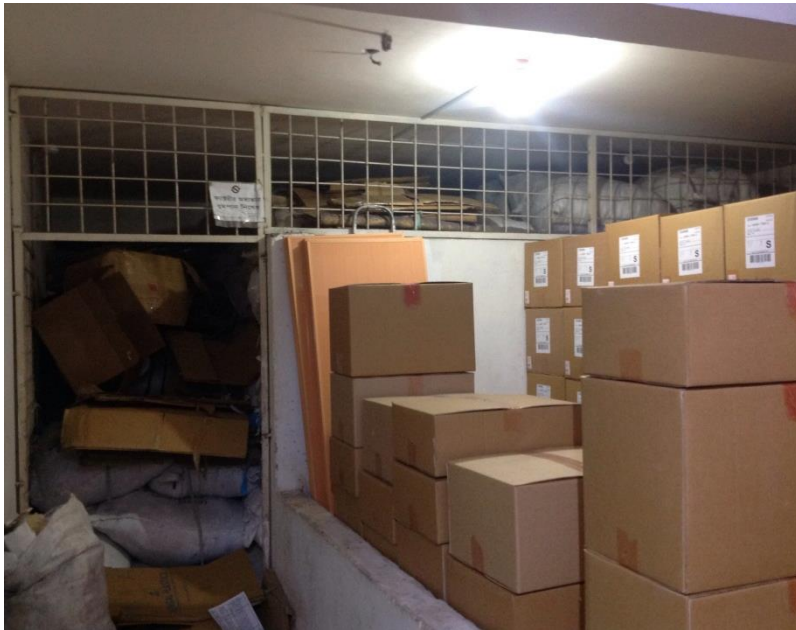
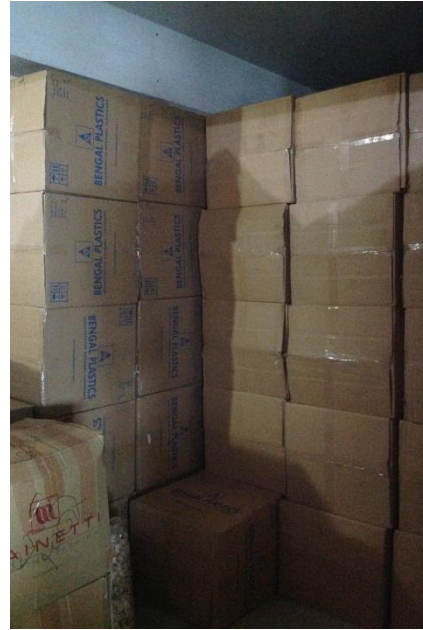
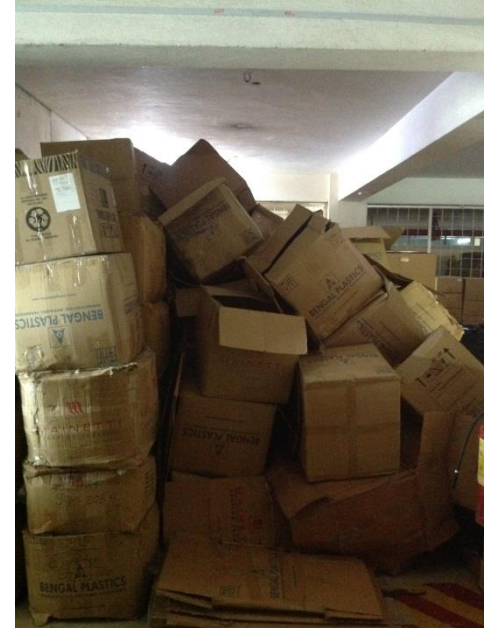
## 2<sup>nd</sup> Floor Storage loads

# Load management of storage loads on 2<sup>nd</sup> Floor

**Storage Loads**  
Plan and height restrictions to be introduced to prevent future overloading.

| Item No. | Observation | Recommended Action Plan | Recommended Timeline |
|---|---|---|---|
| 10 | <b>Garment Factory</b> - Load management of storage loads on 2nd Floor | Produce and actively manage a loading plan for all floor plates within the factory giving consideration to floor capacity and column capacity. (Refer to Item 1) | <b>6-weeks</b> |
| 11 | <b>Garment Factory</b> - Load management of storage loads on 2nd Floor | Continue to implement load management plan | <b>6-months</b> |

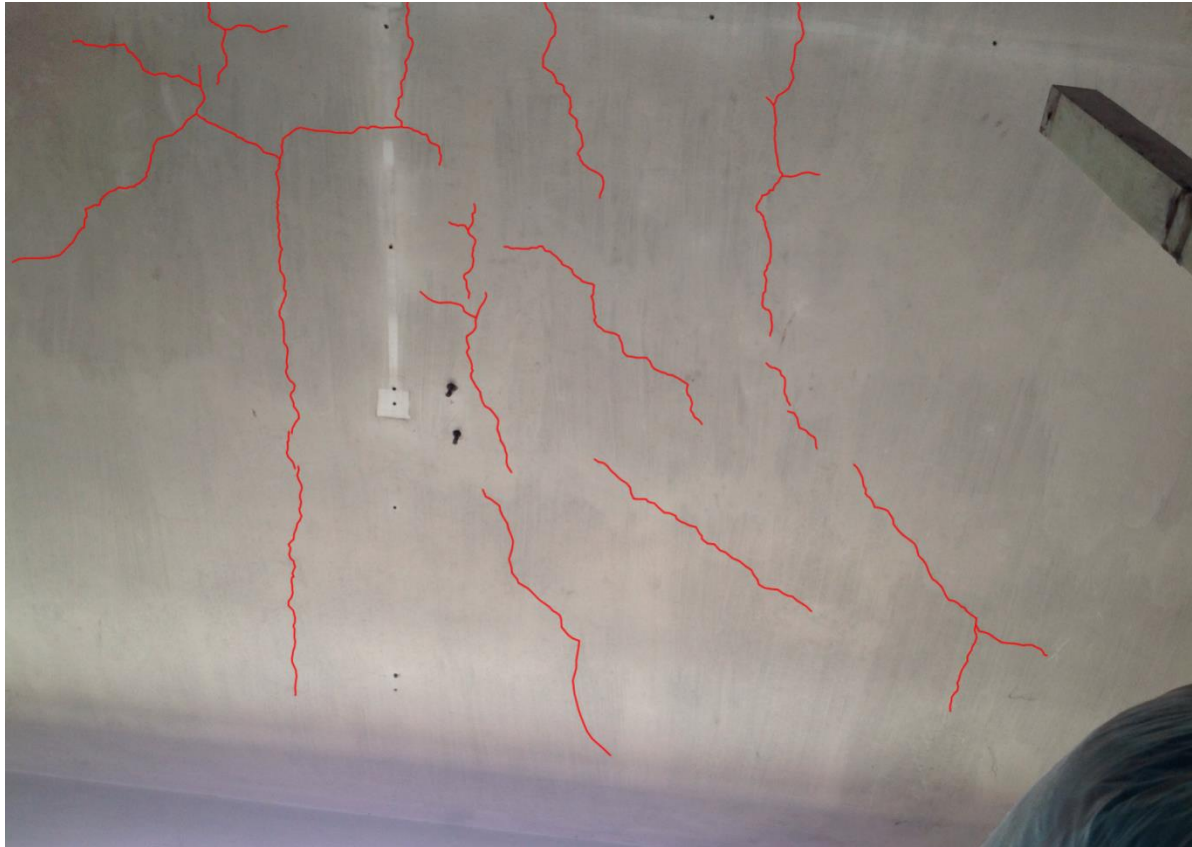
## **Slab Cracks**

# **Cracking to concrete slab on the underside of 2<sup>nd</sup> floor**

**Cracking pattern to concrete slab –  
u/side 2nd floor**

| Item No. | Observation | Recommended Action Plan | Recommended Timeline |
|---|---|---|---|
| 23 | <b>Knitting Building &amp; Fabric Store Building</b> - Cracking to concrete slab on the underside of 2nd floor | Sections of plaster finish to slab to be removed to investigate if cracks penetrate the building structure. | <b>6-months</b> |

| Item No. | Observation | Recommended Action Plan | Recommended Timeline |
|---|---|---|---|
| 24 | <b>Knitting Building &amp; Fabric Store Building</b> - Cracking to concrete slab on the underside of 2nd floor | Building Engineer to carry out design check on slab to confirm that these cracks are non-structural. | 6-months |
| 25 | <b>Knitting Building &amp; Fabric Store Building</b> - Cracking to concrete slab on the underside of 2nd floor | Building Engineer to prepare Allowable Floor Loading Plans | 6-months |

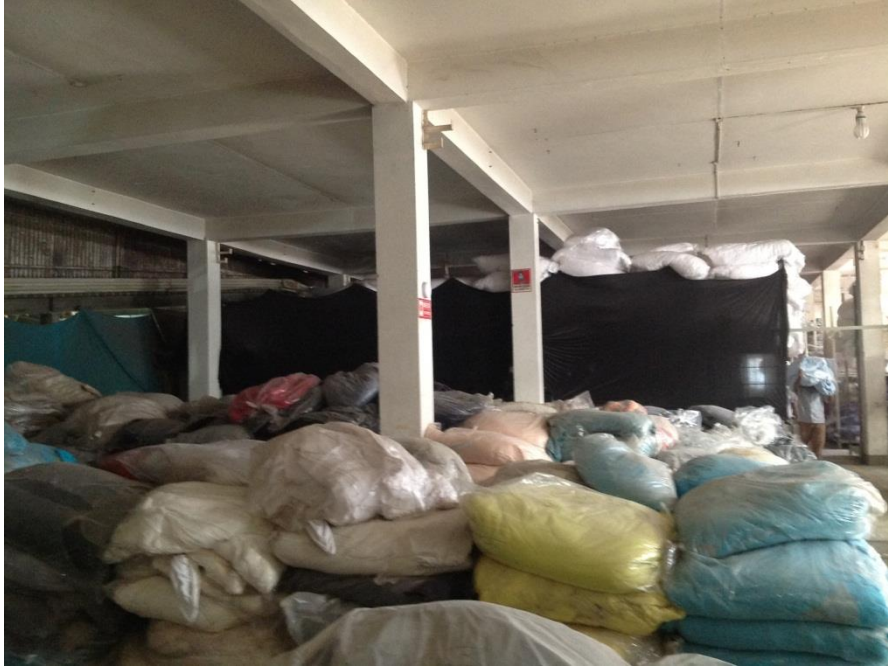
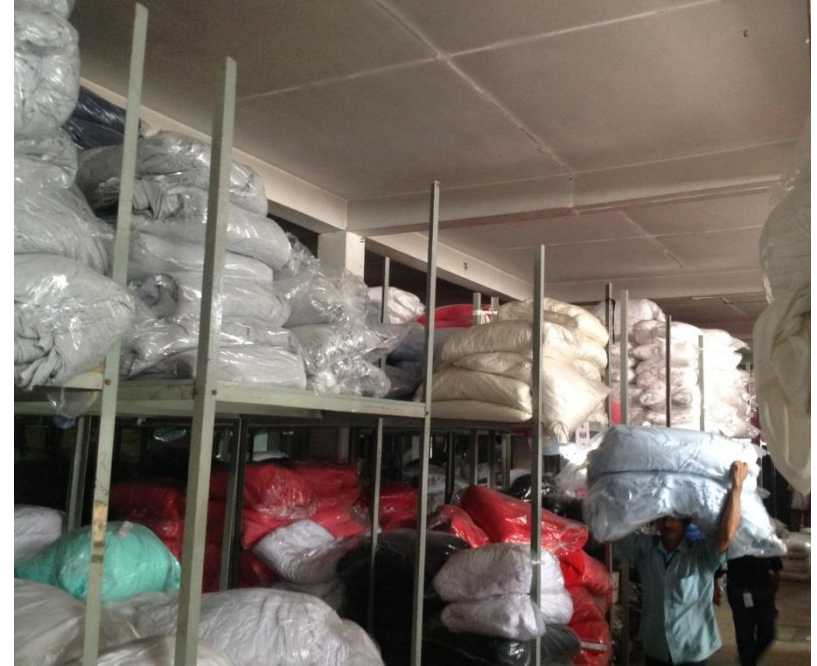
## **1<sup>st</sup> Floor Storage loads**

# Load management of storage loads on 1<sup>st</sup> Floor

**Storage Loads**  
Plan and height restrictions to be introduced to prevent future overloading.

| Item No. | Observation | Recommended Action Plan | Recommended Timeline |
|---|---|---|---|
| 21 | <b>Knitting Building &amp; Fabric Store Building</b> - Load management of storage loads on 1st Floor | Produce and actively manage a loading plan for all floor plates within the Knitting Building & Fabric Store Building giving consideration to floor capacity and column capacity. | <b>6-weeks</b> |
| 22 | <b>Knitting Building &amp; Fabric Store Building</b> - Load management of storage loads on 1st Floor | Continue to implement load management plan | <b>6-months</b> |

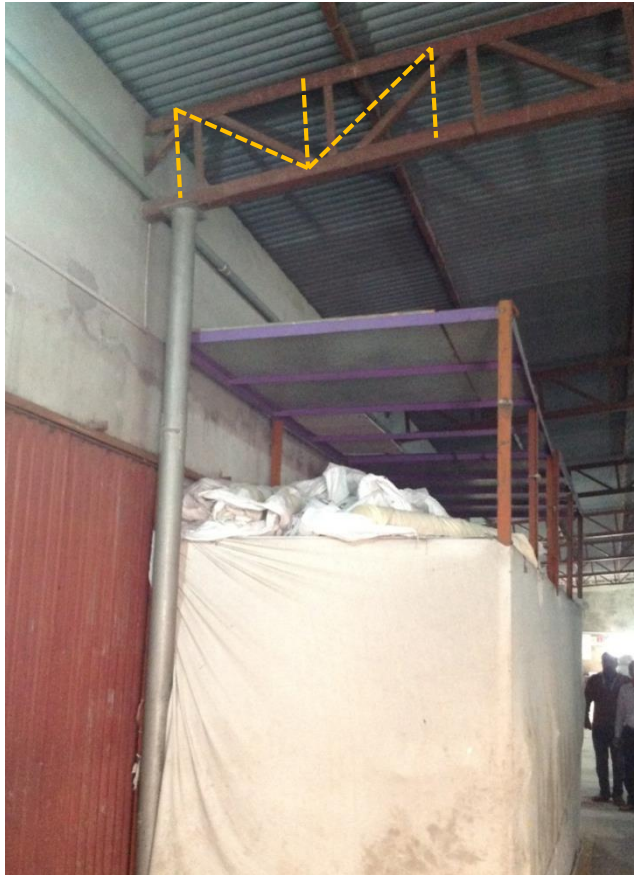
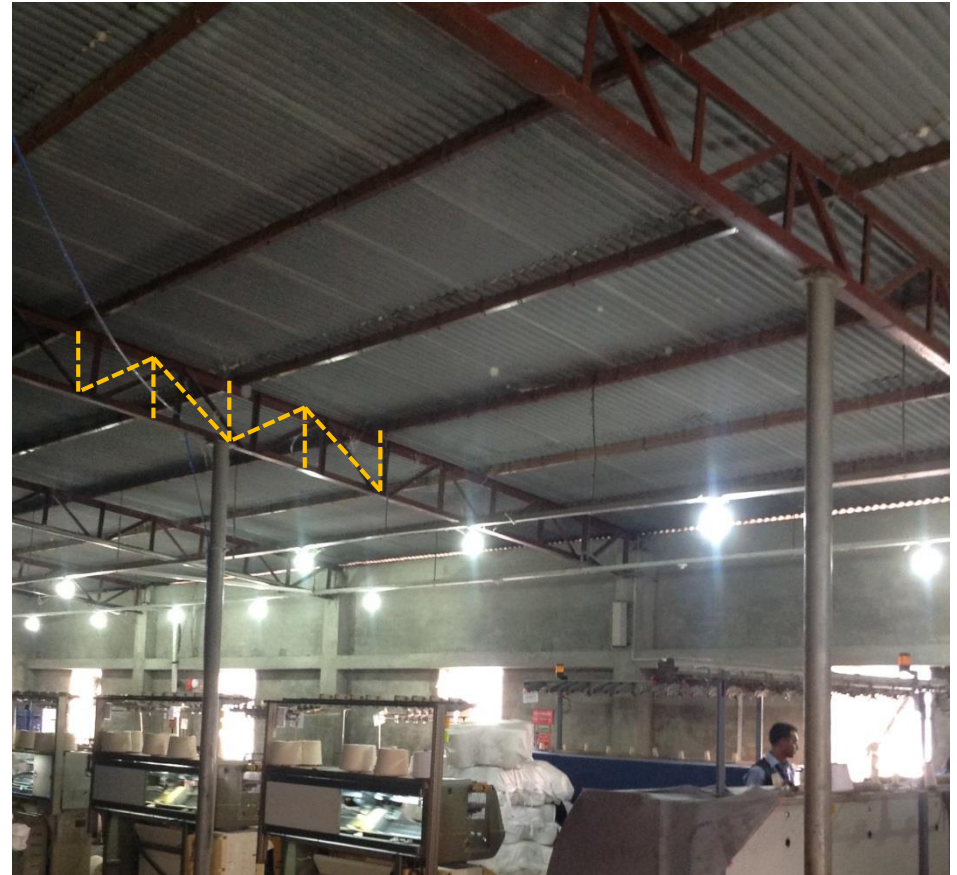
## **Steel Roof to Knitting Section**

**Check required to confirm that steel roof structure is adequate to resist high wind loads**

**Lightweight roof steel structure over Knitting Section on the 2<sup>nd</sup> floor is not shown on the structural design drawings  
No obvious stability system. Roof truss column support offset from node.**

| Item No. | Observation | Recommended Action Plan | Recommended Timeline |
|---|---|---|---|
| 20 | <b>Knitting Building &amp; Fabric Store Building</b> - Check required to confirm that steel roof structure is adequate to resist high wind loads | The steel roof over the Knitting Building & Fabric Store Building should be designed by the Building Engineer and, if required, upgraded to support code vertical and wind loads or they should be vacated and removed. | <b>6-weeks</b> |

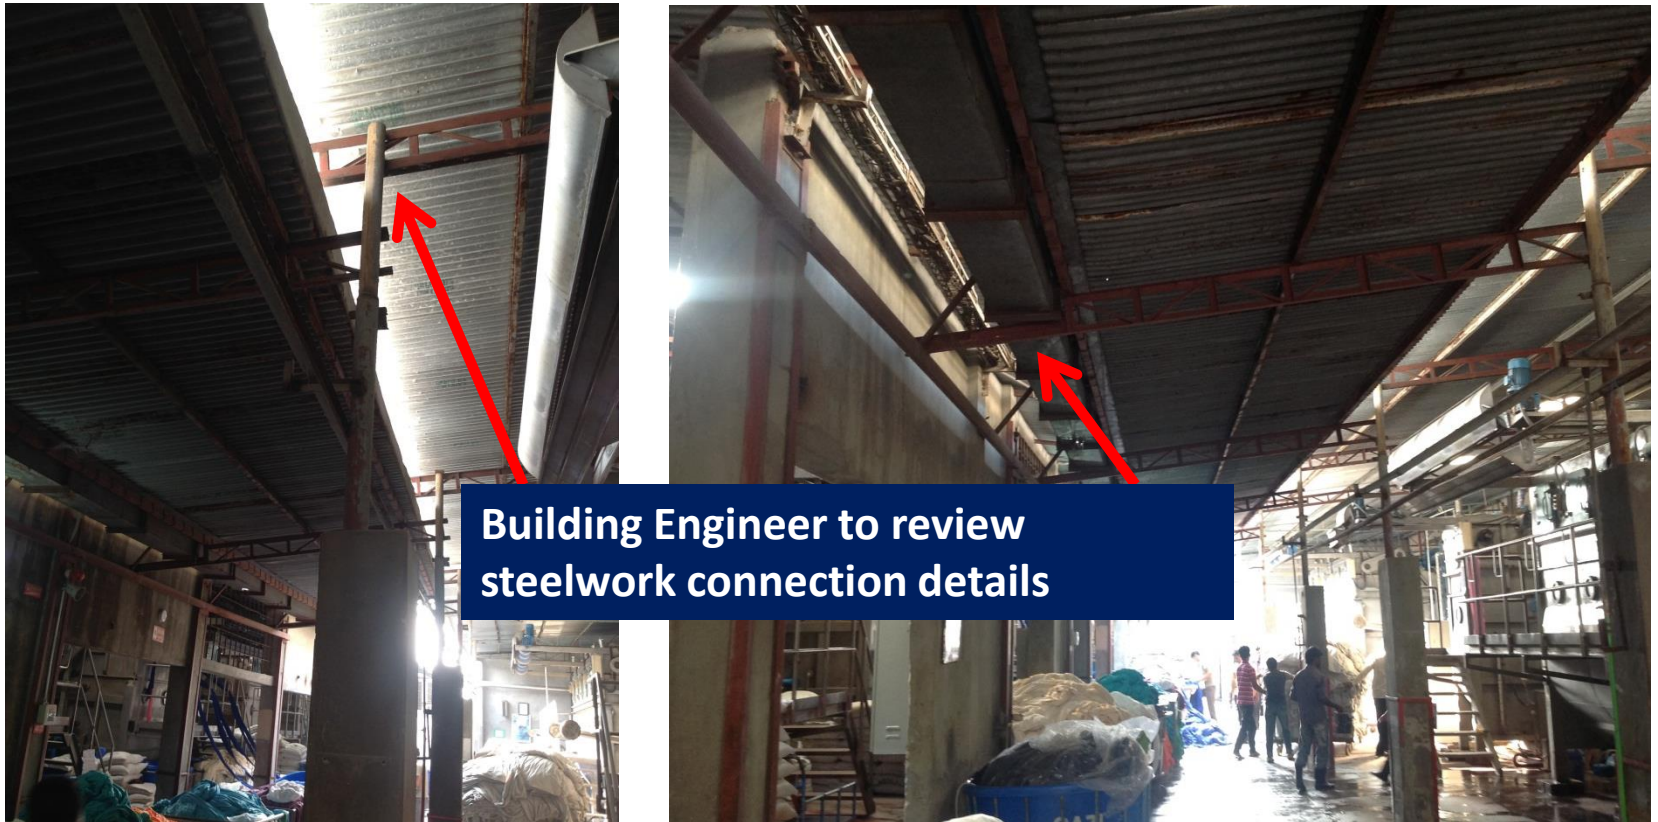
## **Steel Roof to Single Storey Sheds**

**Check required to confirm that steel roof structure is adequate to resist high wind loads**

**Lightweight roof steel structure over Single Storey Sheds is not shown in the structural design drawings  
No obvious stability system provided.**

| Item No. | Observation | Recommended Action Plan | Recommended Timeline |
|---|---|---|---|
| 26 | <b>Single Storey Sheds</b> - Check required to confirm that steel roof structure to the Single Storey Sheds is adequate to resist high wind loads | The steel roof over the Single Storey Sheds should be designed by the Building Engineer and, if required, upgraded to support code vertical and wind loads or they should be vacated and removed. | 6-weeks |
