# Chorka Textile Ltd. (New Building)

Kazichor, Danga, Polas, Norshingdi  
(23.898106, 90.574138)

28<sup>th</sup> September 2017

# Observations

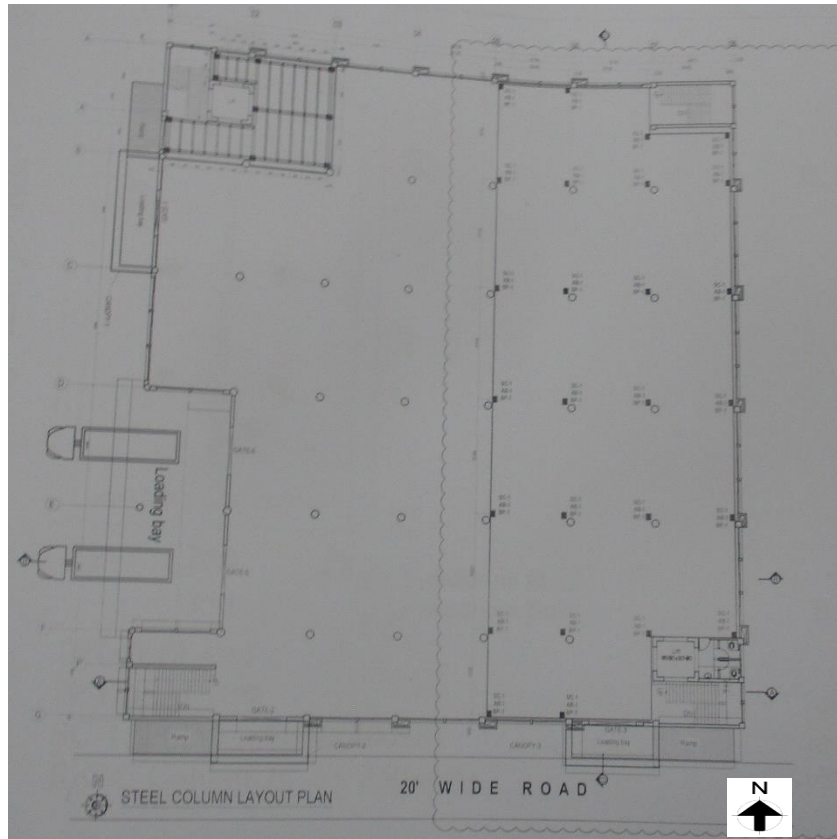
Steel column layout plan

**Discrepancies between provided drawings and on site condition for mezzanine portion.**

Column sizes are not match with provided as-built drawings. Flange widths were found 240 mm instead of 250 mm in some steel columns at mezzanine floor.

| Item No. | Observation | Recommended Action Plan | Recommended Timeline |
|---|---|---|---|
| 6 | Discrepancies between provided drawings and on site condition for mezzanine portion | Building Engineer to survey as-built structure and prepare accurate as-built survey information for steel part. | 6-weeks |

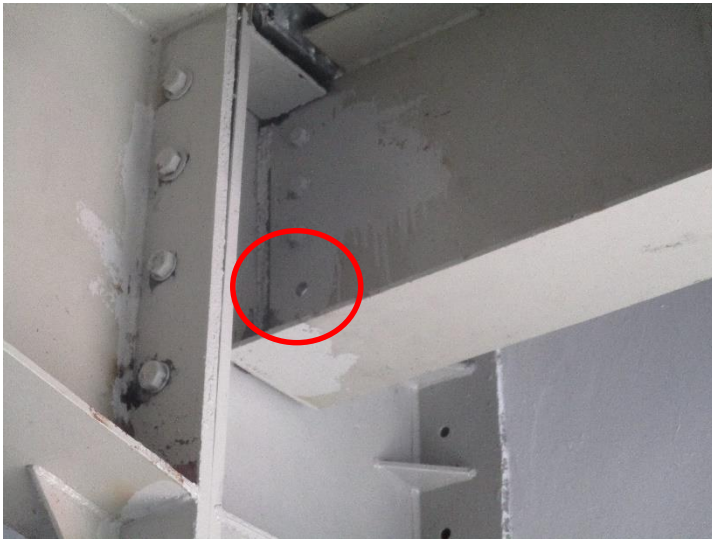
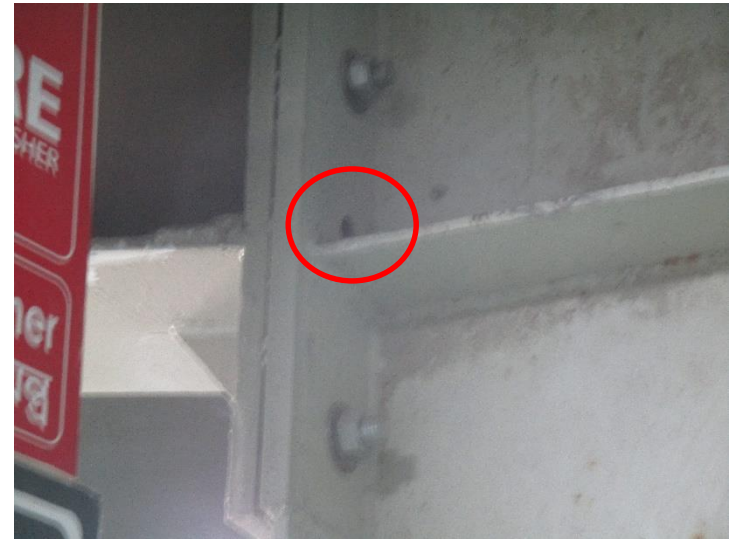
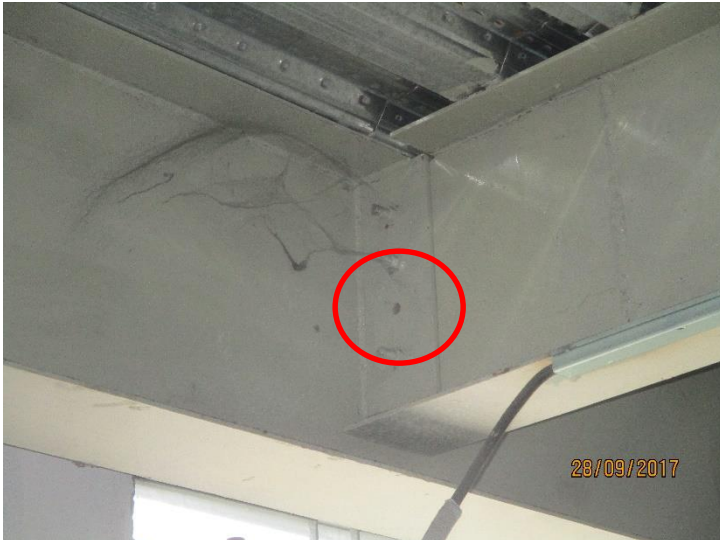
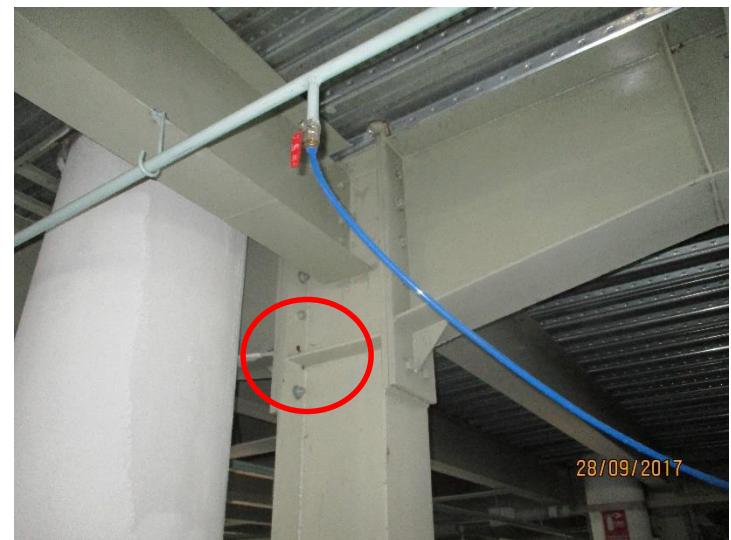
**Bolt missing**

Bolts were missing in several location at sub-beam & main beam connection.

| Item No. | Observation | Recommended Action Plan | Recommended Timeline |
|---|---|---|---|
| 7 | Bolt missing | Install missing bolts | 6-weeks |

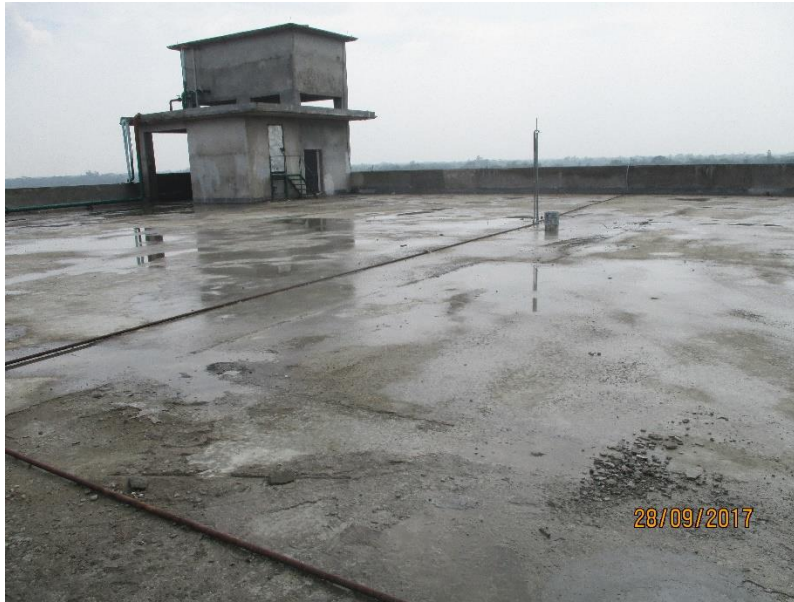
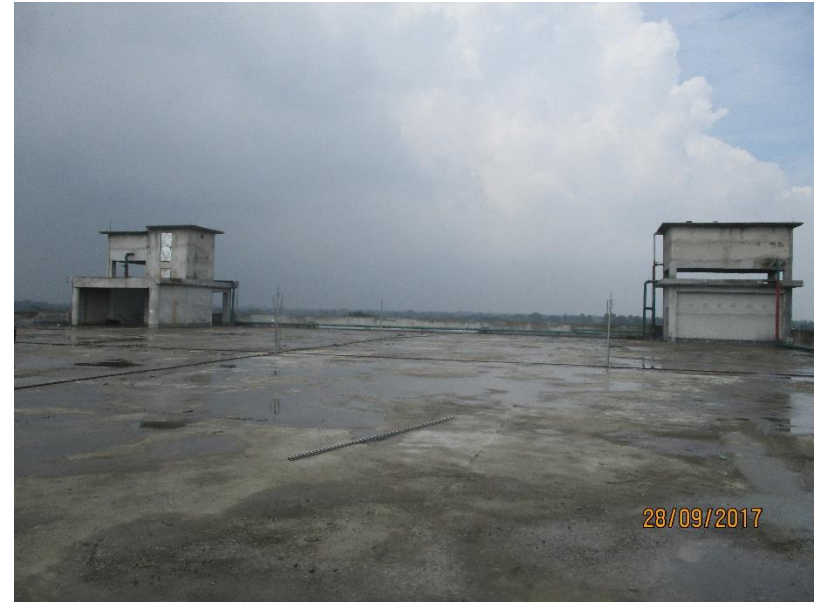
**Roof appears not to have any  
waterproofing system**

During inspection water ponding observed on roof. Factory engineer is required to check that roof finishes have been installed and roof is draining freely.

| Item No. | Observation | Recommended Action Plan | Recommended Timeline |
|---|---|---|---|
| 8 | Roof appears not to have any waterproofing system | Waterproofing on the roof slab is to be applied or improved. Moreover the roof slab drainage system should be investigated and improved. | 6-weeks |

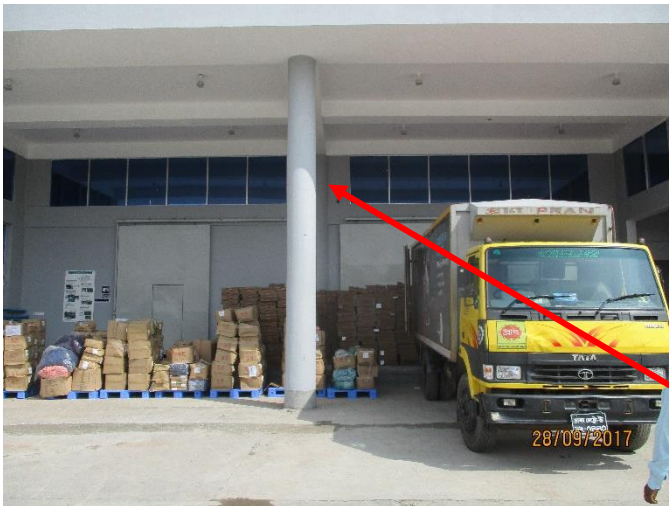
# Columns susceptible to have vehicle impact

Impact protection not provided to columns at loading – unloading area. Columns are susceptible to have impact loading from vehicles.

| Item No. | Observation | Recommended Action Plan | Recommended Timeline |
|---|---|---|---|
| 9 | Columns susceptible to have vehicle impact | Install a barrier to prevent vehicle impact on column | 6-weeks |
