# Jointex Fashion Wears Ltd. (Unit-3)

02, Hossain plaza, Matbar bari, Tanga bari, Ashulia, Savar, Dhaka  
(23.906263, 90.322926)

13<sup>th</sup> September 2017

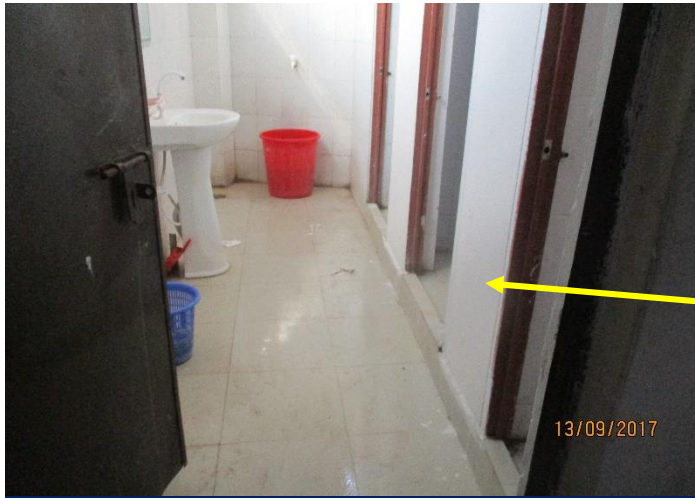
Toilet partition walls

Toilet build up in several floor.  
Max 200 mm

Cursory calculation indicates that Columns appears to be stressed above normal design limits.

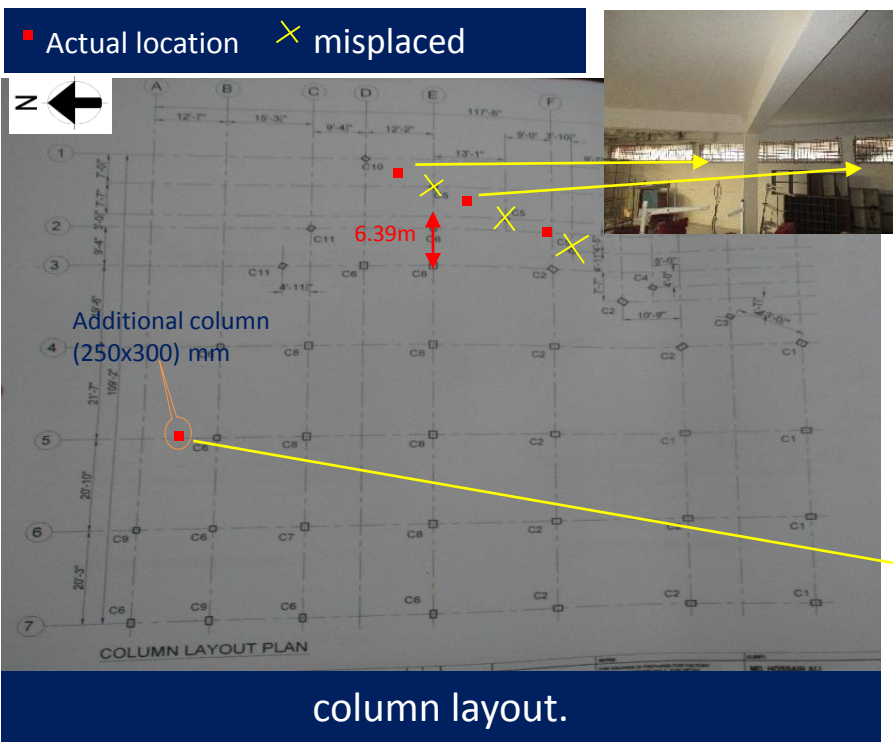
column layout.

Column size and nos. of rebar & rebars dia are not fully match with column schedule. Building engineer is required confirm the dia, size & nos. of rebar on each column.

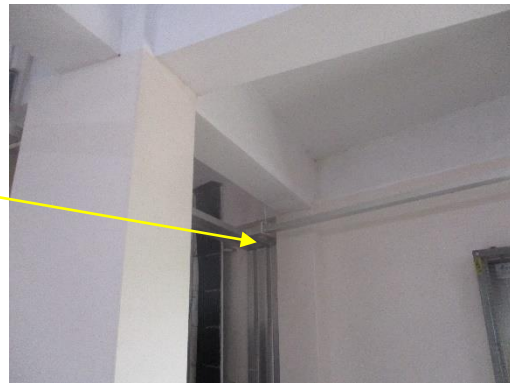
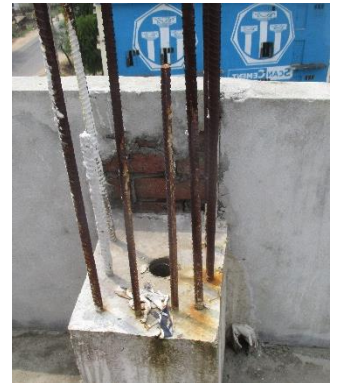
Grid dimension in between grid- 2 & 3 and position of columns at East didn't match with column layout. Also an additional column was found on grid 5. No foundation system is shown on drawings for the additional column. So the load path and foundation system of the column is required to investigate by factory engineer. Mismatches are shown in red on drawings.

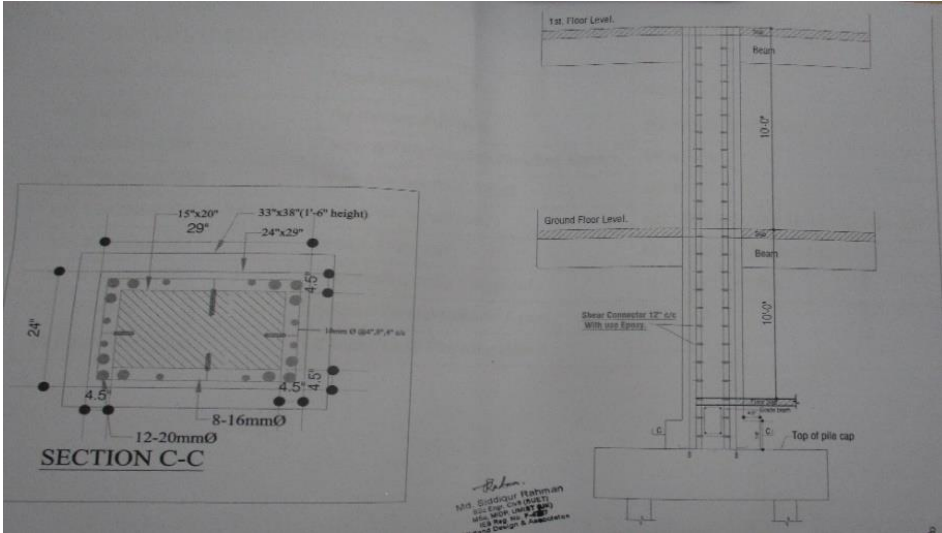
According to the provided DEA report, few columns and foundations are needed to be retrofitted. Factory has already carried out the remedial works. However few columns have found stressed above normal design limits. So DEA report is required to review by ACCORD.

7	Detail Engineering Assessment Report & Strengthening works need to be verified	Complete the review of Detail Engineering Assessment with Accord.	6-weeks
8	Detail Engineering Assessment Report & Strengthening works need to be verified	Verify the concrete strength used in retrofitting works	6-weeks
9	Detail Engineering Assessment Report & Strengthening works need to be verified	Complete remedial works arising from detail engineering assessment after reviewed by Accord.	6-months

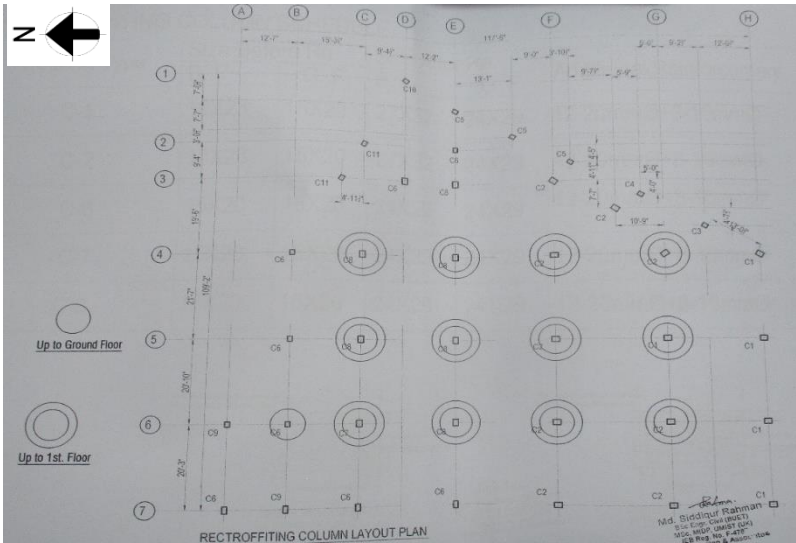
Retrofitting column schedule

No material strength specification were mentioned in retrofitting scheme. No material test report was available for retrofitting work.

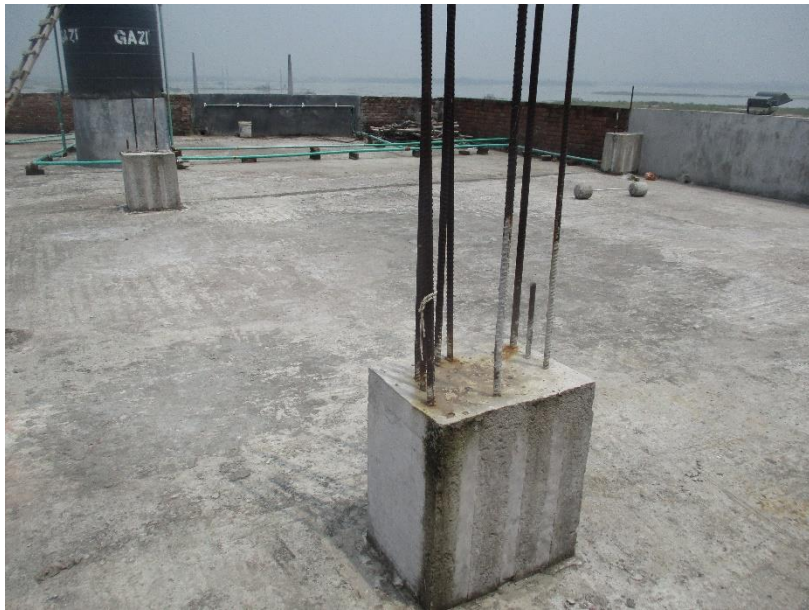
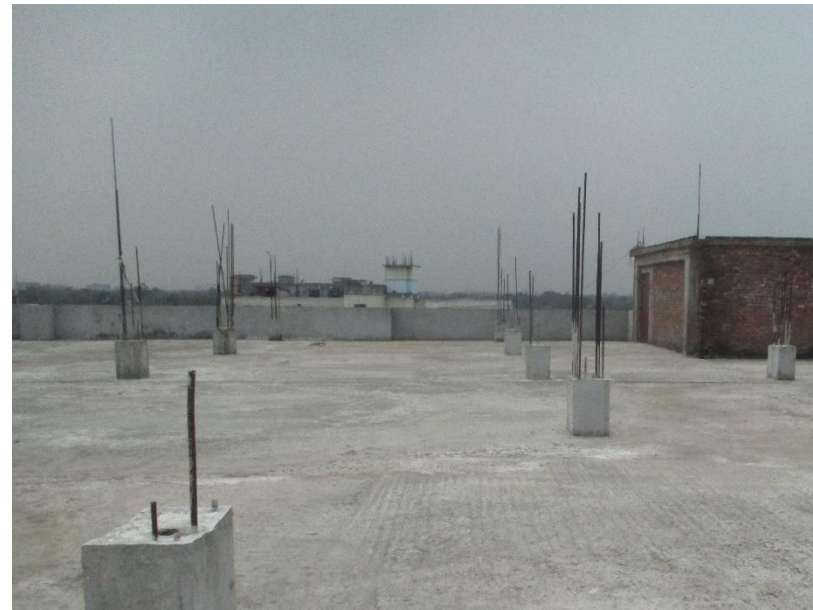
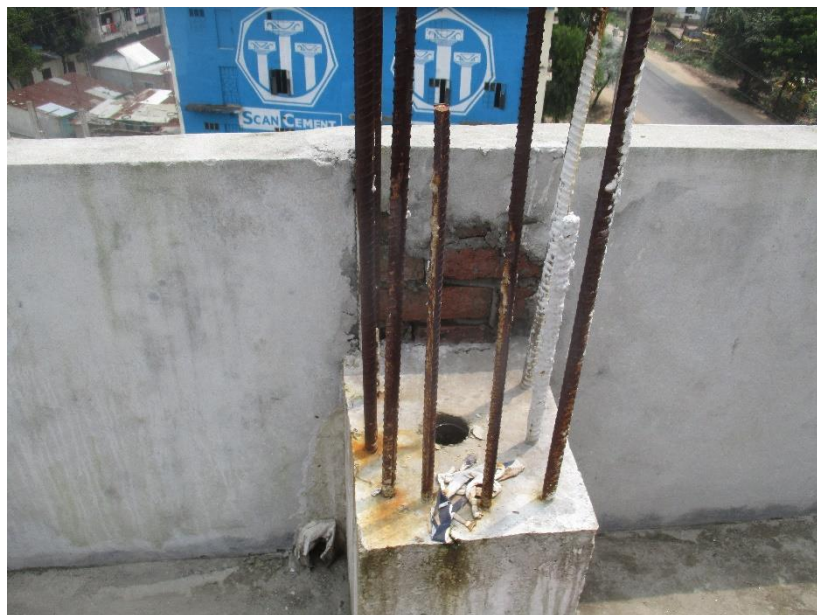
All exposed reinforcement must have adequate protection from the elements. Currently the exposed reinforcement is prone to corrosion.

Item No.	Observation	Recommended Action Plan	Recommended Timeline
10	No water proofing at roof	Waterproofing on the roof slab is to be applied. Moreover the roof slab drainage system should be investigated and improved	6-weeks
11	Protect reinforcement from corrosion	All exposed reinforcement is required to protect from corrosion which may cause degradation of the concrete	6-weeks
12	Cracks found on brick wall	Engage Building Engineer to investigate the cause of cracking in brickwork.	6-weeks
13	Cracks found on brick wall	Carry out repairs as directed by Building Engineer.	6-weeks
14	Unsupported masonry wall above door opening	Factory engineer to investigate the door opening under unsupported masonry wall and install lintel to support the wall	Immediate - Now
15	Lack of documents for utility structures	Prepare as-built drawings for utility structures	6-weeks
16	Apparently non-engineered shed (generator & sub-station)	Building engineer to check the capacity of the lightweight steel roof against lateral loading.	6-weeks

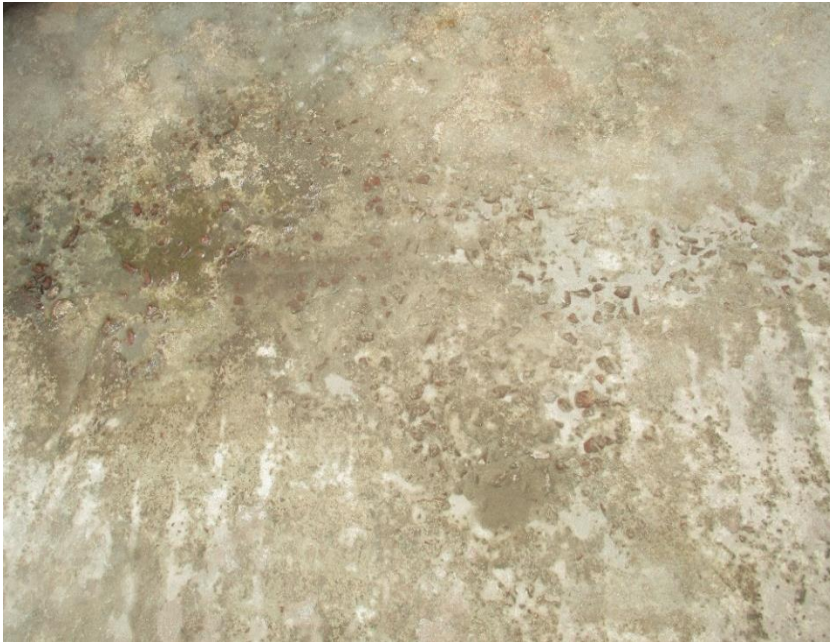
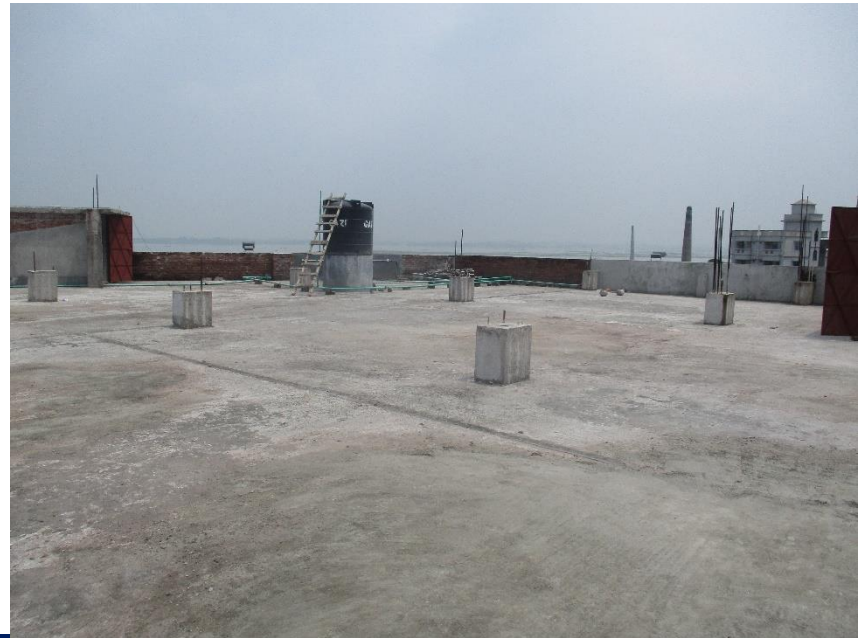
**No water proofing at roof**

Water proofing material hasn't been applied yet. We were informed by the factory management that a screed finish with slopes and proper drainage will be added.

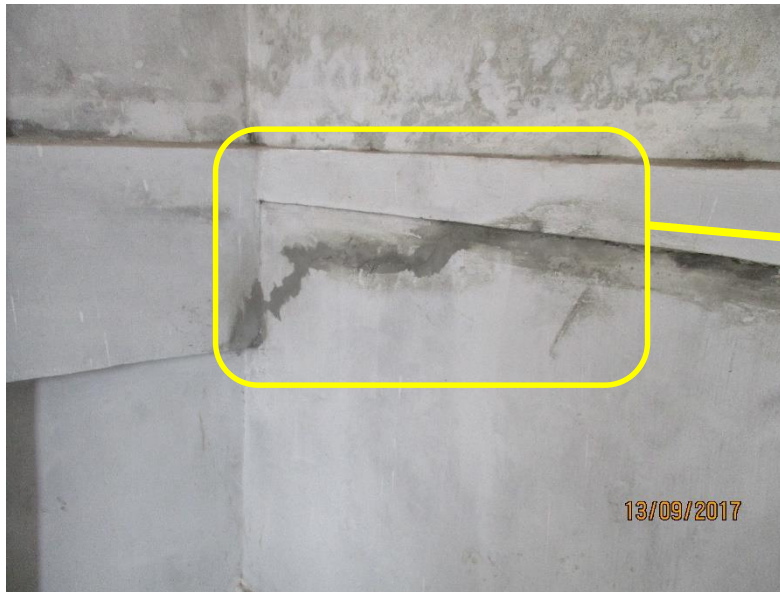
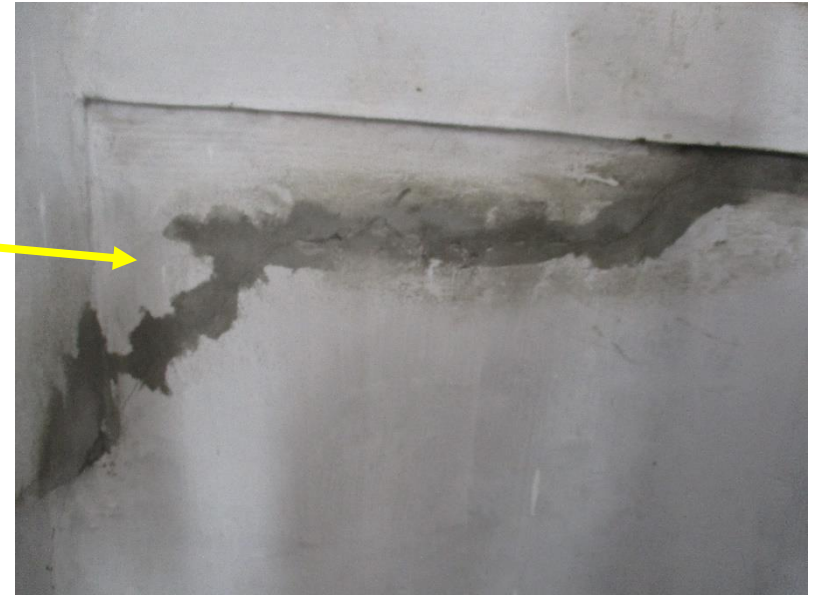
Diagonal cracks found on brick wall at North stair. Factory engineer is required to find the cause of cracking and suggest proper remediation procedure.

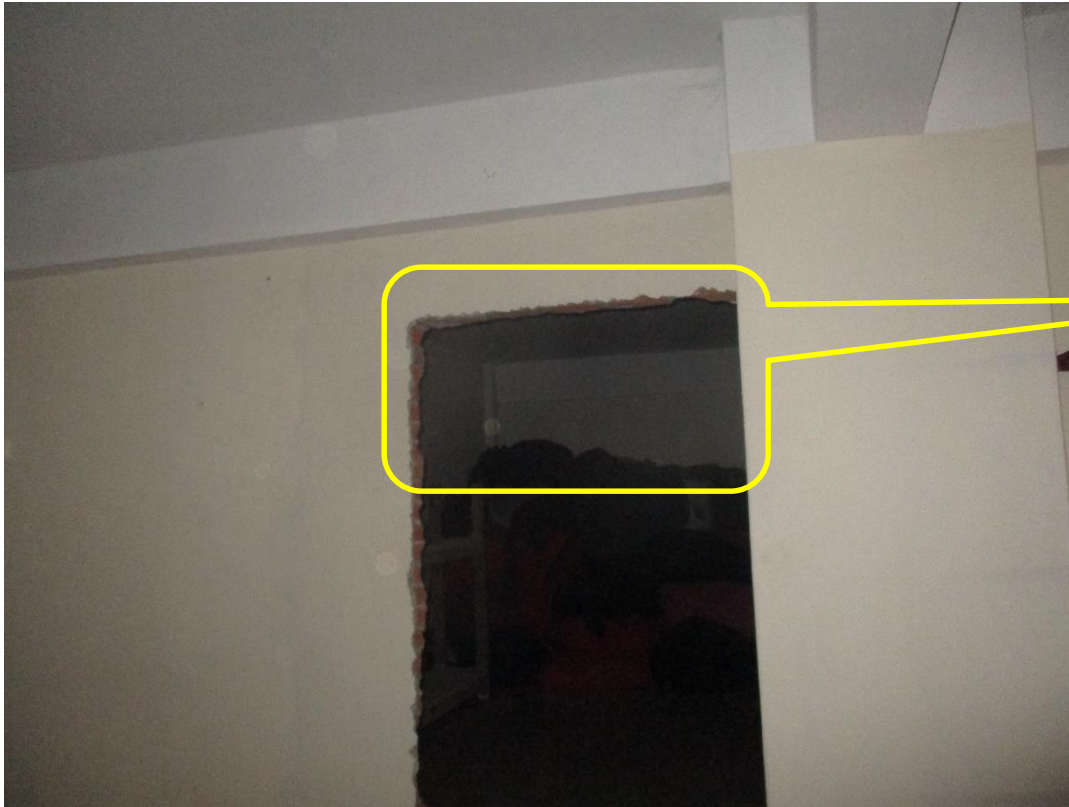
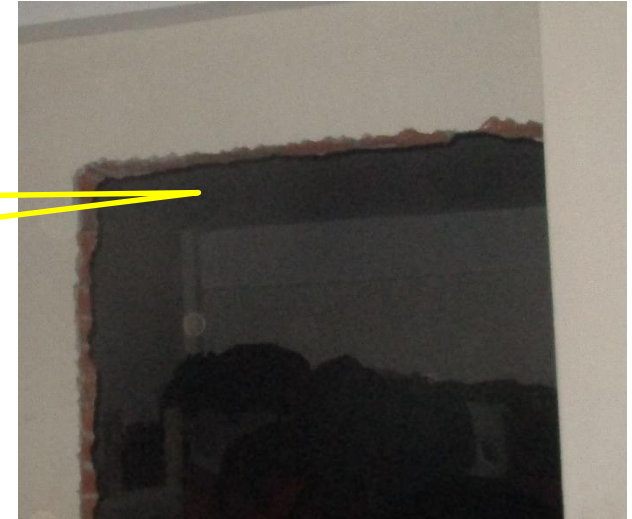
The masonry wall above door opening is not supported at basement floor. There is a probability of falling wall due to unsupported wall. Factory engineer is require to provide support the wall with proper load transfer system.

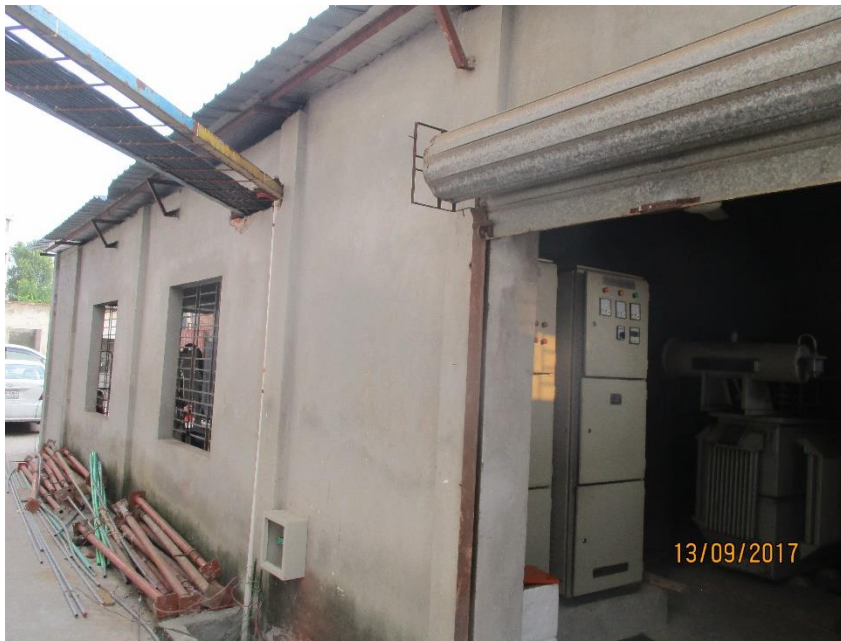
Utility Shed (Generator & Sub-station)

Structural and architectural drawings were not available for all utility structures.

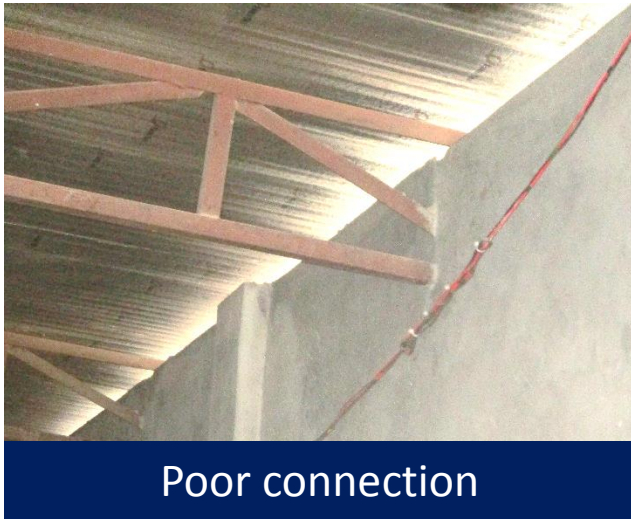
Apparently non-engineered shed. Poor connection between support and truss. Building engineer to check the stability of the lightweight steel roofs against lateral loading.

Poor connection

17	Apparently non-engineered shed (generator & sub-station)	Carry out remedial works resulting from engineering assessment if necessary.	6-months

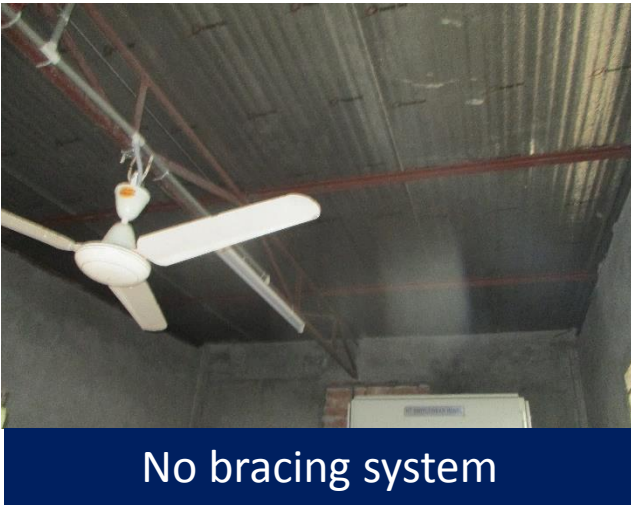
No bracing system
