# Natural Woolwear Ltd.

49/3, Bangabandhu Road, Charabag, Gouripur, Ashulia  
(23.894750N, 90.310454E)  
27<sup>th</sup> August 2017

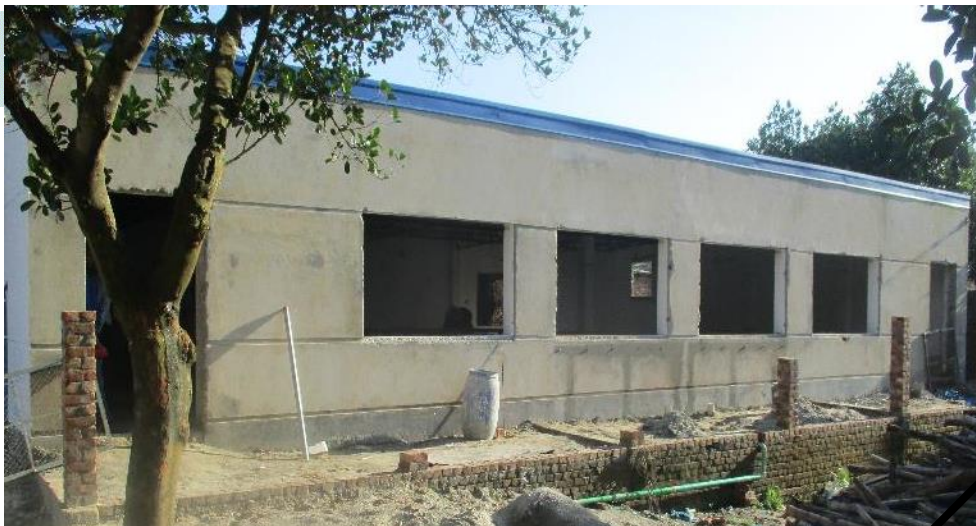
Dining shed

The support condition of the steel truss was very weak and non engineered due to poor detailing of connection. In addition, factory could not provide any document of the shed.

Factory could not provide any structural drawing for **Medical & Daycare shed** and **Dining shed**. Building Engineer is required to produce a full set of as built drawing reflecting on site condition and will assess the lateral stability against vertical and lateral load for those buildings.

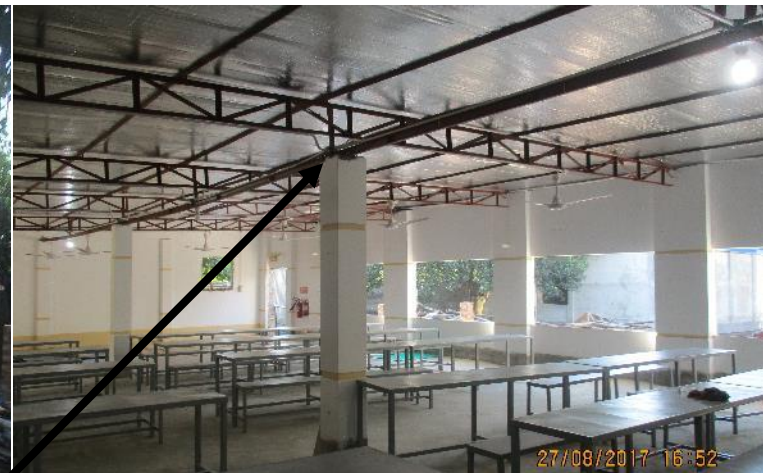
Typical truss frame which supported by reinforcement column

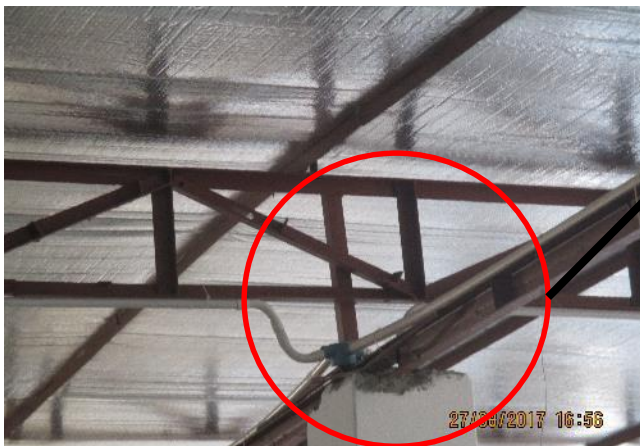
Poor connection detail between RC column and Truss

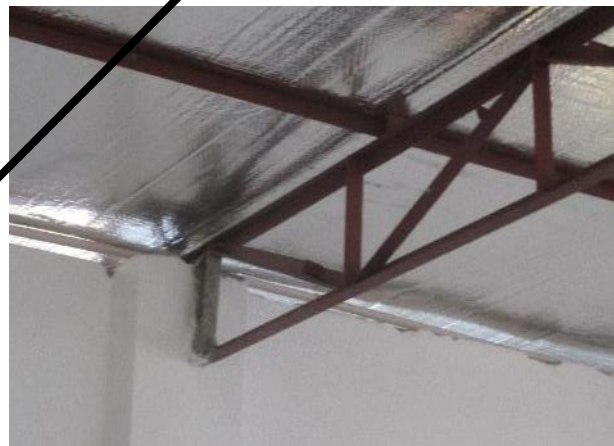
Corner joint between RC column and truss

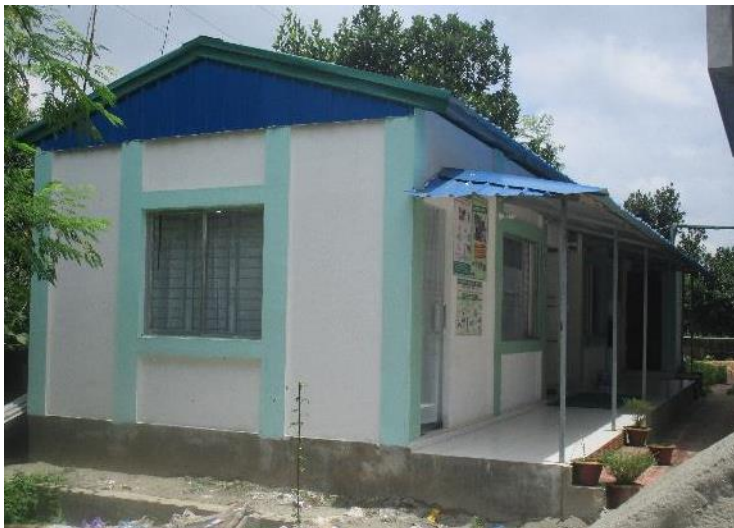
Medical & Daycare shed

The support condition of the steel truss was not clear and apparently non engineered. In addition, factory could not provide any structural document of the shed.

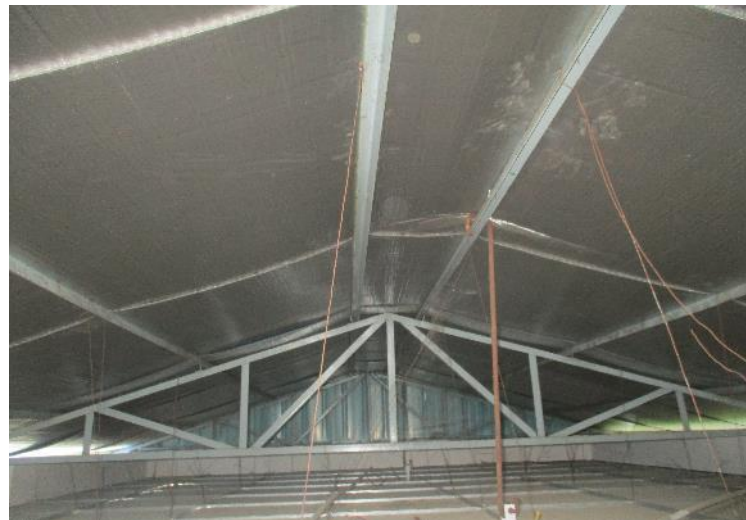
Typical internal truss

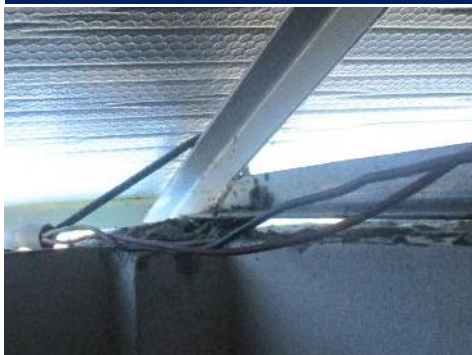
Connection between truss and peripheral RC column

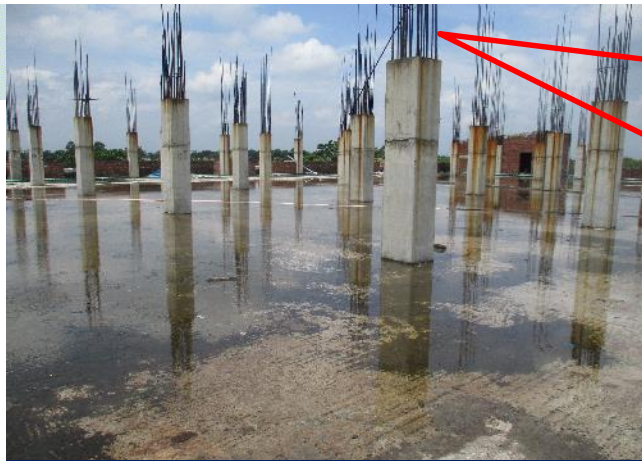
Factory Building

During inspection, corrosion was observed on almost all exposed reinforcement of column on roof top. Moreover, water clogging was observed on above mentioned building's roof top.

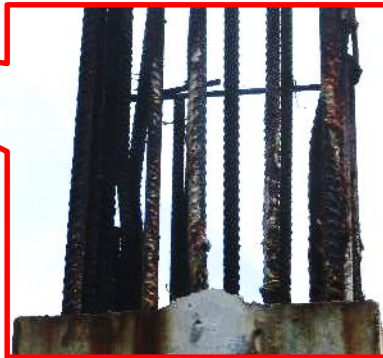
Extensive corrosion was found on exposed rebar

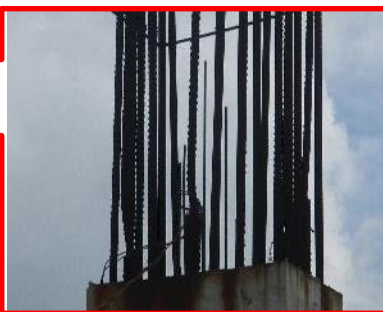
Extensive corrosion was found on exposed rebar

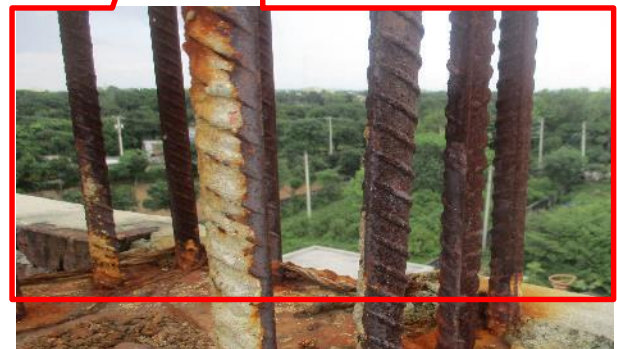
Extensive corrosion was found on exposed rebar

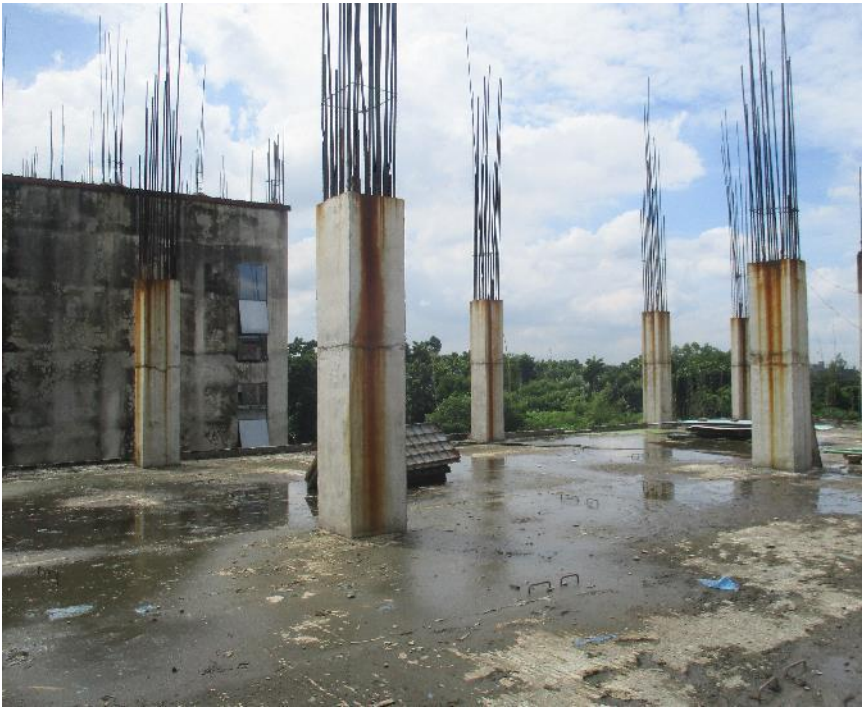
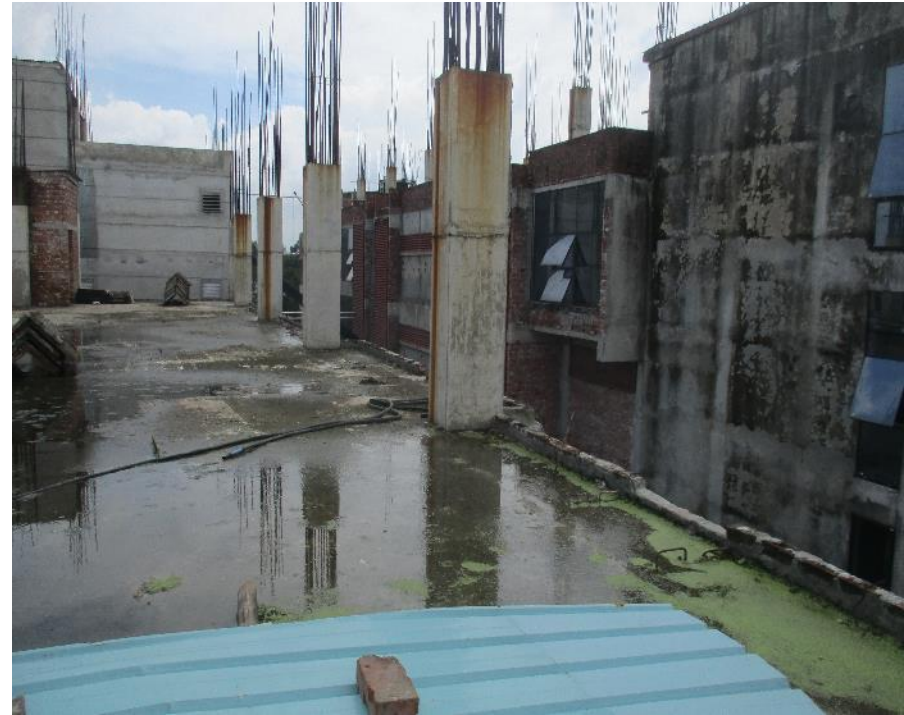
No edge protection was found on any corner of roof top.

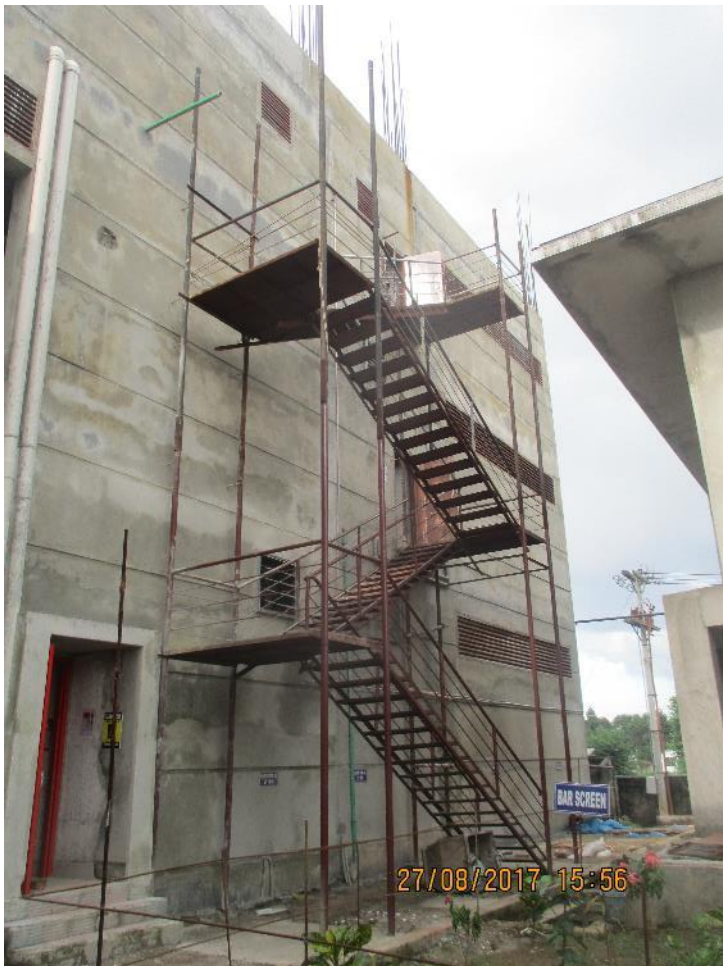
South side Steel stair

The support condition of the steel stair was very weak and non engineered due to poor detailing of connection of members

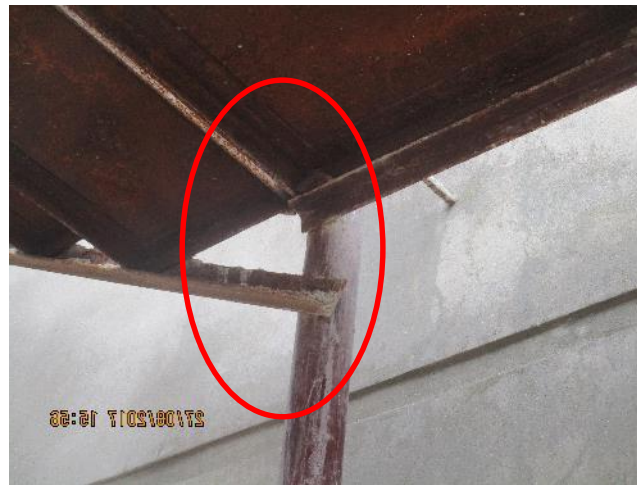
The joint between Pipe and steel landing was observed flimsy

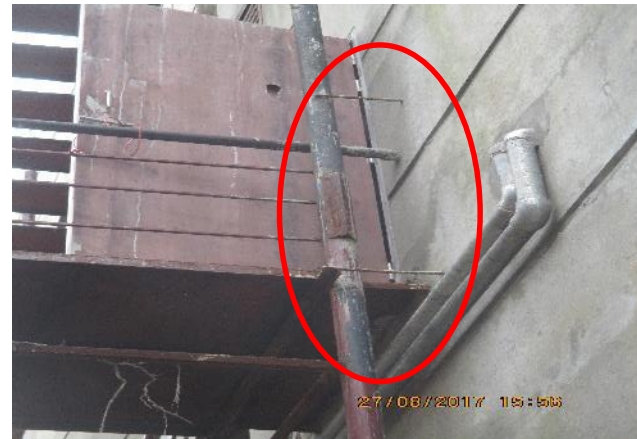
Weak support connection between Steel pipe and Utility building

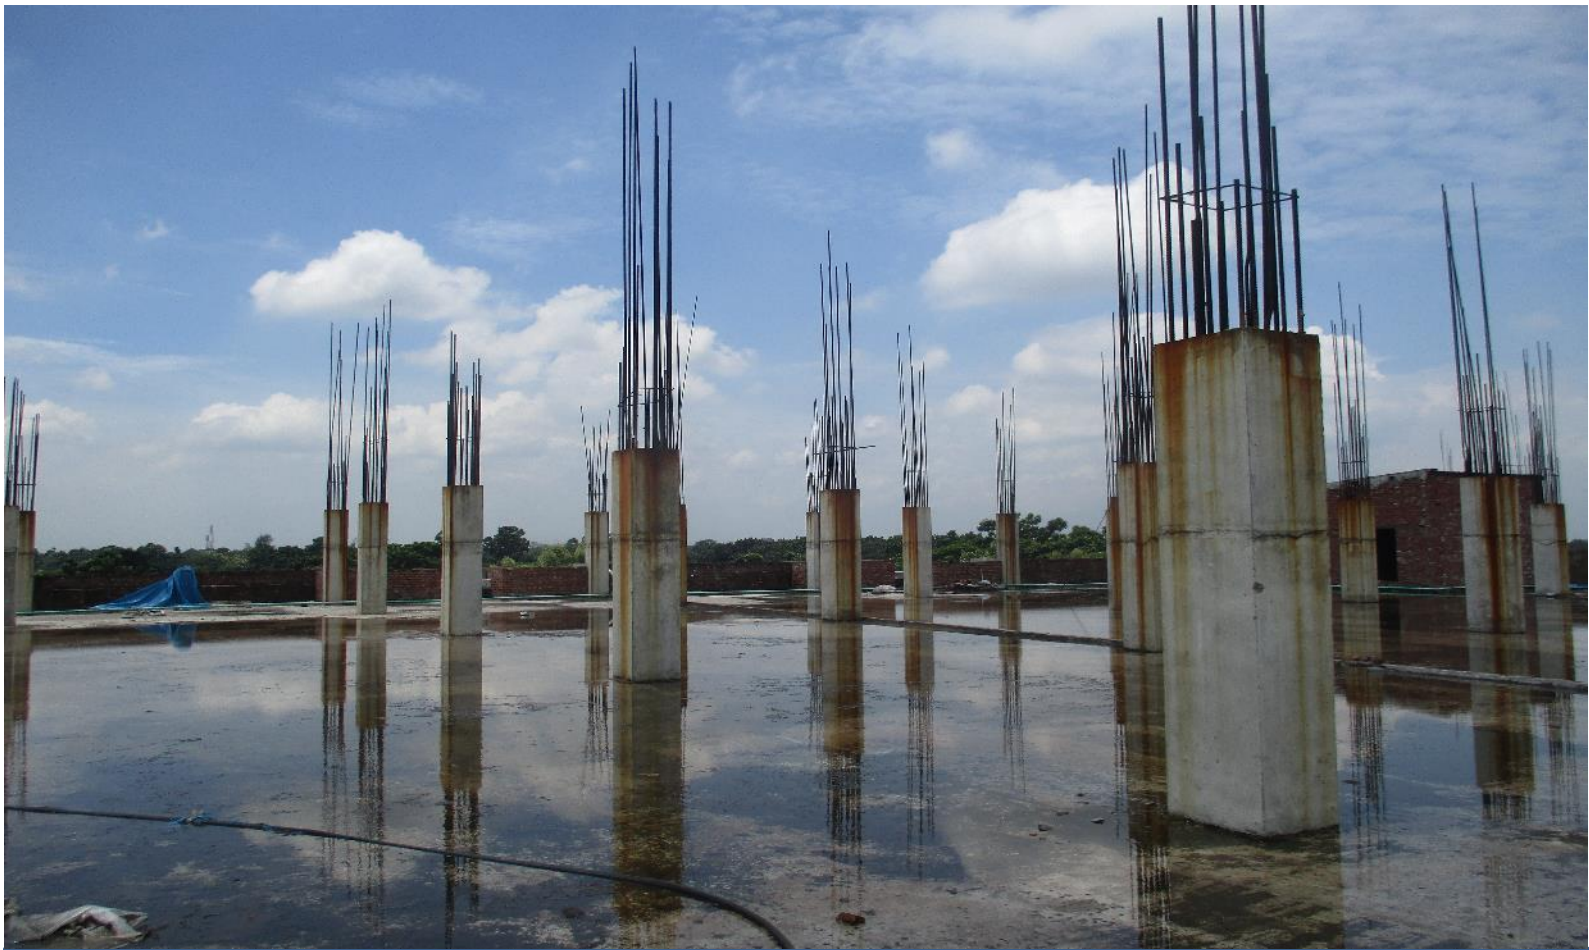
Exposed reinforcement on roof top and building permission for 6-storey was indicate further extension of the building. For any future extension may cause a significant increase in column loads. Details Engineering Assessment would required to be carryout before construction of additional floor above 4 storey.
