# FIRE SAFETY INSPECTION REPORT

**Factory Name: New Asia Fashions Ltd.**

**ACCORD ID: 12884**

**Date: 18th September, 2017**

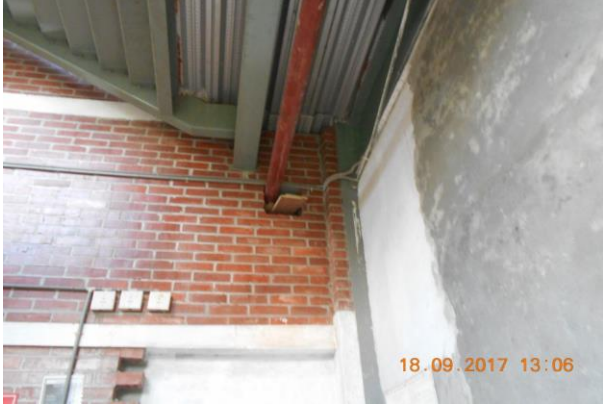
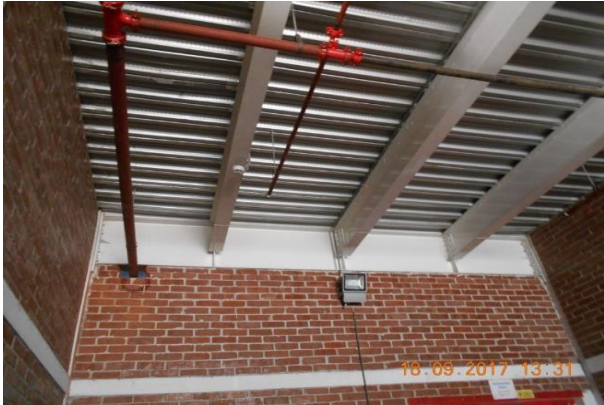
3	<b>Fire Rated Construction</b>	Rooms used for storage of combustible materials are not separated from exit stair enclosure.	Rooms used for storage of combustible materials shall be separated from the surrounding occupancy with a minimum 1 hour construction.	<b>Within 3 months</b>

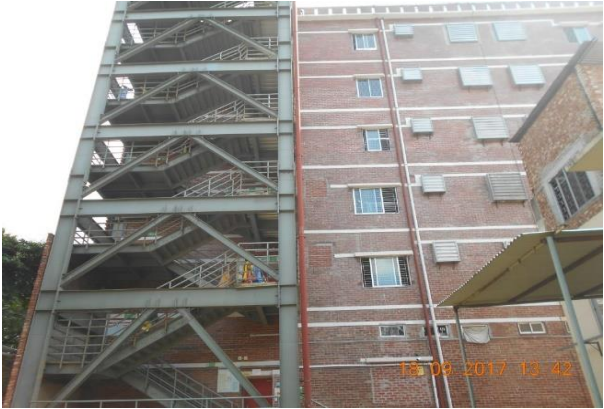
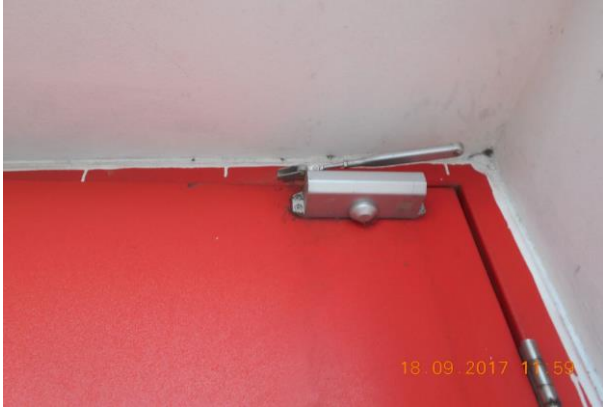
8	<b>Fire Rated Construction</b>	<p>Since the structure is steel-composite type and all the RCC panels are resting on the steel columns and girders. Hence, each floor of the building is not separated by a fire resistive rated construction barriers.</p>	<p>Provide fire-resistive rated construction barriers between floors following Section 4.4 and Table 4.4.1 of the Accord Standard or Table 3.3.1 and Table 4.1.1 from BNBC Part 4. Consult a qualified fire protection engineer to design the rated construction barriers.</p>	<b>Within 4 months</b>

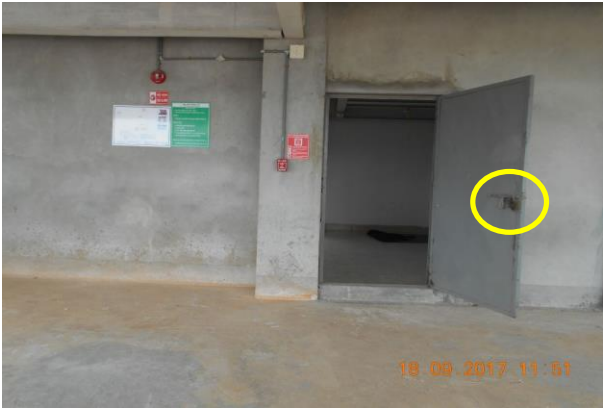
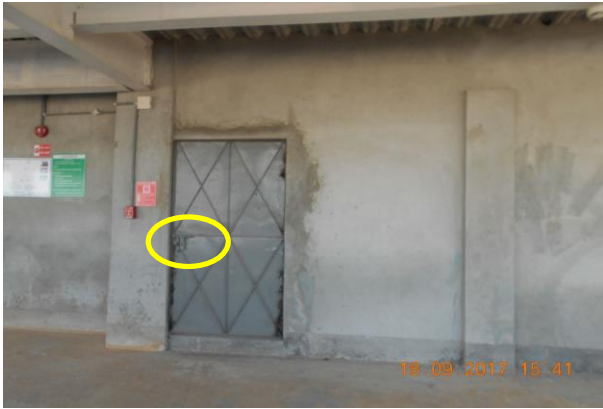
10	Egress	<p>Exit stair door/egress door serving 50 or more occupants does not swing in the direction of egress travel.  <b>Location: Roof floor exit (Stair-1).</b></p>	<p>Modify the egress door to swing in the direction of egress travel.</p>	<p><b>Within 1 month</b></p>

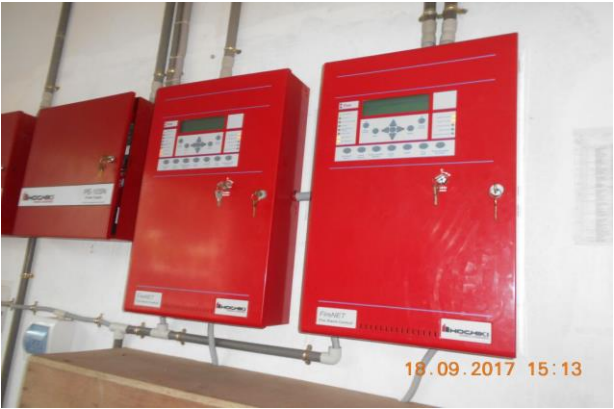
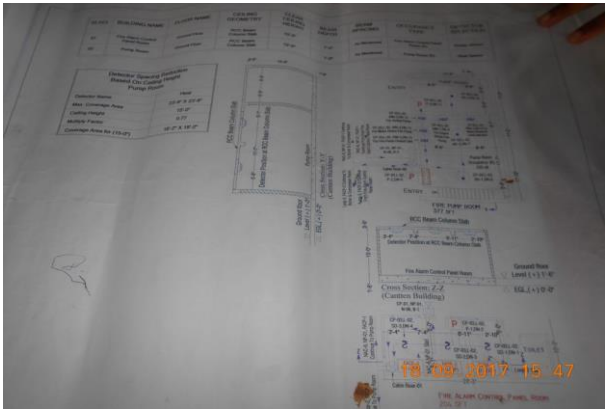
14	<b>Fire Detection &amp; Alarm System (ITM)</b>	Inspection, testing, and maintenance for the fire alarm system is not in accordance with NFPA 72 or as per Accord standard.	Inspect, test and maintain the fire alarm system, and keep written records on-site, in accordance with NFPA 72 or as per Accord standard.	<b>Within 2 months</b>

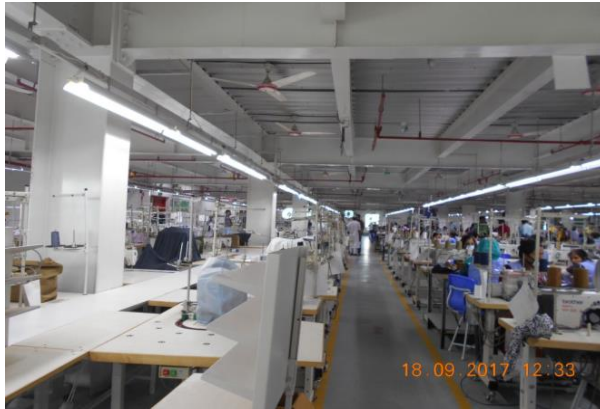
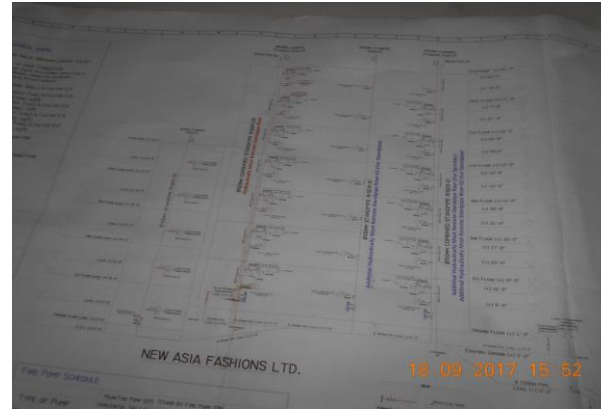
SI No.	Category	Findings	Required Action	Remediation Time Frame
15	<b>Fire Protection</b>	The factory has been designed & installed the sprinkler system without having approval from AHJ (Authorities Having Jurisdiction). Note: Installation work is going on.	Existing sprinkler system and required standpipe system shall be designed & installed as per NFPA 13,14,20,22 & 24. Modify the system (if required) after getting approval from AHJ.	<b>Within 8 months</b>

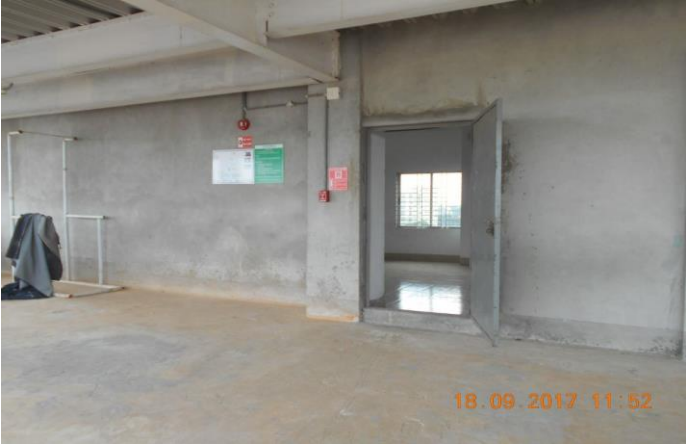
21	Egress Lighting	<p>Based on the number and location of emergency lights observed, adequate illumination levels are not anticipated along egress routes.  <b>Location: Stores and stair in Ground Floor and few required places.</b></p>	<p>Test the emergency lighting system on each floor and provide additional emergency fixtures to provide adequate illumination along the means of egress. Provide a minimum illumination of 10 lux at the floor level within exit stairs and exit discharge paths and minimum 2.5 lux along exit access aisles.</p>	<p><b>Within 3 months</b></p>

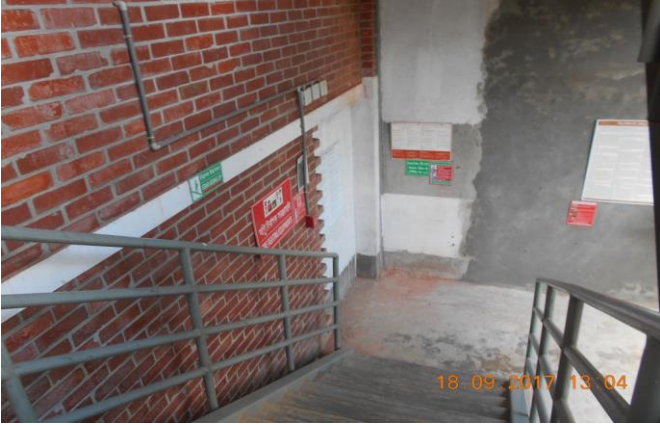
22	Egress	<p>Door width in means of egress have found less than 1 m (39 in.).  <b>Location: North exit in Dining area.</b></p>	<p>Doors in means of egress shall have a minimum width of 1 m (39 in.).</p>	<p><b>Within 1 month</b></p>
