# Grameen Fabrics & Fashions Ltd. (11501)

Grameen Industrial Park, Sarabo, Kashimpur, Gazipur Sador, Gazipur

25.June.2014

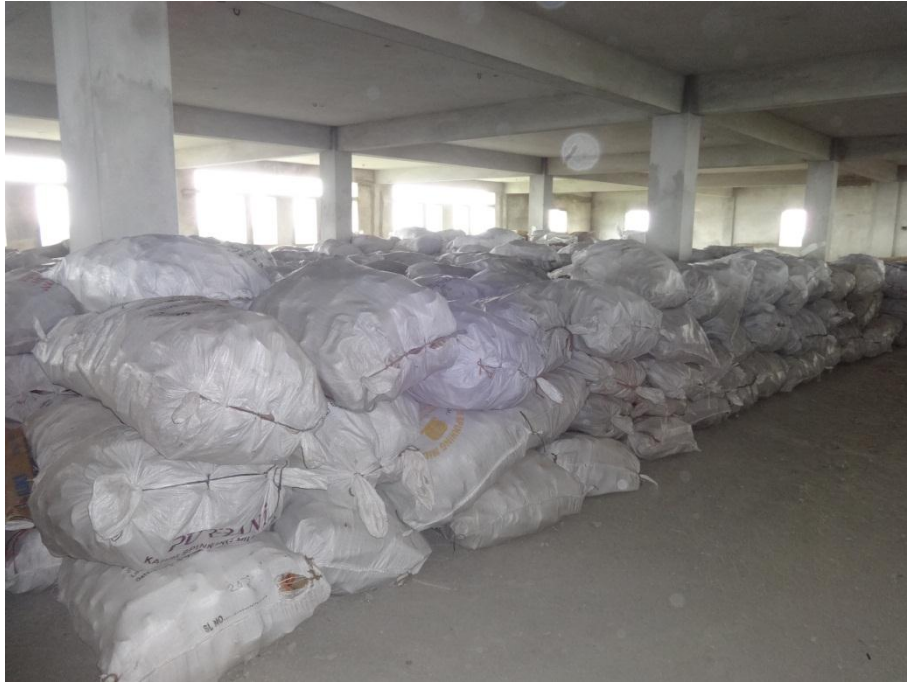
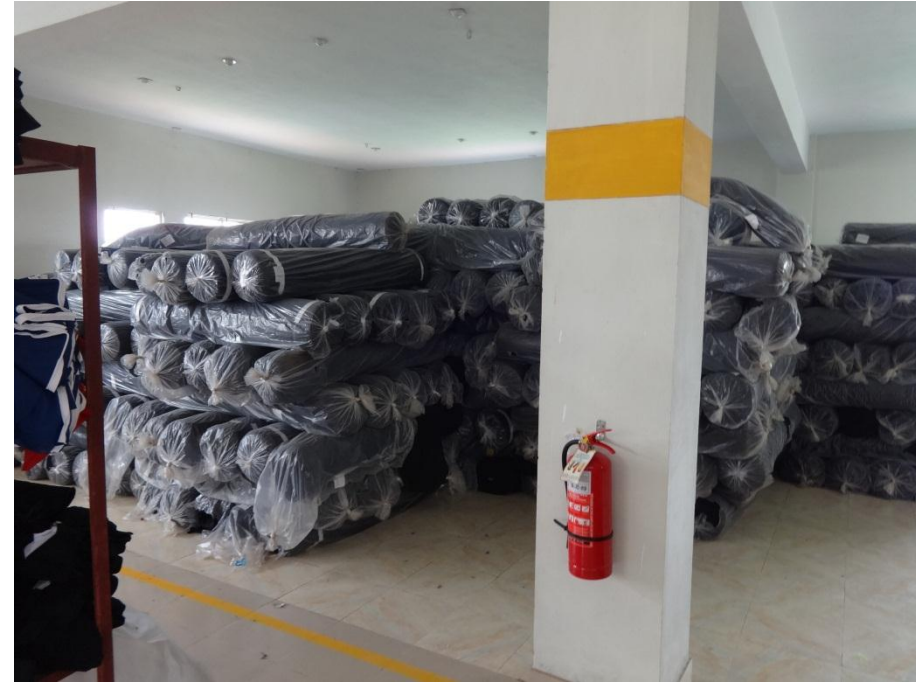
## 1<sup>st</sup> Priority 1 Concern

Storage loading to upper floors of the main factory building and first floor of utility building.

Rolls of yarn were calculated to weigh up to 5.5kPa.

Mass of 1 roll – 25kg  
Stacked 10 rolls high  
Dimensions 1500mm long, 300mmØ  
$$[(25 \times 9.81)/(1.5 \times 0.3)] \times 10 = \underline{5.45\text{kPa}}$$

Item No.	Observation	Recommended Action Plan	Recommended Timeline
1	1st Priority 1 - Storage loading to upper floors of the main factory building and first floor of utility building.	Reduce loading on slab to 3kPa (60psf)	Immediate - Now
2	1st Priority 1 - Storage loading to upper floors of the main factory building and first floor of utility building.	Produce loading plans for each level of each building. Ensure these are displayed and managed at each level.	6-weeks
3	2nd Priority 1 - Cantilevers around the stairs on main factory are excessive, poorly detailed and not on the structural drawings.	Do not store any construction materials on the cantilevers.	Immediate - Now
4	2nd Priority 1 - Cantilevers around the stairs on main factory are excessive, poorly detailed and not on the structural drawings.	Carry out an Engineering Assessment to establish if the cantilevers are adequate for the design loading.	6-weeks

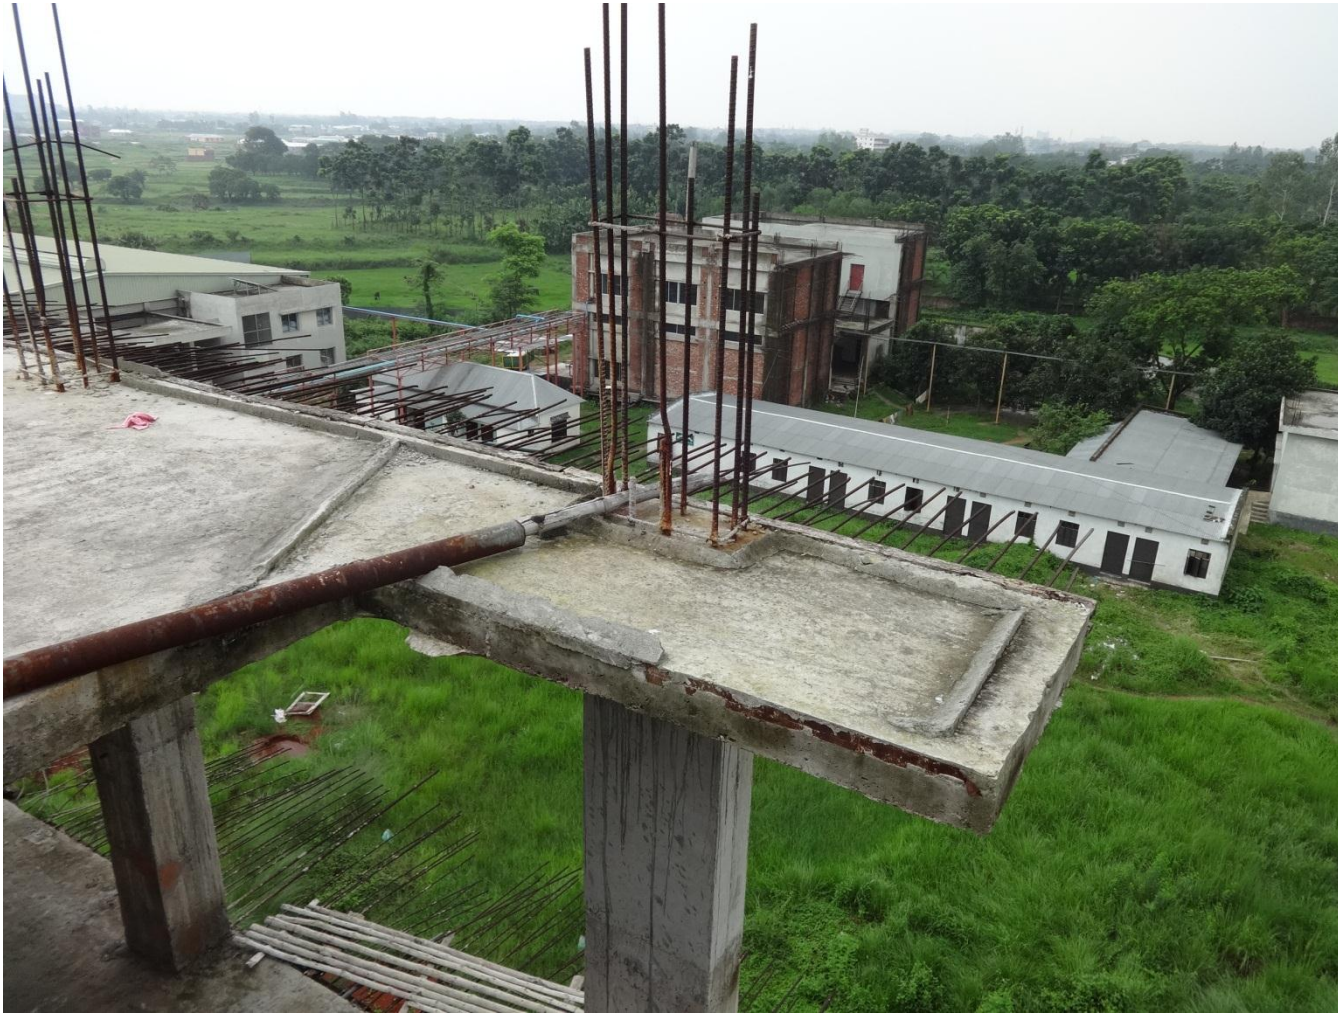
## 2<sup>nd</sup> Priority 1 Concern

Cantilevers around the stairs on main factory are excessive, poorly detailed and not on the structural drawings.

5	2nd Priority 1 - Cantilevers around the stairs on main factory are excessive, poorly detailed and not on the structural drawings.	Carry out all recommendations of the Engineering Assessment. Update structural drawings to show cantilevers as necessary.	6-months
6	No obvious stability system to any of the buildings.	Carry out an Engineering Assessment on the building to verify that it is stable under lateral loading.	6-weeks
7	No obvious stability system to any of the buildings.	Carry out all recommendations of the Engineering Assessment.	6-months
8	1st Priority 2 - Telecommunications mast on the roof of the main factory is not adequately guyed down to the slab.	Carry out an Engineering Assessment concentrating on the anchor points to establish if the slab and connections are sufficient for the applied loadings.	6-weeks
9	1st Priority 2 - Telecommunications mast on the roof of the main factory is not adequately guyed down to the slab.	Carry out actions from the Engineering Assessment. Update structural drawings to show mast.	6-months

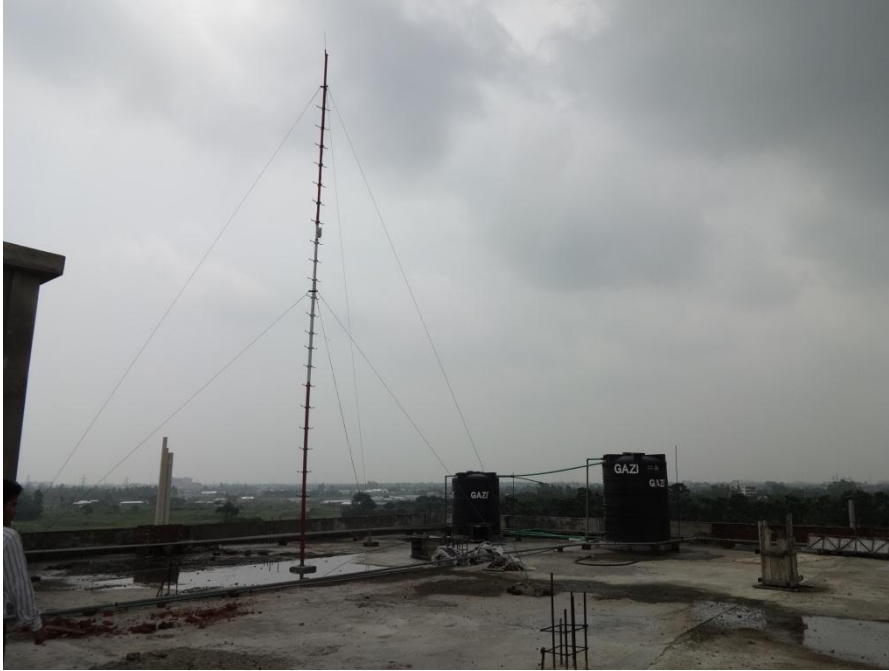
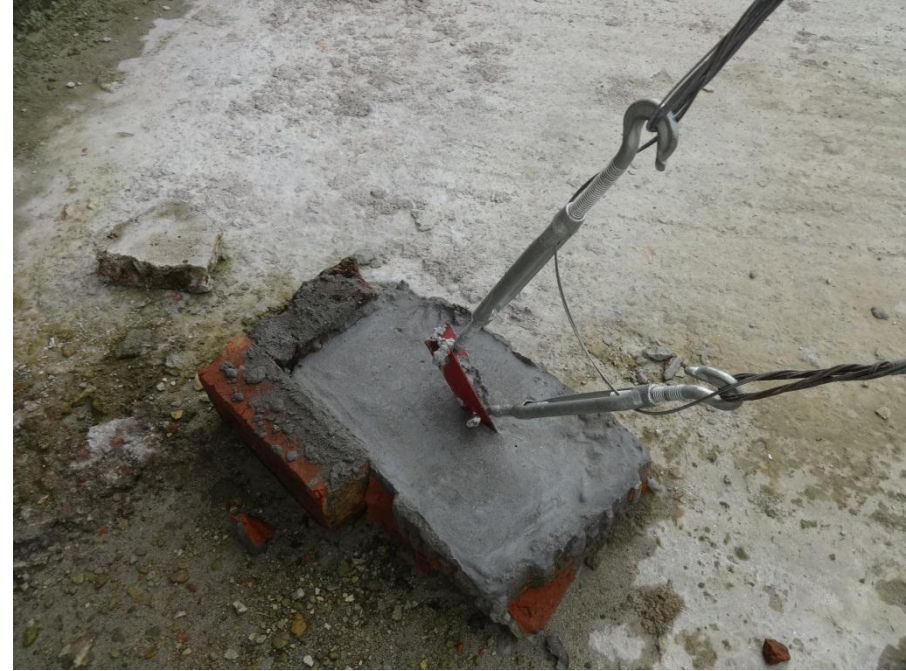
## 1<sup>st</sup> Priority 2 Concern

Telecommunications mast on the roof of the main factory is not adequately guyed down to the slab.

Guy wires are connected to a steel angle which does not appear to be adequately sized or fixed to the slab.

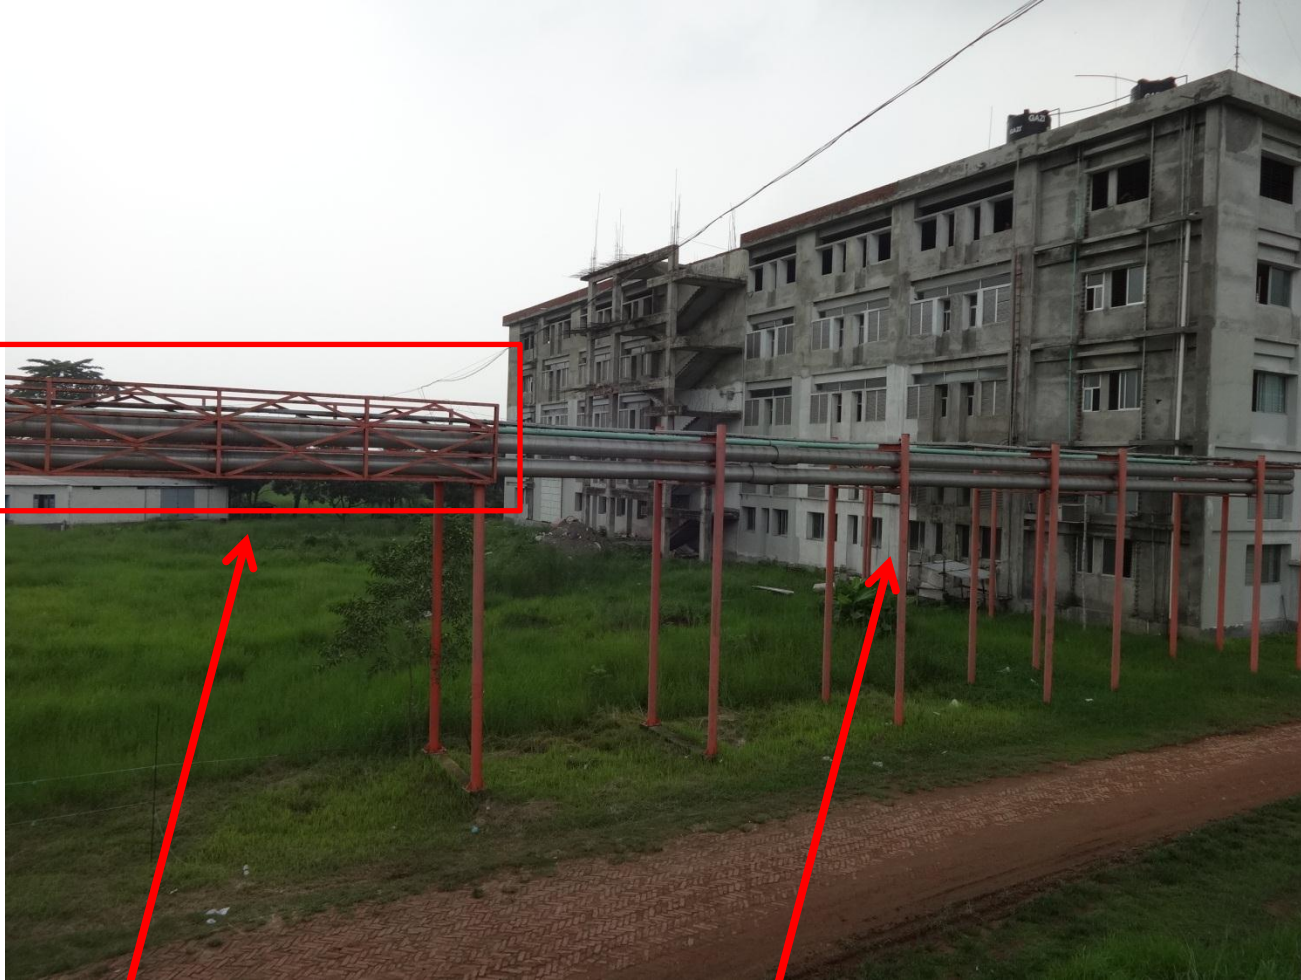
## 2<sup>nd</sup> Priority 2 Concern

Inconsistent detailing to pipe bridge, inadequate base plate details and no structural drawings exist.

Trussed bridge

Piers only

Item No.	Observation	Recommended Action Plan	Recommended Timeline
10	2nd Priority 2 - Inconsistent detailing to pipe bridge and no structural drawings.	Carry out an Engineering Assessment concentrating on the base connections to verify if the pipe bridge is stable and able to carry the load adequately.	6-weeks
11	2nd Priority 2 - Inconsistent detailing to pipe bridge and no structural drawings.	Carry out actions from the Engineering Assessment. Produce as built drawings for the pipe bridge.	6-months
12	3rd Priority 2 - Water tank cantilevered off column in Boiler Room & pipes supported on cantilevered brackets off columns in Main Factory.	Carry out Engineering Assessment on steel to concrete connections of brackets.	6-weeks
13	3rd Priority 2 - Water tank cantilevered off column in Boiler Room & pipes supported on cantilevered brackets off columns in Main Factory.	Carry out recommendations highlighted in Engineering Assessment. Update structural drawings to show brackets and fixings.	6-months

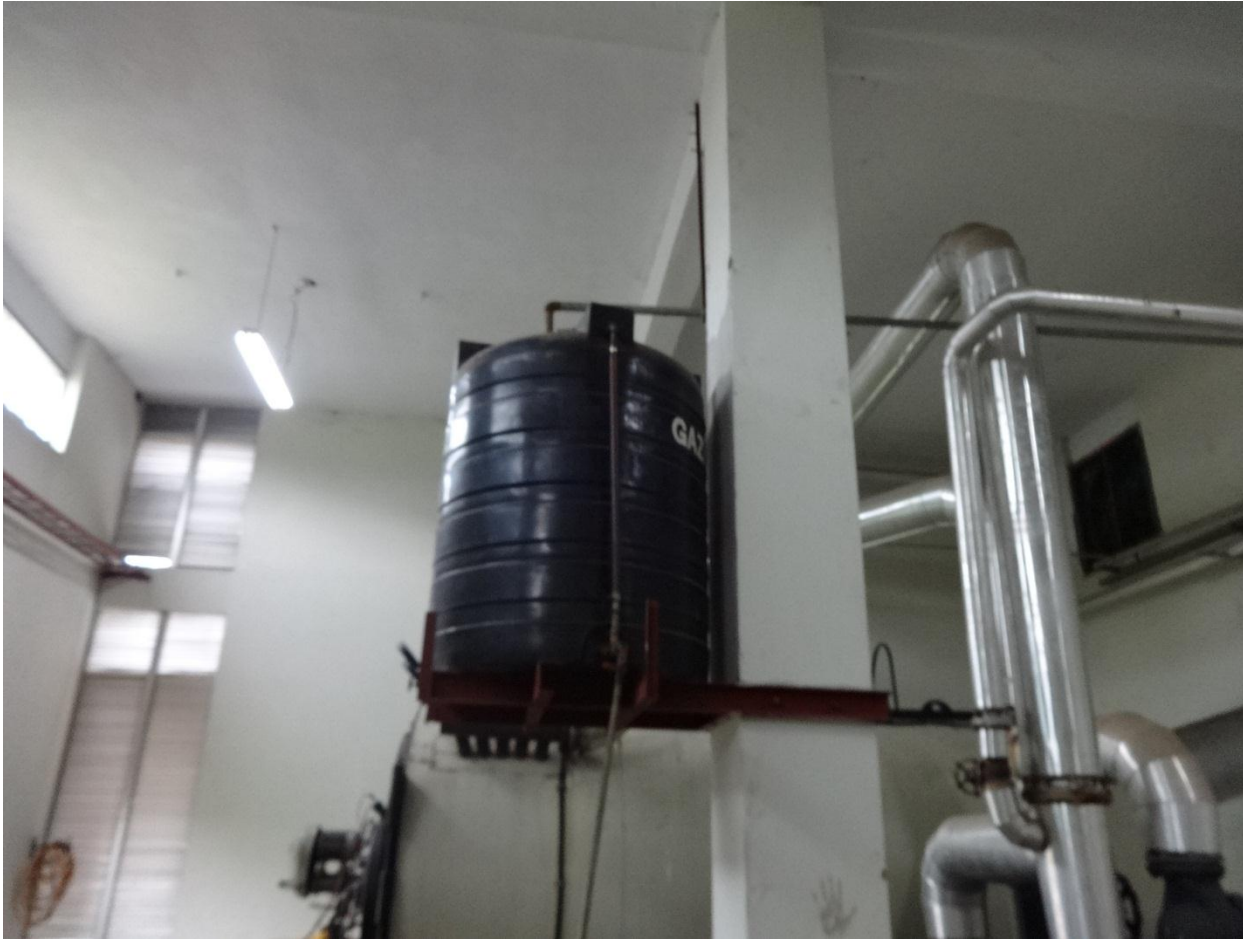
### 3<sup>rd</sup> Priority 2 Concern

Water tank supported by steel frame cantilevered off column in Boiler Room. There are only 2 bolts each side holding the steel bracket to the concrete column.

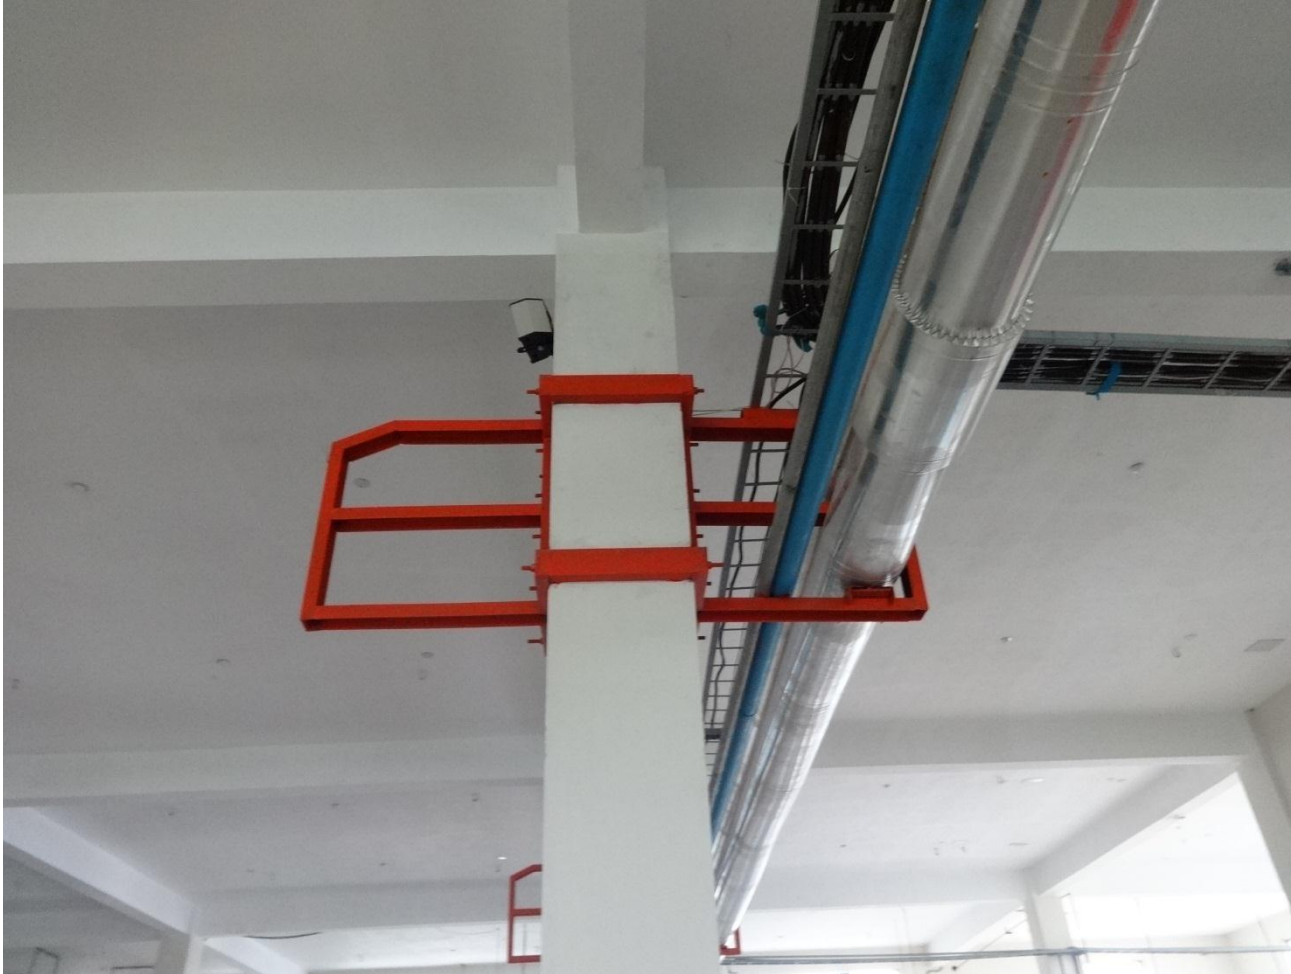
### 3<sup>rd</sup> Priority 2 Concern Continued

Pipes supported on brackets cantilevered off concrete columns. There are only 4 bolts each side holding the steel bracket to the concrete column.

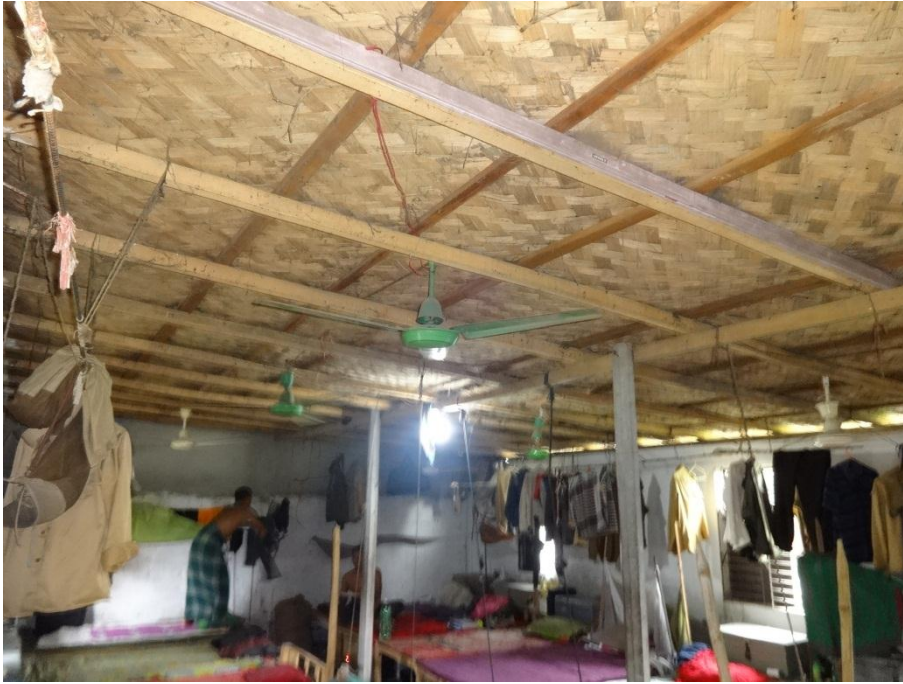
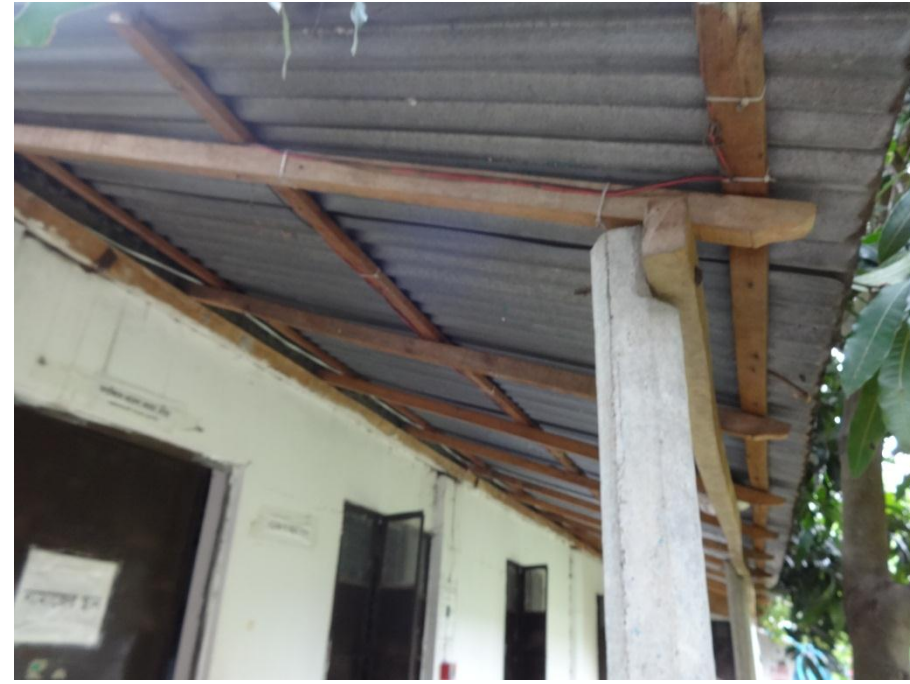
## 4<sup>th</sup> Priority 2 Concern

Inadequate detailing to timber roofs to “temporary” shed buildings.

14	4th Priority 2 - Inadequate detailing to timber roofs to “temporary” shed buildings.	Carry out Engineering Assessment on steel roof to determine if any strengthening works are required.	6-weeks
15	4th Priority 2 - Inadequate detailing to timber roofs to “temporary” shed buildings.	Carry out recommendations highlighted in Engineering Assessment.	6-months
16	1st Priority 3 - No steelwork drawings for knitting shed roof.	Produce as built steelwork drawings for the roof of the knitting shed.	6-months
17	2nd Priority 3 - No drawings for any of the “temporary” shed buildings.	Produce as built structural drawings for these buildings based on site conditions.	6-months
18	No waterproofing to concrete roofs.	Cover the concrete roofs with a suitable waterproofing membrane, e.g. waterproof screed.	6-months
19	Unable to survey the sub store.	Carry out a structural survey of the sub store highlighting any defects and undertaking a repair schedule where necessary.	6-months

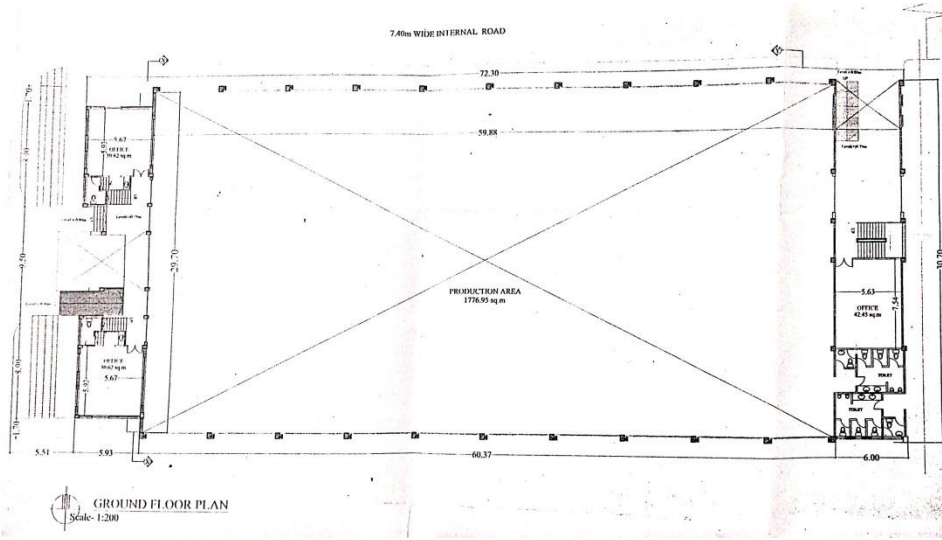
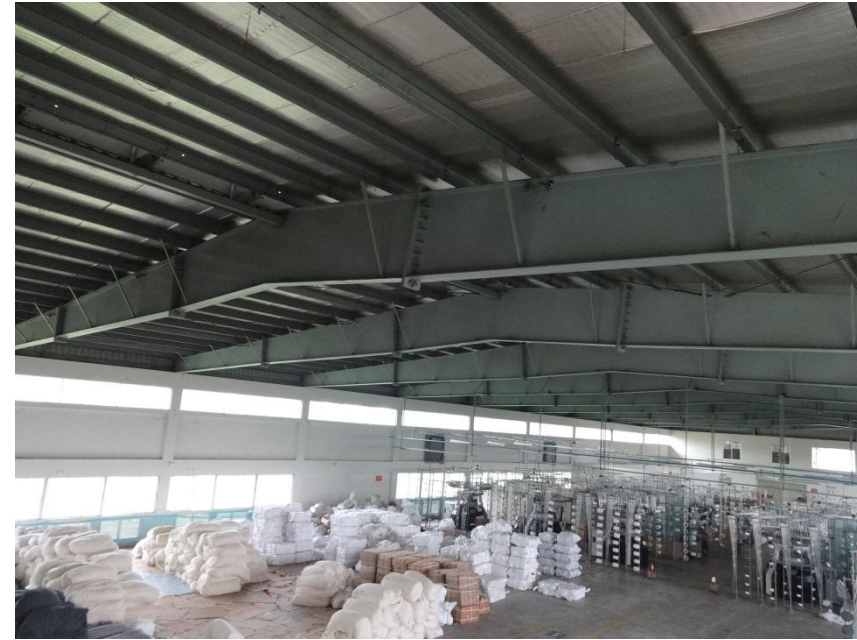
# 1st Priority 3 Concern

No steelwork drawings for knitting shed roof.

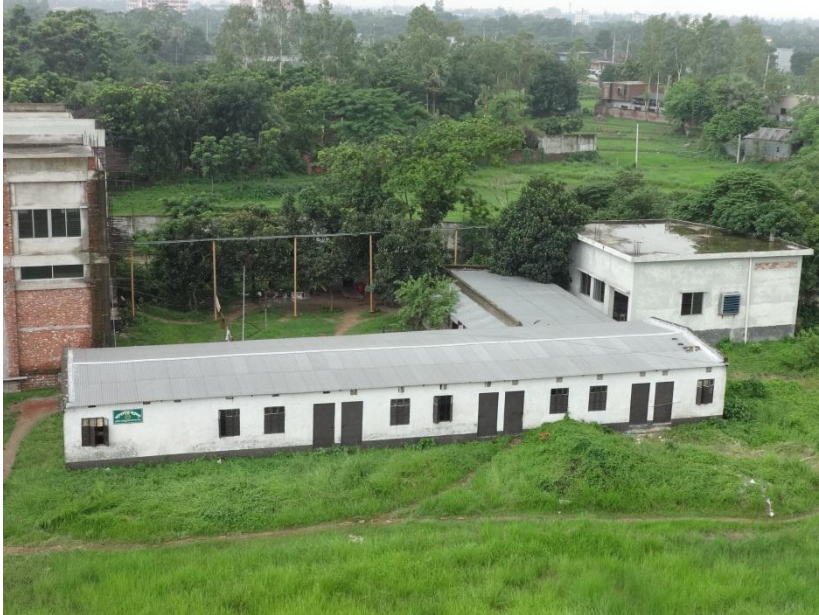
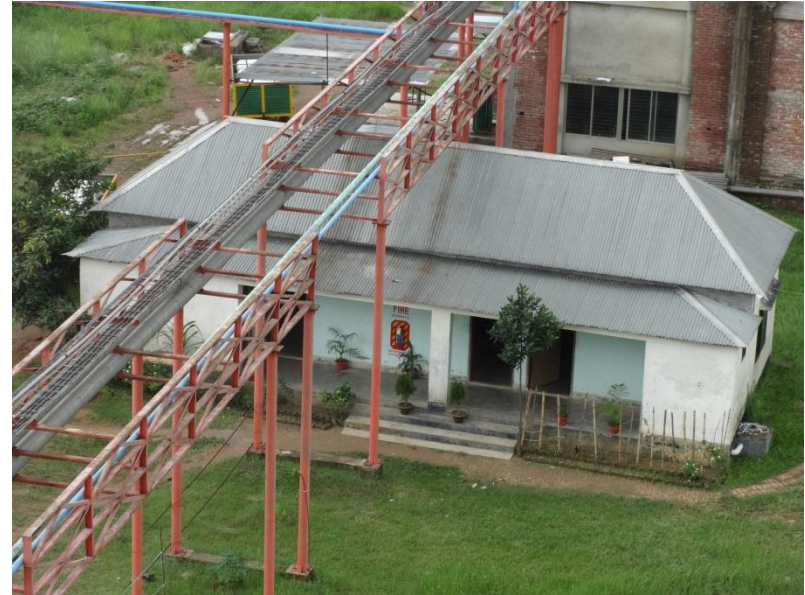
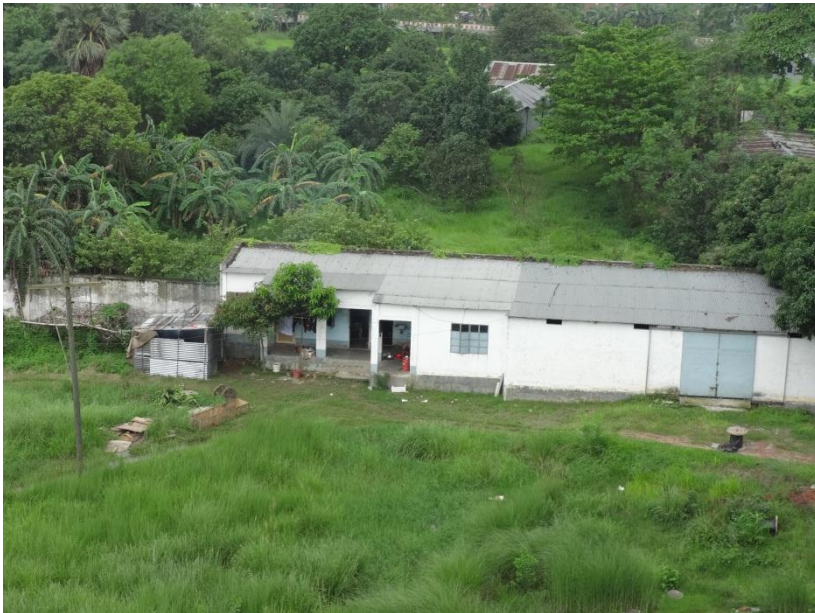
## 2<sup>nd</sup> Priority 3 Concern

No drawings for any of the “temporary” shed buildings.

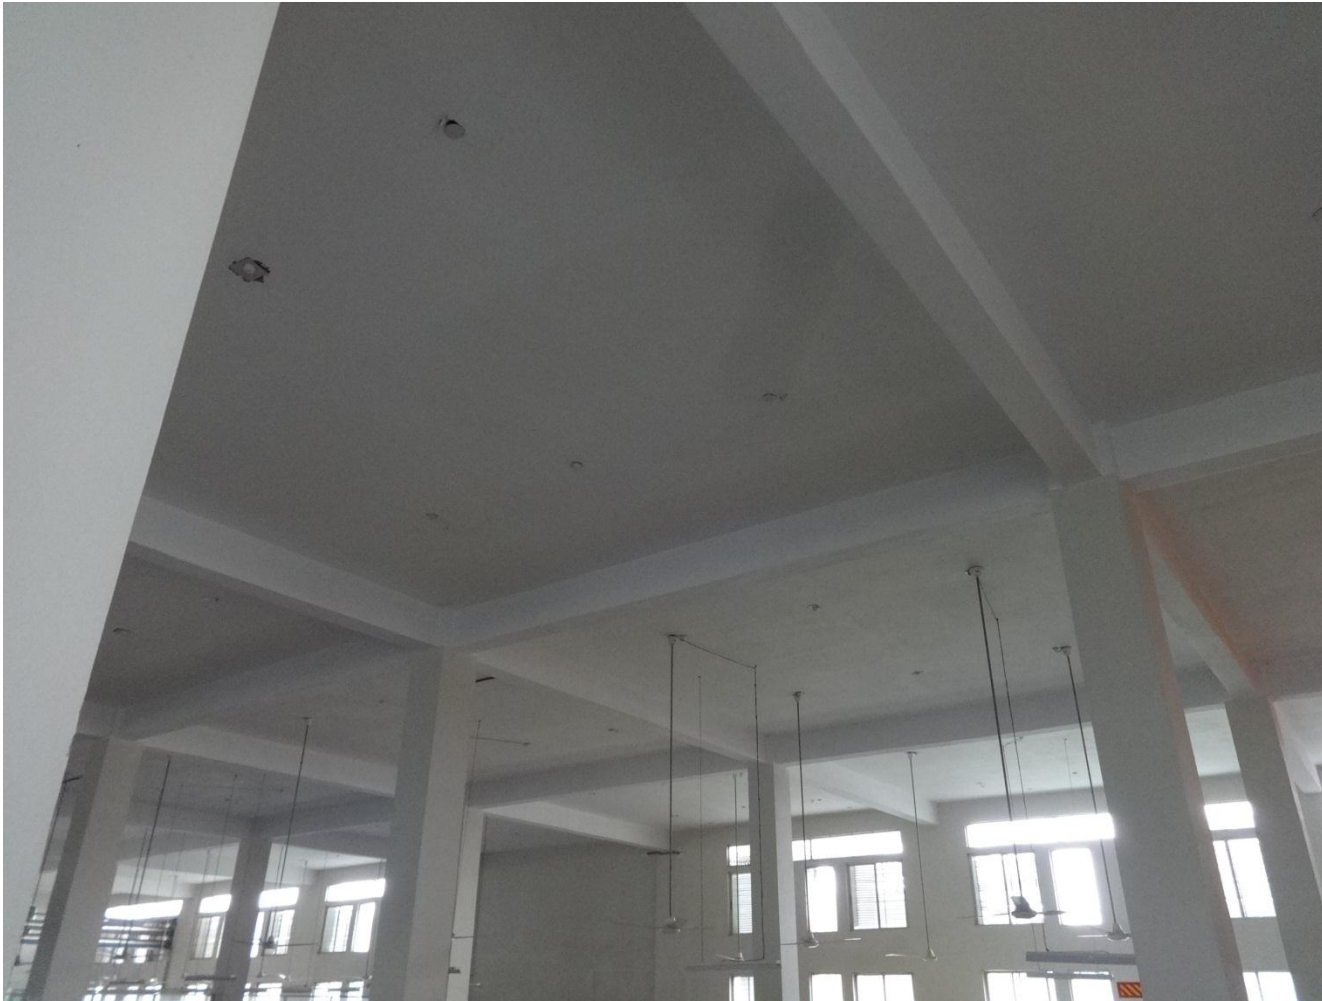
# Overall Stability System

The building did not feature any core or shear walls. Stability was achieved through sway action between beams and columns and masonry infill walls.

We require that these items be investigated in an Engineering Assessment

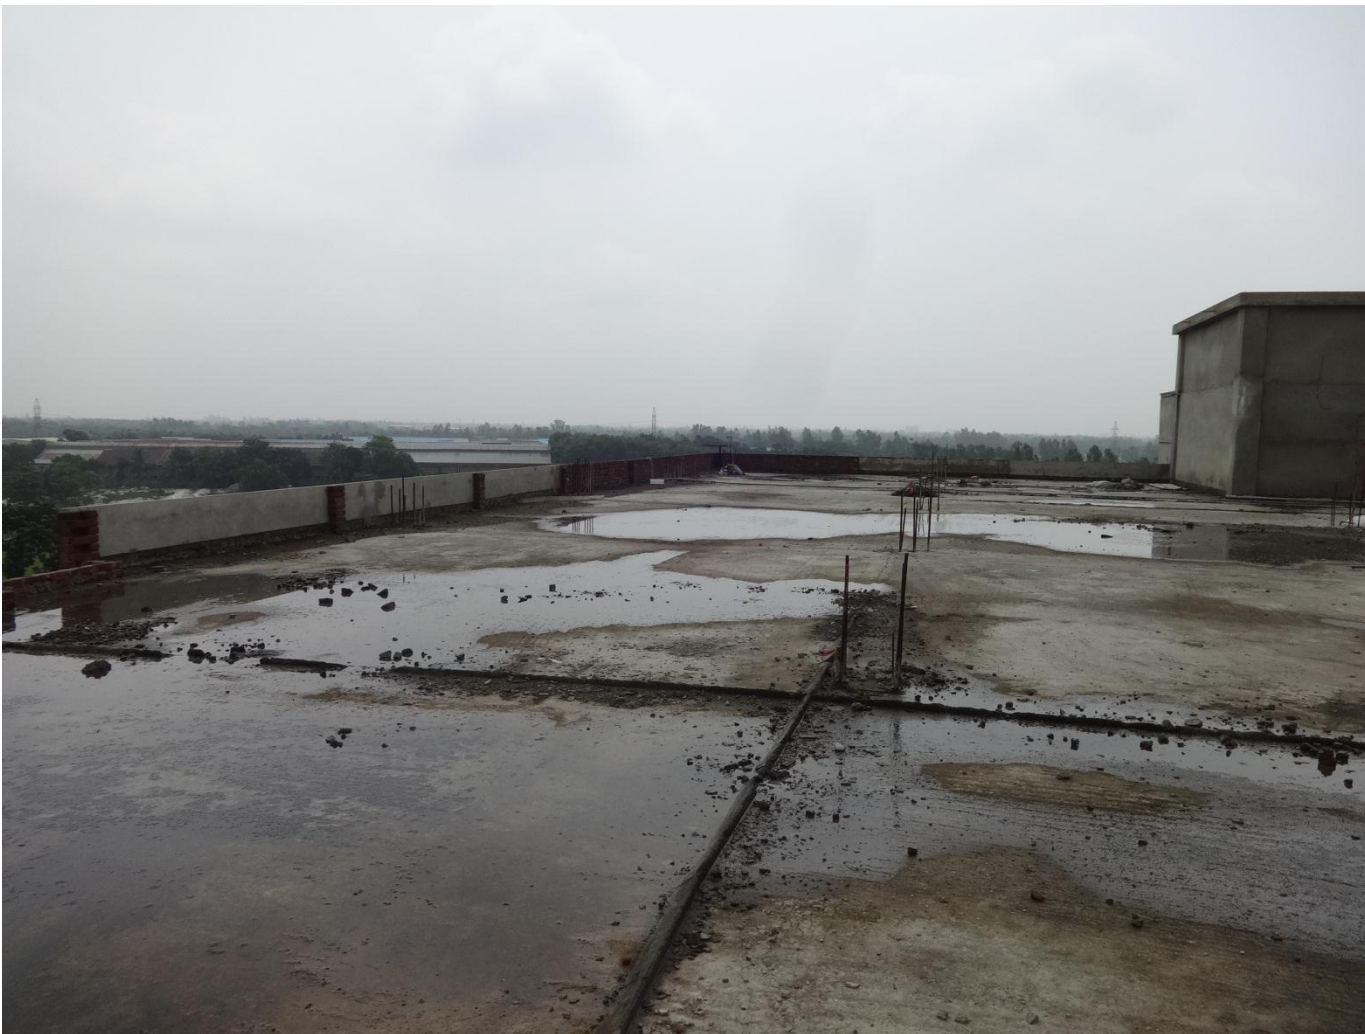
# Water Ingress at Roof Level

No waterproofing membrane was visible on the roof of the main factory building. This means that any cracks in the surface finishes on the roof will allow water to seep into the concrete slab beneath the finishes, and cause corrosion of the reinforcing steel.
