# Panorama Apparels Ltd. (9315)

Vogra,Basan Sarak, National University,Gazipur

30.June.2014

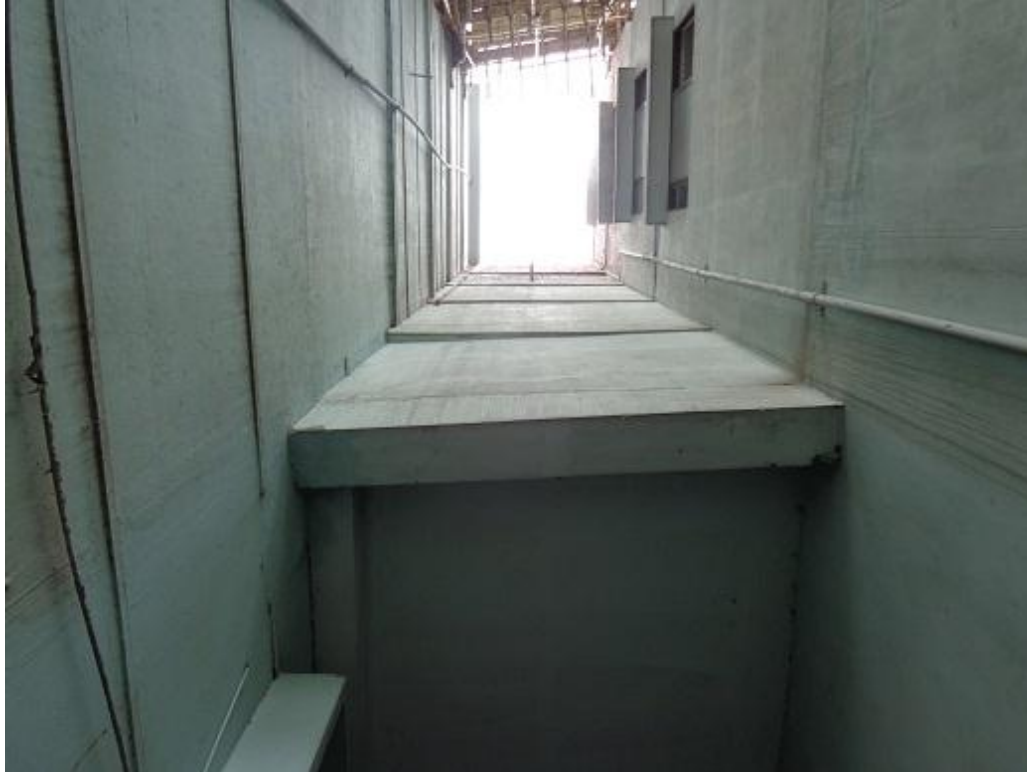
Existing cantilever bridge between building 1 and 2.

The cantilever bridge from building 2 to building 1 was not shown on the structural drawings.

| Item No. | Observation | Recommended Action Plan | Recommended Timeline |
|---|---|---|---|
| 1 | 1st Priority 2 - The bridges between the two buildings do not appear on structural plan. | Carry out an Engineering Assessment to verify if cantilever bridge is adequately designed. | 6-weeks |
| 2 | 1st Priority 2 - The bridges between the two buildings do not appear on structural plan. | Update existing drawings to include bridge.<br>Carry out recommendations of Engineering Assessment. | 6-months |

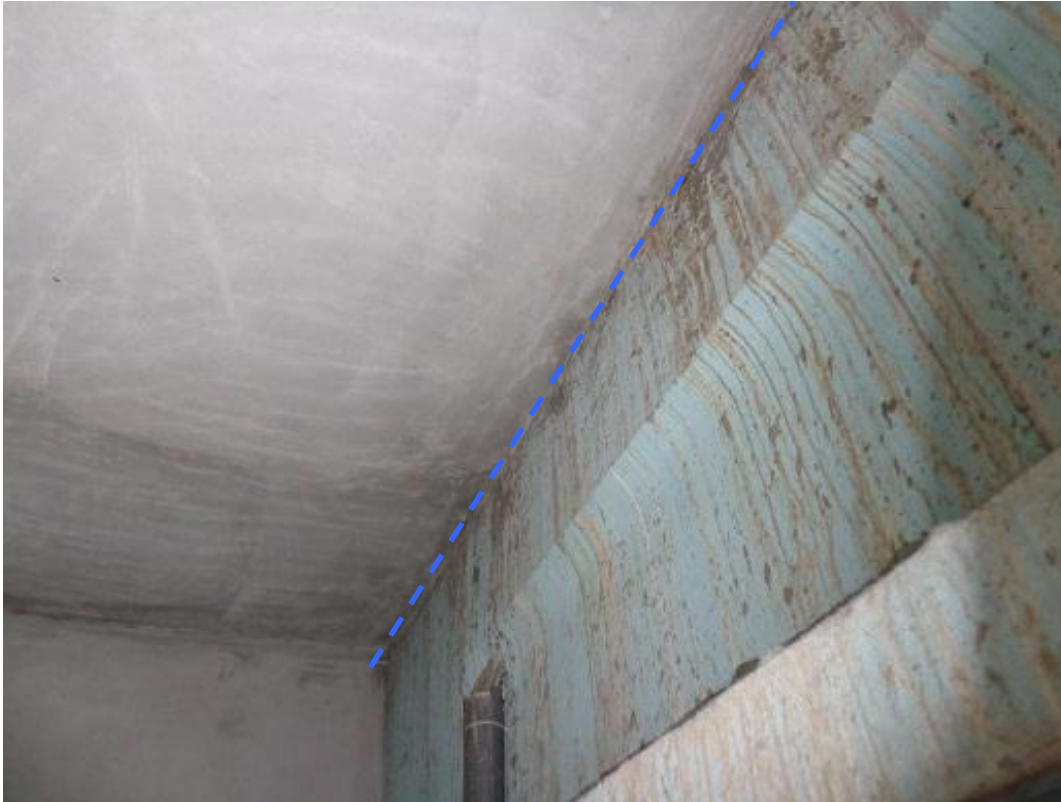
No movement joint  
between buildings 1,2  
and 3.

The movement joint  
seems to be filled with  
plastered materials.

| Item No. | Observation | Recommended Action Plan | Recommended Timeline |
|---|---|---|---|
| 3 | 2nd Priority 2 - Absence of movement joint. | Remove all materials to obtain proper movement joint.<br>Appropriate method should be approved by a qualified Engineer. | 6-months |

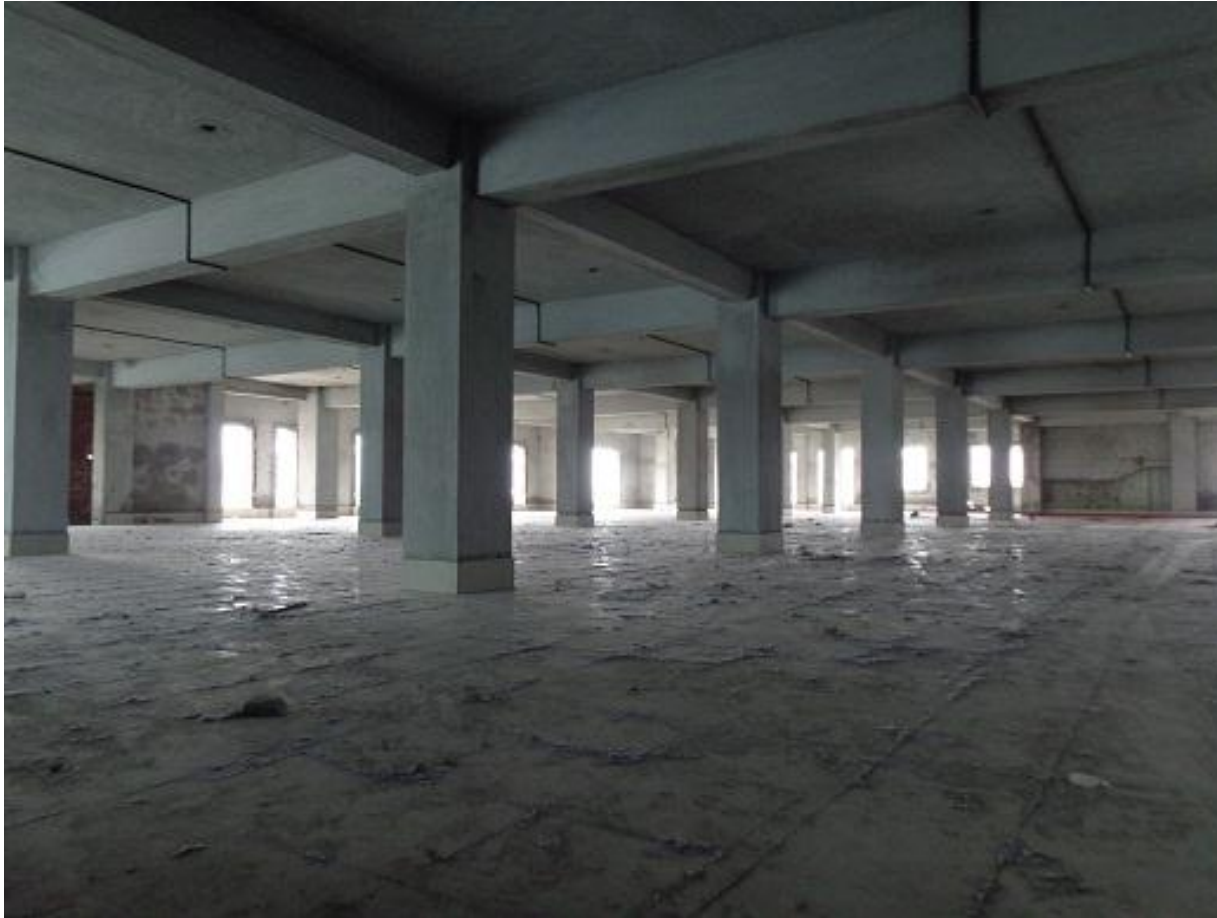
The buildings did not feature any core or shear walls. Stability was achieved through sway action between beams and columns and masonry infill walls.

We require that this item be investigated in a Engineering Assessment

| Item No. | Observation | Recommended Action Plan | Recommended Timeline |
|---|---|---|---|
| 4 | 3rd Priority 3 - No obvious lateral stability system for these buildings. | Carry out an Engineering Assessment on the building to verify that it is stable under lateral loading. | 6-weeks |
| 5 | 3rd Priority 3 - No obvious lateral stability system for these buildings. | Carry out recommendations of Engineering Assessment. | 6-months |

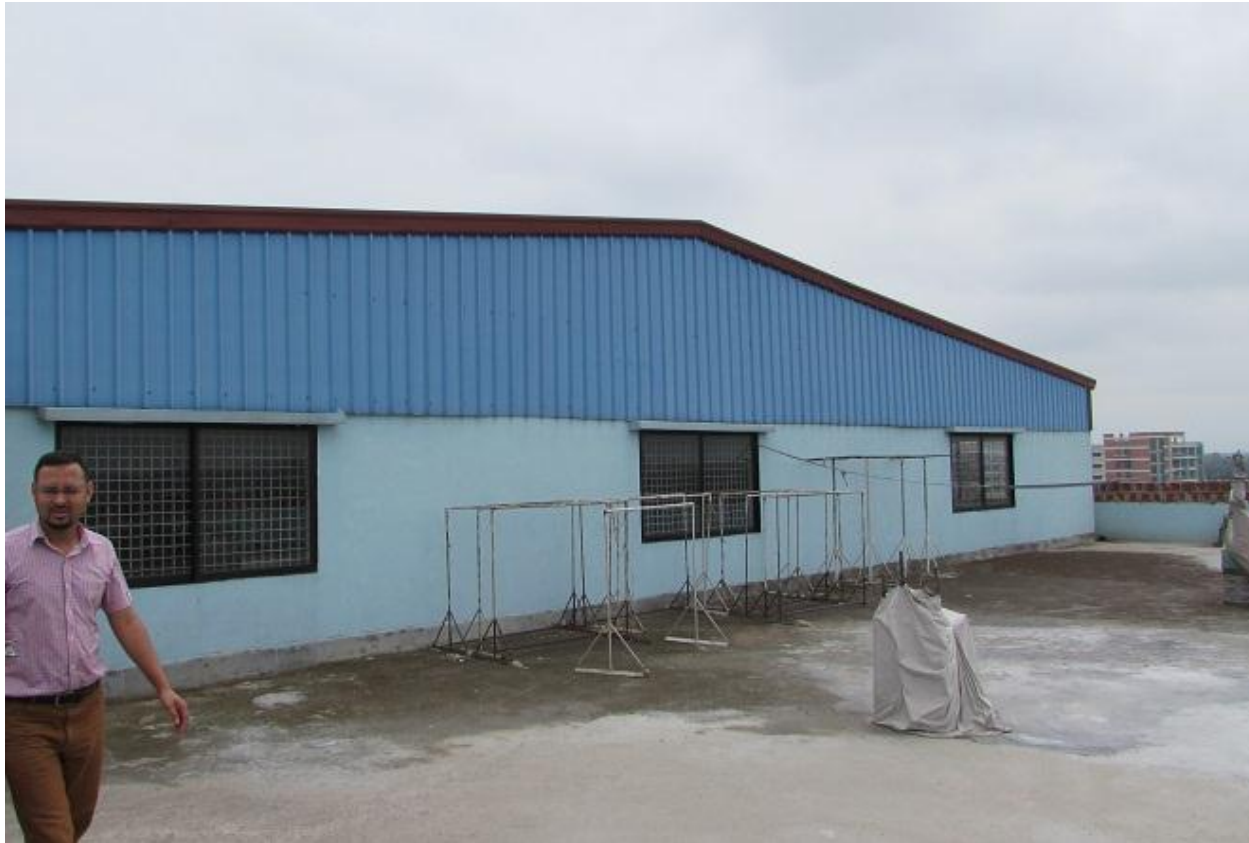
No waterproofing membrane was visible on the roof of the building. This means that any cracks in the surface finishes on the roof will allow water to seep into the concrete slab beneath the finishes, and cause corrosion of the reinforcing steel.

| Item No. | Observation | Recommended Action Plan | Recommended Timeline |
|---|---|---|---|
| 6 | 4th Priority 4 - Water ingress | Waterproofing on the roof slab is to be applied. Moreover the roof slab drainage system should be investigated and improved. | 6-months |
