# Jamuna Apparels

94/95 (Old), 46 (New), Block –C, Tongi I/A, Tongi, Gazipur  
(23.901086N, 90.399888E)

7<sup>th</sup> November 2013

# Building Observations

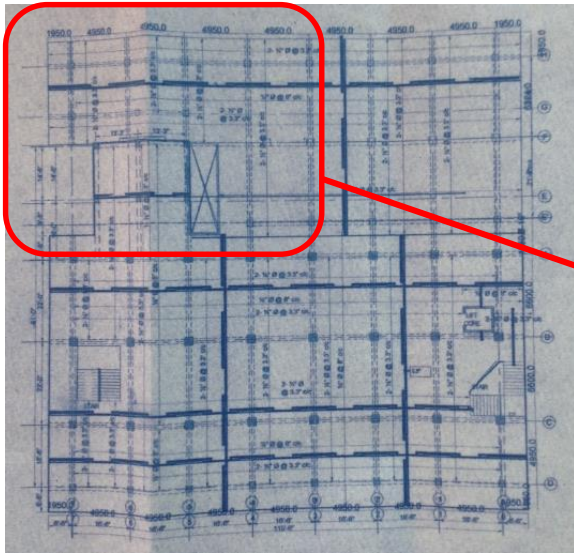
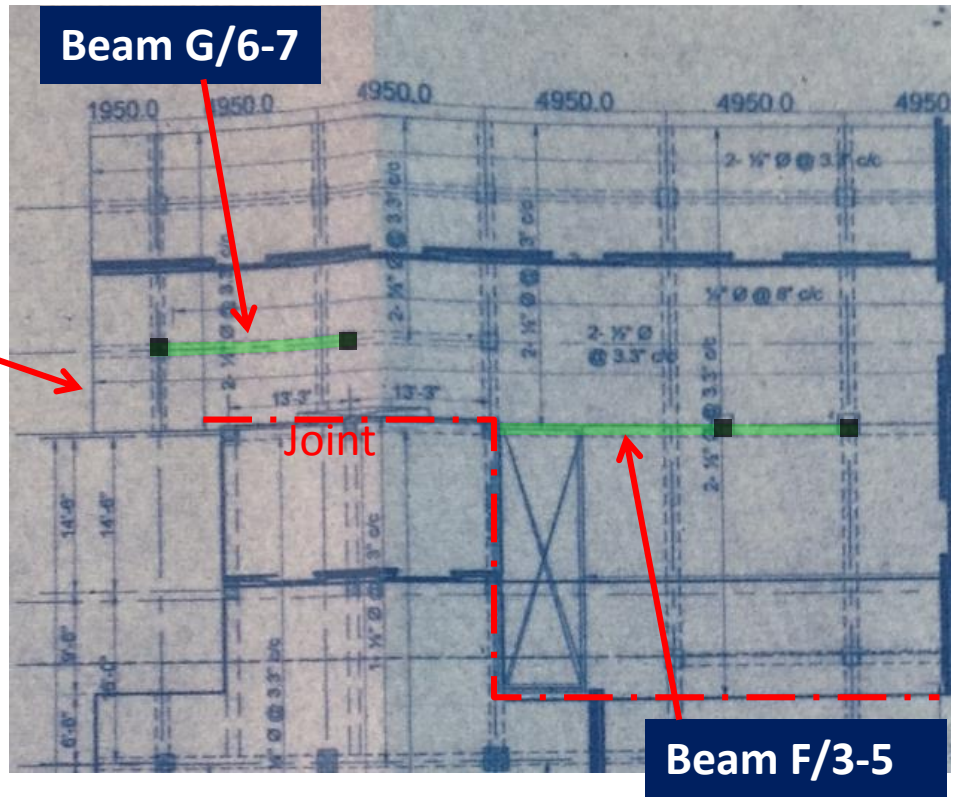
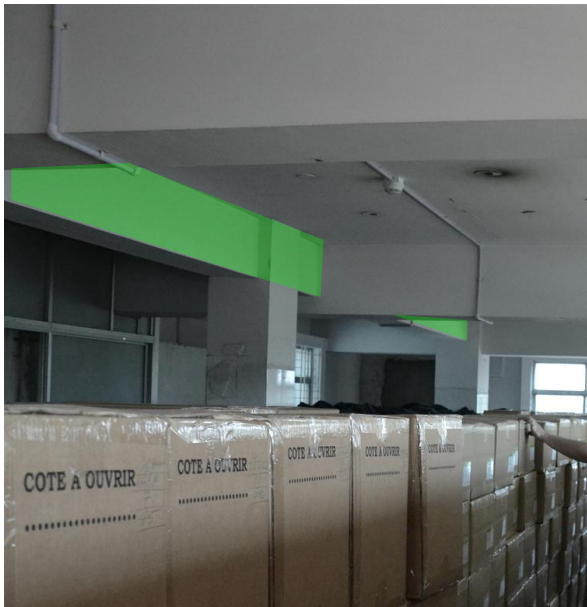
# Floor and Ground Beams grids G/6-7 & F/3-5

Columns supporting the beams indicated are offset from the main grid. From a cursory check of the reinforcement drawings the beams indicated do not comply with code requirements.

portion	beams and 0.96 in2/d as stirrup	bar scanning test	
6.	Required reinforcement in maximum loaded beams in south portion as per existing loadings	2.85 in2 top rebar in 27.5" depth beams and 0.72 in2/d as stirrup	Analysis (1.05D + 1.275L + 1.4025E)	Two beams (G3 to G7 and F3 to F5) are inadequate
	Provided reinforcement in maximum loaded beams in south portion	3.5 in2 top rebar in 27.5" depth beams and 0.72 in2/d as stirrup	Drawings and by re-bar scanning test	
7.	Required reinforcement in maximum loaded beams in north portion	2.27 in2 top rebar and 0.48 in2/d as stirrup in 27.5" depth beams	Analysis	Adequate

**Remedial Solution for beam support to be implemented as per Checking Engineers report**

Item No.	Observation	Recommended Action Plan	Recommended Timeline
1	Floor and Ground Beams grids G/6-7 & F/3-5	Remove Storage Loading from area indicated	<b>Immediate - Now</b>
2	Floor and Ground Beams grids G/6-7 & F/3-5	Check with Engineer that light access loading of 1.5KN/m <sup>2</sup> is acceptable for access of operatives prior to completion of remedial support works	<b>Immediate - Now</b>
3	Floor and Ground Beams grids G/6-7 & F/3-5	Actions have already been identified by the building owner's engineers and tenders have been issued for construction remediation. Remediation works should be completed to comply with the building engineers requirements	<b>6-weeks</b>
