# A Plus Industries Ltd.

Plot-28, Sec-7, Milk Vita Road, Mirpur, Dhaka; Bangladesh  
(23.820062N, 90.359582E)  
10 December 2013

# Observations

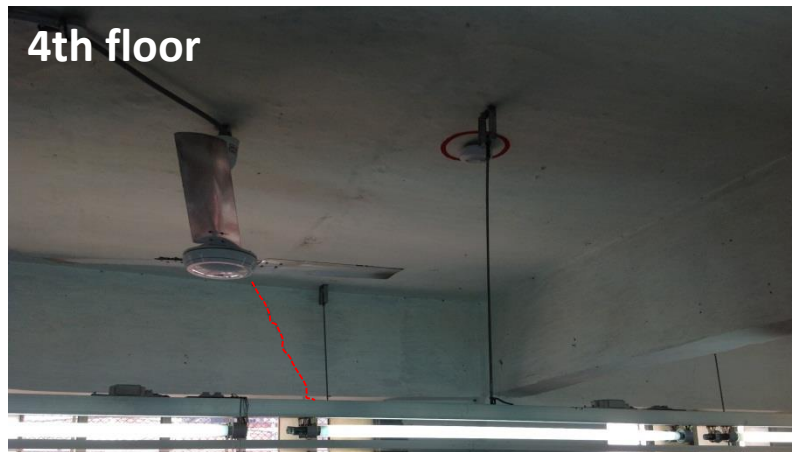
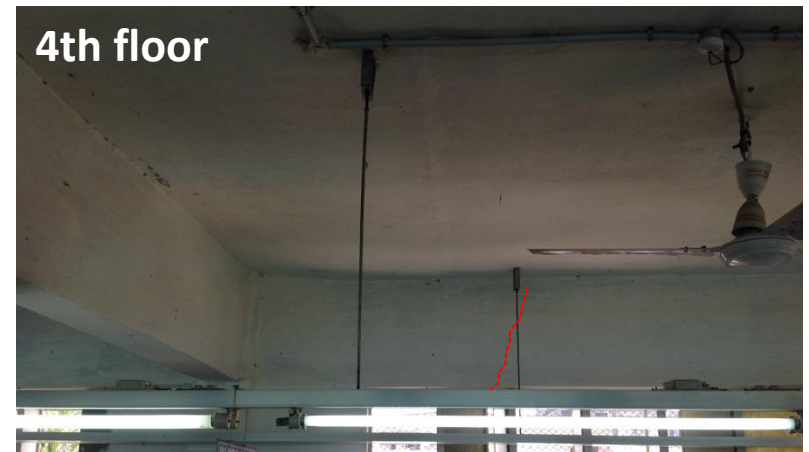
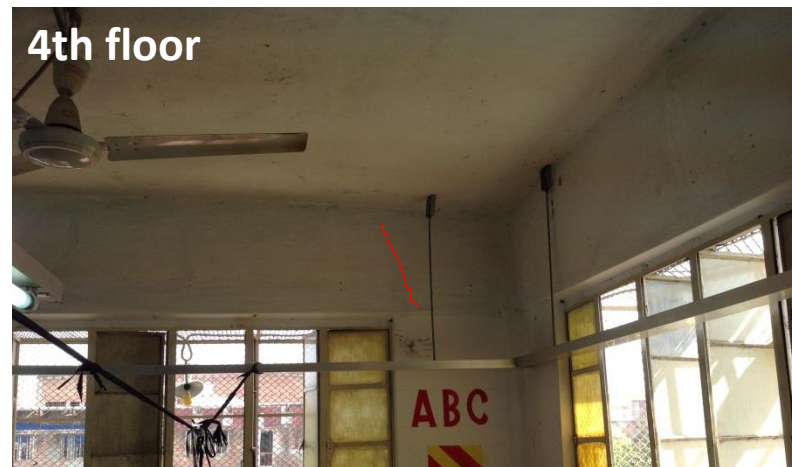
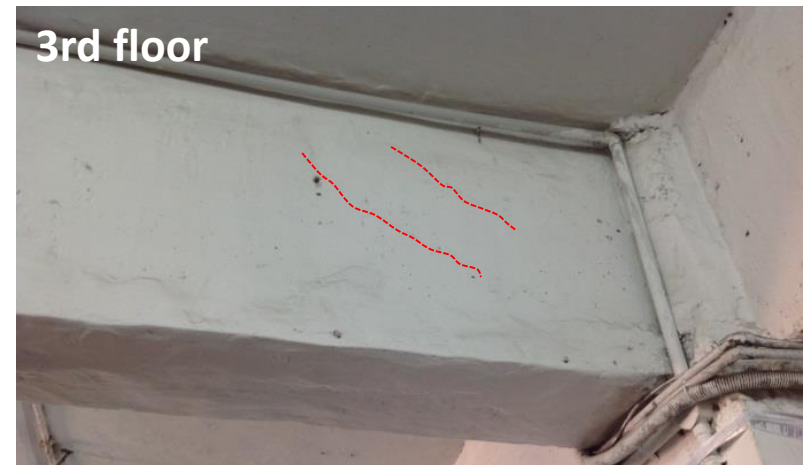
# Inclined cracks on side beams

**Inclined cracks**  
Monitor cracks on beams. Conduct regular inspection of cracks. Investigate if cracks are only in the plastering.

Item No.	Observation	Recommended Action Plan	Recommended Timeline
7	Concrete strength in columns	Continue to implement load plan	6-months
8	Inclined cracks on side beams near supports in some located areas	Monitor cracks on beams. Conduct regular inspection of cracks. Investigate if cracks are only in the plastering.	6-months
9	Inclined cracks on side beams near supports in some located areas	If cracks grow larger, removing all items above the slab and close working areas below the affected areas . Engage an engineer to investigate, repair and strengthen the beams.	6-months
10	Non engineered steel structure for additional mezzanine above ground floor	Addition structures should be designed and upgraded to support code loads by the building Engineer, or they should be vacated and removed.	6-months
11	Leaking water causing damage and corrosion	Building engineer to inspect slabs in room near washrooms.	6-weeks

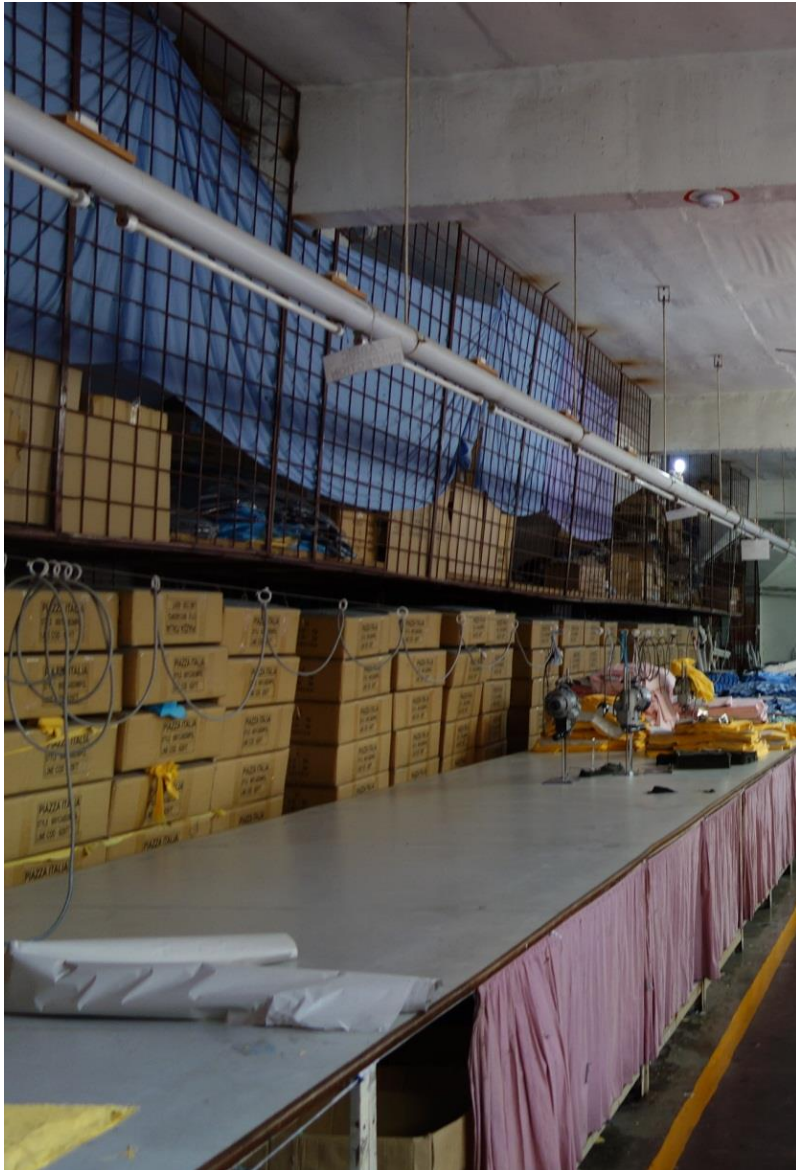
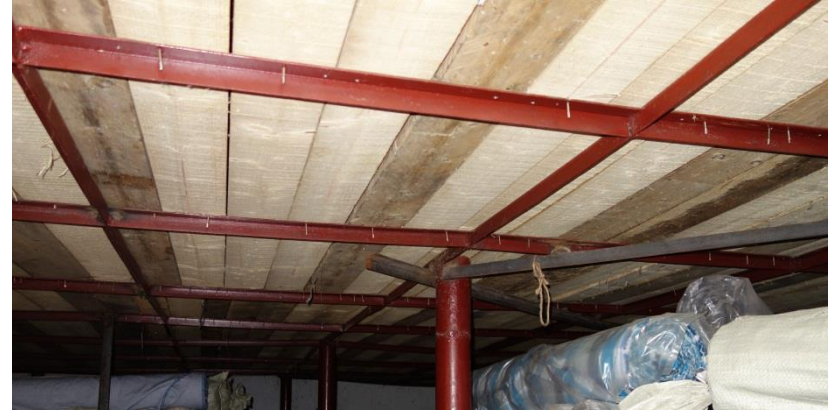
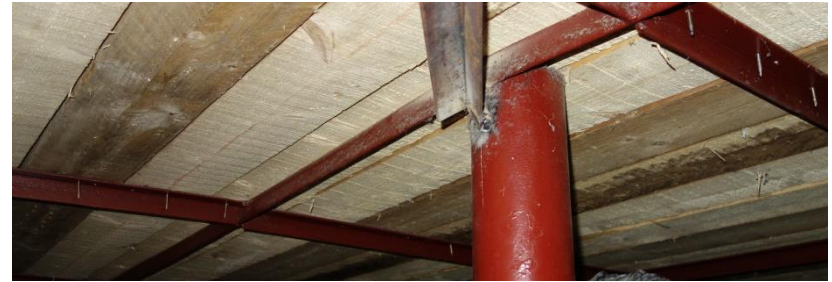
# **Non engineered steel structure for additional mezzanine above ground floor**

## Lightweight steel mezzanine non engineered

Connections not designed

Connections executed improperly

Additional not designed elements have been added according to what has been needed

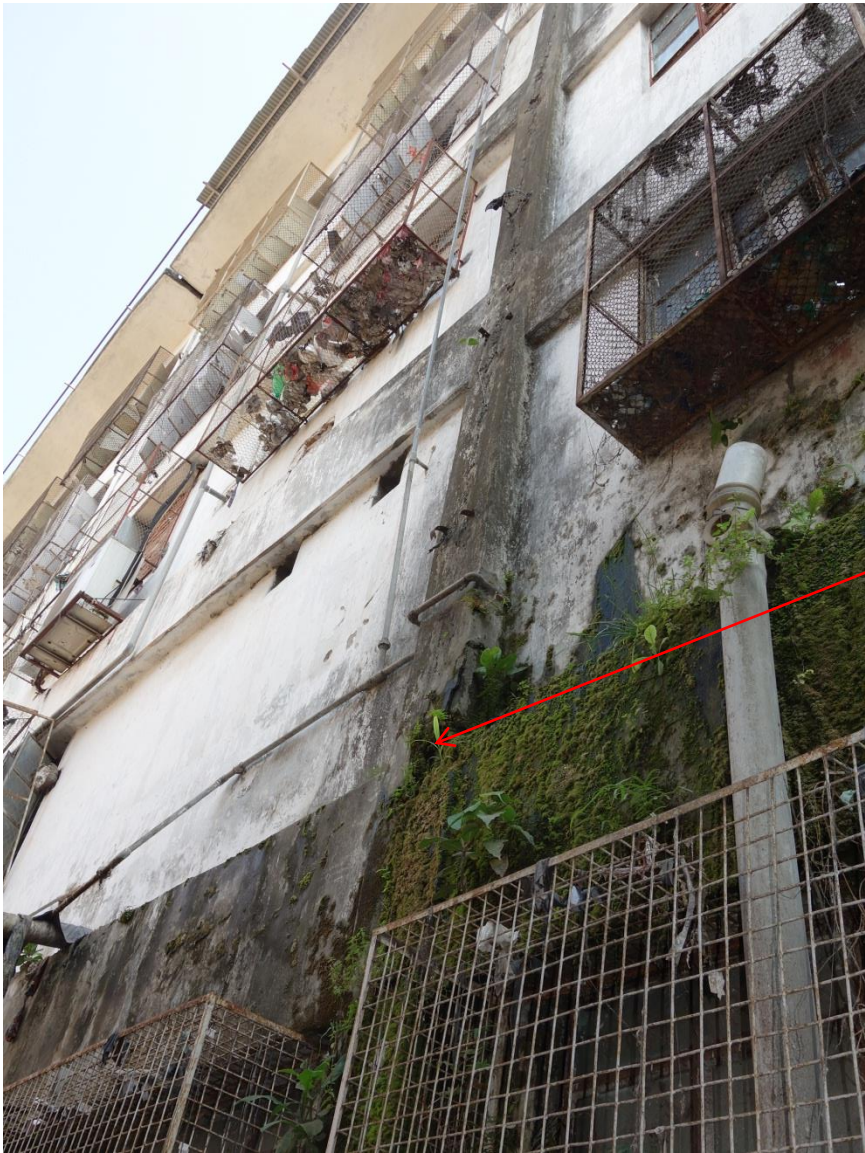
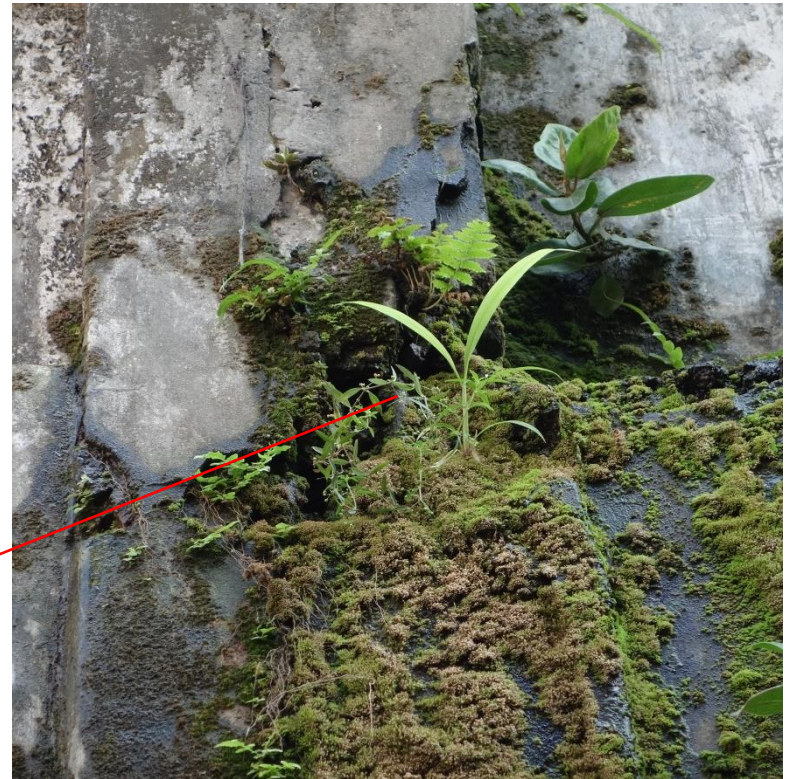
# Leaking water causing damage and corrosion

Running water visible.  
Unmanaged leaking drainage causing  
corrosion to façade and structure.  
Spalled concrete on column. Column  
rebars exposed

12	Leaking water causing damage and corrosion	Manage drainage from above levels to downpipes to avoid structural corrosion due to continuous moisture.	6-months

Item No.	Observation	Recommended Action Plan	Recommended Timeline
13	Leaking water causing damage and corrosion	Mitigate water source from washrooms and roof. Manage drainage, waterproof system and isolating layer.	6-months
14	Leaking water causing damage and corrosion	If required, specify a treatment system for corrosion and concrete repair	6-months
15	High loads on bonded/storage areas on roof	Building's Engineer to ensure the structure is not loaded beyond capacity. We recommend limit stack height to 1.80m (1.50x1.50m area) and keep 0.60-0.70 m cleared strip around. Limit height to 1.80 m for loose clothing.	6-months
16	High loads on bonded/storage areas on roof	Building Engineer to create controlled loading plans for all floors	6-months
17	Non engineered steel structure on roof	Building engineer to check the structure and its supports and propose additional reinforcements and stability system.	6-months

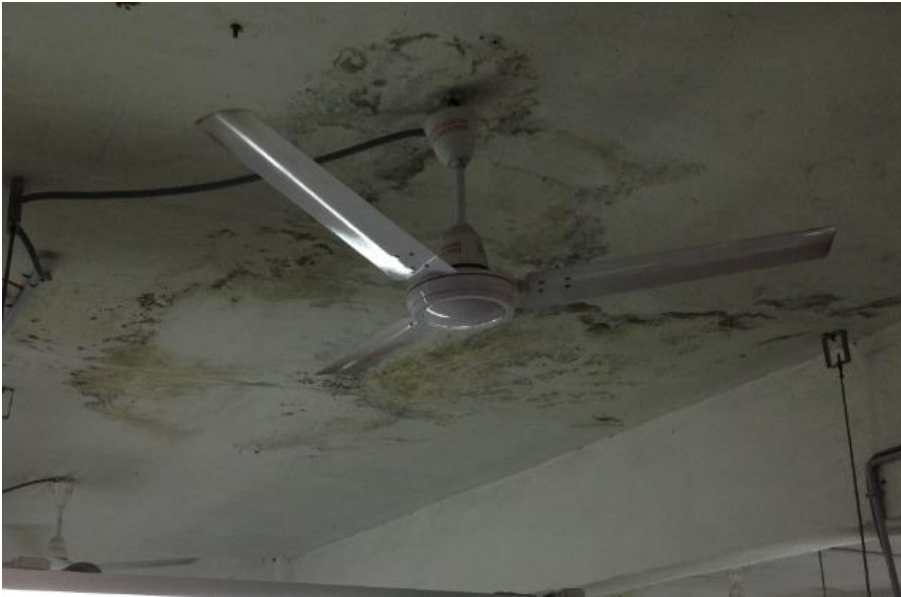
Leaking from roof and washrooms causes constant wetting causing corrosion and spalling.

Local concrete spalling caused by corrosion of lower reinforcement bars.

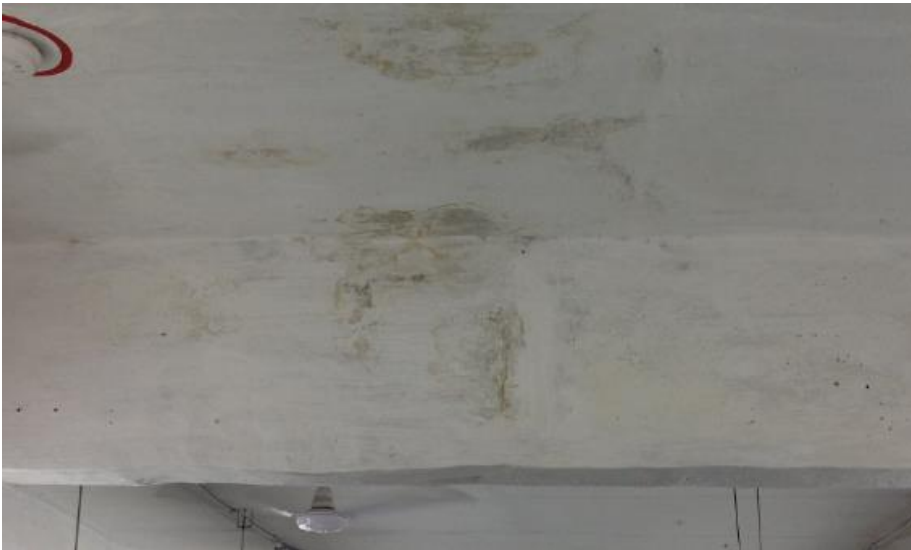
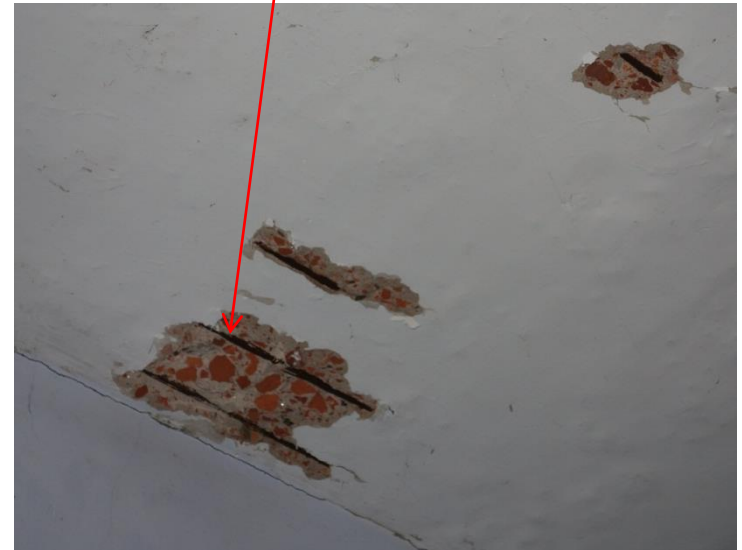
**Leaking water**

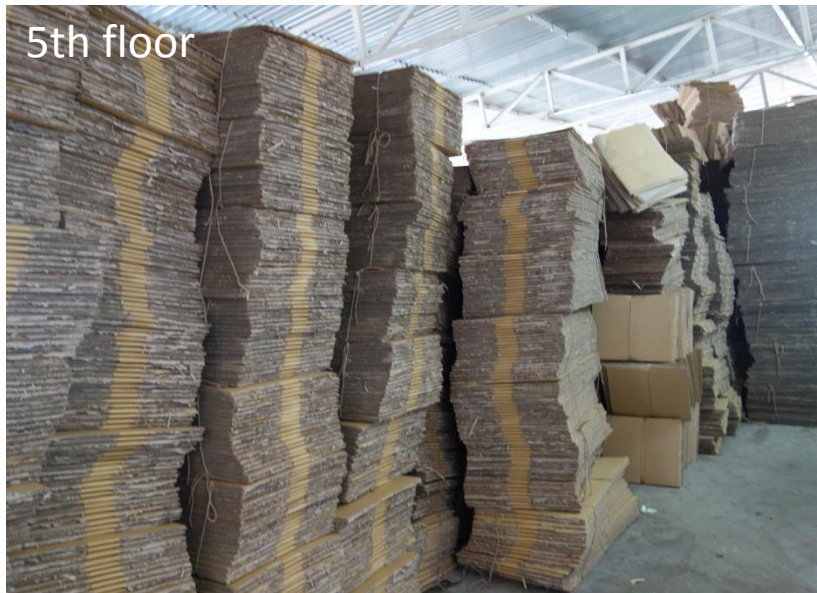
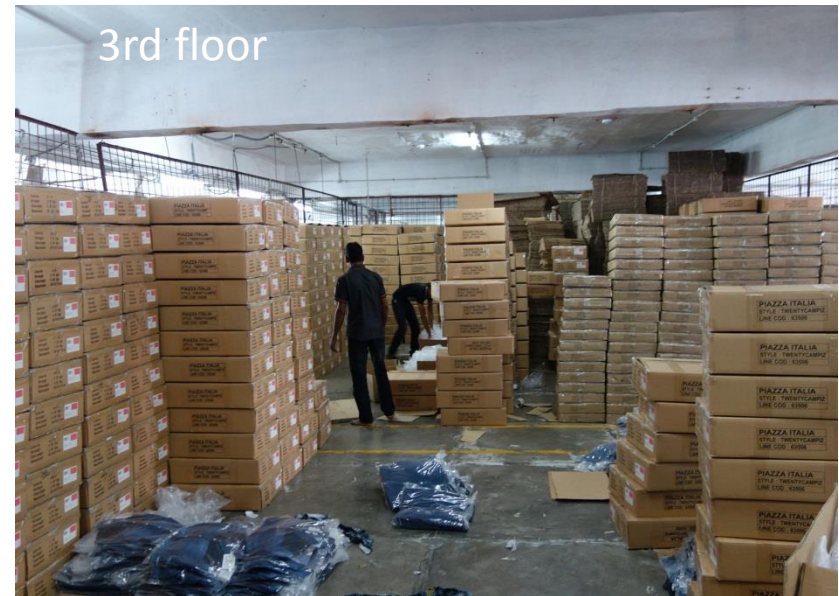
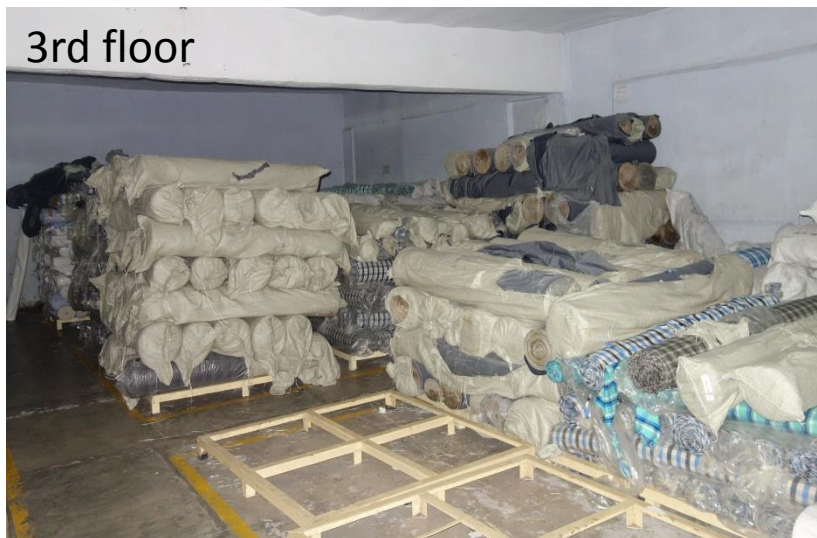
# High loads on bonded/storage areas on roof

Building designed for factory/commercial use. Live load assumed 3.0 kPa  
Plan and height restrictions to be introduced to prevent future overloading.  
Limit stack height to 1.80 m (1.50x1.50 area) and keep 0.60-0.75 m cleared strip around.

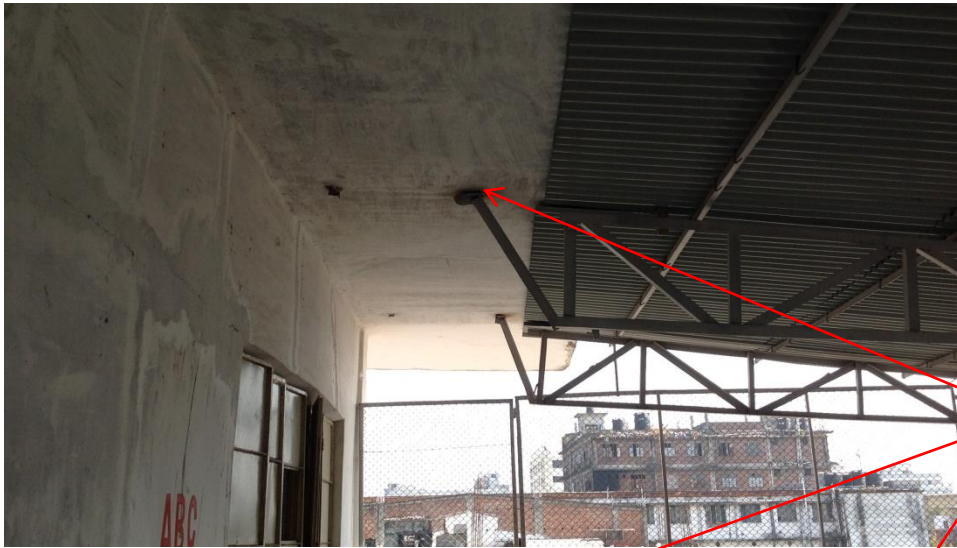
## Non Engineered steel structure on roof

Structure without bracing.

Connections not designed, executed Improperly and supported on cantilever ends and parapets at cantilever ends.

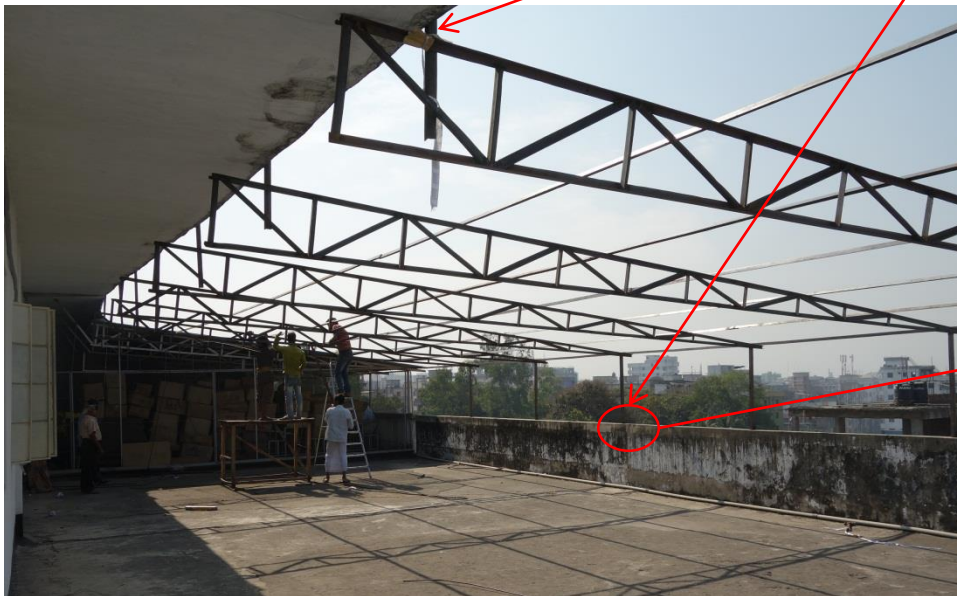
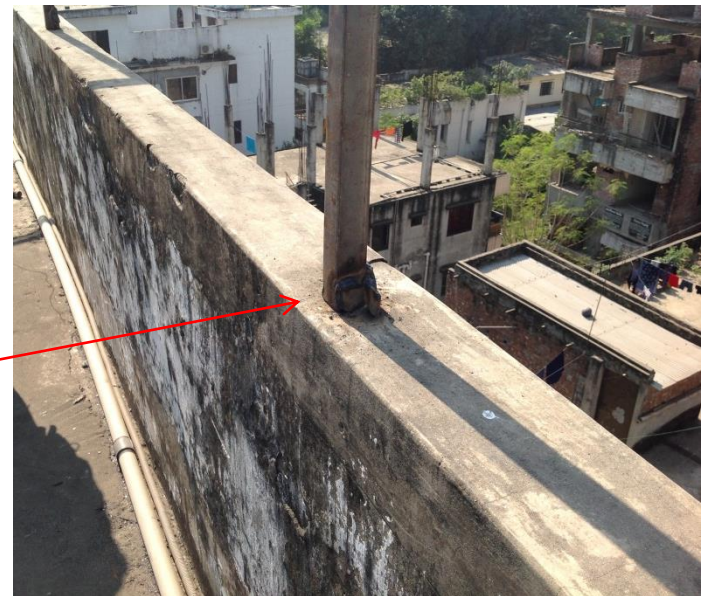
## Non engineered structure

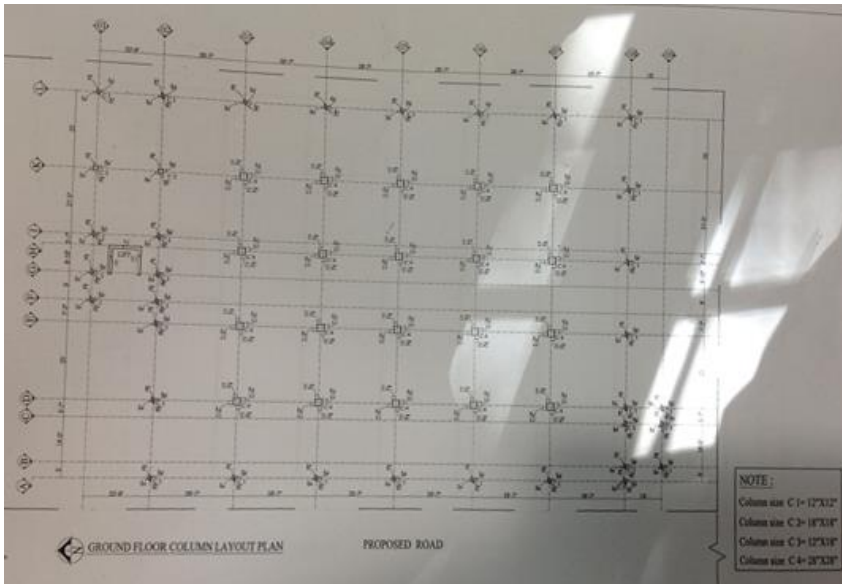
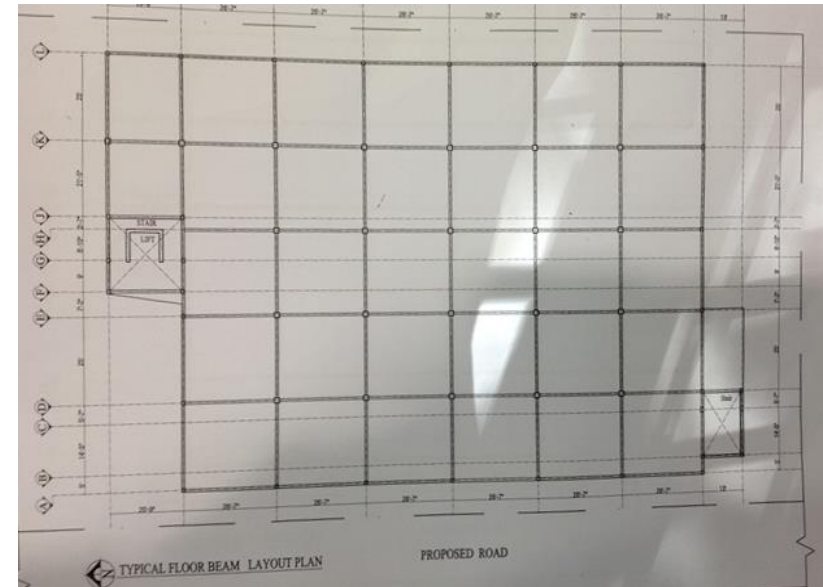
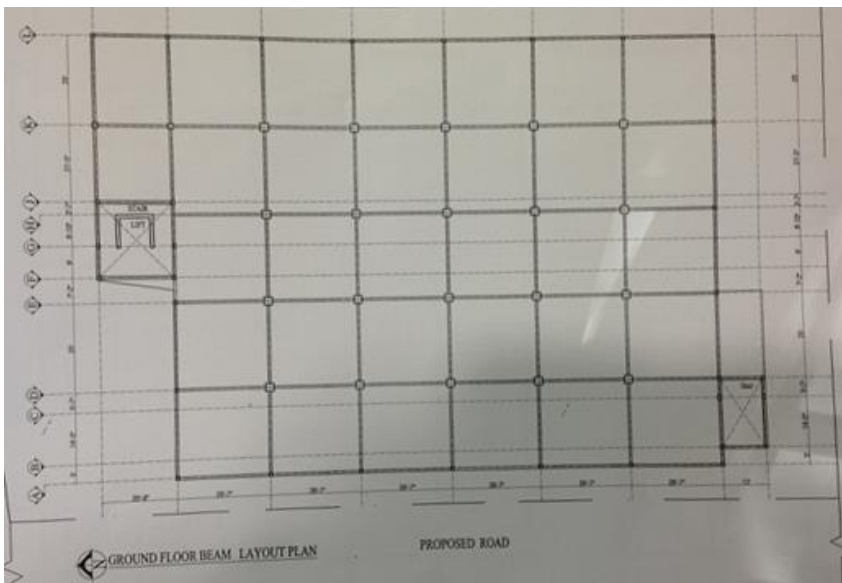
**Structural drawings are not completed**

Structural drawings are not completed, only geometry drawings and layout were shown for the concrete structure.

No information about the metal roof structure.

18	Structural drawings are not completed	Building engineer to check, collect information and produce accurate and complete as-built documentation soonest.	6-months
