Techno Fiber Ltd.(11518) Network Clothing Ltd.(10863)

Afiz complex, Chowdhybari, Vora, Gazipur, Bangladesh

28.MAY.2014

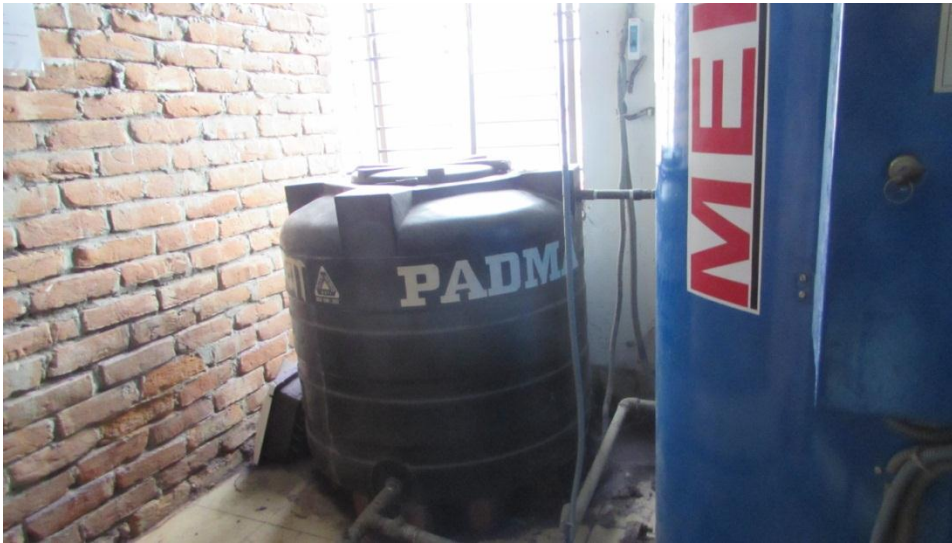
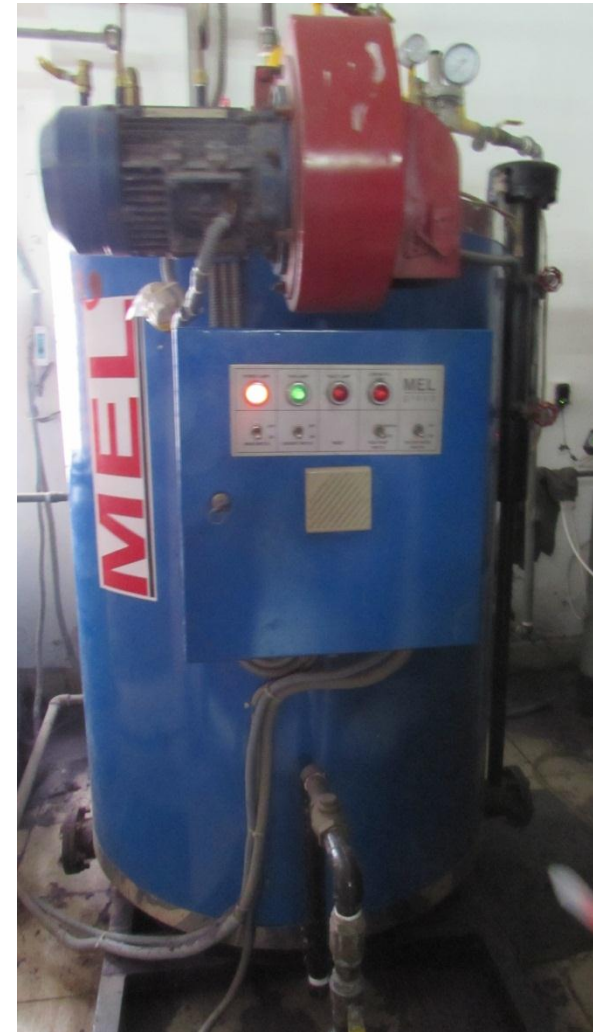
In the boiler room on the 5th Floor, there doesn't seem to be any information regarding the operating weight of the boiler. Nevertheless, it appears to be heavy, and there is significant vibration. It is suggested to check to see if the boiler and water tank weight falls within the design live load of the building in this area.

Item No.	Observation	Recommended Action Plan	Recommended Timeline
1	1st Priority 1 - Boiler room on the 5th floor	Building Engineer to check that the weight of the boiler and water tank does not exceed the permissible live load of the floor system	Immediate - Now
2	1st Priority 1 - Boiler room on the 5th floor	If the loading from the boiler and water tank exceeds the permissible imposed load of the floor, strengthening works to be designed to alleviate the loading on the existing floor.	6-weeks
3	1st Priority 1 - Boiler room on the 5th floor	If required, construct the strengthening works as per the approved strengthening works details.	6-months
4	1st Priority 2 - Steel roof truss added over roof to form dining area	Check with the appropriate authorities as to whether the roof area can be used for the dining hall purpose Building Engineer to properly assess the roof structure or perform as part of a Detailed Engineering Assessment, to ensure full compatibility with the design codes.	6-weeks

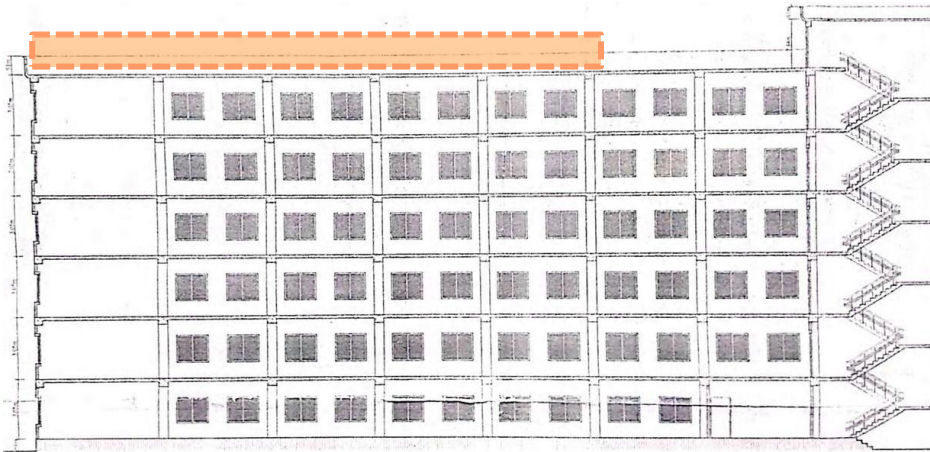
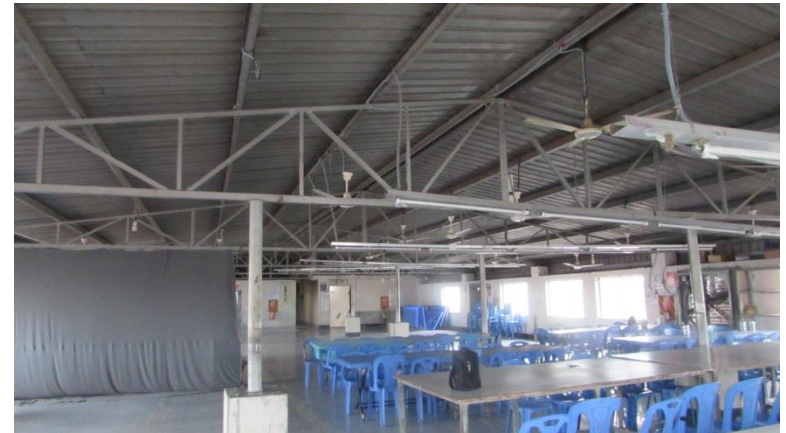
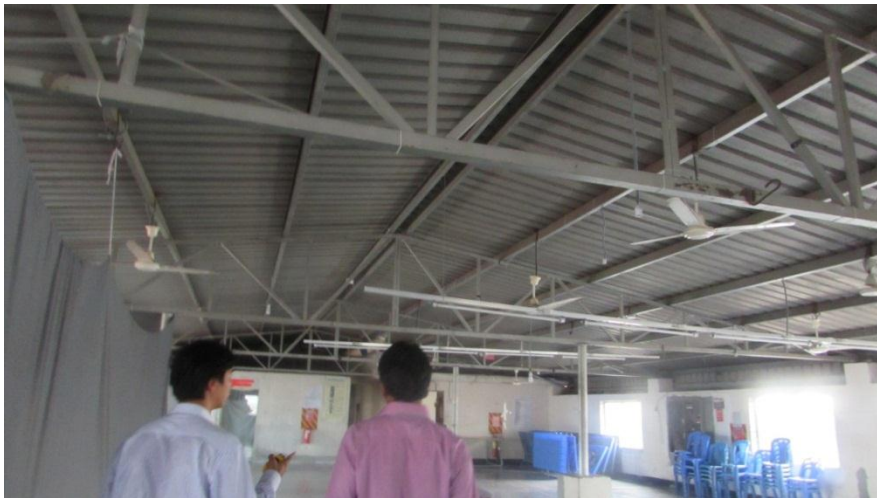
The dining area on the roof is covered by an additional lightweight steel roof. This does not appear on any structural or planning drawing. There are also no calculations for this roof structure.

5	1st Priority 2 - Steel roof truss added over roof to form dining area	If found deficient, appropriate modifications to the roof truss to be made to ensure safety of the structure. Drawings to be updated accordingly with full structural details	6-months
6	1st Priority 3 - Lateral load resisting system appears to be lacking from the structural design.	Building Engineer to carry out structural analysis to justify the building performance with regard to the lateral load resisting system. Alternatively, this can be carried out as part of a Detailed Engineering Assessment.	6-weeks
7	1st Priority 3 - Lateral load resisting system appears to be lacking from the structural design.	If the building is found not to comply with the performance conditions, remedial works to be designed and implemented to ensure satisfactory lateral stability.	6-months

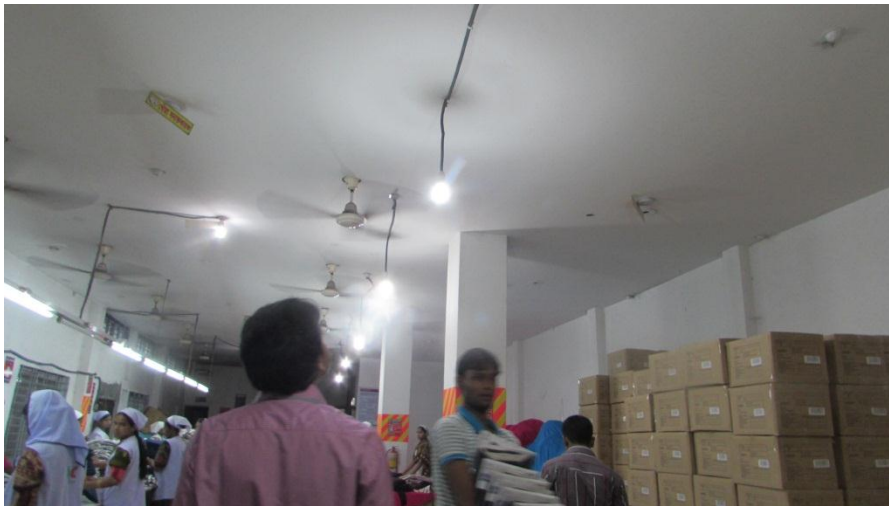
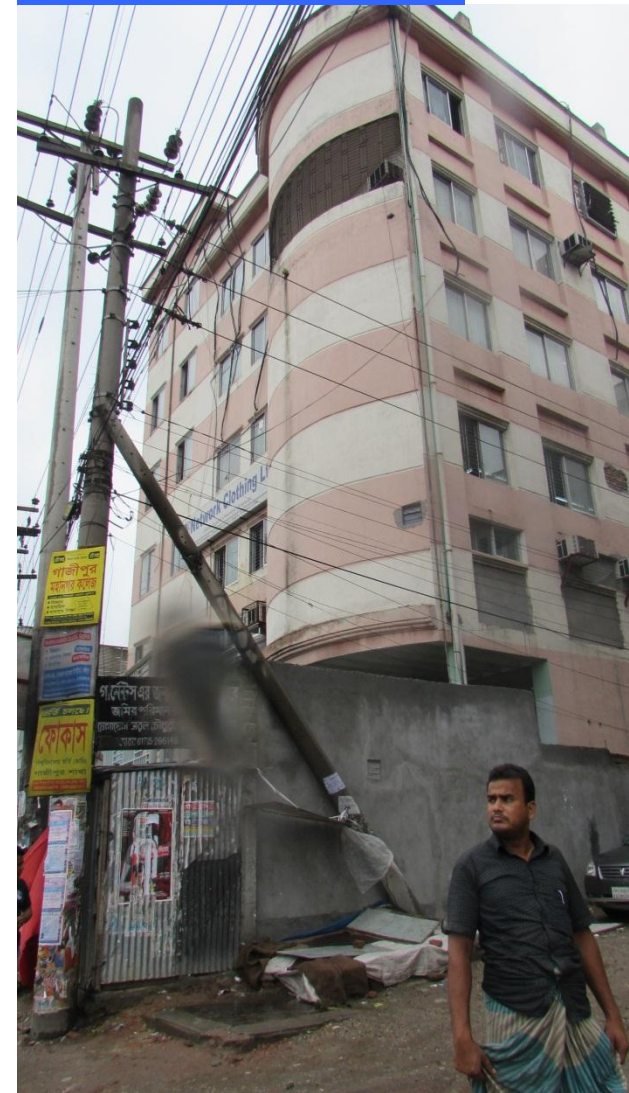
Lateral load resisting system appears to be lacking from the structural design

The overall structural arrangement in buildings does not appear to have any rational form of lateral stability system to resist the wind or earthquake loads. It is essential to design for lateral loads. We require that these items be investigated as part of a Detailed Engineering Assessment.

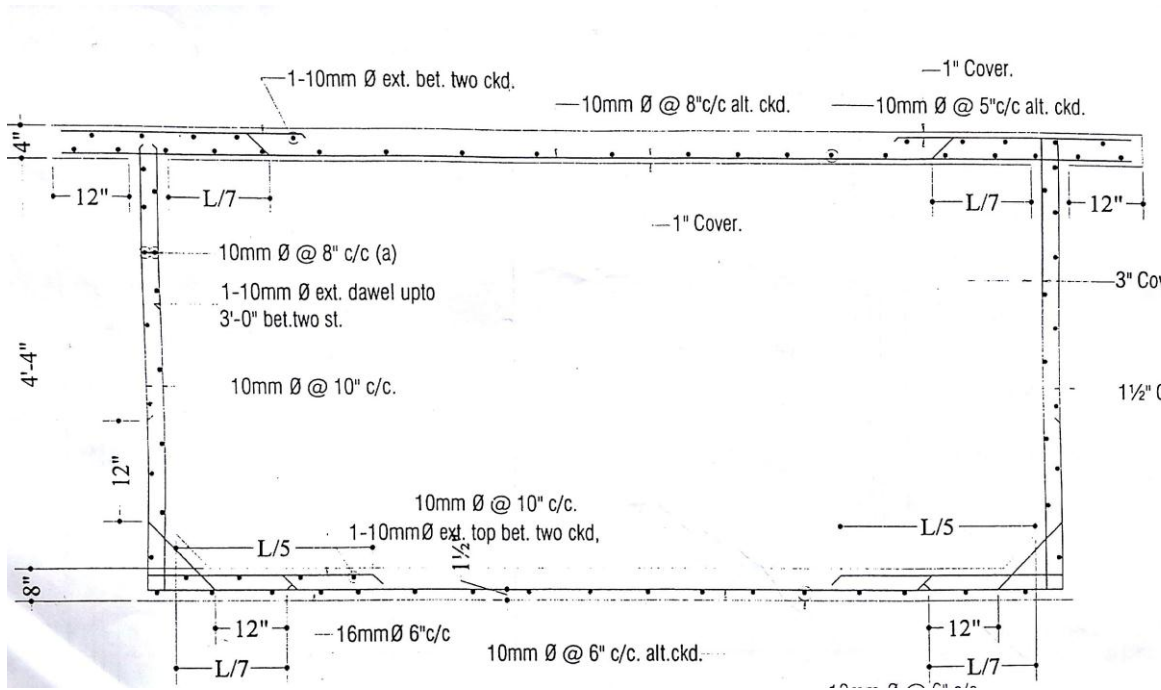
Drawings do not show the framing plans or supporting structure for the water tank

Although the water tank RC detail is provided, there are no location plans or overall framing plans in the drawings.

The supporting structure (above the staircase shaft) is also missing.

Due to the size of the water tank, the structure of the supporting elements should be evaluated and documented in the drawings.

Item No.	Observation	Recommended Action Plan	Recommended Timeline
8	2nd Priority 3 - Drawings do not show the framing plans or supporting structure for the water tank.	Building Engineer to check the record drawings/as built drawings for consistency with the as-built structural condition, and make modifications to the drawings where necessary	6-weeks
9	2nd Priority 3 - Drawings do not show the framing plans or supporting structure for the water tank.	Detailed Engineering Assessment to be carried out to determine unknown areas of the structure in order to complete the compilation of the as-built structural drawing records.	6-months
10	3rd Priority 3 - As-built concrete does not match with the drawing specifications	Building Engineer to check the record drawings/as built drawings for consistency with the as-built structural condition, and make modifications to the drawings where necessary	6-weeks

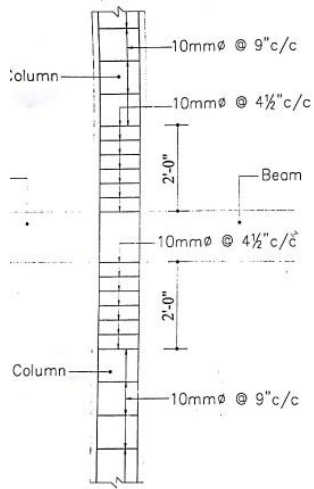
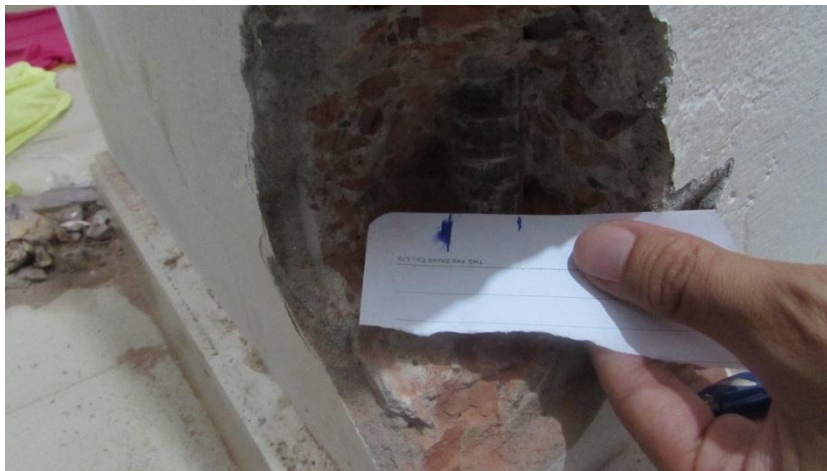
Column material in drawing inconsistent with out side

11	3rd Priority 3 - As-built concrete does not match with the drawing specifications	Detailed Engineering Assessment to be carried out to determine unknown areas of the structure in order to complete the compilation of the as-built structural drawing records.	6-months
