# Esquire Knit Composite

22/58 Kanchur, Sonargaon, Narayangonj  
(GPS Coordinates 23.7100,90.5177)

17<sup>th</sup> September 2013

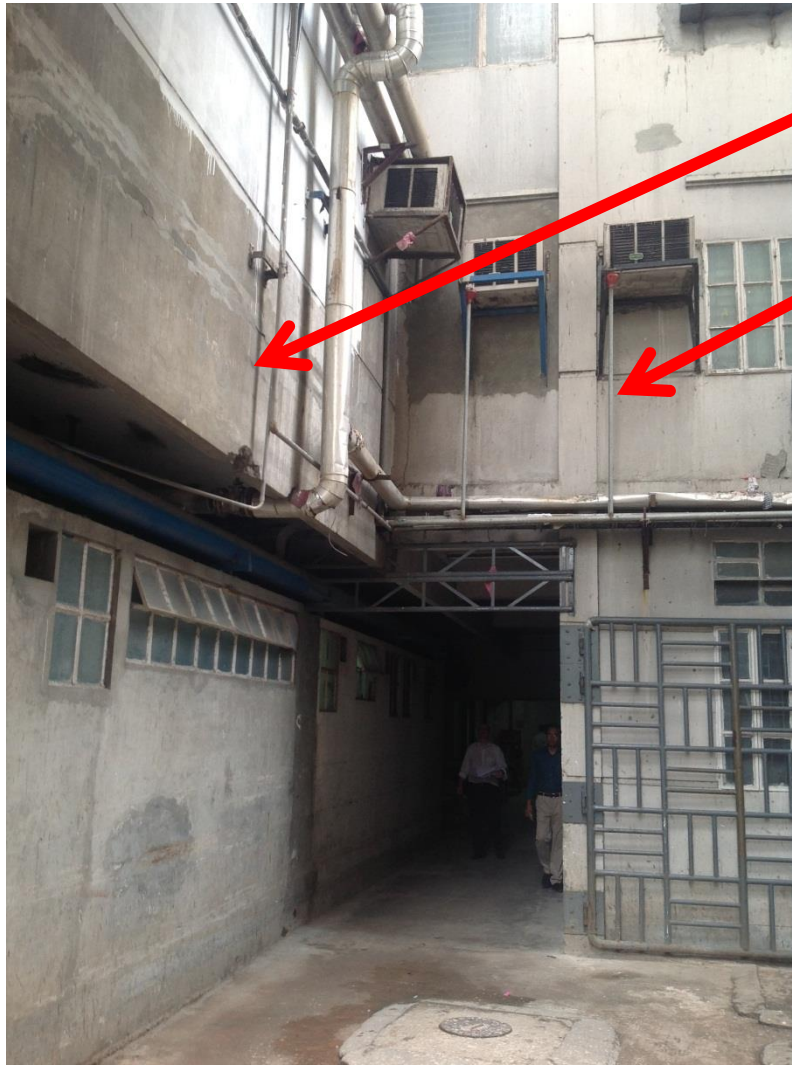
# **Additional 3 storey building connected to existing**

**ITEM 1:** Additional 3 storey building constructed to the north at later date without drawings or permit. Connected to existing building. Evidence of differential settlement where the two buildings are connected at ground level. Cracking along the junction between the two.

| Item No. | Observation | Recommended Action Plan | Recommended Timeline |
|---|---|---|---|
| 1 | Additional 3 storey building annex | Permit and as-built drawings should be provided for additional building. The as-built drawings should indicate the construction joint detail between the existing and new build at each level | 6-months |

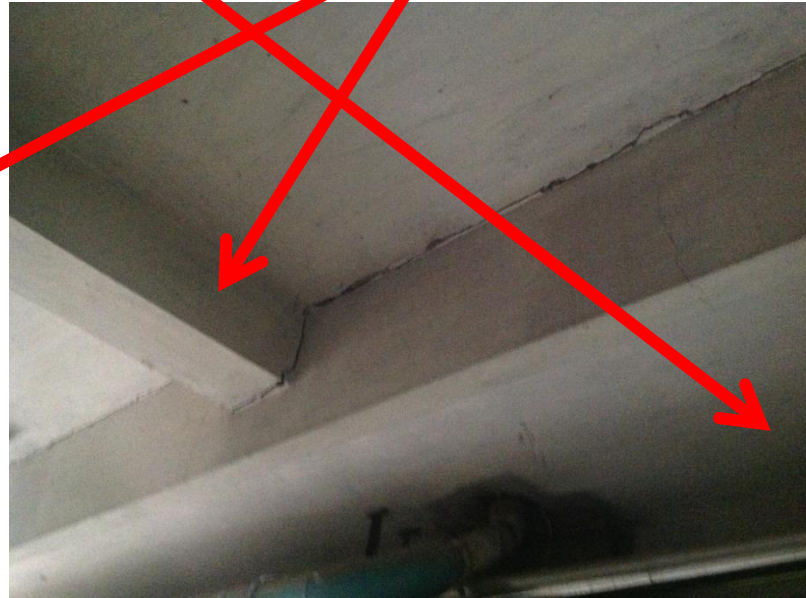
**Bldg 2 structure cantilevers towards Bldg 1. Finishes are continuous over the joint between the two and have cracked due to differential movement**

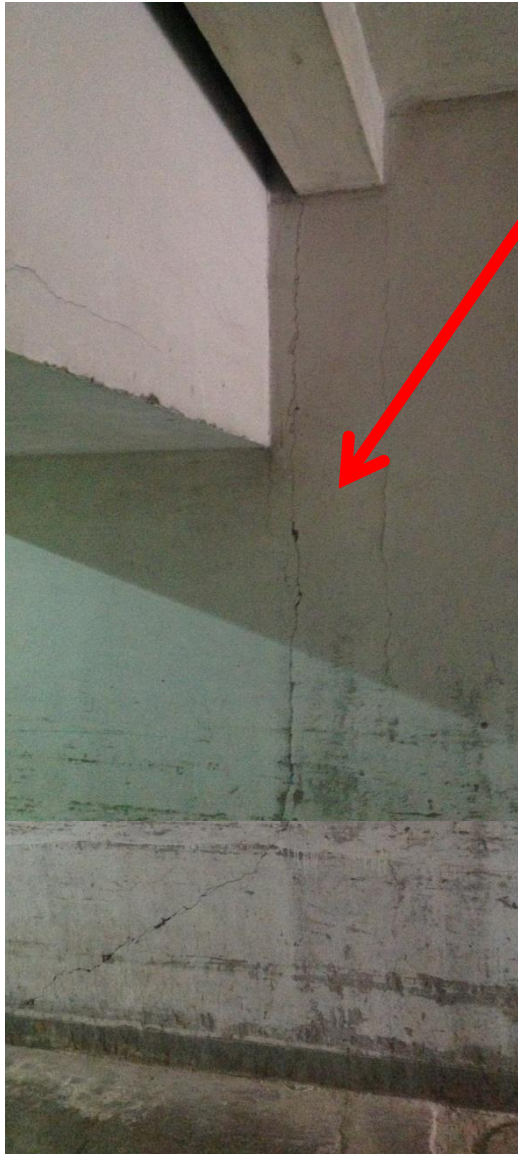
Cracking in walls likely caused by differential settlement between Bldg 1 and Bldg 2

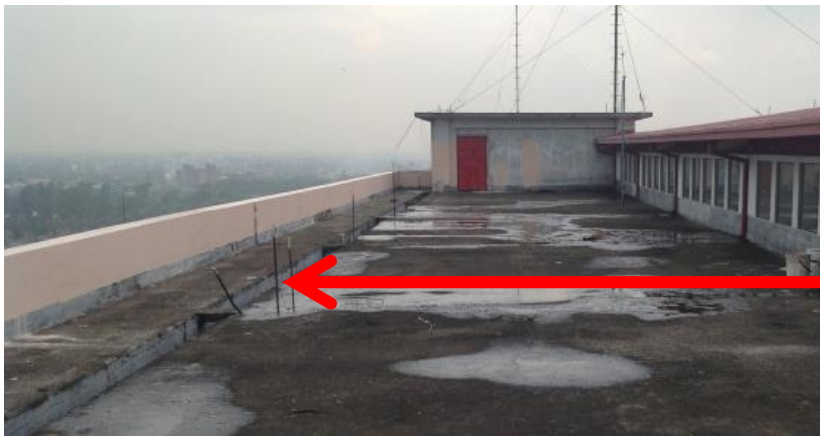
**Roof drainage gully  
with downpipe  
adjacent to columns**

| Item No. | Observation | Recommended Action Plan | Recommended Timeline |
|---|---|---|---|
| 2 | Perimeter columns are permanently wet due to roof drainage water running down the side of the column between roof and Level 11. Rebar cover reduced to zero in some places. | Fix or re route drainage from roof level to avoid structural corrosion due to continuous moisture | 6-months |

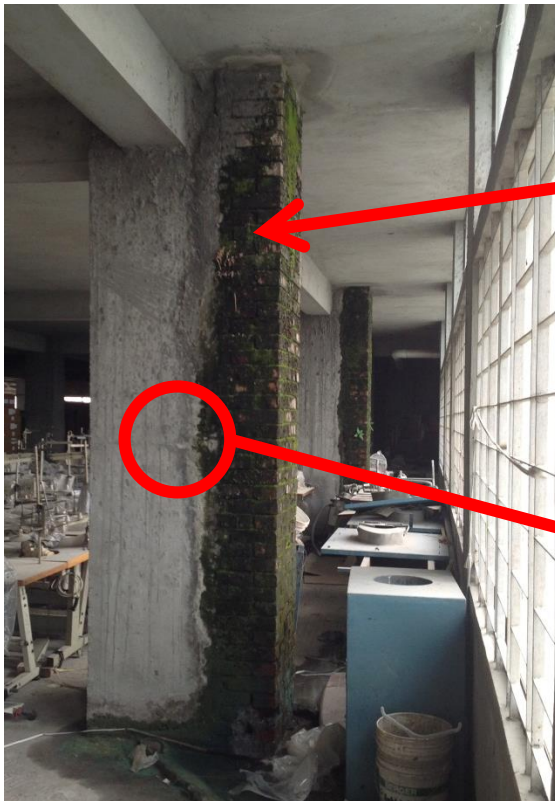
**Downpipes enclosed by  
brickwork- vegetation  
growth indicates moisture.  
Running water visible**

| Item No. | Observation | Recommended Action Plan | Recommended Timeline |
|---|---|---|---|
| 3 | Perimeter columns are permanently wet due to roof drainage water running down the side of the column between roof and Level 11. Rebar cover reduced to zero in some places. | Break out brick drainage enclosures in order to inspect columns. Repair any corrosion damage and add cover. | 6-months |

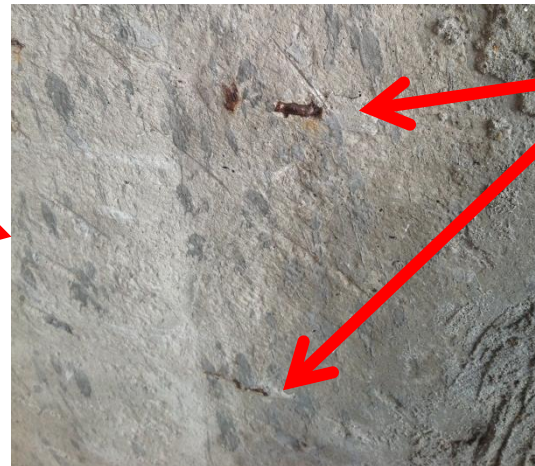
**Links with no  
cover**

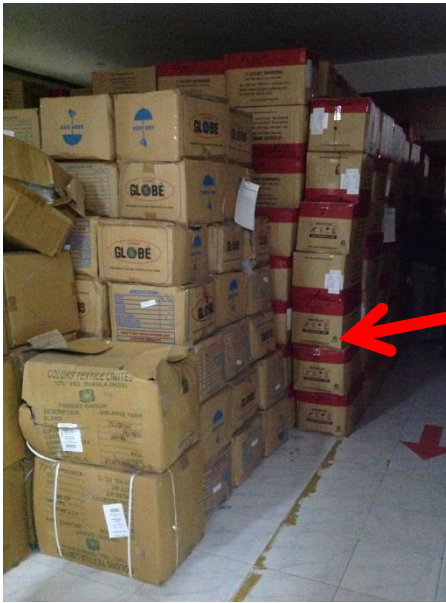
**Dense Storage up to approx  
16KN/m<sup>2</sup> noted on some  
levels**

**Plan and height restrictions  
to be introduced to prevent  
future overloading.**

| Item No. | Observation | Recommended Action Plan | Recommended Timeline |
|---|---|---|---|
| 5 | Materials stacked close to ceiling in densely spaced piles | Create controlled loading plans for all floors designating where storage can be placed and can not be placed. Designated areas must be posted and communicated to the factory management | 6-months |

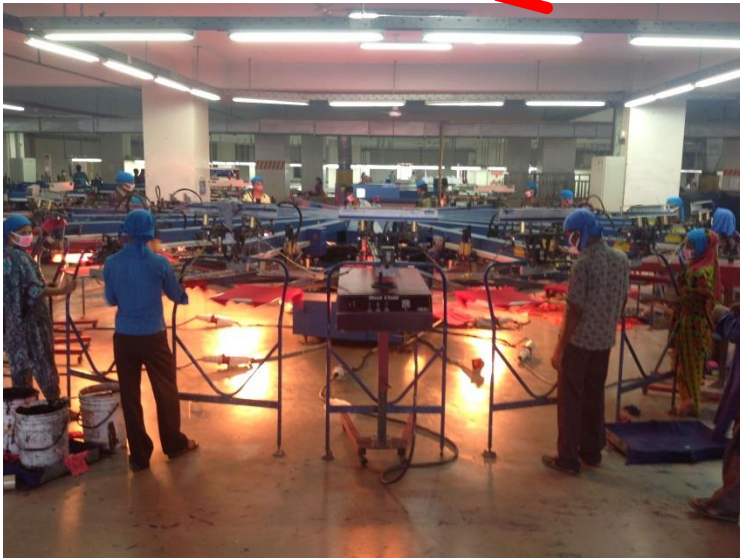
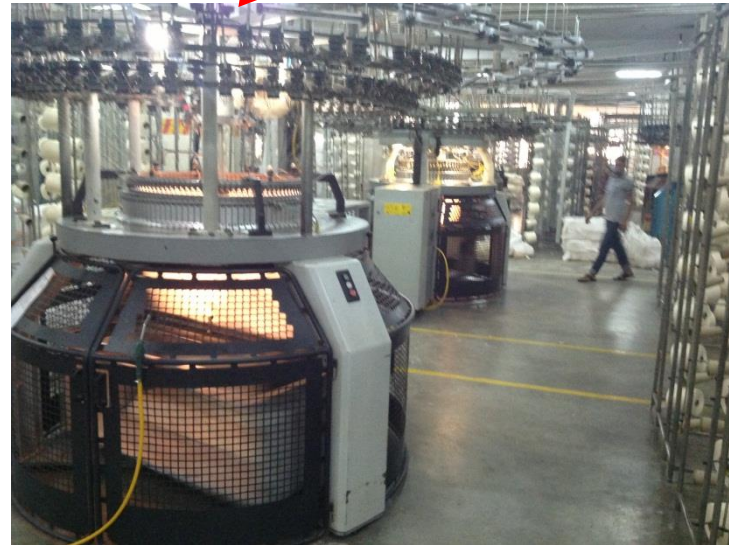
**Heavy Equipment Loading  
on suspended floors –  
Floor slabs to be checked  
against loading given on  
equipment data sheets**

| Item No. | Observation | Recommended Action Plan | Recommended Timeline |
|---|---|---|---|
| 4 | Materials stacked close to ceiling in densely spaced piles | Design check on floor slabs against equipment data sheet loading to be carried out for printing and knitting floors | 6-months |

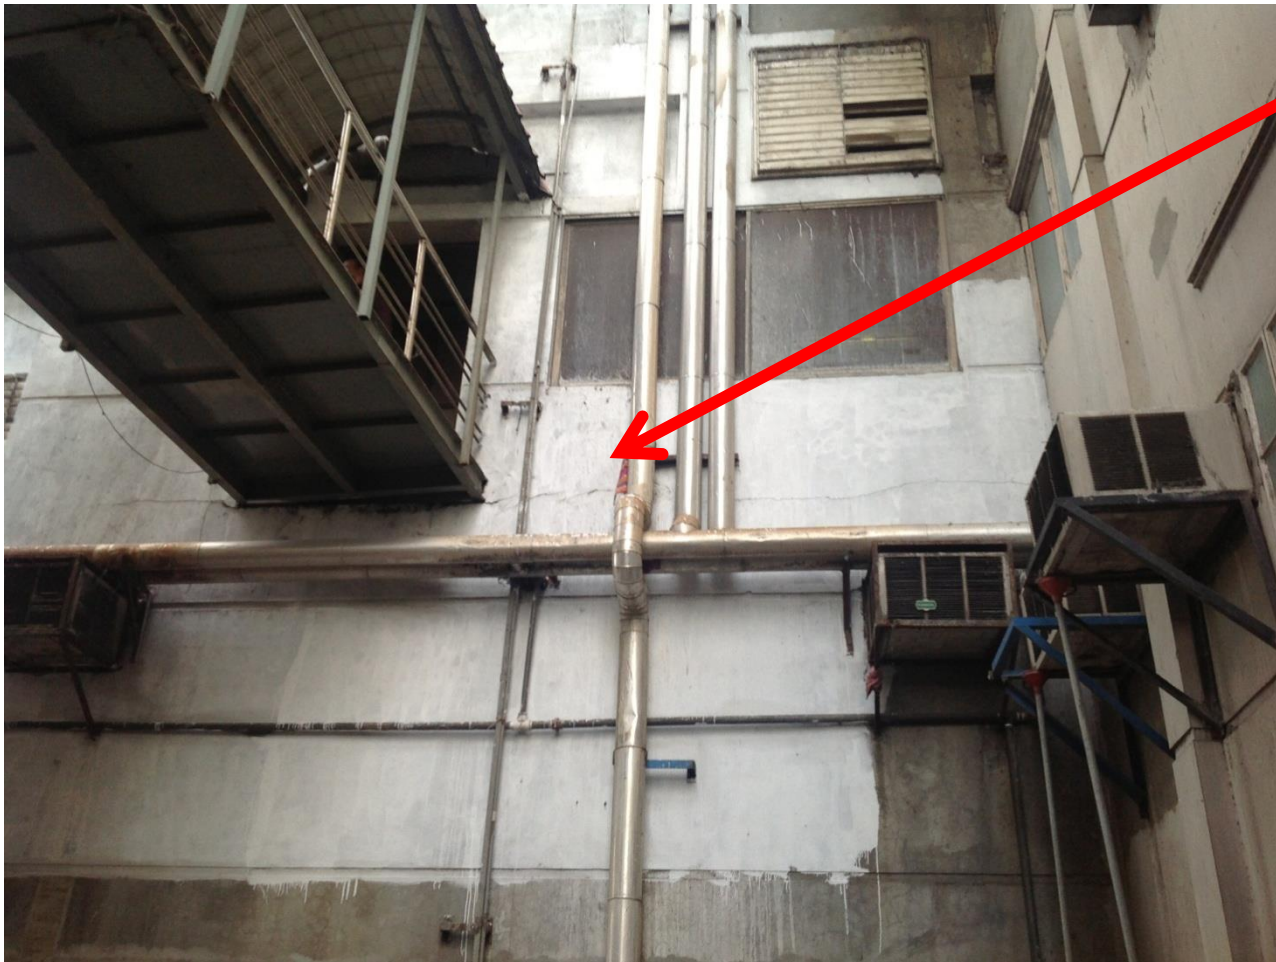
**Crack in Façade under  
Bridge Link**

**ITEM 4:** Cracking to Façade propagating from Bridge link at level 2 above ground on north façade – support conditions are unknown and some movement is evident from the horizontal cracking in the facade

| Item No. | Observation | Recommended Action Plan | Recommended Timeline |
|---|---|---|---|
| 6 | Bridge Links on North Facade | Provide as built drawings and Engineer's Calculation<br>Check for Link Bridges including connection, support details at North Façade and Justification for support on existing Buildings | 6-months |
