Ehsan Garments Moonlight Garments Ltd

Kuniapachar, Targach, Gazipur, Dhaka
(+23.928808N, 90.389160E)

25 September 2013

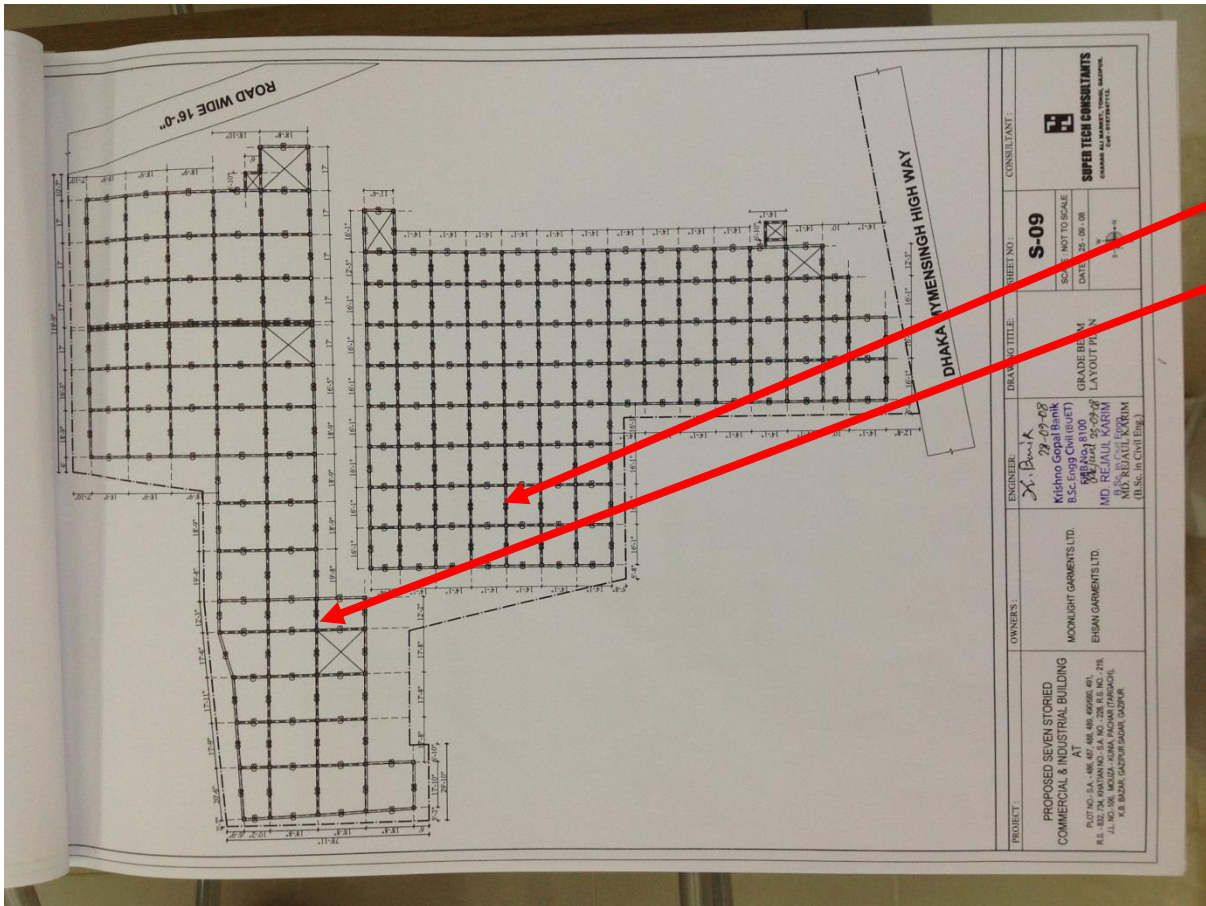
Local column spacing on structural drawings does not match the as constructed condition

5th & 6th floors are of flat slab construction. Other floor are beam & slab.

Building Engineer to review implications of deviations from structural drawings.

Updates Required to Structural Drawings to reflect as-constructed structure

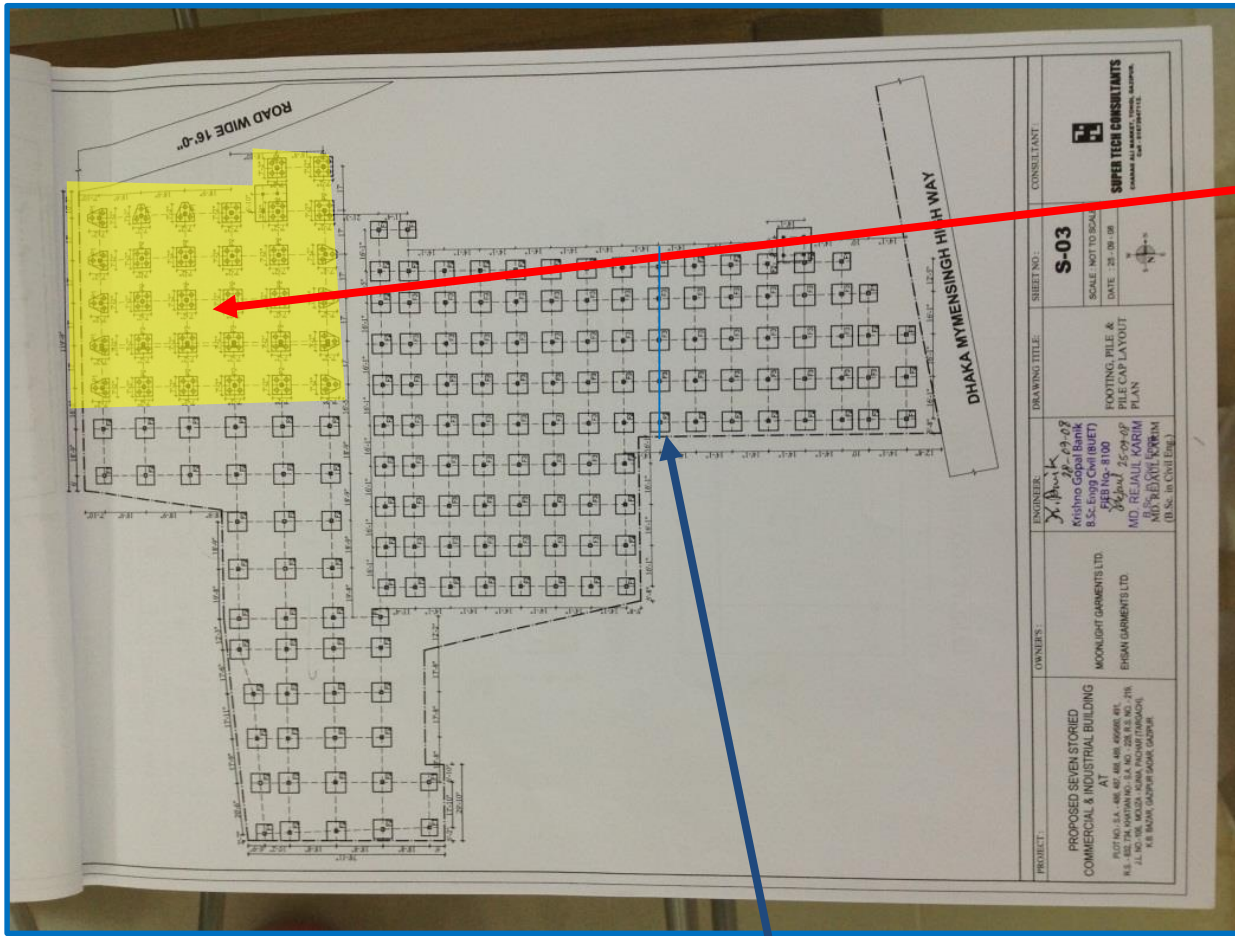
Ground Investigation report dated 2012 available for this area-recommends piling.

No Ground Investigation information available for remainder of site.

Approx location of building movement joint

Collate Ground Investigation Information

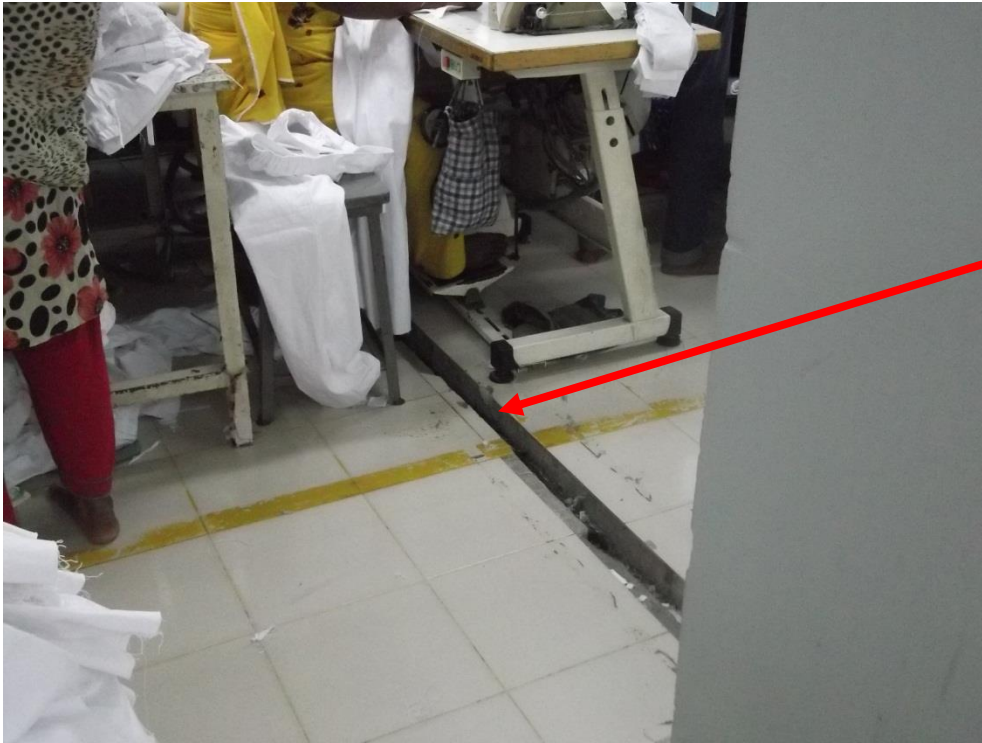
Relative movement at floor slab movement joint within the East Factory.

Collate Ground Investigation Information
