# FIRE SAFETY INSPECTION REPORT

**Sirajgonj Fashions Limited (UNIT 02)**

**ACCORD ID: 12878**

**Date: 28 August, 2017**

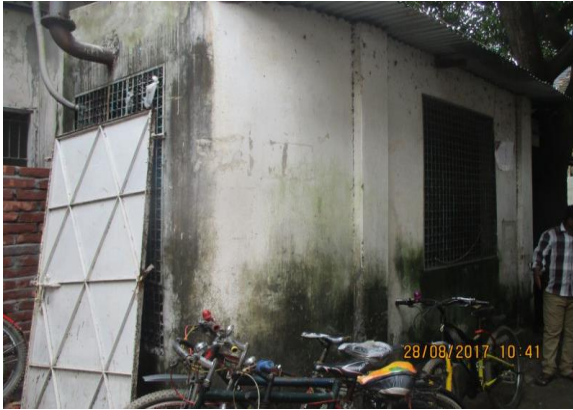
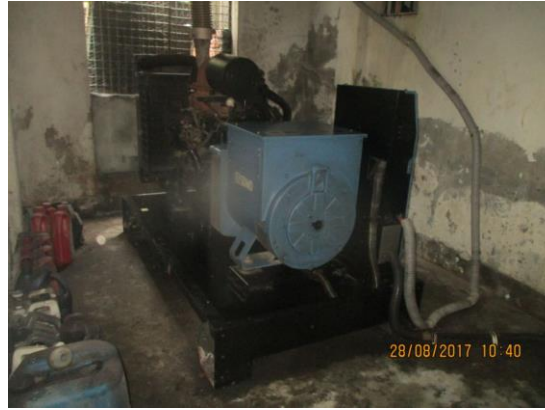
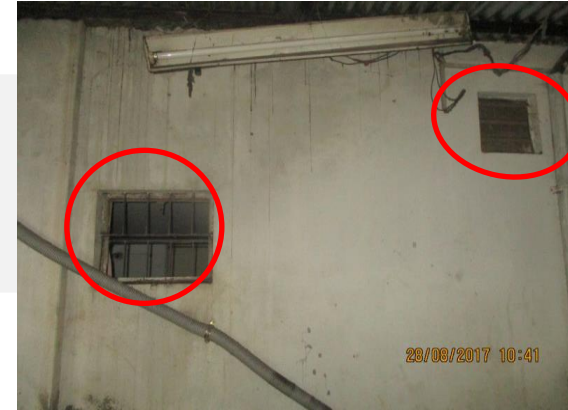
| Sl No. | Category | Findings | Required Action | Remediation Time Frame |
|---|---|---|---|---|
| 1 | Fire Rated Construction | Generator room is not separated by fire rated construction (openings, non-rated doors, penetrations) <b>Location: South-west corner of shed-1.</b> | Separate the generator room by a minimum 2-hr fire rated construction. Seal and/or protected all openings to maintain fire separations. | Within 3 months |

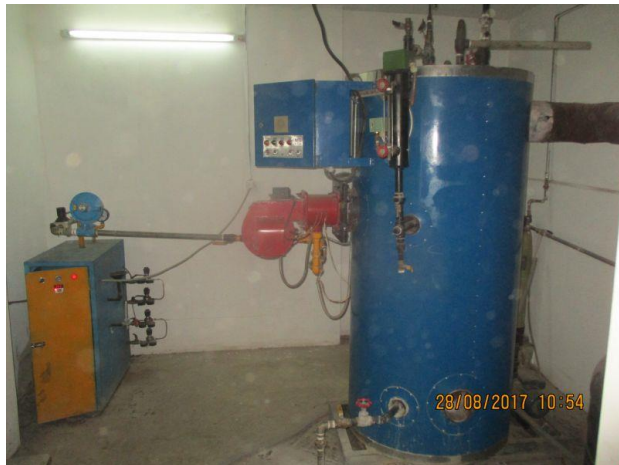
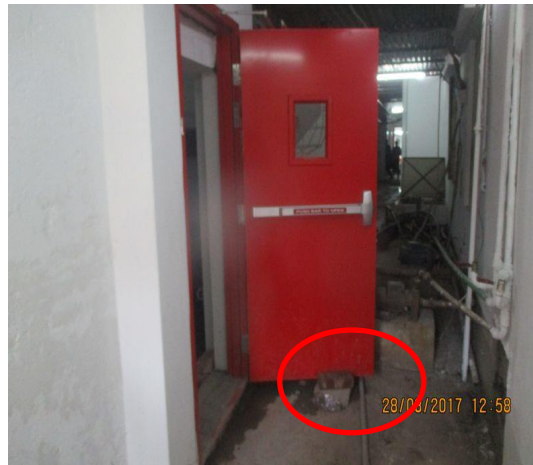
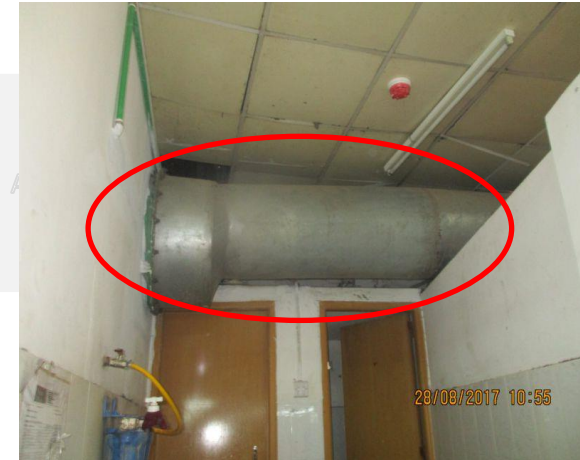
| 2 | Fire Rated Construction | The boiler room is not separated by fire rated construction (openings, non-rated doors, penetrations). <b>Location: South-west corner of shed-1.</b> | Separate the boiler room by a minimum 2-hr fire rated construction (for high rise building)/ 1-hr fire rated construction (for low rise building). Seal and/or protected all openings to maintain fire separations. | Within 3 months |

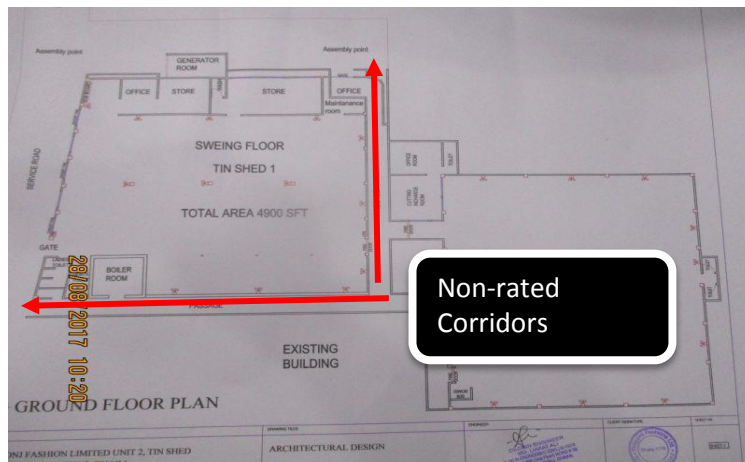
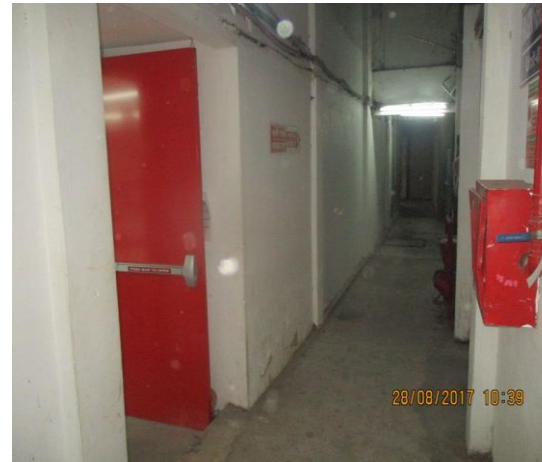
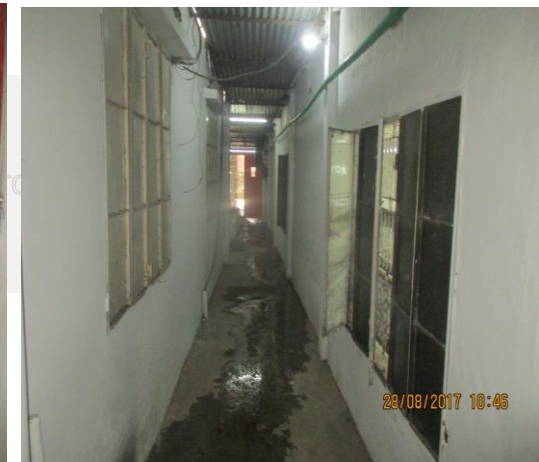
| 3 | Fire Rated Construction | Occupant from shed-1 and shed-2 has to discharge outside through two non-rated egress corridor. Unseal penetrations and openings were found on the egress discharge path. | Separate the corridor by a minimum 2-hr fire rated construction leading directly outside. | Within 3 months |

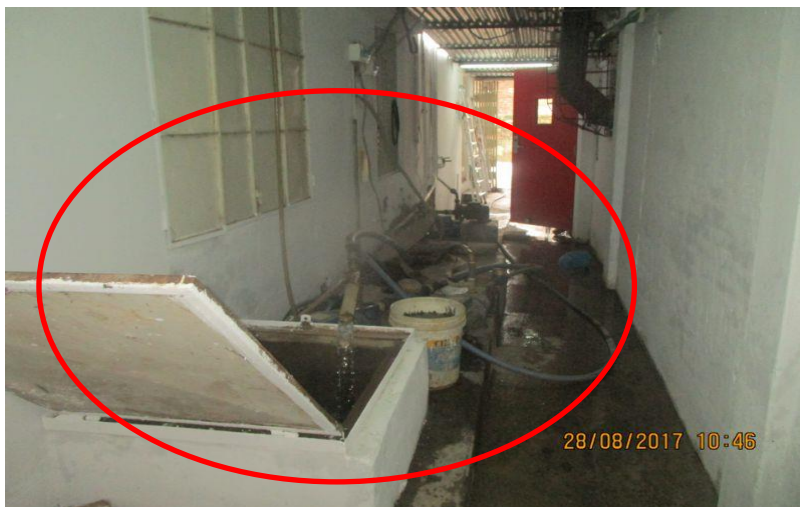
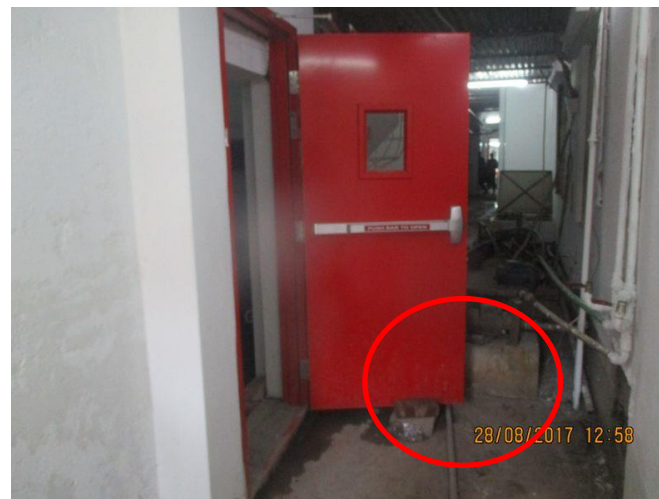
| 4 | Egress | Storage was located in the egress path. <b>Location: Pumps and other obstacles were observed on the discharge corridor from shed-2, middle exit.</b> | Keep egress path and stair clear of storage. | Immediate |

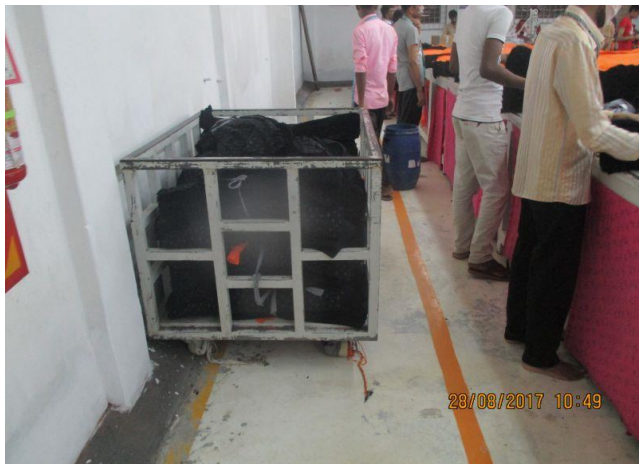
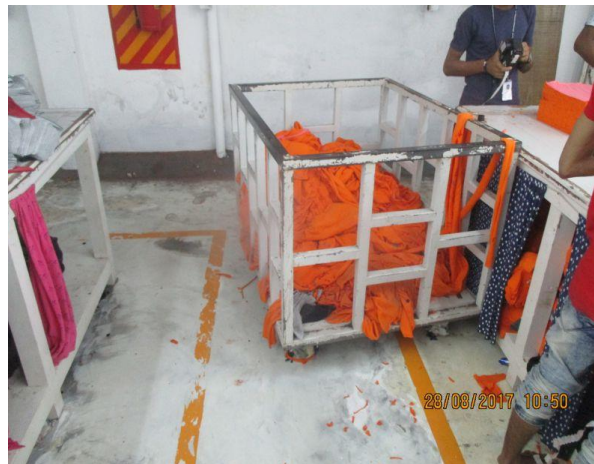
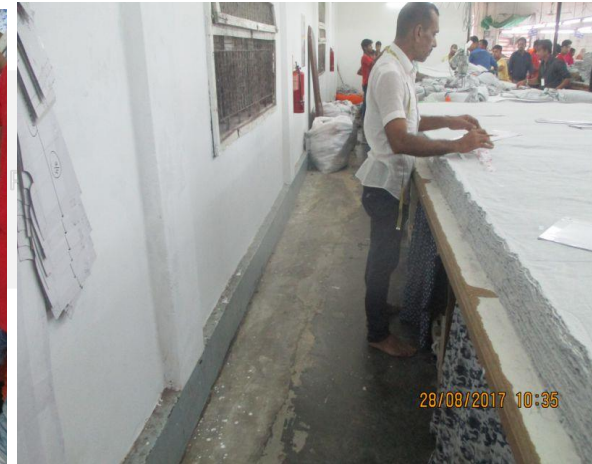
| 5 | Egress | The width of egress aisles is less than 36-inch and even unmarked. | Provide minimum aisle widths of 36-inch. All the aisles shall be free from any kind of obstruction. | Within 3 months |

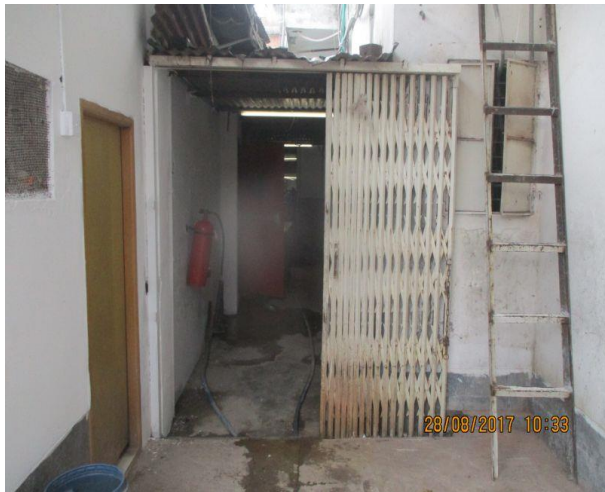
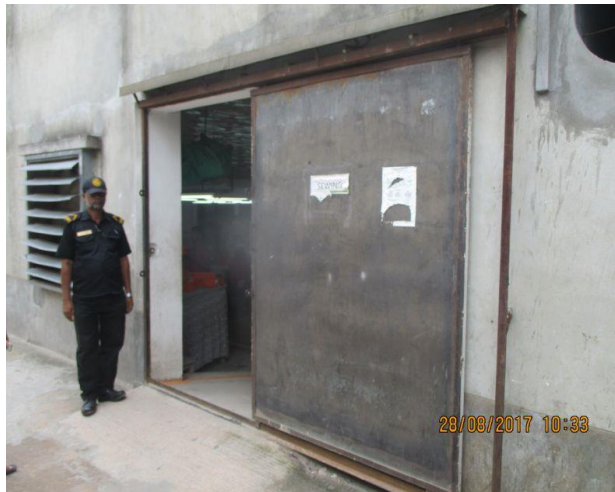
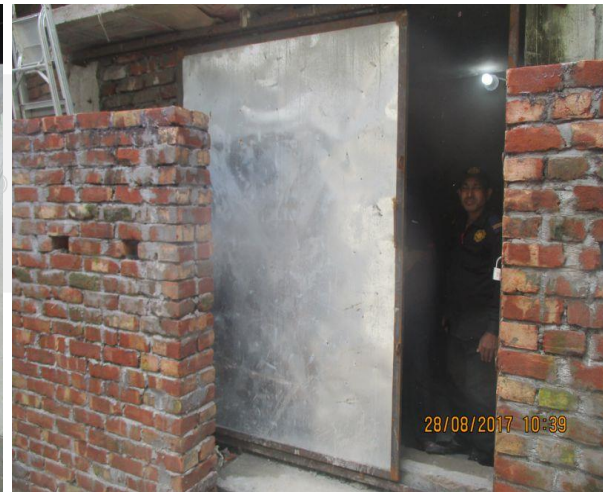
| 6 | Sliding Door & Gates | Collapsible gates/sliding doors/rolling shutter doors are provided at [building exits, exit stairs, along egress routes, exit discharge] | <p>Replace all collapsible gates/ sliding doors/ rolling shutter doors along the means of egress with side-hinged, swinging egress doors.</p> <p>If locks are required for security reasons, utilize specialized door locking features complying with NFPA101.</p> | Within 1 month |

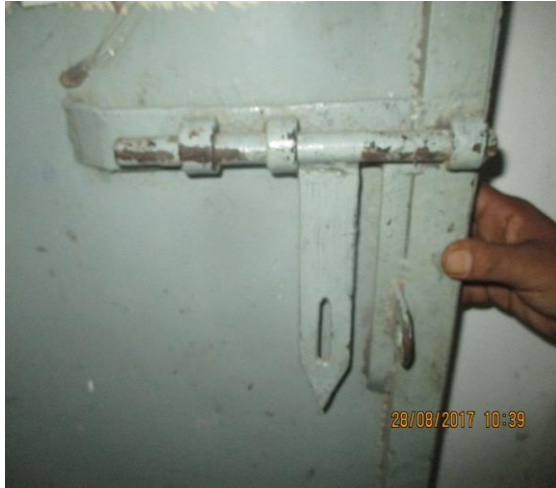
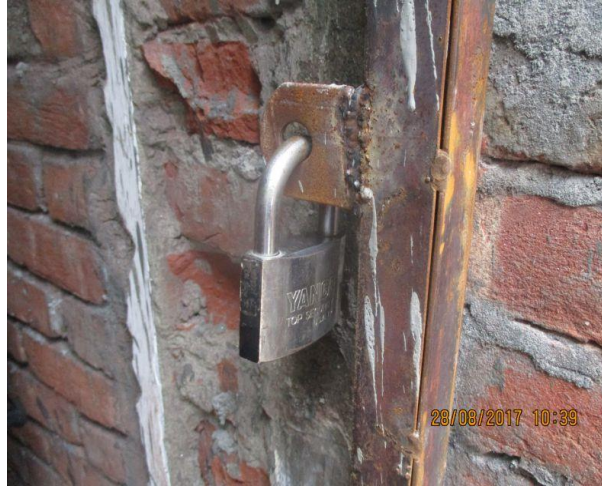
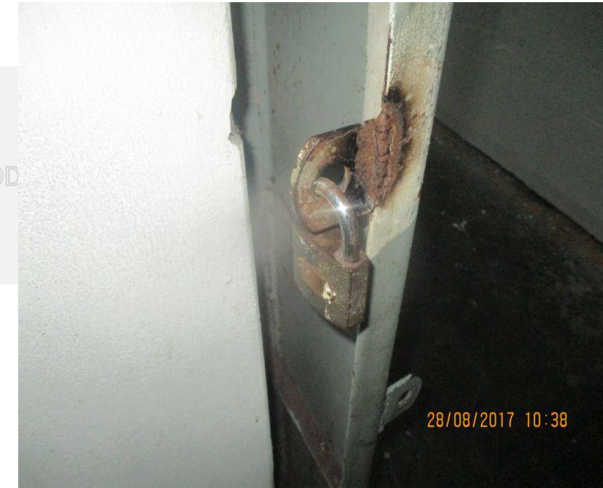
| 7 | Lockage Egress Doors | Egress doors/gates with locking features not complying with NFPA101 are provided at [ building exits, exit stairs, along egress routes, exit discharge] | Remove locking features from all egress doors/gates. If locks are required for security reasons, utilize specialized door locking features complying with NFPA101. | Immediate |

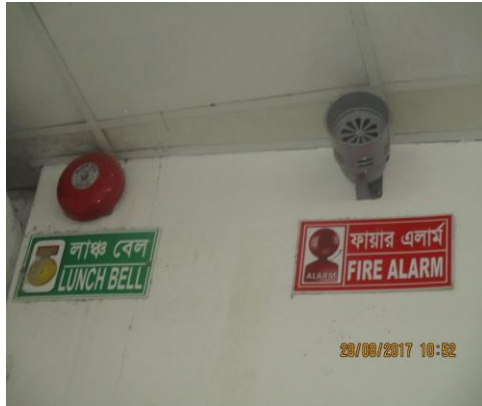
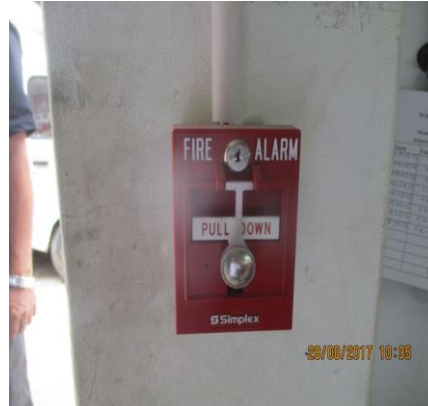
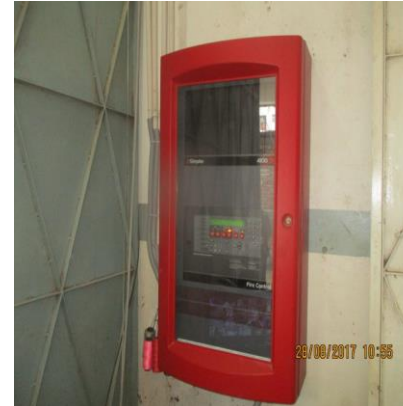
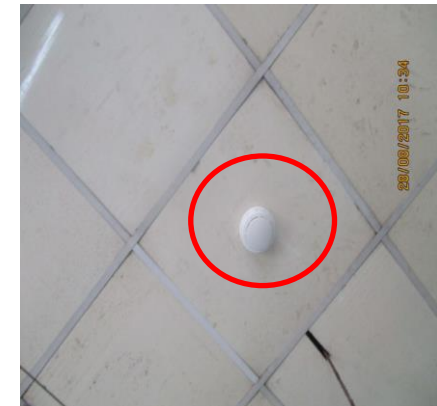
| 8 | As Built Fire Detection System | Fire detection system installation requires detailed review to confirm compliance with NFPA 72 and ACCORD standards | Submit as-built drawings, testing records, equipment certification and other relevant documentation to the ACCORD for review and approval | Drawing within 1 month, Modification within 6 month. |

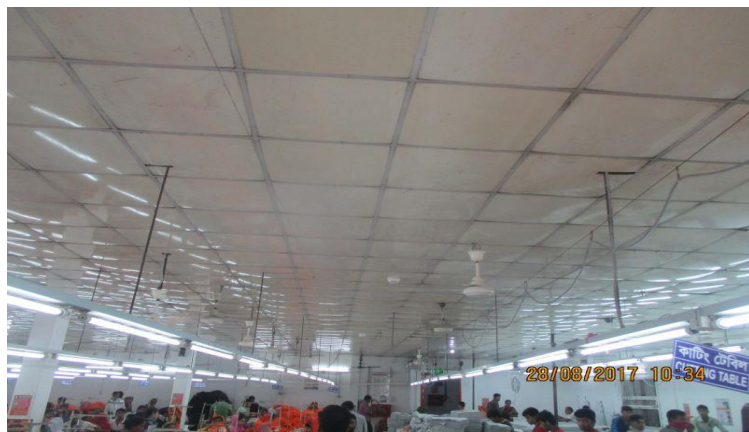
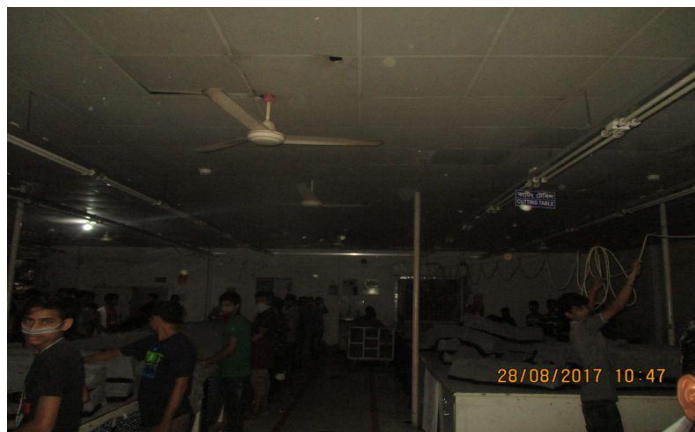
| 10 | Inadequate Lighting | Based on the number and location of emergency lights observed, adequate illumination levels are not anticipated along egress routes. | Test the emergency lighting system on each floor and provide additional emergency fixtures to provide adequate illumination along the means of egress. Provide a minimum illumination of 10 lux at the floor level within exit stairs and exit discharge paths and minimum 2.5 lux along exit access aisles. | Within 3 months |
