# Square Fashions Ltd

Rokeyapur, Jamirdia, Habir Bari, Valuka, Mymensingh, Bangladesh  
(+24.29540N,90.38831E)  
29<sup>th</sup> June 2014

# Observations

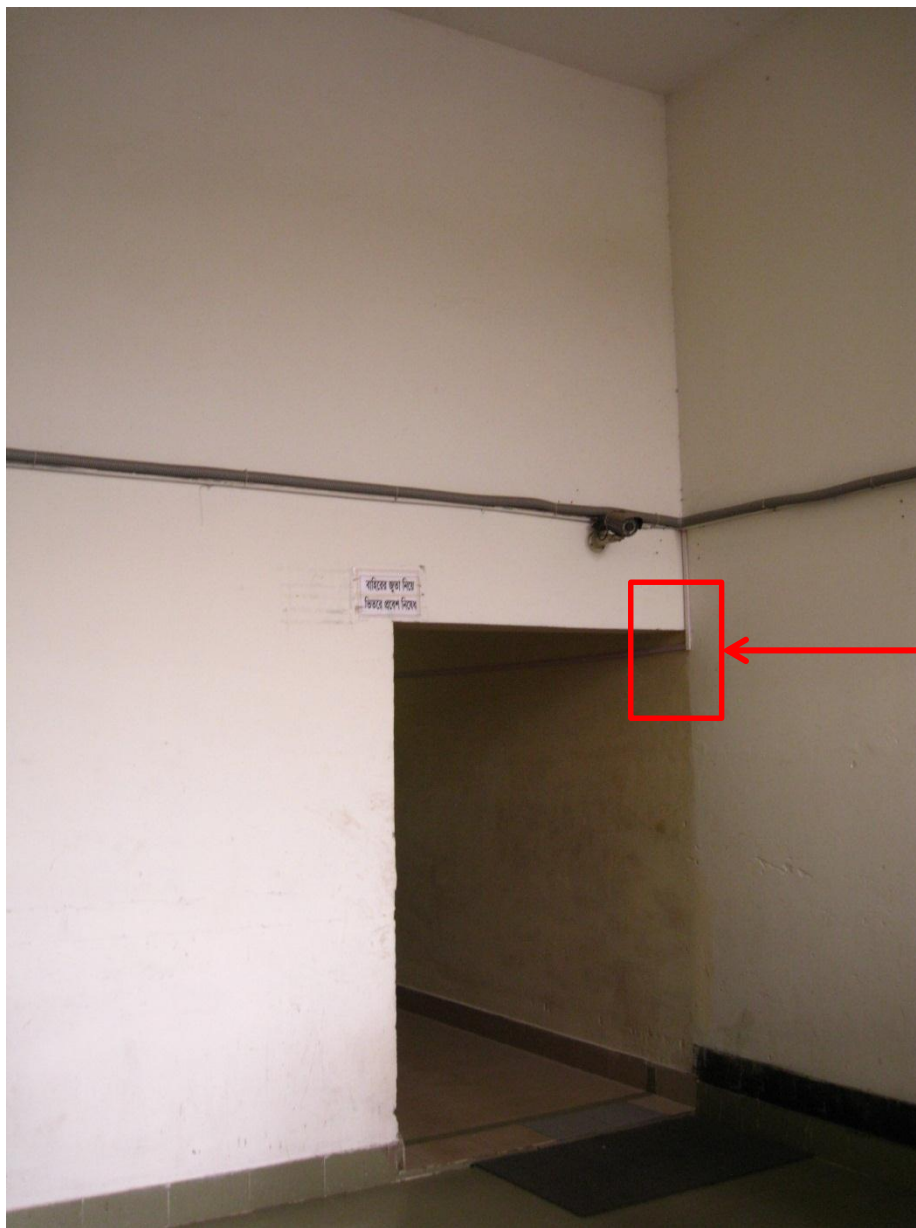
Elevation of Lintel

Cracking was observed to a load bearing masonry wall supporting a lintel. The masonry wall is located along the East elevation of Building 1 where the RC stair core meets the steel frame structure. The connection detail between the structures is not clear.

| Item No. | Observation | Recommended Action Plan | Recommended Timeline |
|---|---|---|---|
| 1 | Building 1 - Cracking to load-bearing masonry wall | Building Engineer to review extent of cracking in masonry wall and carry out a design check on this element for the applied loads. | 6-weeks |
| 2 | Building 1 - Cracking to load-bearing masonry wall | Building Engineer to implement any actions / supervise remedial works to masonry wall as identified following the review. | 6-weeks |

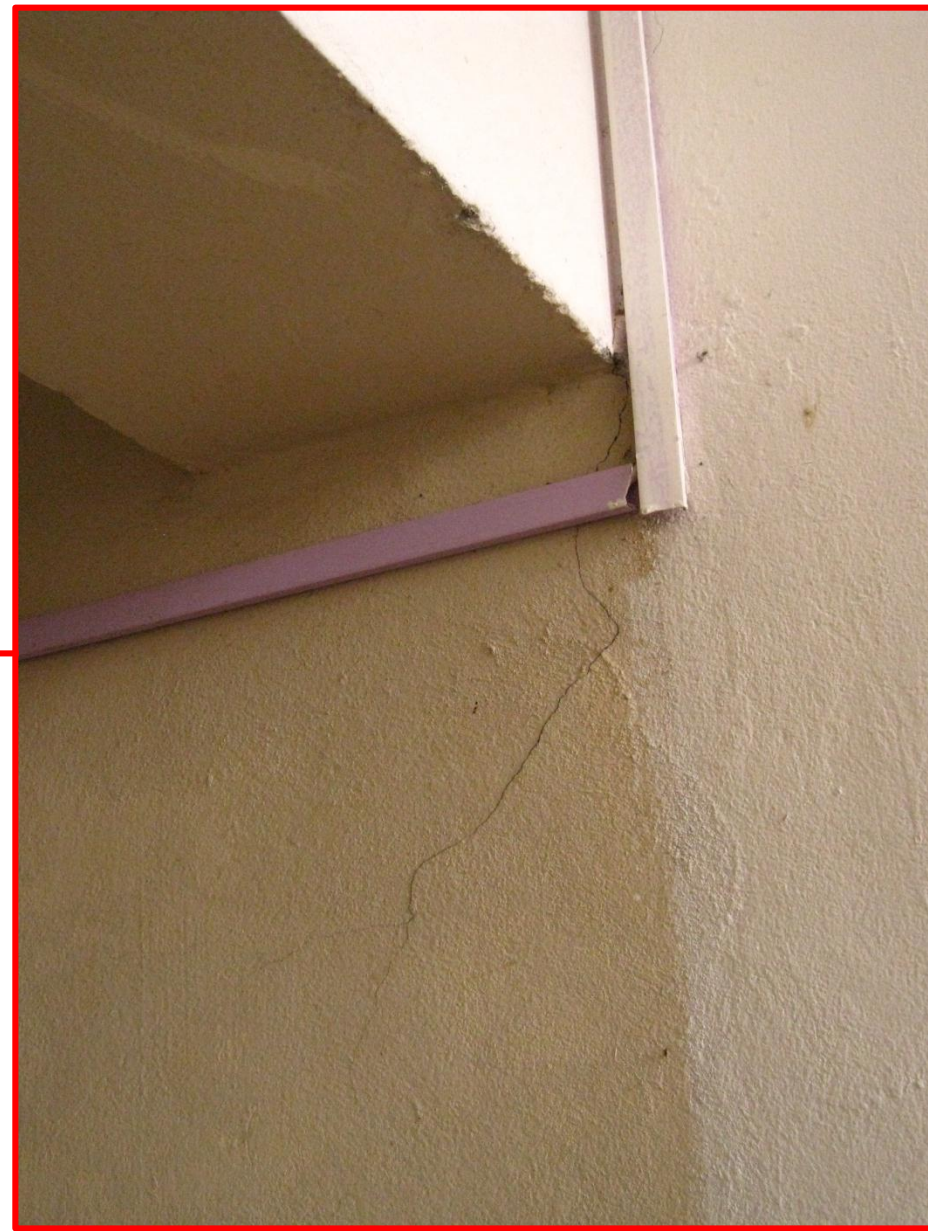
Cracking to masonry wall

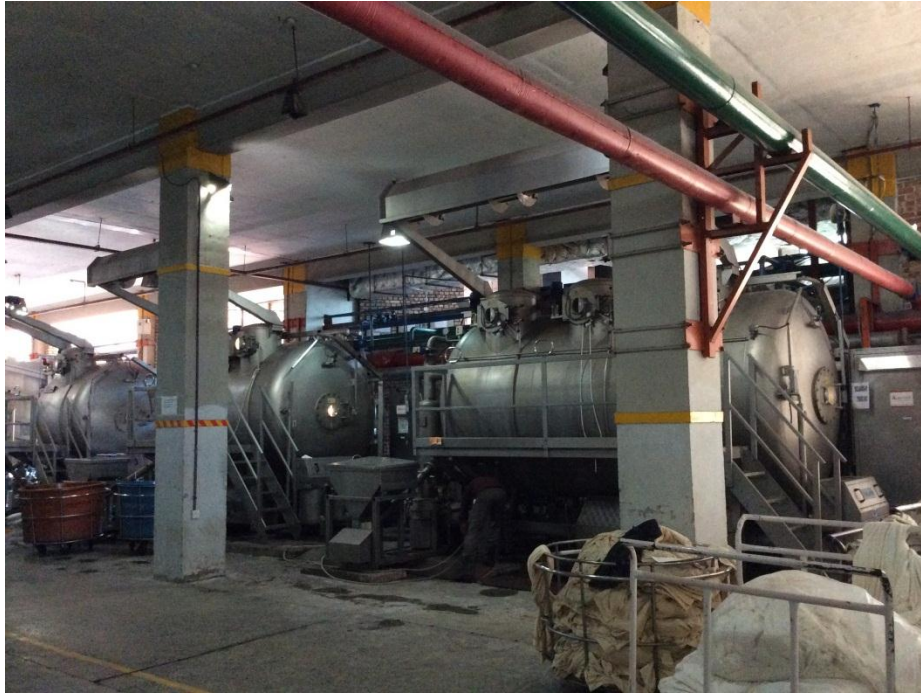
Loading to Ground Floor

Heavy and apparently unmanaged floor loading was observed in Building 2. While a loading plan was provided, it appears to be based on loadings observed at the factory at one particular moment in time; it is not clear whether the loads represent maximum allowable floor loading.

| Item No. | Observation | Recommended Action Plan | Recommended Timeline |
|---|---|---|---|
| 3 | Building 2 - Heavy floor loading and lack of adequate loading plan | Building Engineer to produce a loading plan for each area of the building, with due consideration to column and floor capacity in each area. | 6-weeks |
| 4 | Building 2 - Heavy floor loading and lack of adequate loading plan | Factory Management to ensure loading plan is implemented and actively managed. | 6-weeks |
| 5 | Building 2 - Heavy floor loading and lack of adequate loading plan | Continue to implement loading plan | 6-months |

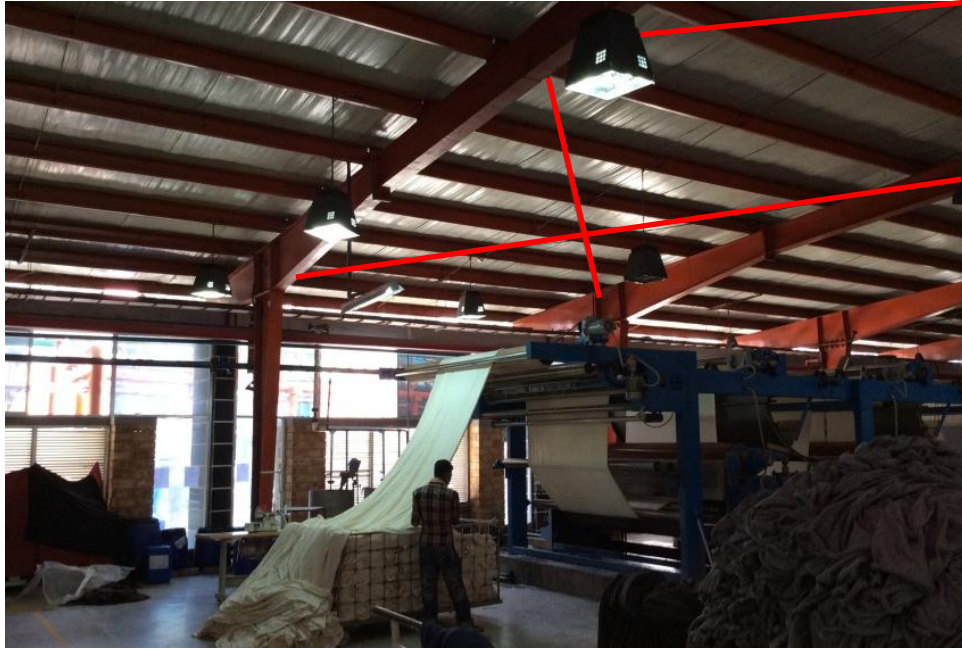
Vertical bracing is missing to the steel frame structure at Ground Floor level and, where provided, bracing is loose and therefore ineffective to the steel structures at both Ground and 3<sup>rd</sup> Floor levels. Wind posts are missing to the gable end at 3<sup>rd</sup> Floor level.

Missing vertical bracing in single storey shed

| Item No. | Observation | Recommended Action Plan | Recommended Timeline |
|---|---|---|---|
| 6 | Building 2 - Lack of stability members to steel roof structures | Building Engineer to review stability design and stability systems provided to each area of Building 2 and prepare a schedule of necessary remedial works. | 6-weeks |
| 7 | Building 2 - Lack of stability members to steel roof structures | Stability member remedial works to be carried out. | 6-months |

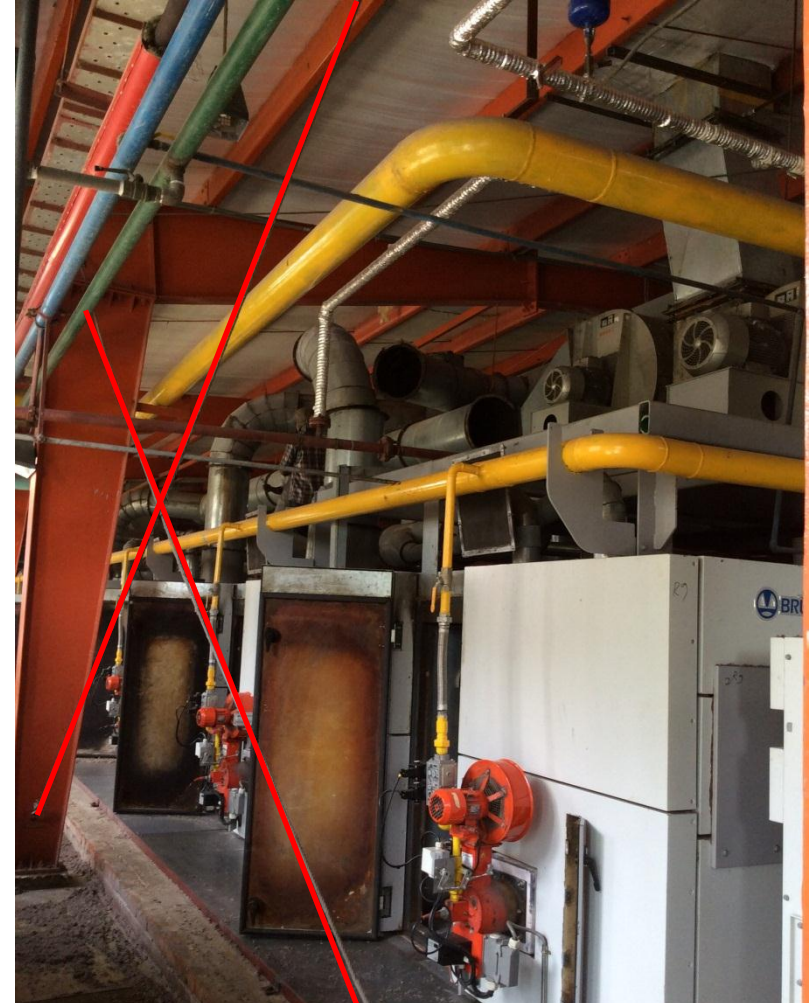
Loose bracing in single storey shed

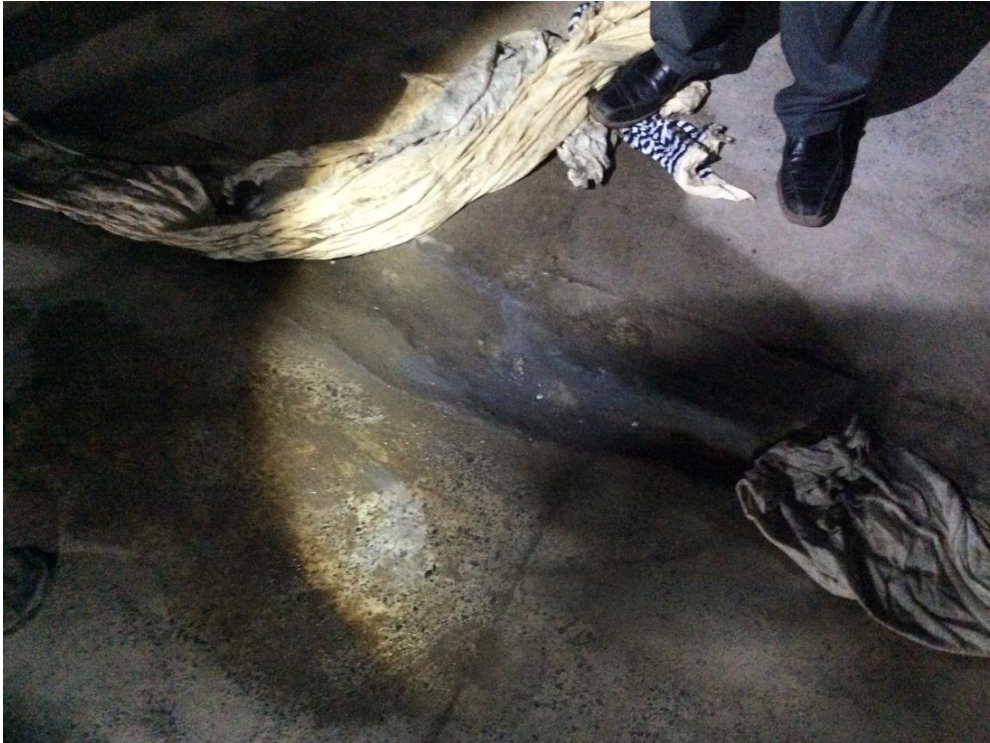
Cracking and water ingress was observed in a number of locations to the Basement slab. It is understood that repair works are being carried out.

Cracking and water ingress to Basement slab

| Item No. | Observation | Recommended Action Plan | Recommended Timeline |
|---|---|---|---|
| 8 | Building 2 - Cracking to Basement slab | Building Engineer to review extent of cracking to slab and carry out design check on this element for the applied loads. | 6-weeks |
| 9 | Building 2 - Cracking to Basement slab | Building Engineer to implement any actions / supervise any remedial works as identified following the review. | 6-months |

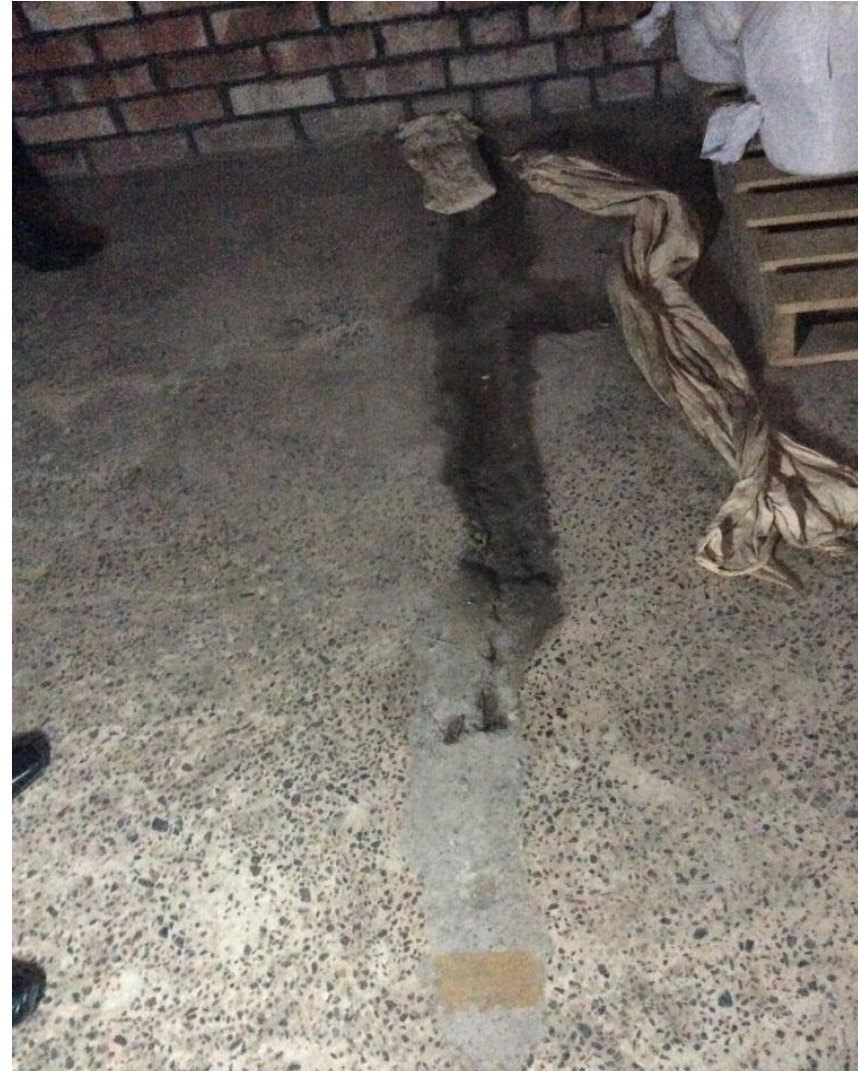
Cracking and water ingress to Basement slab

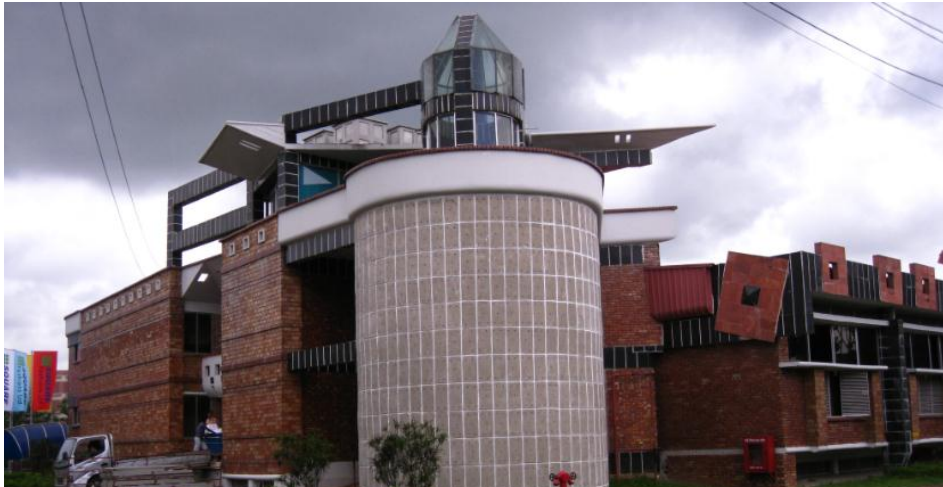
There are concerns about the structural adequacy of the architectural features to the façade and the roof. These features do not appear to be structurally designed. Inadequate supports, cracking and deflections were observed. It is not clear whether the extra load of these features is taken into account in the overall structural design of the building.

Typical architectural features to Building 2

| Item No. | Observation | Recommended Action Plan | Recommended Timeline |
|---|---|---|---|
| 10 | Building 2 - Design check required for architectural features | Building Engineer to review extent of deflection and cracking to architectural features and to assess the impact of these on the primary structure. | 6-weeks |
| 11 | Building 2 - Design check required for architectural features | Building Engineer to implement any actions / supervise any remedial works as identified following the review. | 6-months |

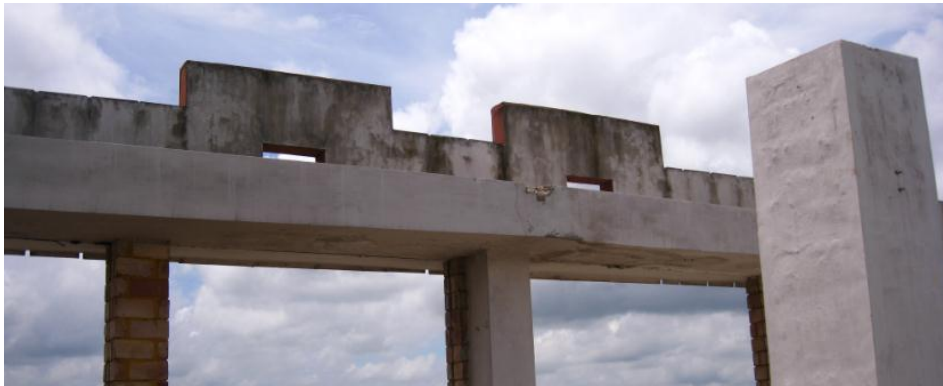
Cracking and deflections to support structure

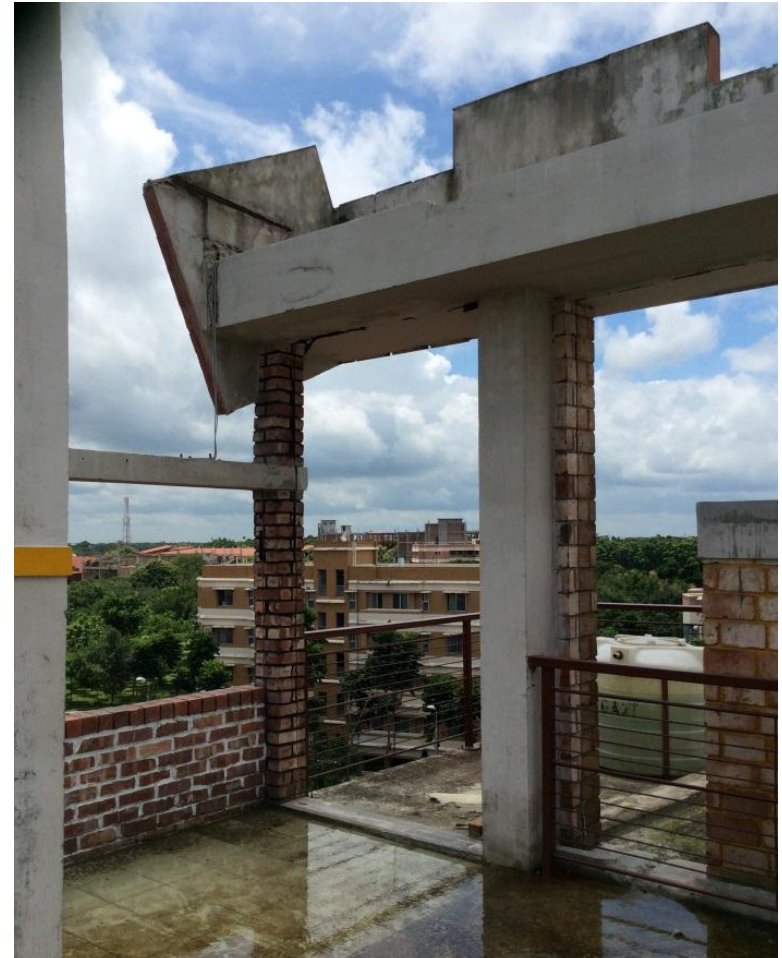
Inadequate supports

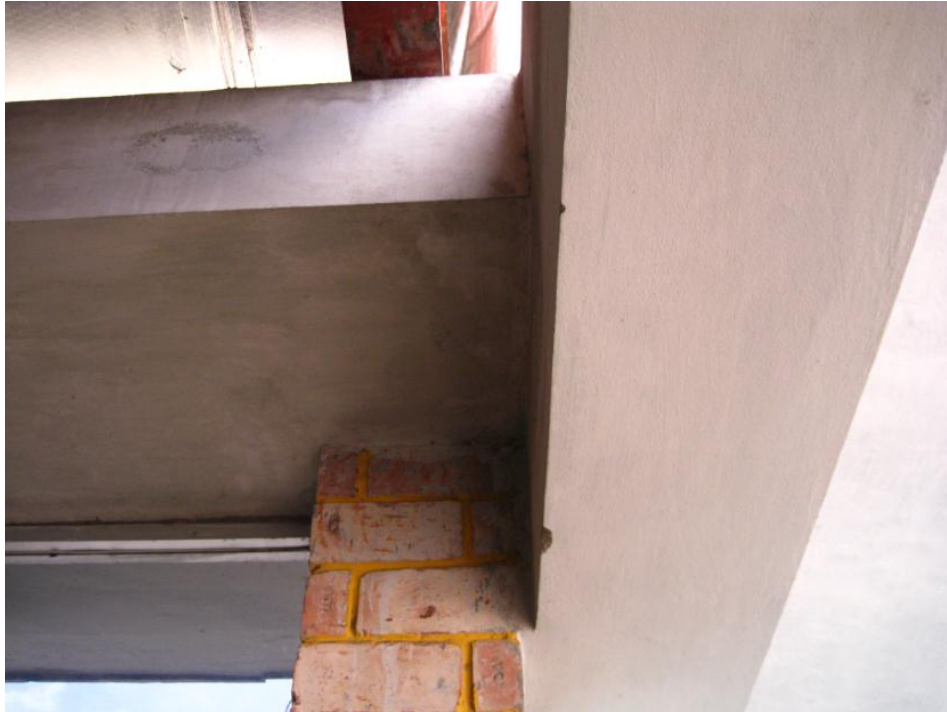
The expansion joint in the RC structure does not appear to be incorporated at roof level.

Front side: Movement joint should be here

| Item No. | Observation | Recommended Action Plan | Recommended Timeline |
|---|---|---|---|
| 12 | Building 2 - Movement Joint does not appear to be incorporated at Roof level | Building Engineer to review beam-column detail across movement joint and prepare a schedule of remedial works as required. | 6-weeks |
| 13 | Building 2 - Movement Joint does not appear to be incorporated at Roof level | Building Engineer to implement any actions / supervise any remedial works as identified following the review. | 6-months |

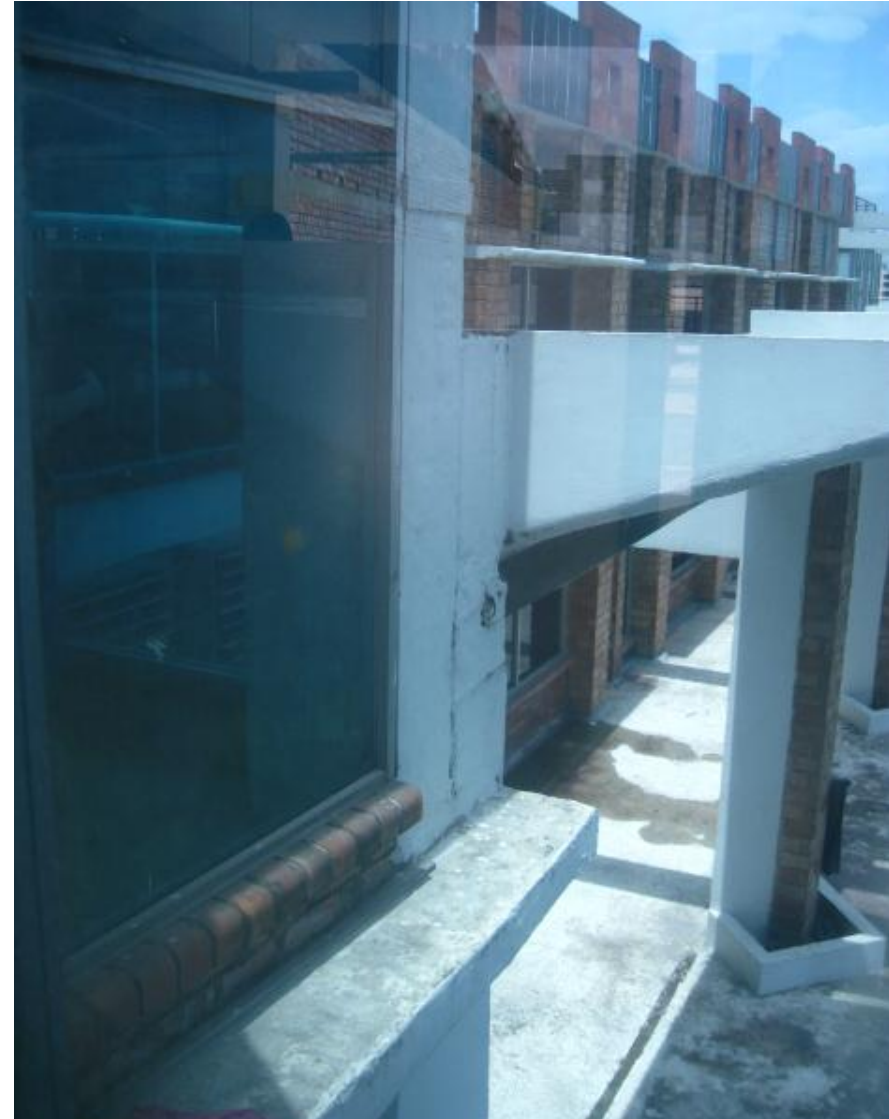
Back side: Movement joint in façade

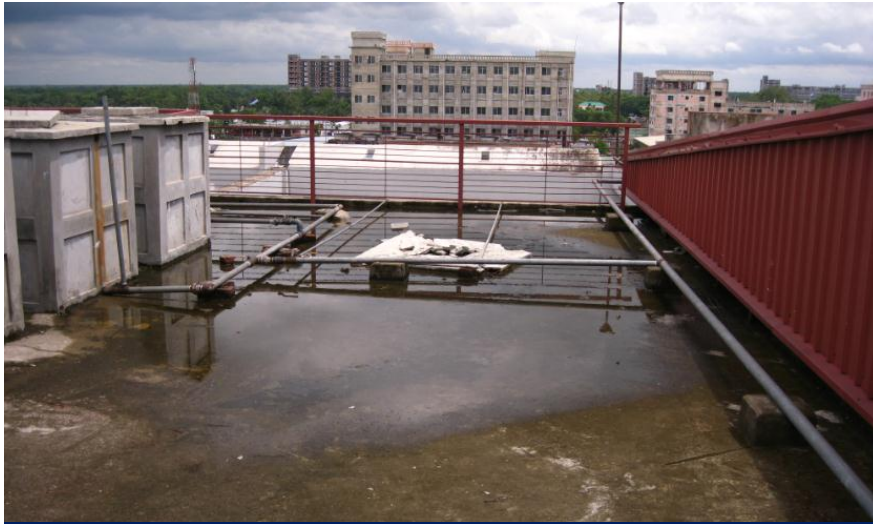
Ponding was observed to the RC roof slabs in a number of locations.

Ponding to roof slab

| Item No. | Observation | Recommended Action Plan | Recommended Timeline |
|---|---|---|---|
| 14 | Building 2 - Ponding to RC Roof slabs | Building Engineer to review the roof drainage and implement an appropriate drainage system that will prevent water ponding on the roof areas. | 6-months |

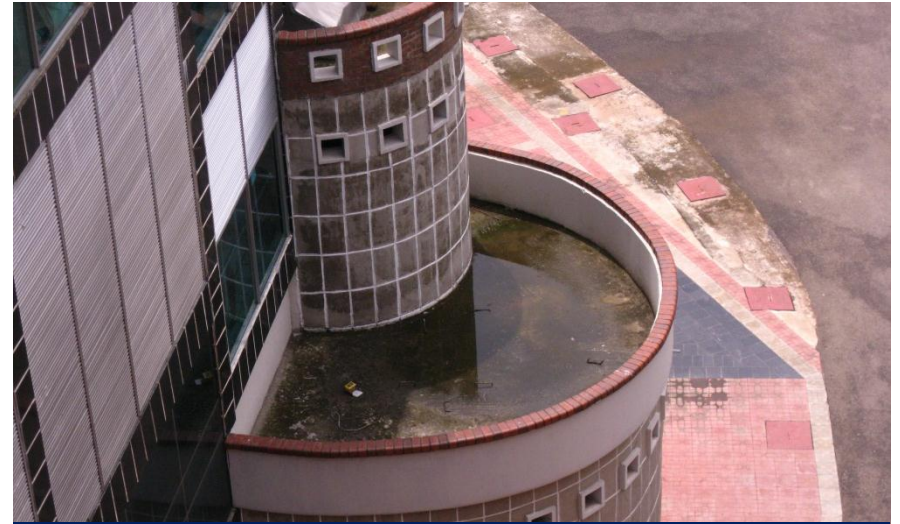
Ponding to roof slab

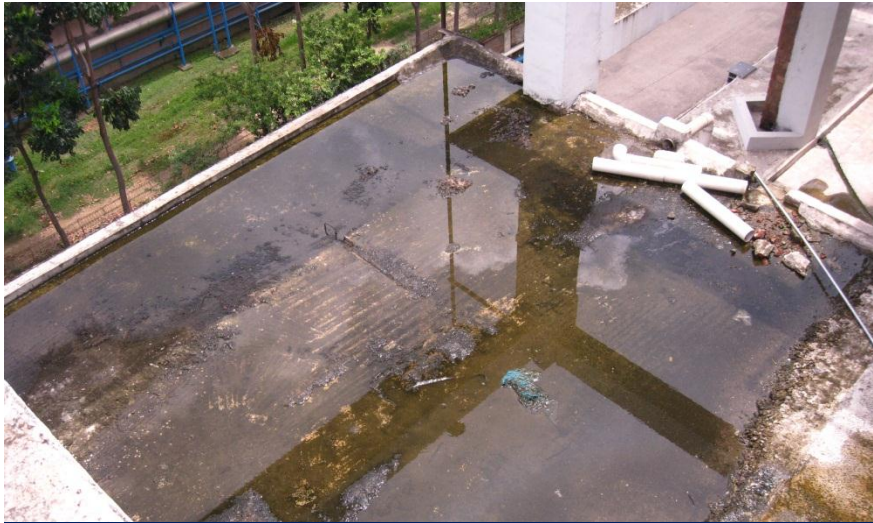
Ponding to roof slab

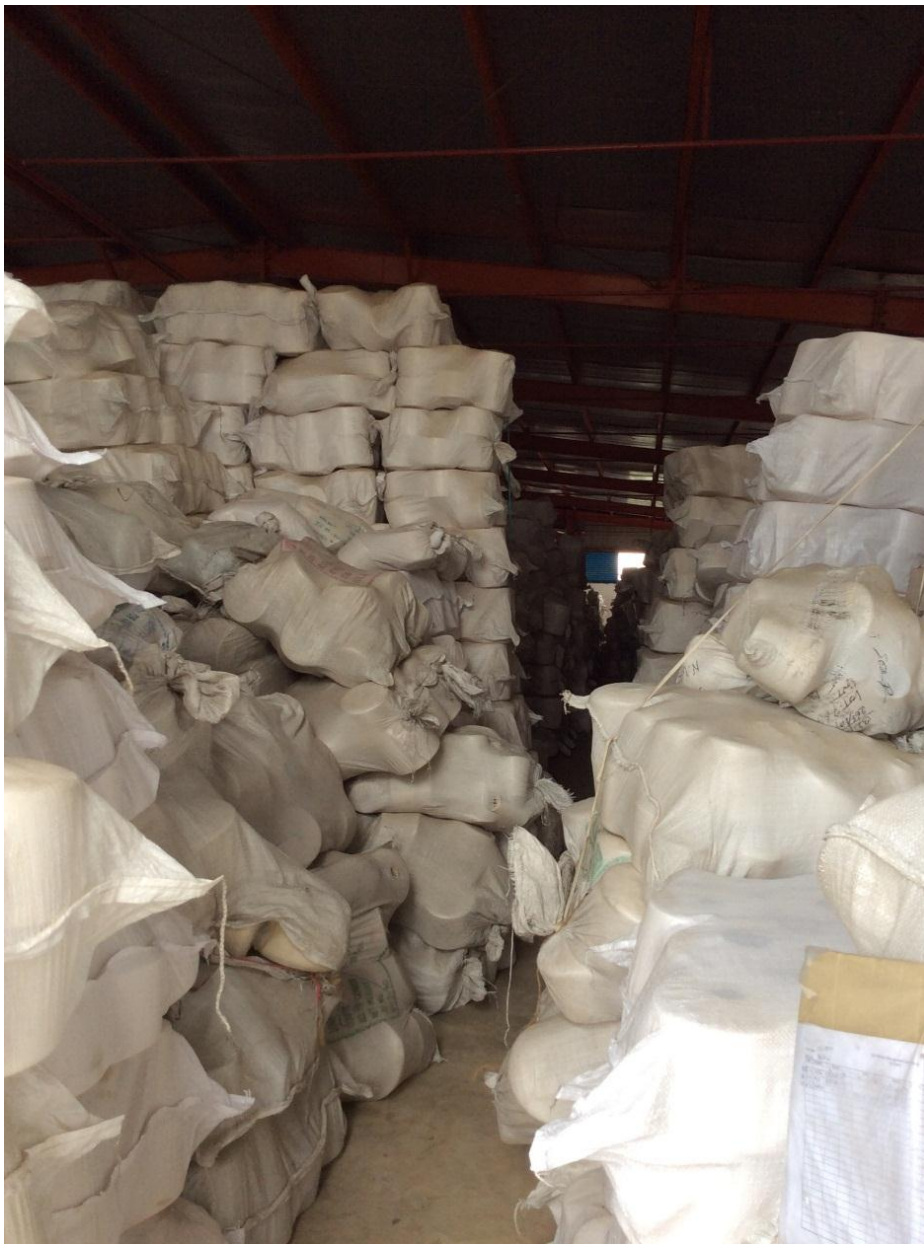
Heavy loading was observed to Buildings 3, 5 and 7. While these buildings appear to have been designed as storage buildings, the loading on the floors does not appear to be managed. While some loading plans were provided, these appeared to be based on loadings observed at the factory at a particular time; it is not clear whether the loads represent the maximum allowable floor loading.

Loading to all suspended floors of Building 5

| Item No. | Observation | Recommended Action Plan | Recommended Timeline |
|---|---|---|---|
| 15 | Buildings 3, 5 and 7 - Heavy loading to suspended floors and lack of adequate loading plans | Building Engineer to produce a loading plan for each of the buildings, with due consideration to column and floor capacity. | 6-weeks |
| 16 | Buildings 3, 5 and 7 - Heavy loading to suspended floors and lack of adequate loading plans | Factory Management to ensure loading plan is implemented and actively managed. | 6-weeks |
| 17 | Buildings 3, 5 and 7 - Heavy loading to suspended floors and lack of adequate loading plans | Continue to implement loading plan | 6-months |

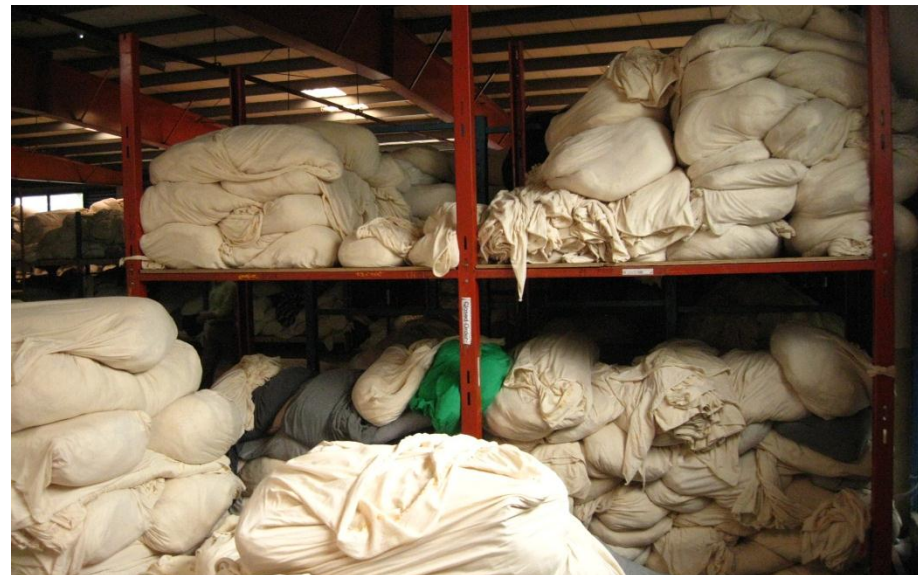
Loading to 1<sup>st</sup> Floor of Building 3

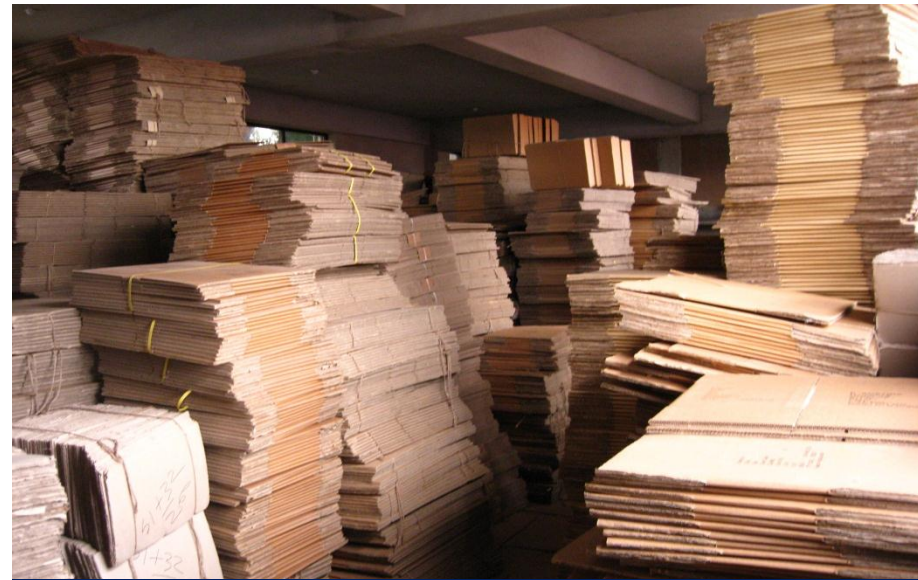
Loading to all suspended floors of Building 3

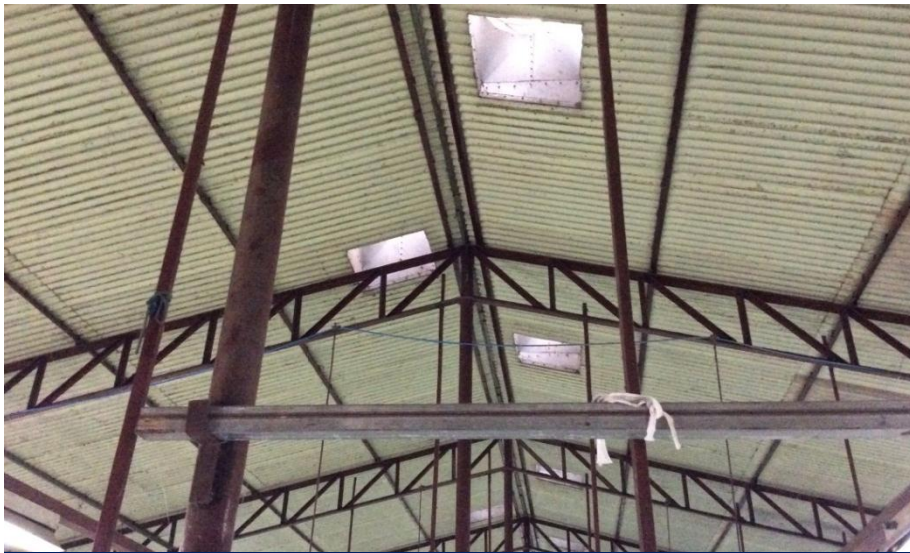
Shed 3 appears to be non-engineered. The prefabricated roof trusses appear to be supported on a combination of masonry walls and RC-encased steel posts, the connections to which are unclear. The lateral stability system of the building is not clear. The design documents are incomplete.

Lateral stability system unclear – no apparent bracing system

| Item No. | Observation | Recommended Action Plan | Recommended Timeline |
|---|---|---|---|
| 18 | Shed 3 appears to be non-engineered | Building Engineer to review the design of Shed 3, and to confirm, by calculations, its ability to withstand wind loading pressure, suction and uplift forces, with special emphasis on connections and bracing. | 6-weeks |
| 19 | Shed 3 appears to be non-engineered | Building Engineer to implement any actions / supervise any remedial works as identified following the review. | 6-months |

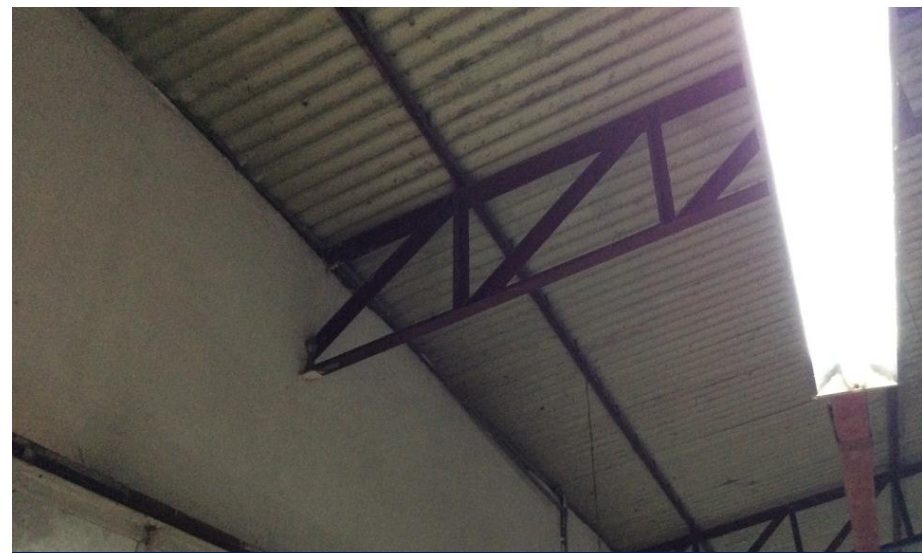
Connection details between trusses and support structure are not clear

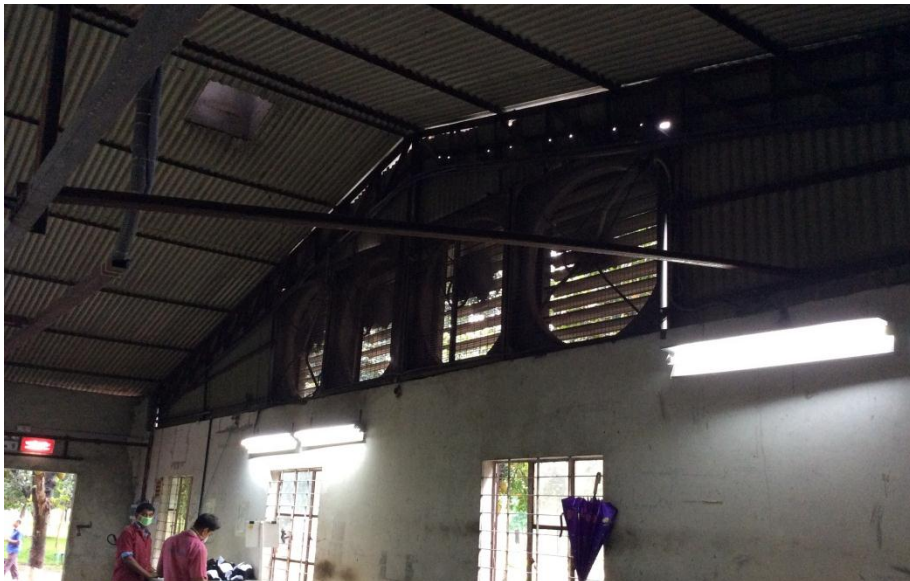
Wind posts missing to gable end

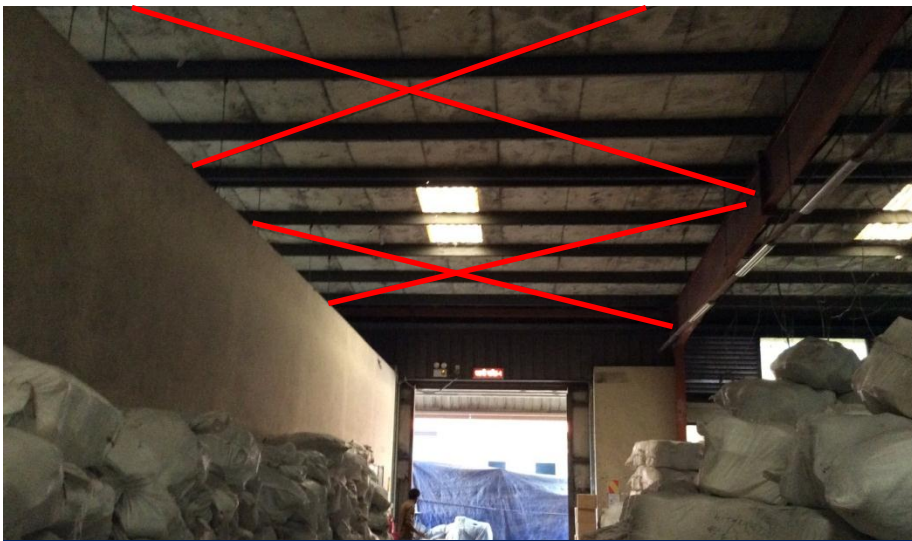
There is missing bracings to Shed 2 and Building 1 and, where provided, bracing to Sheds 1 and 2 and to Building 5 is loose and therefore ineffective.

Shed 2 – Vertical bracing not complete. Horizontal bracing provided as indicated in red.

| Item No. | Observation | Recommended Action Plan | Recommended Timeline |
|---|---|---|---|
| 20 | Sheds 1 & 2 and Buildings 1 & 5 - Missing / loose bracing | Building Engineer to provide adequate bracing to Shed 2, and to tighten bracing to Sheds 1 and 2 and Buildings 1 and 5. | 6-weeks |

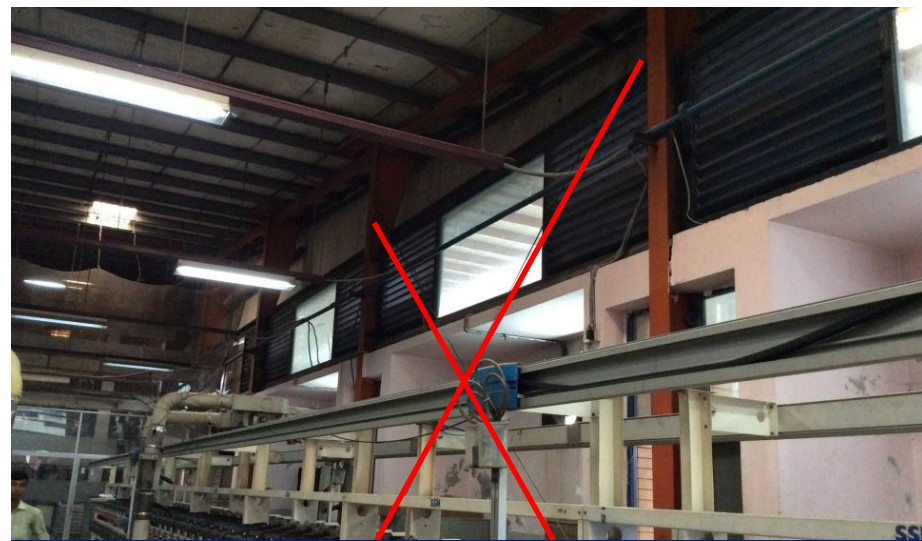
Shed 2 – Bracing not over full height – Building Engineer to review.

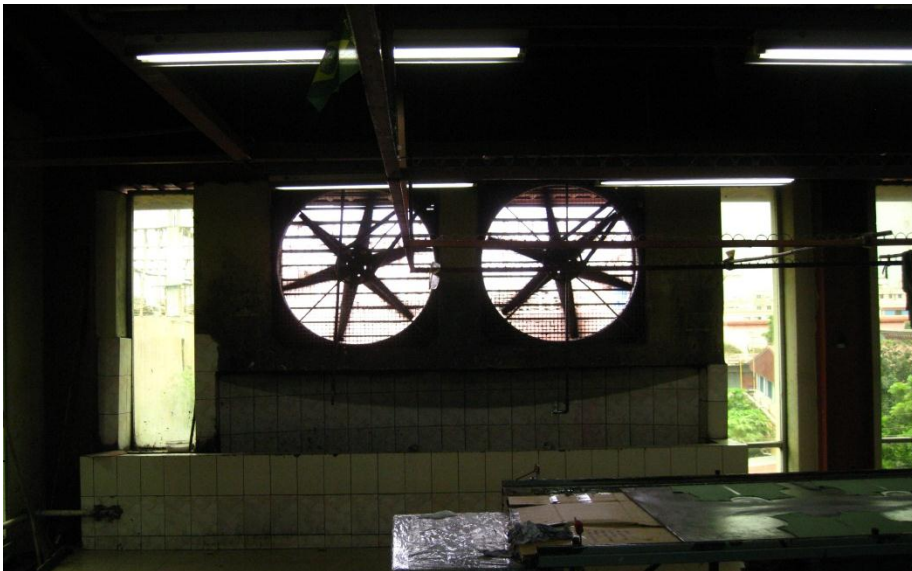
Building 1 – Missing vertical bracing

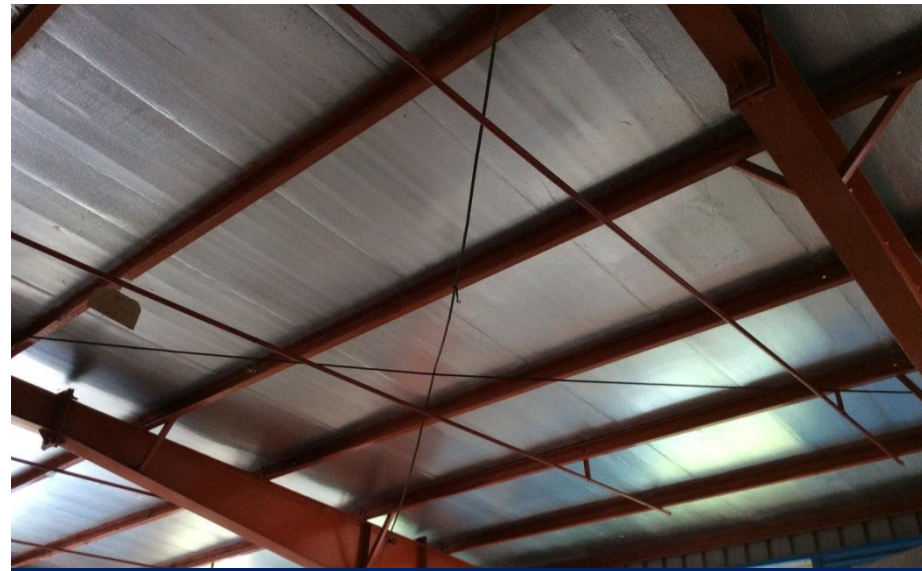
Shed 5 – Loose Bracing

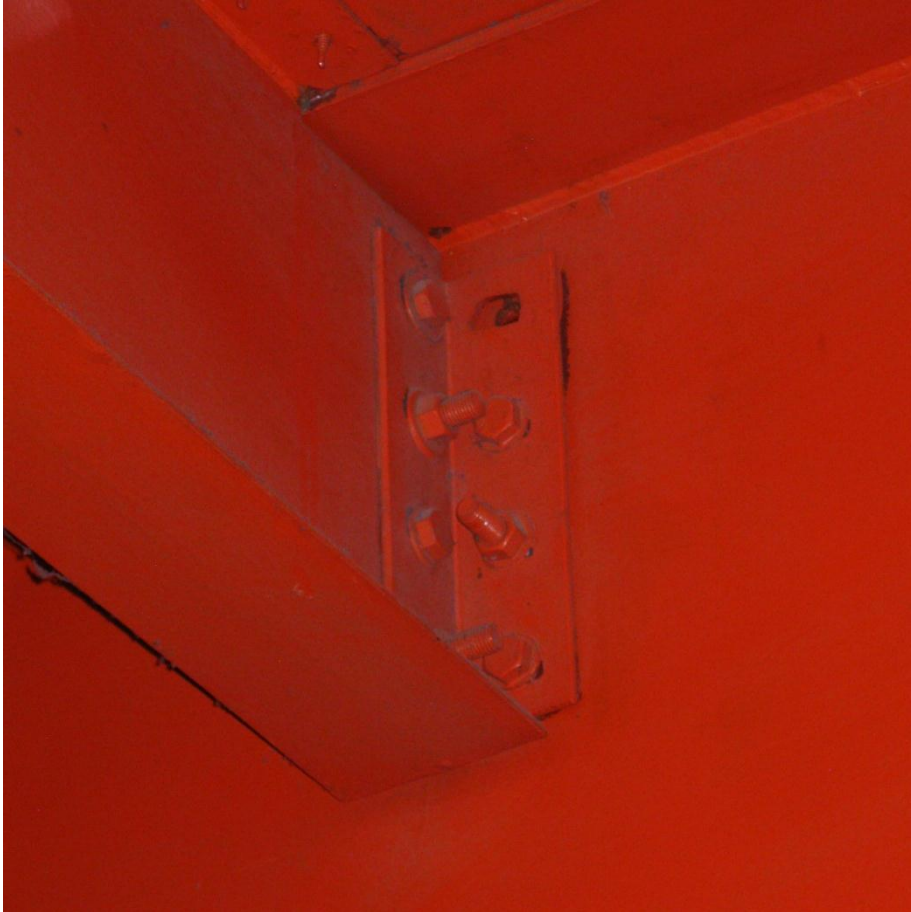
Steel connection details in a number of buildings were observed to be substandard, including inadequate bearing / opening up of end / splice plates, missing or inadequately installed bolts, over-sized bolt-holes, etc.

Building 1 – Missing bolts

| Item No. | Observation | Recommended Action Plan | Recommended Timeline |
|---|---|---|---|
| 21 | Shed 1 and Buildings 1 & 5 - substandard connection details | Building Engineer to review all connection details to Sheds 1 and Buildings 1 and 5, and to prepare a schedule of actions / remedial works, as required. | 6-weeks |
| 22 | Shed 1 and Buildings 1 & 5 - substandard connection details | Building Engineer to implement any actions / supervise any remedial works as identified following the review. | 6-months |

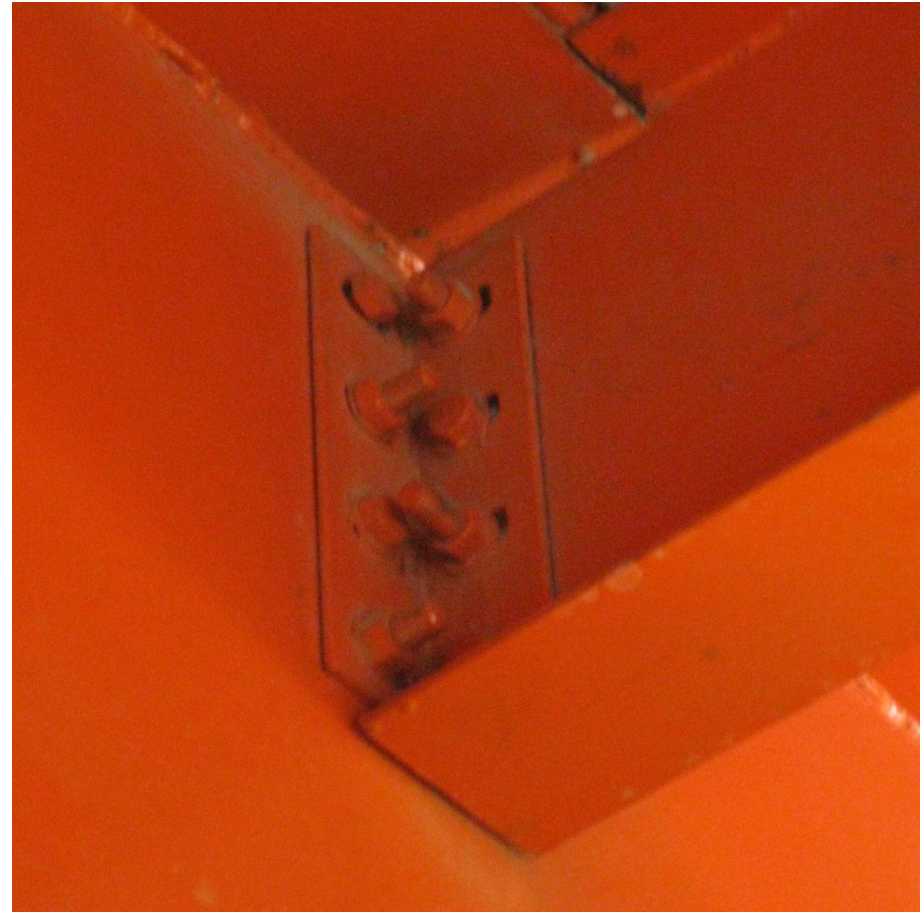
Building 1 – Oversized bolt holes

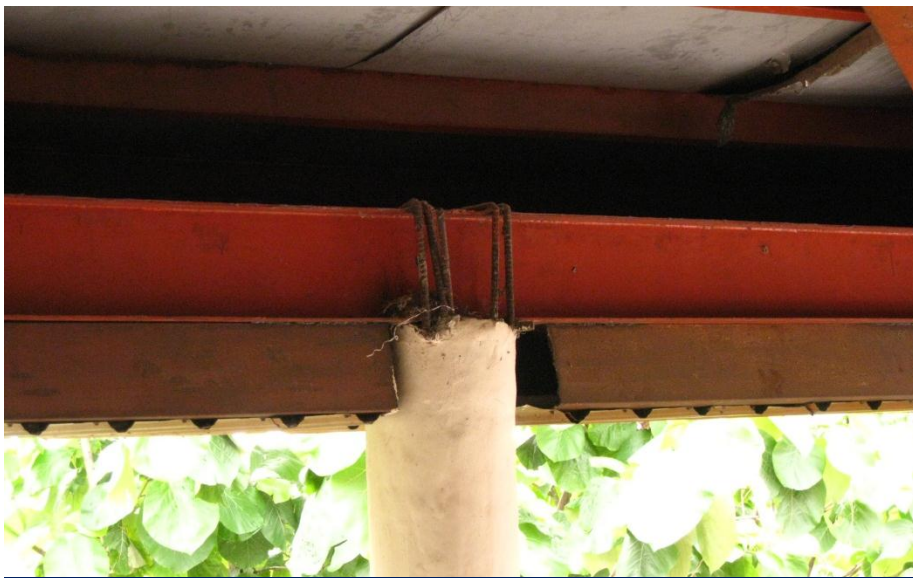
Building 1 – RC column to steel beam connection

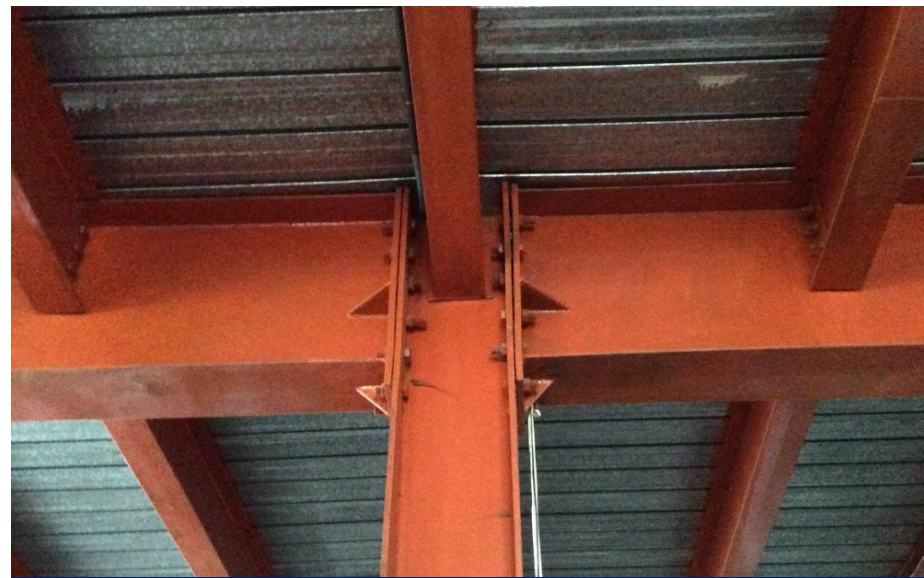
Building 5 – Minimal bearing of end plates

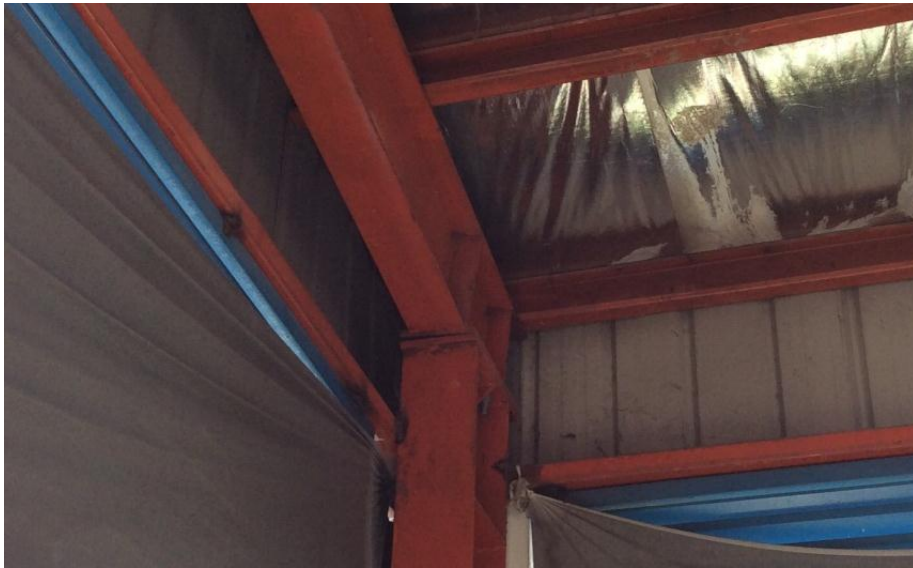
Building 5 – Minimal bearing of end plates

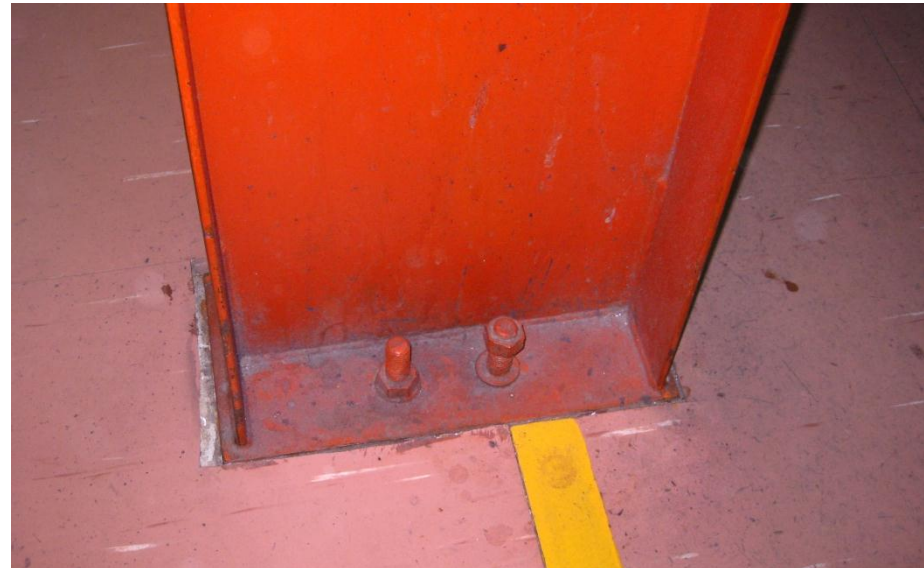
Shed 1 – Loose nuts to bolts
