# Square Fashions Ltd

Rokeyapur, Jamirdia, Habir Bari, Valuka, Mymensingh, Bangladesh  
(+24.29540N,90.38831E)  
29<sup>th</sup> June 2014

# Observations

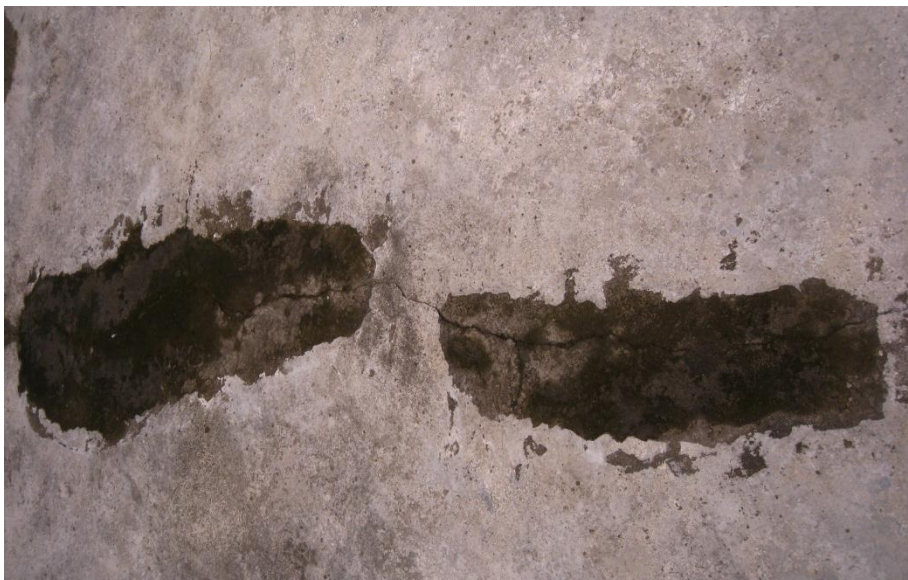
Cracking, ponding and water damage was observed to the roof slabs of the perimeter single-storey RC structures to Sheds 1 and 2.

Shed 1 – Cracking to roof slab

| Item No. | Observation | Recommended Action Plan | Recommended Timeline |
|---|---|---|---|
| 23 | Sheds 1 and 2 - Cracking, ponding and water damage to perimeter RC roof slabs | Building Engineer to review extent of cracking, ponding and water damage to roofs and to prepare a schedule of remedial works, as required. | 6-weeks |
| 24 | Sheds 1 and 2 - Cracking, ponding and water damage to perimeter RC roof slabs | Building Engineer to implement actions / supervise any remedial works as identified following the review. | 6-months |

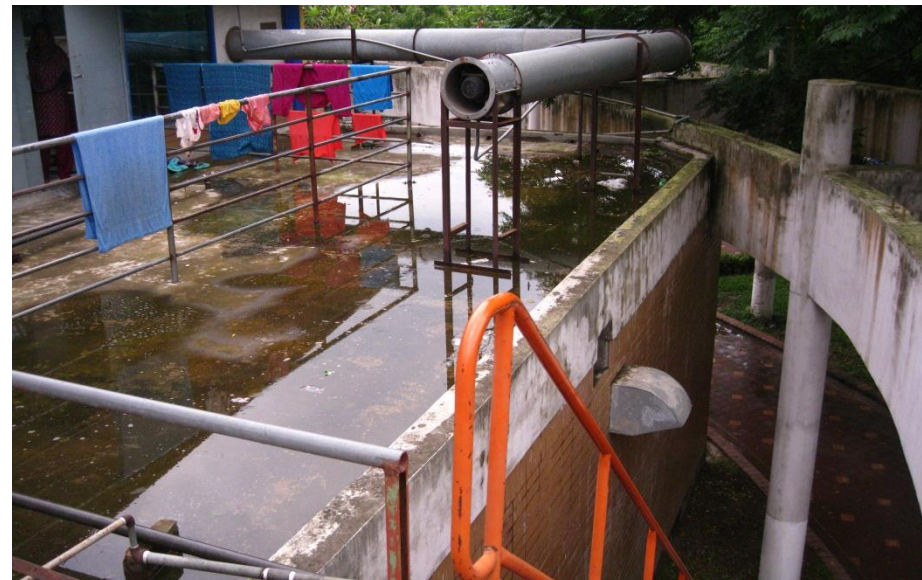
Shed 1 – Water ponding on roof slab

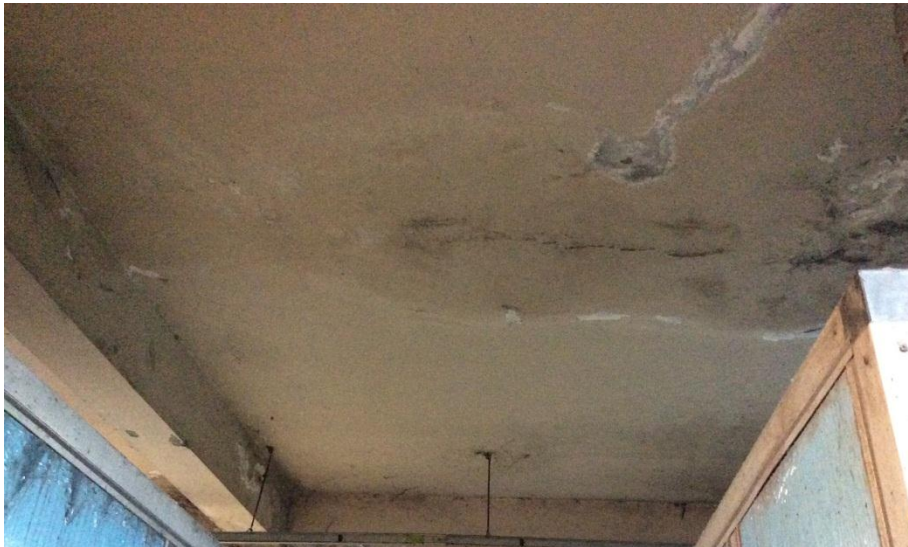
Shed 1 – Water damage to roof slab

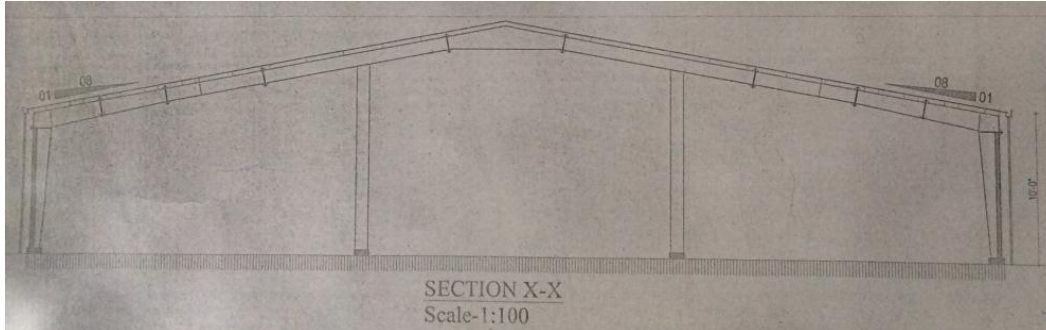
Permit drawings were not provided for review. Furthermore, there are a number of inconsistencies between the documents provided and the constructed buildings, particularly with the architectural drawings.

Shed 3 – Architectural section does not match constructed building

| Item No. | Observation | Recommended Action Plan | Recommended Timeline |
|---|---|---|---|
| 25 | Missing original documentation and inaccuracies in documentation provided | Building Engineer to check, collect information and produce accurate and fully complete as-built documentation. | 6-months |

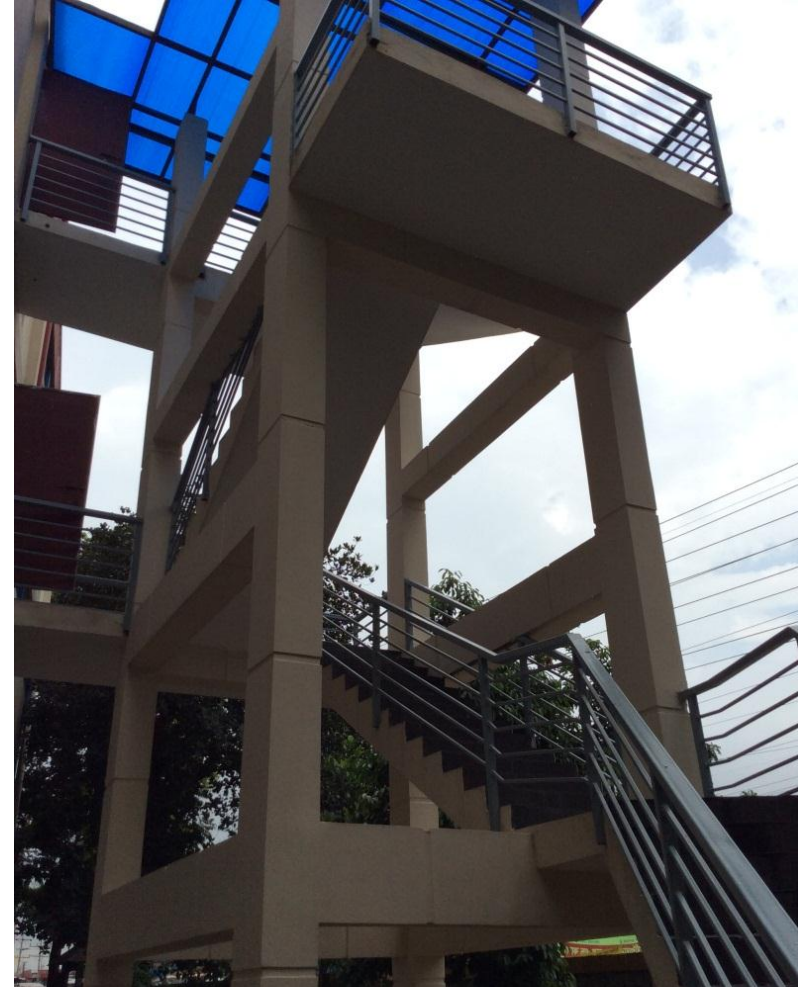
Building 5 – Staircase not shown on drawings
