# AST Knitwear Ltd

Plot: 3/1, East Chandon, Joydebpur, Gazipur  
(+23.994761N, +90.407653E)

06 October 2013

# Building Observations

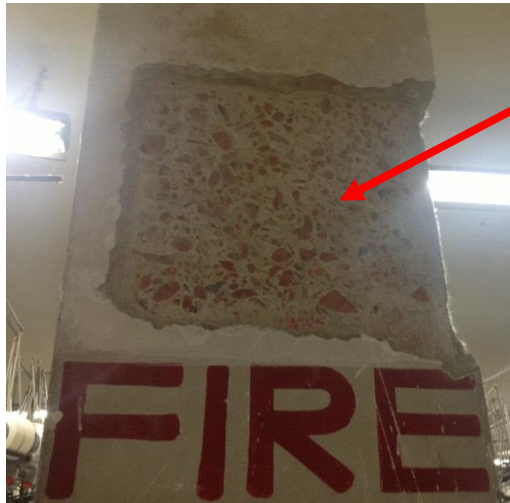
**As built columns at ground level smaller than  
shown on permit drawings**

Typical column size  
according to drawings:  
20" x 20" (500mm x 500mm)

Typical column size as  
measured:  
15" x 15" (380mm x 380mm)

As built columns at ground level  
smaller than shown on permit  
drawings

Create loading plan for all  
floors

Provide calculations  
showing loading and design  
of columns as constructed

| Item No. | Observation | Recommended Action Plan | Recommended Timeline |
|---|---|---|---|
| 1 | Column strengths and As built columns at ground level smaller than shown on permit drawings | Factory Engineer to review design, loads and columns stresses | 6-weeks |
| 2 | Column strengths and As built columns at ground level smaller than shown on permit drawings | Verify insitu concrete stresses either by cores or existing cylinder strength data for 4 typical columns at Ground Level | 6-weeks |
| 3 | Column strengths and As built columns at ground level smaller than shown on permit drawings | Produce and actively manage a loading plan for all floor plates within the factory giving consideration to floor capacity and column capacity | 6-months |

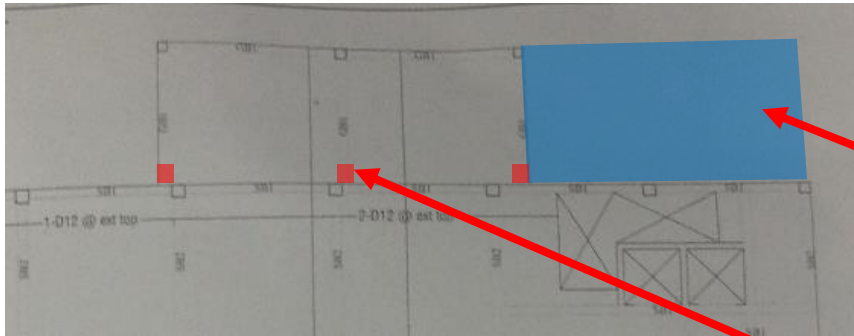
**No permit for the additional 3 story annex office building  
5 story annex building not built as shown on permit drawings**

**3-Storey Annex not on structural drawings**

**Provide calculations showing loading and design of slabs, beams, columns and footings as constructed**

| Item No. | Observation | Recommended Action Plan | Recommended Timeline |
|---|---|---|---|
| 4 | No permit for the additional 3 story annex office building, and 5 story annex building not built as shown on permit drawings | Provide calculations showing the structural adequacy of all beams, slabs, columns and footings of the east side additions, taking into account the loading plans and as-built structure including additions beyond the original design. | 6-months |

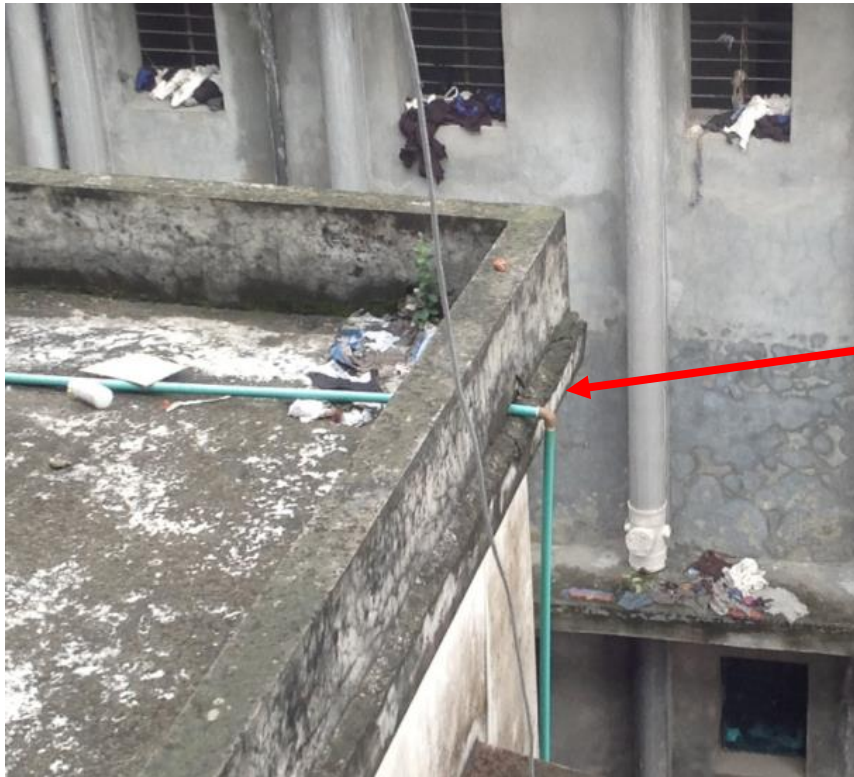
**Loose concrete at roof level of 5-story annex**

**Mitigate source of water damage to prevent future cracking**

**Repair spalling render at this location.**

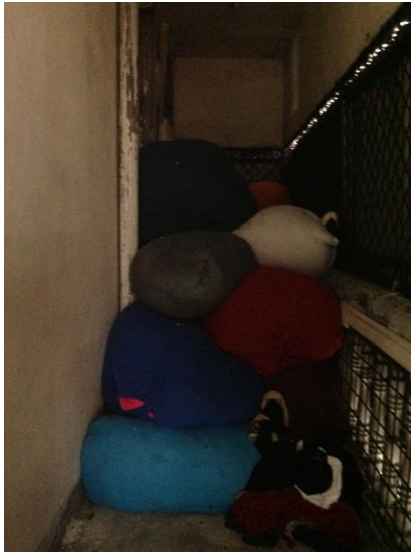
**Loading on cantilever balconies  
too heavy in places**

**Cantilever balconies used for uncontrolled storage**

**Building engineer to create controlled loading plan for all floors**

**Designate where storage can and cannot be placed**

**Ensure loading on cantilever balcony slab are within structural design limits**

| Item No. | Observation | Recommended Action Plan | Recommended Timeline |
|---|---|---|---|
| 7 | Loading on cantilever balconies too heavy in places | Building Engineer to create controlled loading plans for all floors designating where storage can be placed and can not be placed. | 6-months |
| 8 | Loading on cantilever balconies too heavy in places | Ensure loading on west side cantilever slab are within limits | 6-months |

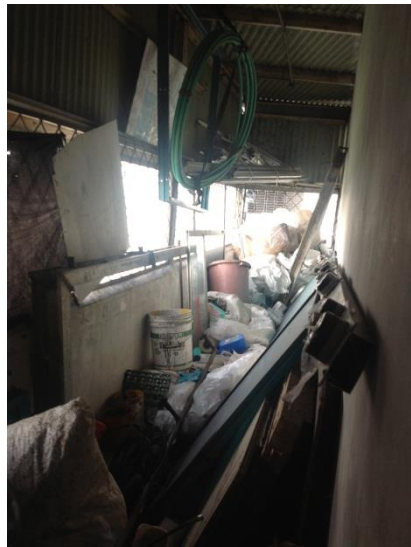
**Loading on cantilever balconies too heavy in places**

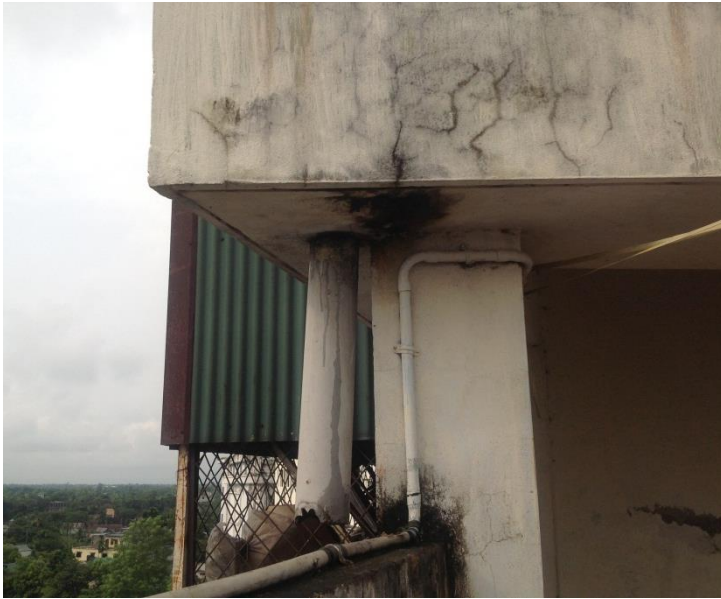
# Water causing damage and corrosion

**Building generally showing signs of water damage on facade**

**Building engineer to confirm damage is not structural**

**Sources of water to be identified, leaks to be repaired, drainage roof drainage system to be installed / improved**

| Item No. | Observation | Recommended Action Plan | Recommended Timeline |
|---|---|---|---|
| 9 | Water causing damage and corrosion | Engineer to inspect water damaged structure including the exterior and verify no structural damage has occurred.<br>Install or repair roof drainage system. | 6-months |

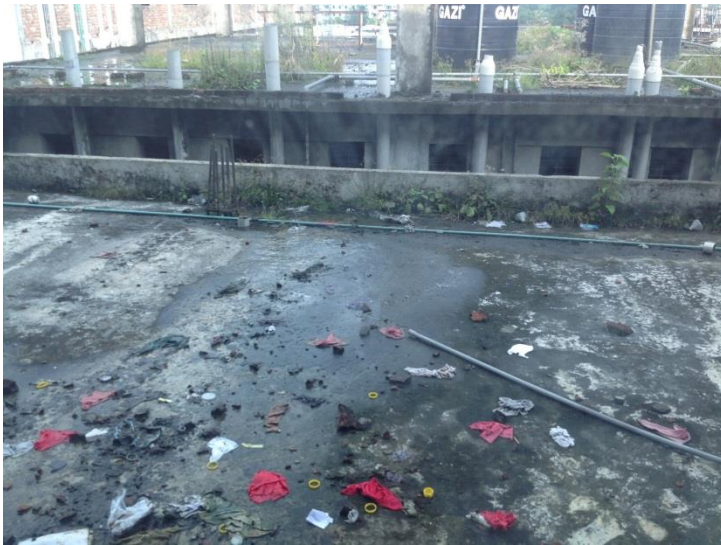
**Water damage occurring**

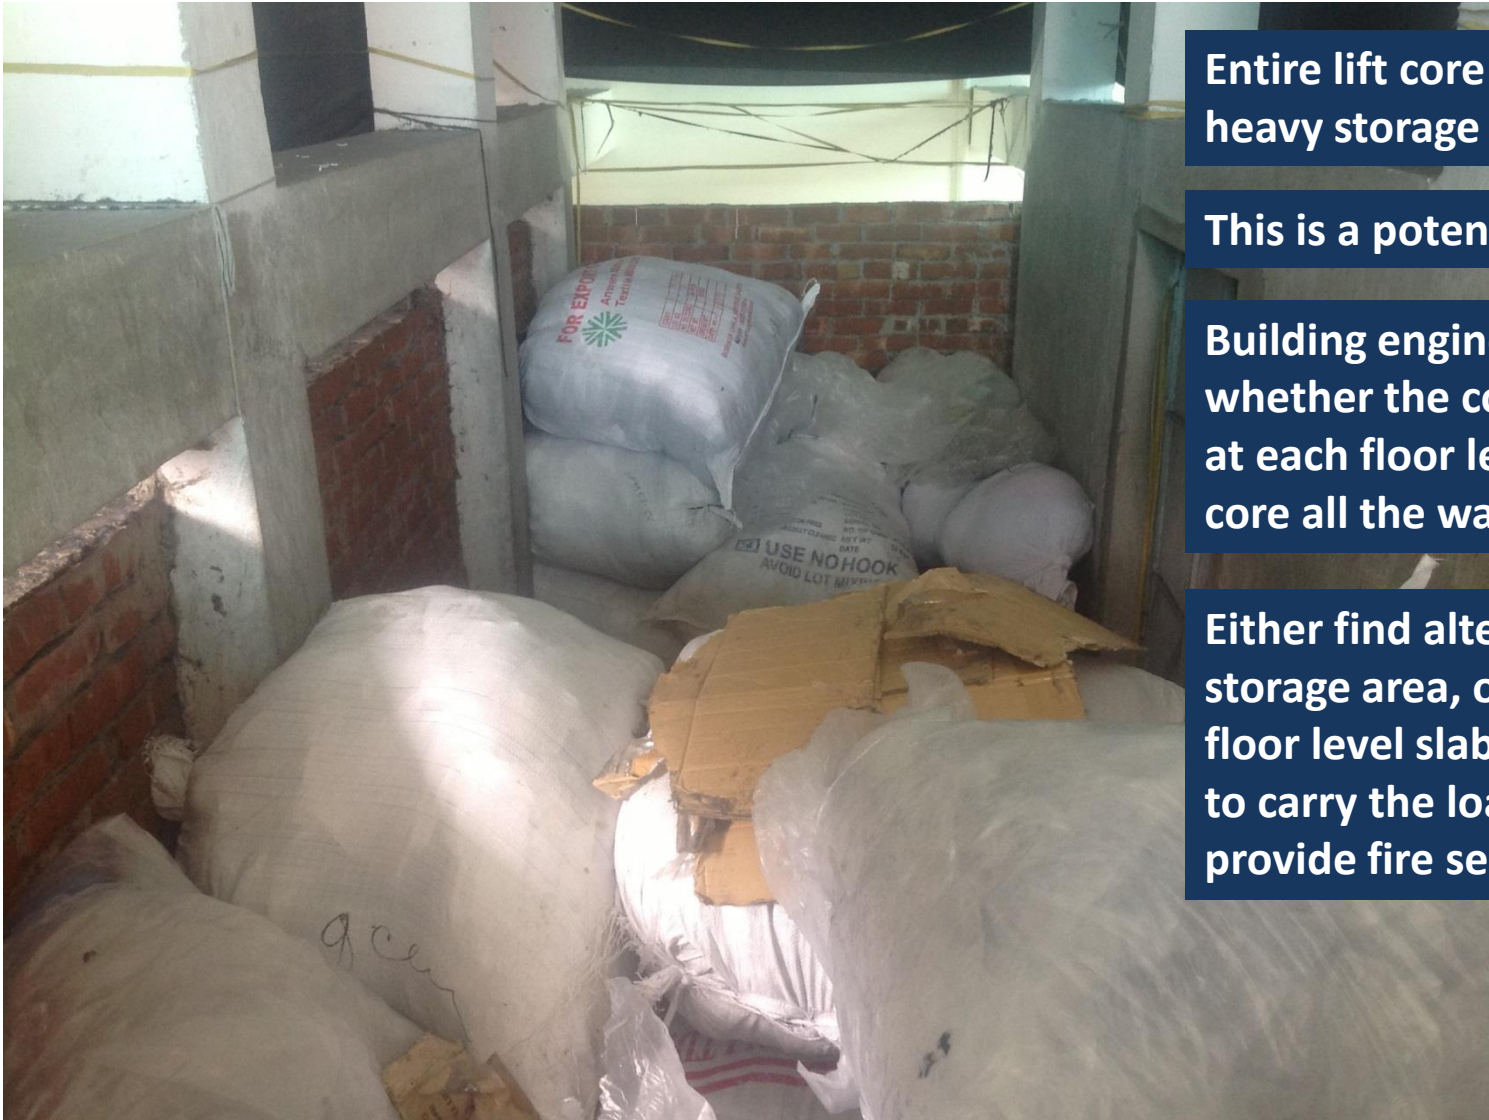
# **Elevator lift core filled with bags of fabric for storage**

**Entire lift core used for heavy storage**

**This is a potential fire hazard**

**Material storage within lift core**

**Building engineer to confirm whether the core has slabs at each floor level or open core all the way up**

**Either find alternative storage area, or provide floor level slabs within core to carry the load and provide fire separation**

| Item No. | Observation | Recommended Action Plan | Recommended Timeline |
|---|---|---|---|
| 10 | Elevator lift core filled with bags of fabric for storage | Non-structural comment: Remove all bags of fabric and any other flammable material from lift core. | 6-weeks |
