EH Textiles Ltd

221 – 225 Sataish Rd, Khortoil, Dhaka
(23.9208N, 90.3880E)

31 October, 2013

Building Observations

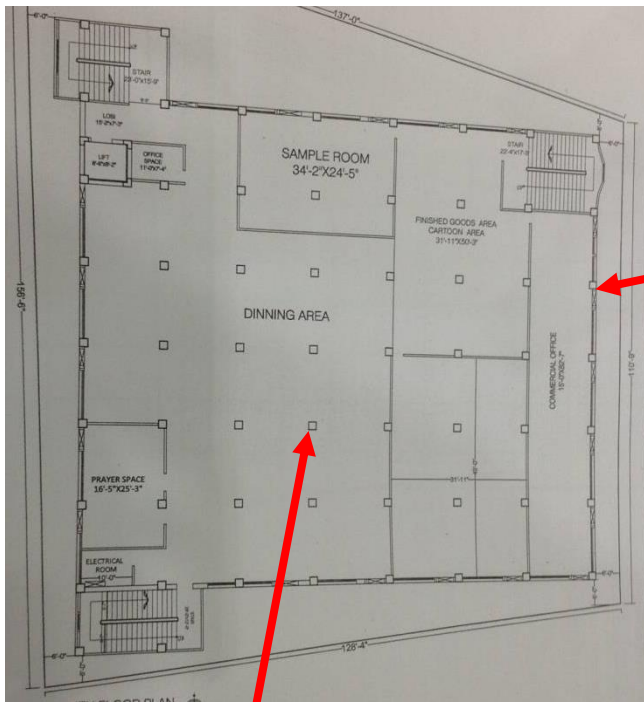
C2 – perimeter columns drawings show 20" x 15" at all floors (not as constructed)

**Check on column required:
Constructed columns smaller than those shown on Engineering drawings**

Perimeter columns
Expected size: 15" x 20"

Perimeter columns
Constructed as: 15" x 15"
(including render)
Likely actual column size:
14" x 14"

ITEM 1: Verify the structural adequacy of all building columns at all levels based on as built dimensions and material properties and reduce loads as detailed below

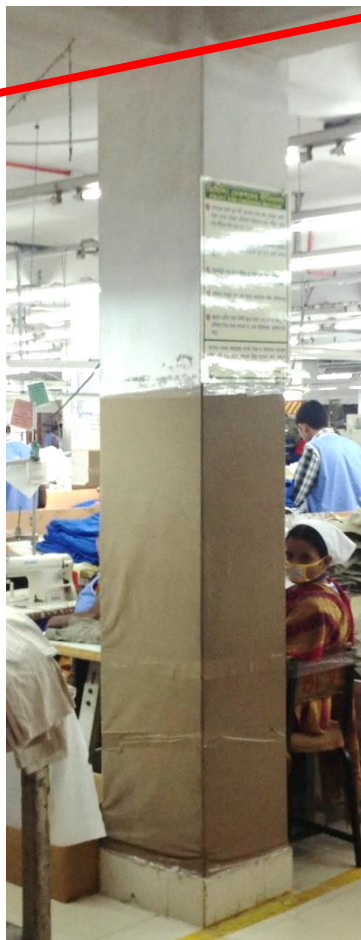
C3 – interior columns drawings show 20" x 20" at all floors (not as constructed)

Interior columns
Expected size: 20" x 20"

Interior columns
Constructed as: 17" x 17"
(including render)
Likely actual column size:
16' x 16'

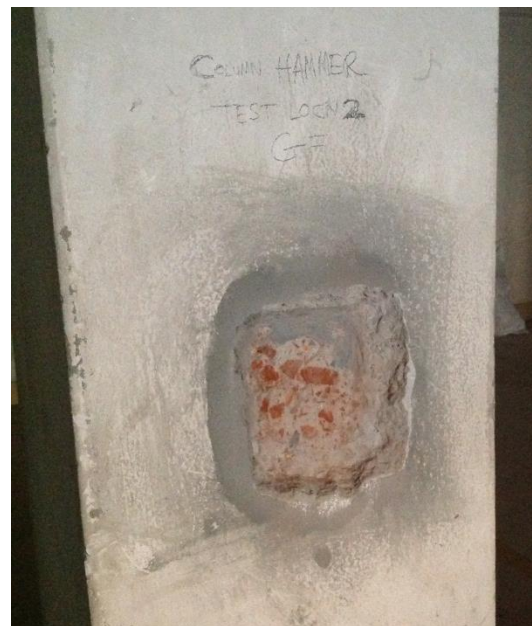
Brick aggregate columns
throughout

Column Stresses appear high for all columns, require immediate Engineering assessment.

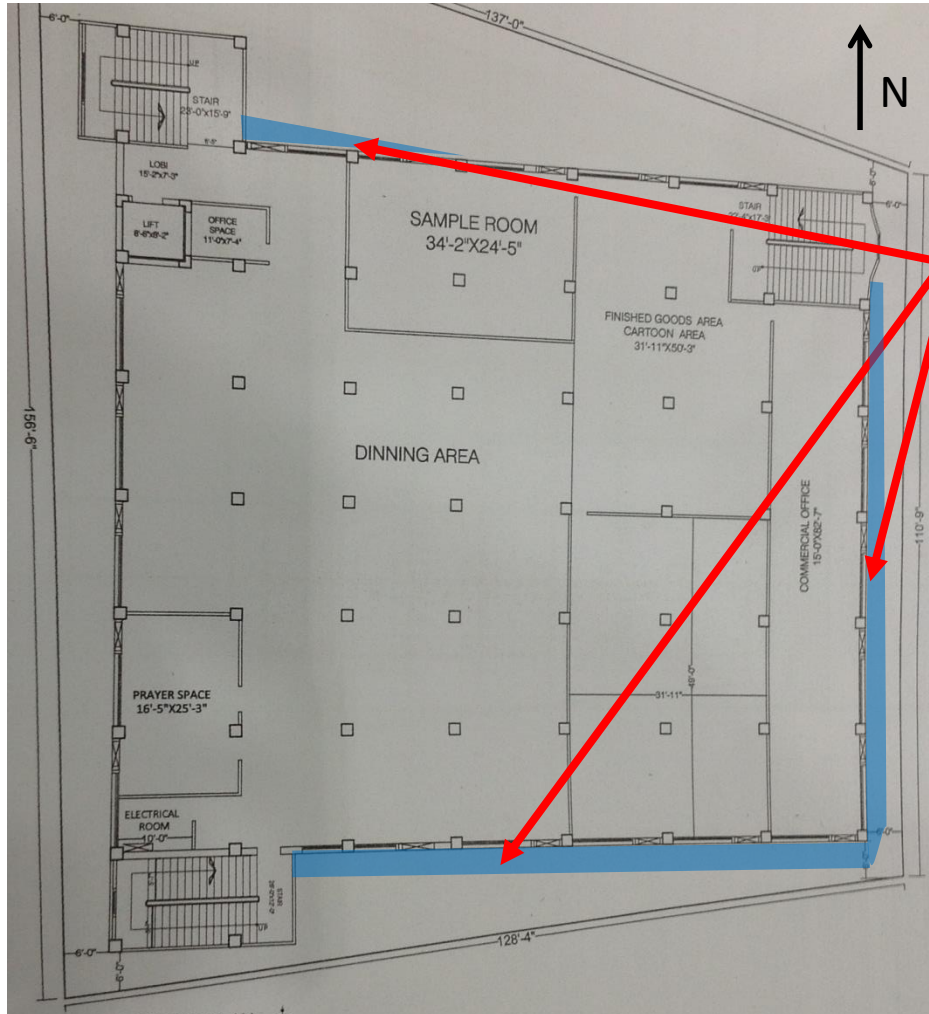
**Additional cantilevers have been constructed
on 3 sides of the building.**

Additional cantilevering slab on 3 sides not shown on engineering or permit drawings. Constructed from 1st to 6th Floor.

ITEM 2: Cantilever alterations to façades (all elevations) to be Reviewed and checked

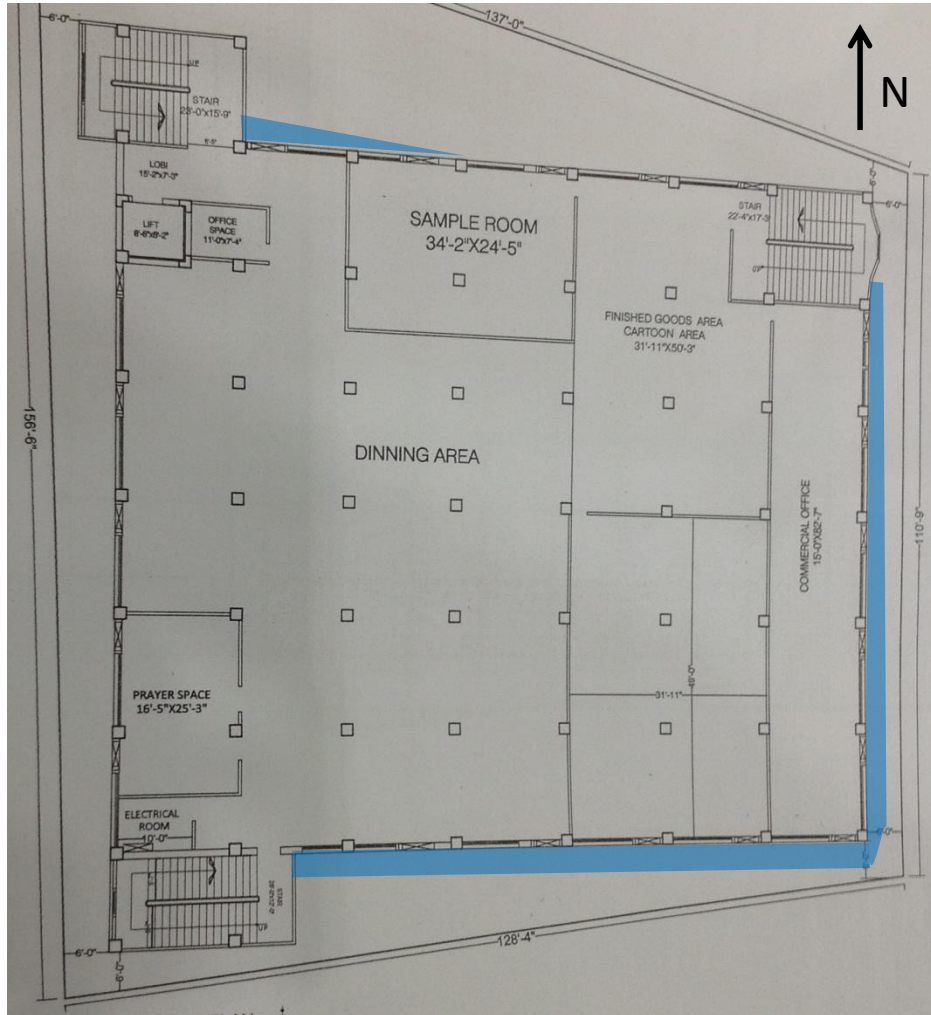
**Additional Cantilever
1st to 6th Floor**

Additional Cantilever 1st to 6th Floor

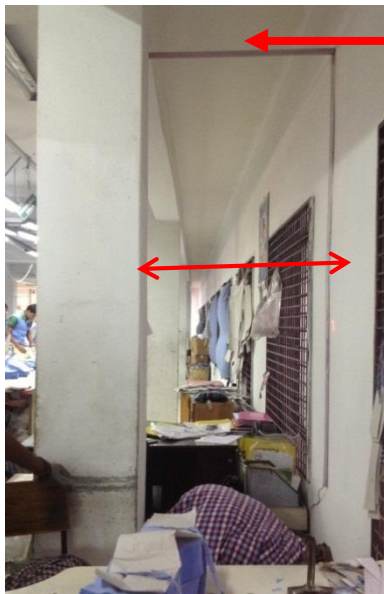
Flat slab cantilever

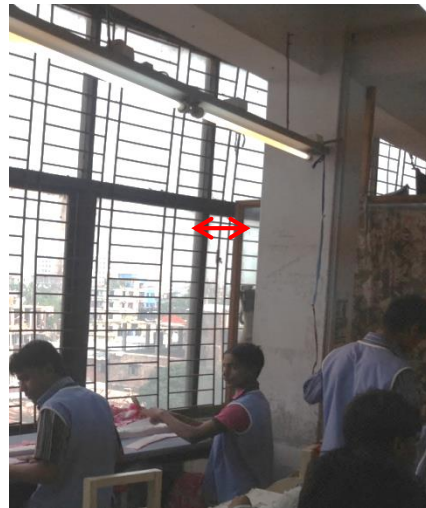
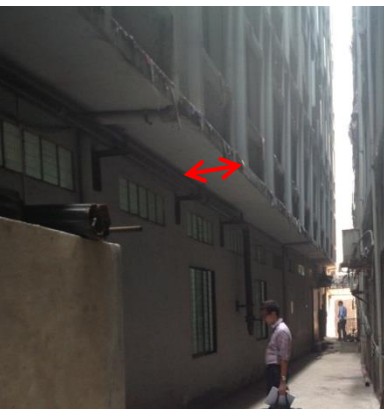
Cantilever – South Façade
Approx. 1.6m

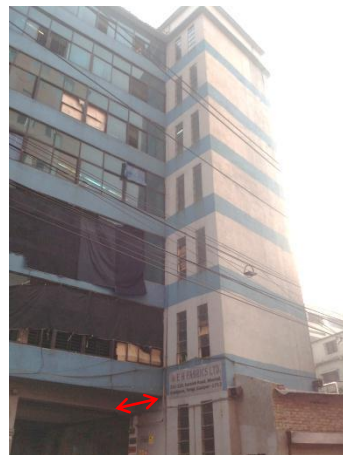
Cantilever – North Façade
Approx. 0.8m

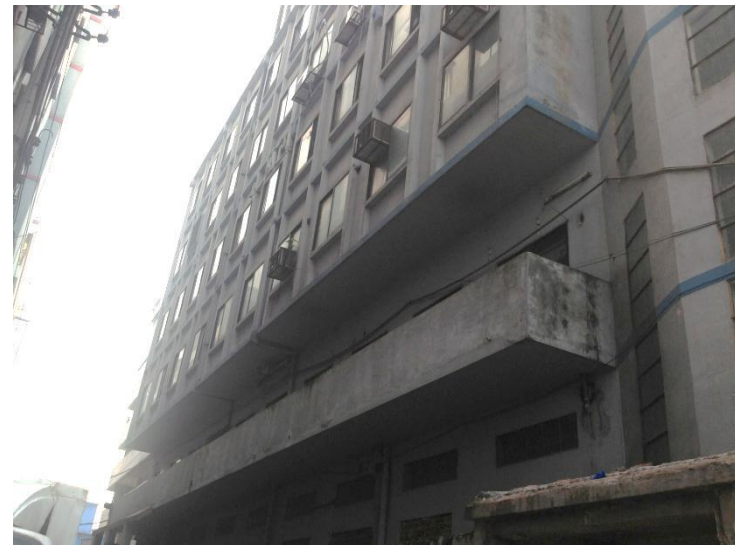
Cantilever – East Façade
Approx. 1.0m

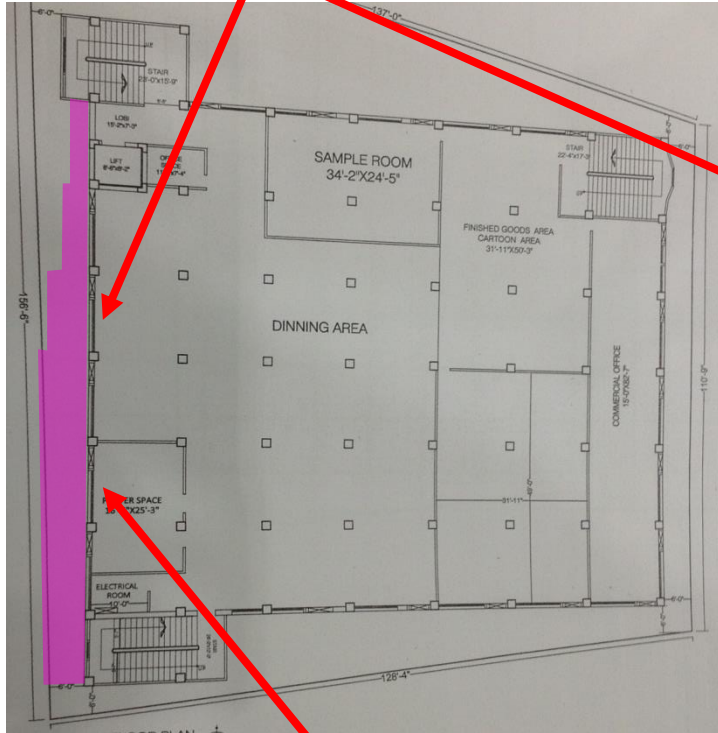
**Irregular façade on
Western Elevation – all
levels**

**Appeared to be
supported by additional
columns at façade line**

**Additional columns and slab outline
not shown on engineering or permit
drawings**

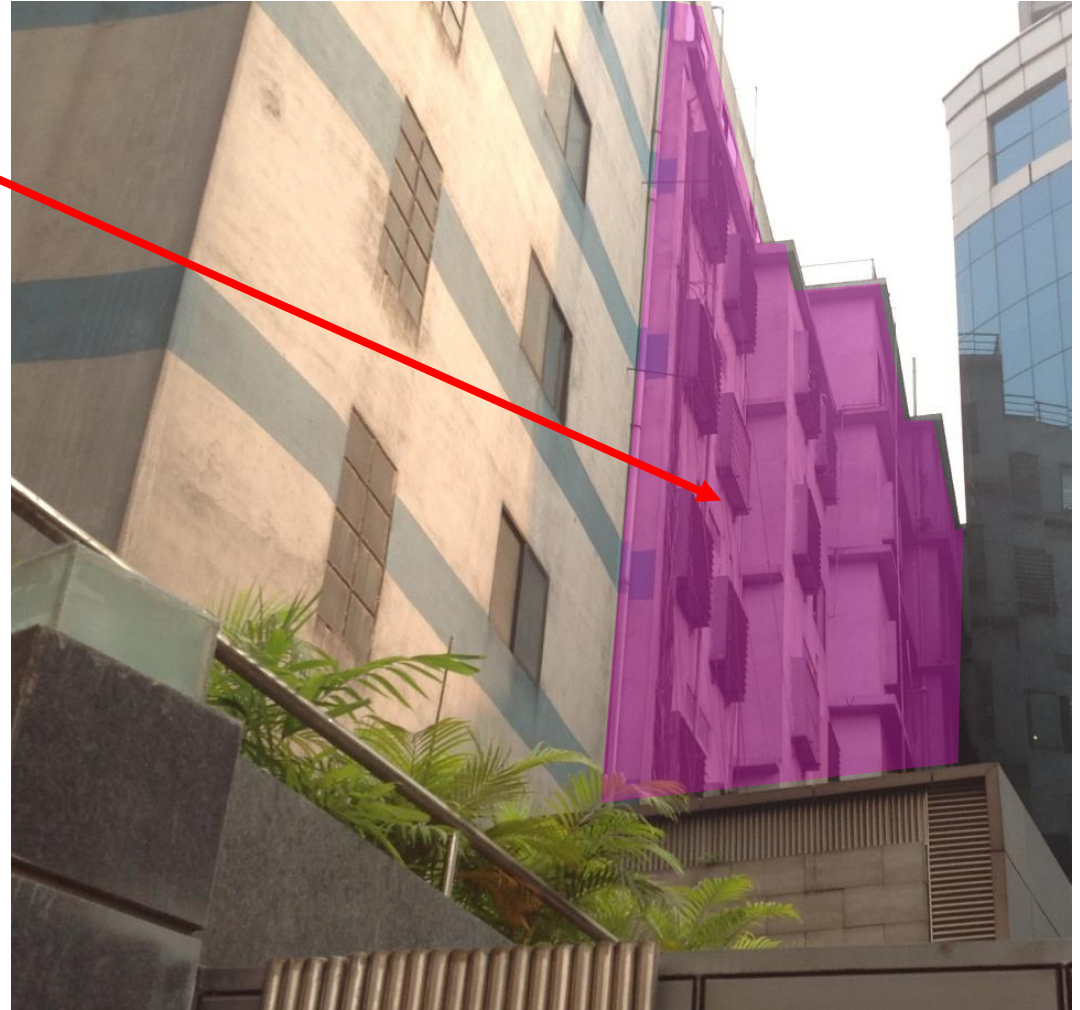
Irregular Western Facade

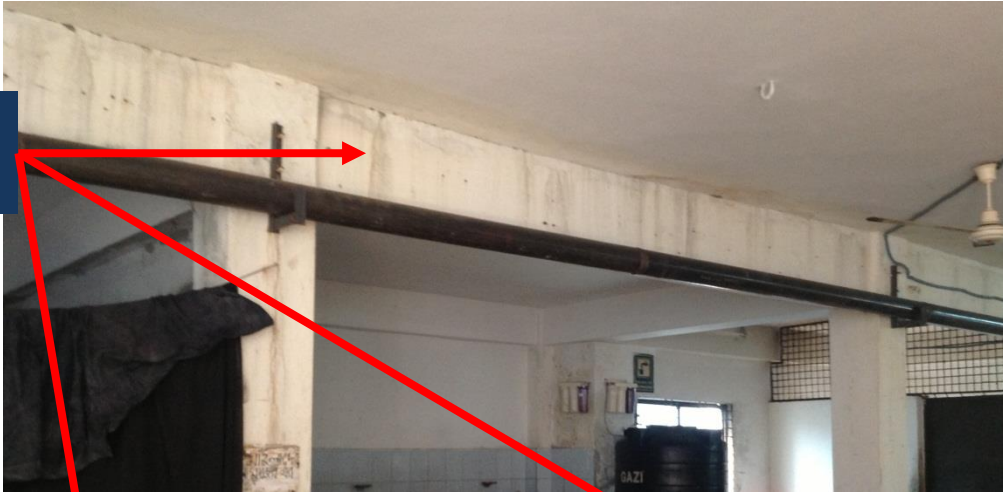
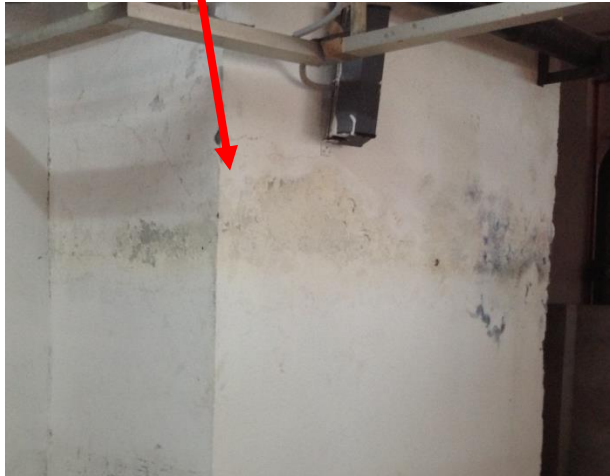
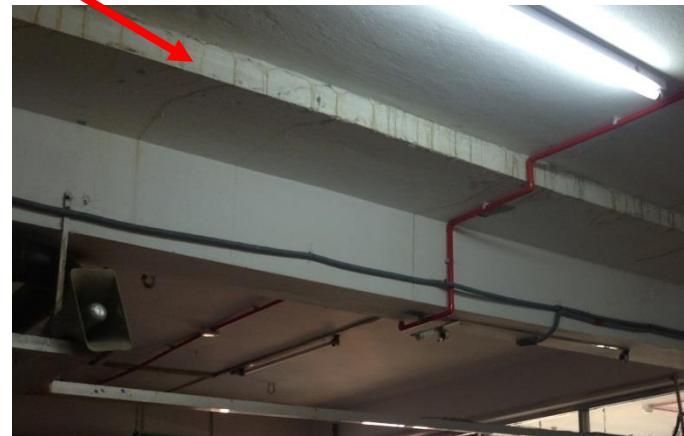
Water leakage from roof slab

Water leakage
from roof slab

ITEM 3: Rectify Water issues causing damage and corrosion

11	Water causing damage and corrosion	Engineer to inspect water damaged structure including the exterior and implement an appropriate repair solution.	6-weeks

Item No.	Observation	Recommended Action Plan	Recommended Timeline
12	Water causing damage and corrosion	Roof drainage system/water proofing to be installed	6-weeks
13	Fire stairs at roof level inadequate and in poor condition.	Inspect, repair/replace any badly corroded treads in stair	6-weeks
14	Fire stairs at roof level inadequate and in poor condition.	Repair/Replace all handrails where anchorage is damaged	6-weeks
15	Fire stairs at roof level inadequate and in poor condition.	Escape stairs/supports should be designed and upgraded to support code loads by the building Engineer.	6-months
16	Access and egress from fire exits is down a narrow passage beside the building	Remove/repair trip hazards so that fire escape passage is clear	6-weeks
17	Access and egress from fire exits is down a narrow passage beside the building	Review building fire escape routes and if possible do not use stairs leading to narrow passage as primary fire escape	6-months

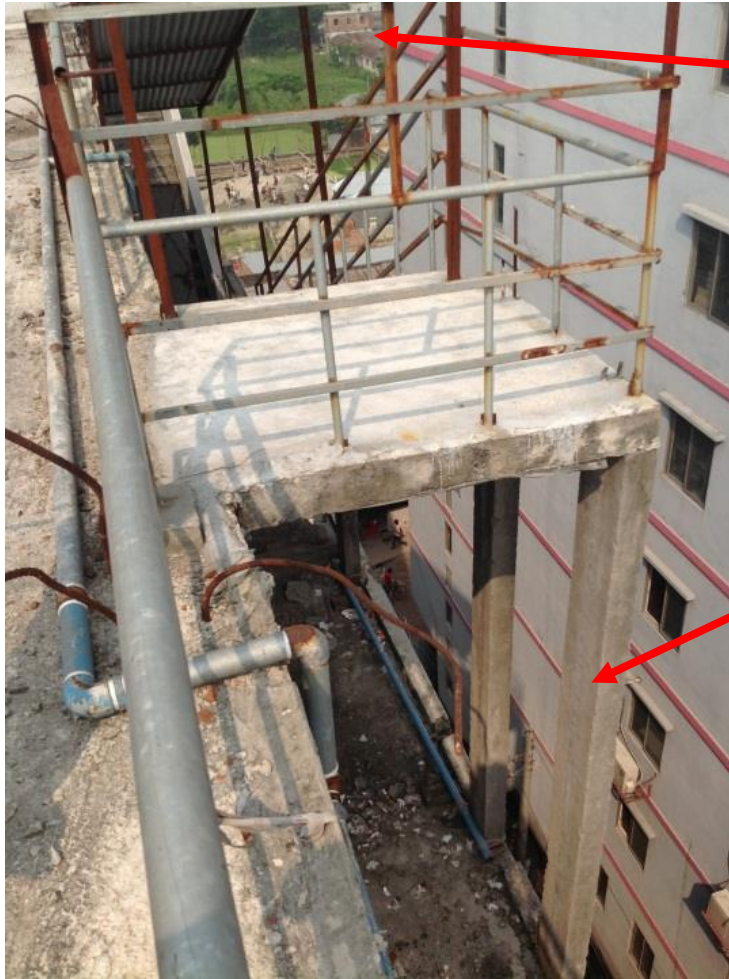
Stair 1

Steel stairs is badly corroded and may not support required access/escape loadings. The Concrete supports appear very slender and their design should be checked.

Flimsy corroding handrail

Very lightweight structure with significant corrosion apparent

Very slender support columns

ITEM 4: Rectify Fire stairs at roof level

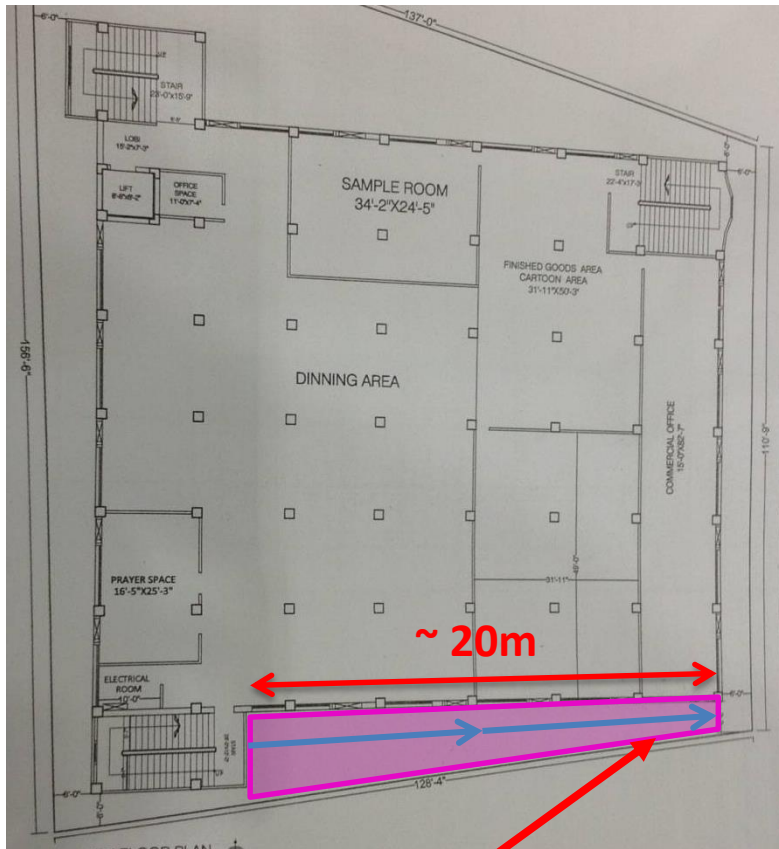
- Access and egress from fire exits is down a narrow passage beside the building which has several obstacles that may hinder escape – non-structural issue
- Some broken panes of glass – non structural issue

Passage narrows towards end

Overhanging cantilever

Trip hazards

ITEM 5: Address issues at ground level with Access and egress from fire exits

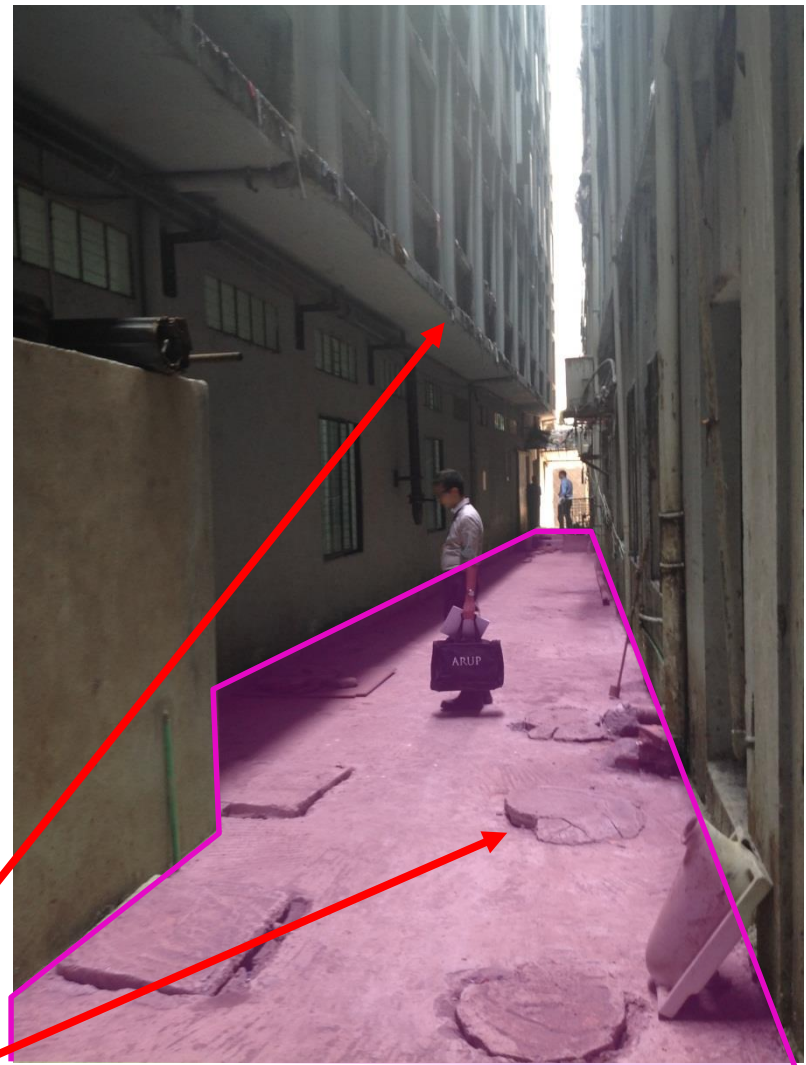
Access and egress from fire exits is down a narrow passage beside the building

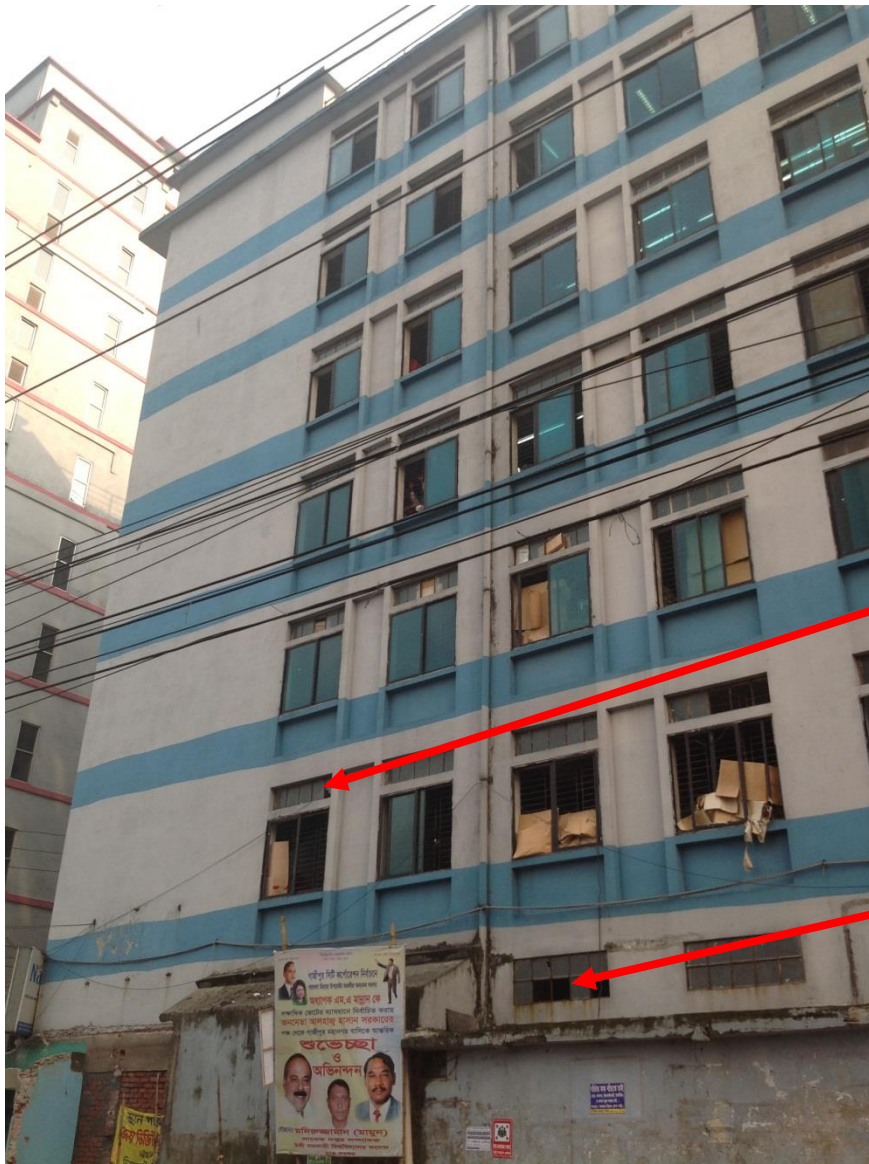
Broken glass could fall onto street below

Broken panes of glass may lead to water ingress

Some broken panes of glass

Item No.	Observation	Recommended Action Plan	Recommended Timeline
18	Broken glass on facades facing street	Carry out general maintenance and remove broken glass from windows	6-months
