# Fashion 2000 Ltd.

367/1, Senpara, Parbata, Mirpur-10, Dhaka  
(+23.80486667N, 90.37358333E)

03 October 2013

# Building Observations

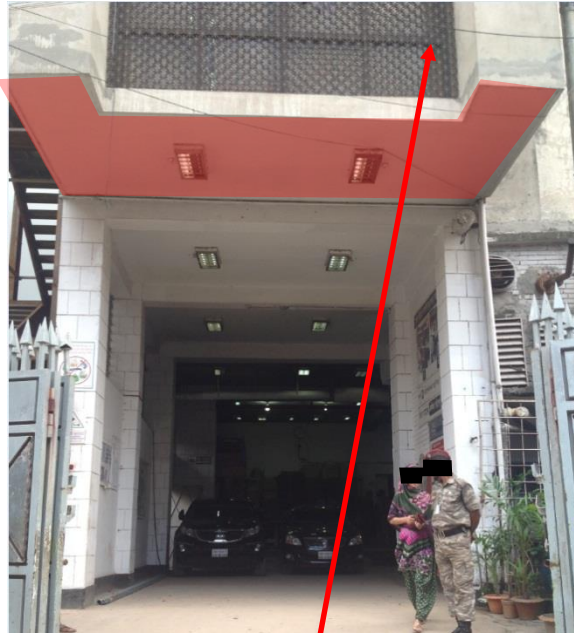
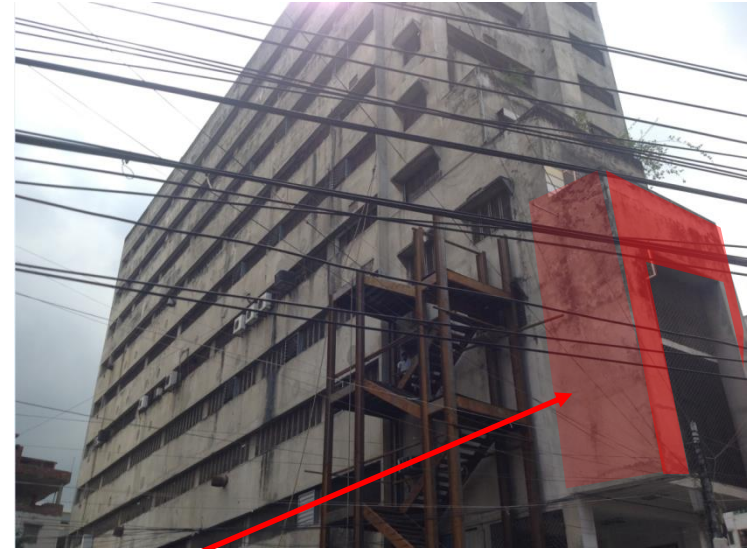
**Two storey cantilever area at front of  
building not shown on drawings**

| Item No. | Observation | Recommended Action Plan | Recommended Timeline |
|---|---|---|---|
| 4 | Two storey cantilever area at front of building not shown on engineering drawings | Building Engineer to carry out design check of cantilever slab and support columns at front of building. Revise As-Built drawings showing actual building perimeter. Create loading plan for cantilever area. | 6-weeks |

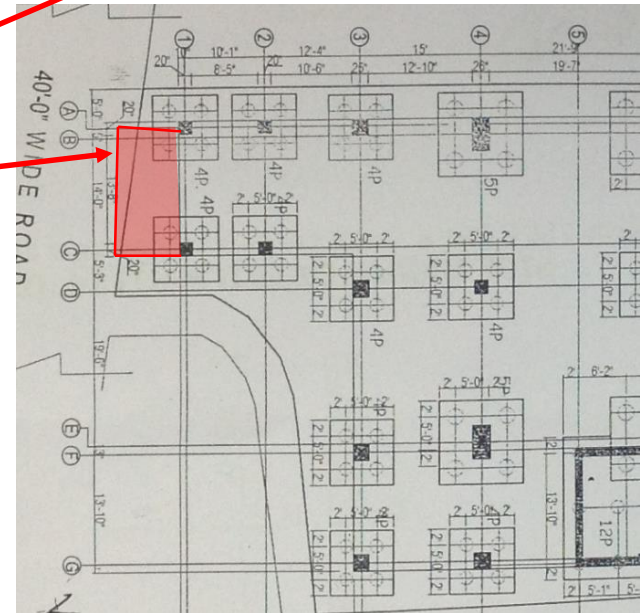
**Cantilever slab is not shown on drawings**

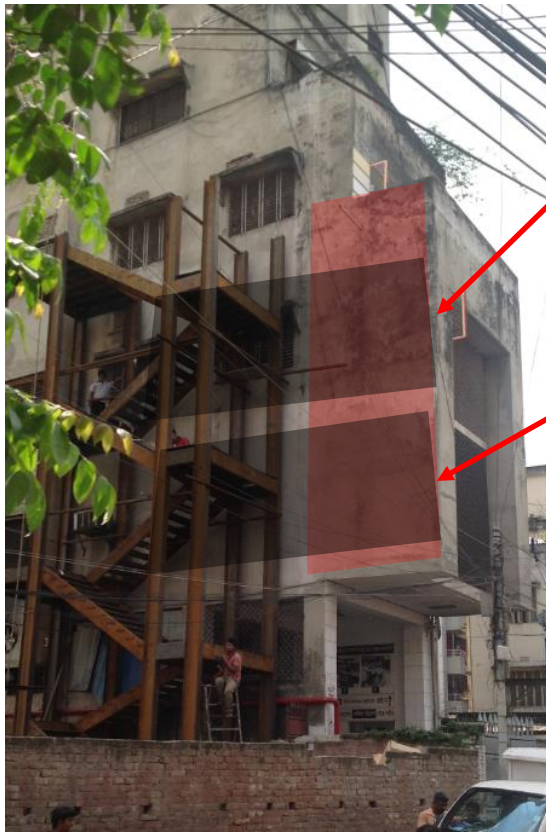
**Two Storey Cantilever**

Structure of 2<sup>nd</sup> floor cantilever could not be determined because of stored material

Structure of 1<sup>st</sup> floor cantilever could not be determined because of false ceiling and floor finishes in place (office space)

It is unclear if the slab alone is supporting the cantilever, or if there are beams in place

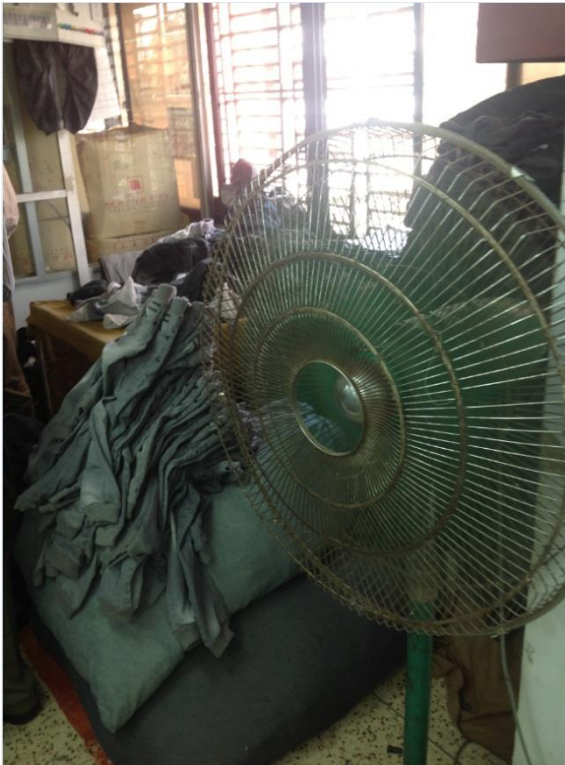
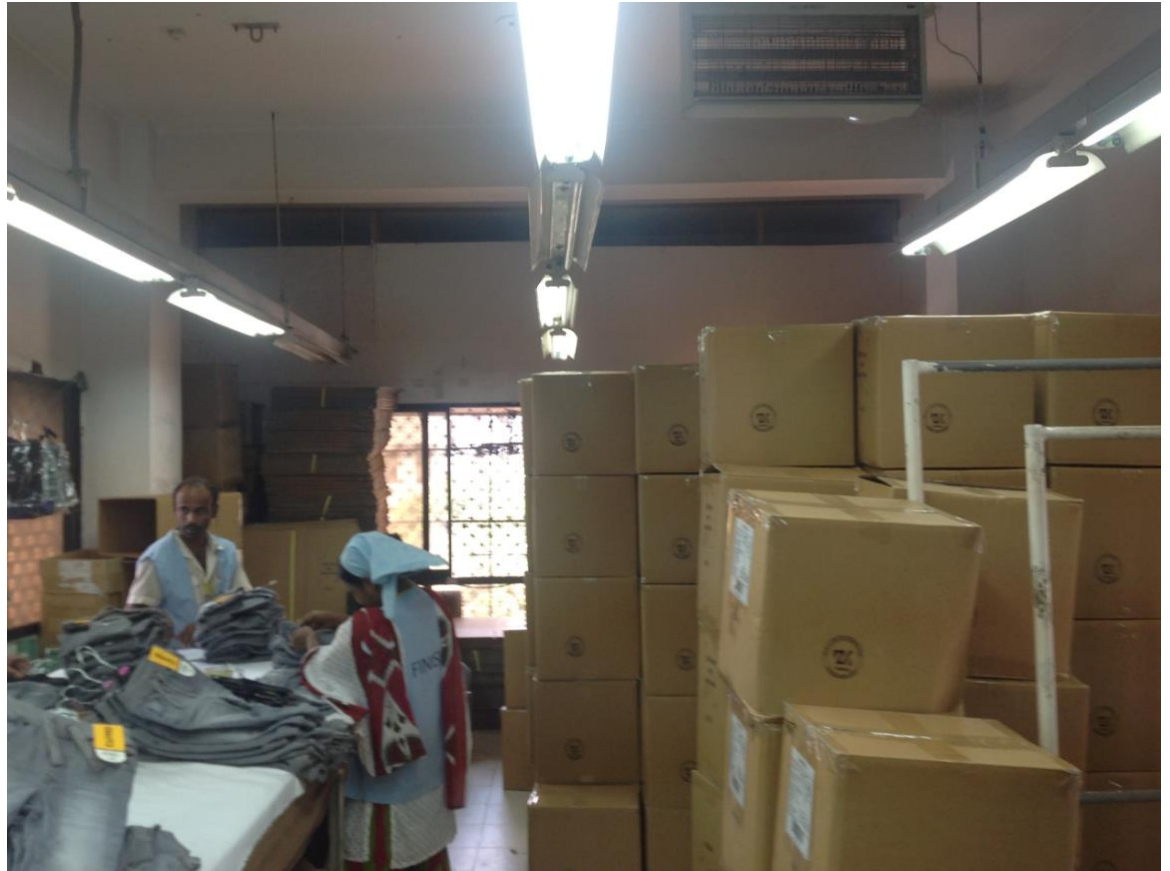
## Storage loading on 2<sup>nd</sup> floor cantilever

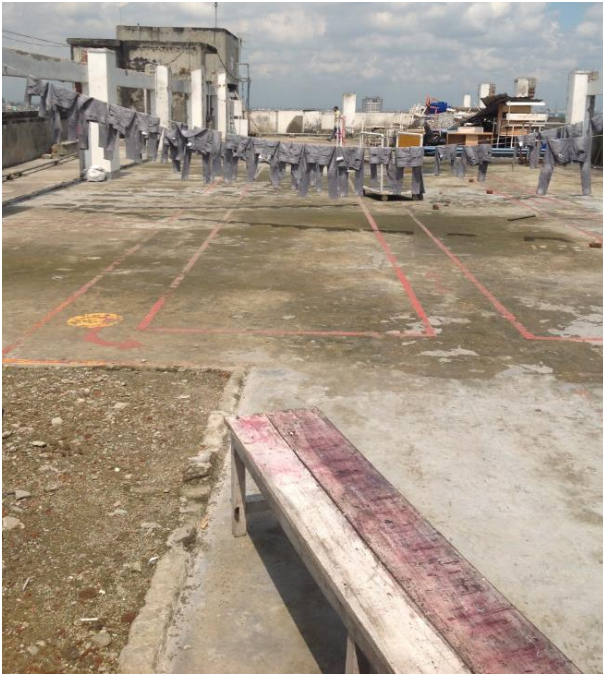
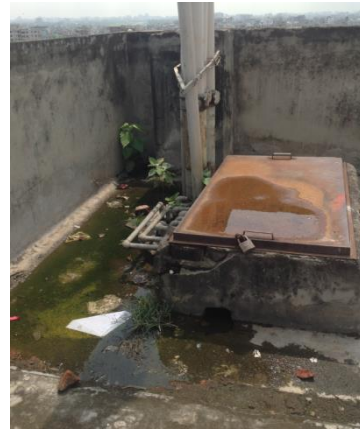
# **Roof Slab - Water causing damage to building fabric and potential for reinforcement corrosion**

| Item No. | Observation | Recommended Action Plan | Recommended Timeline |
|---|---|---|---|
| 5 | Damaged areas of roof slab due to removal of steel frame and walls | Engineer to inspect roof slab and propose a suitable repair system. Roof drainage system to be installed and damaged slab repaired. | 6-months |

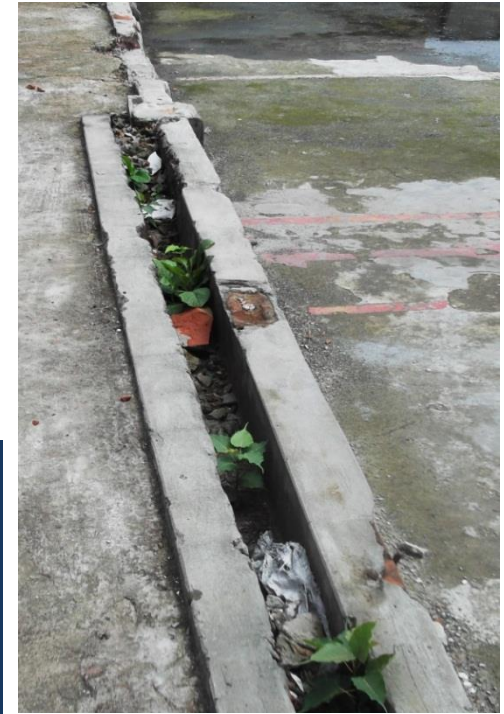
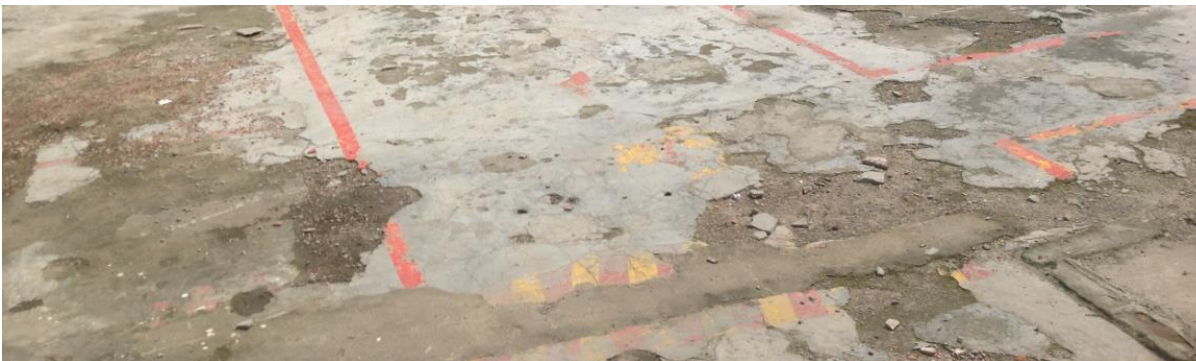
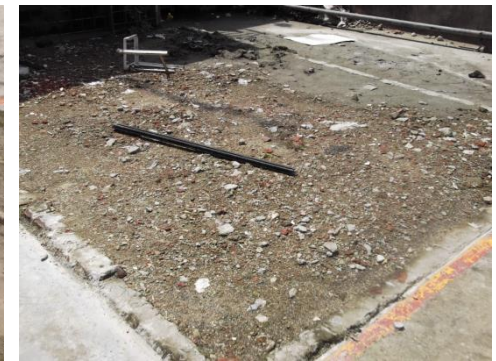
**Removal of previous roof structure resulted in damage to concrete slab. Roof drainage is not effective.**

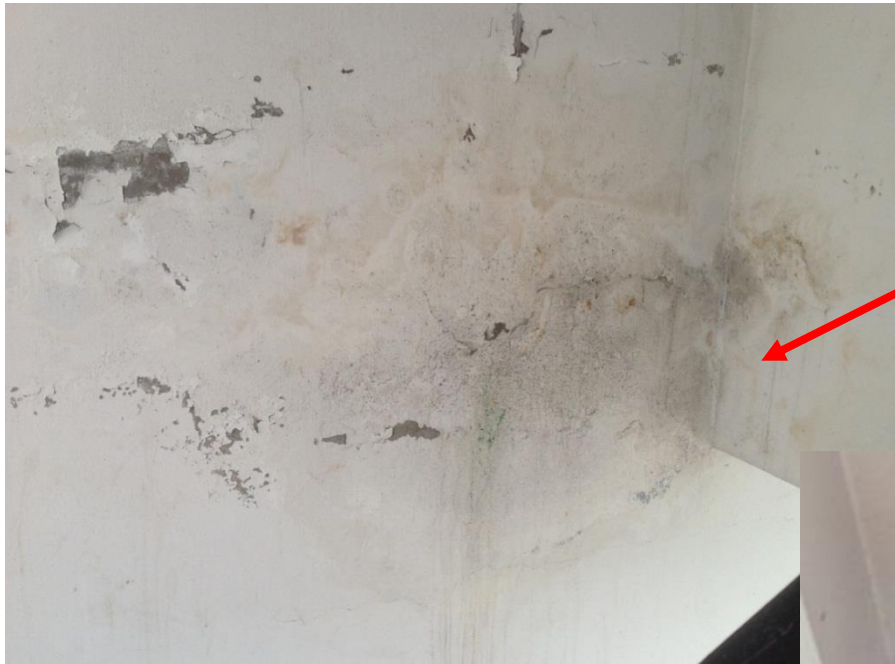
**Water causing deterioration of building fabric**

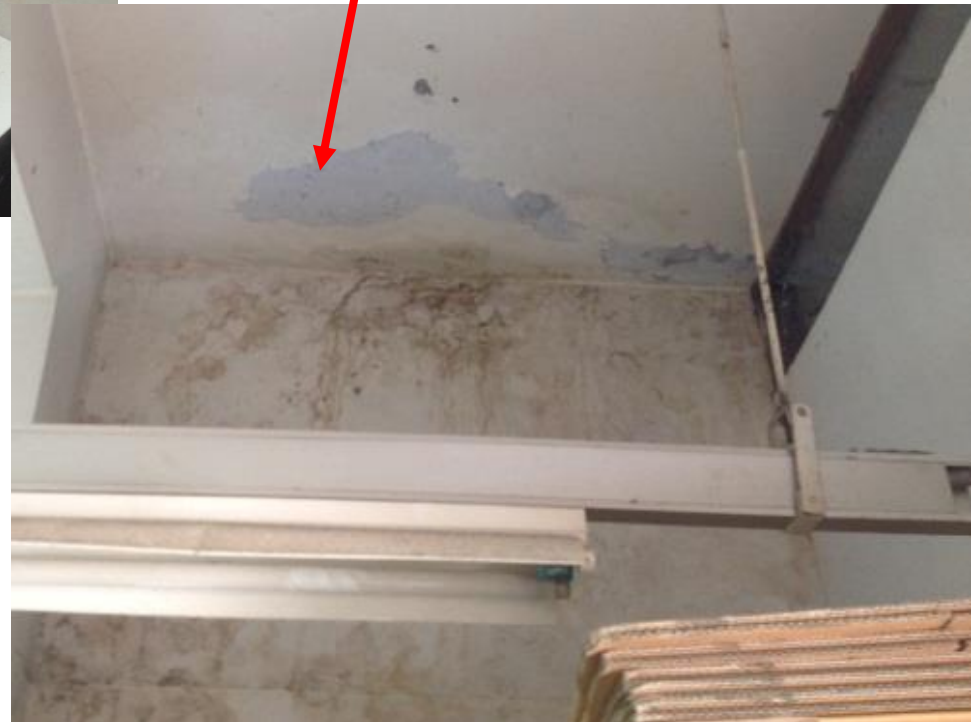
**Unmanaged roof  
drainage and roof surface  
causing deterioration of  
building fabric**

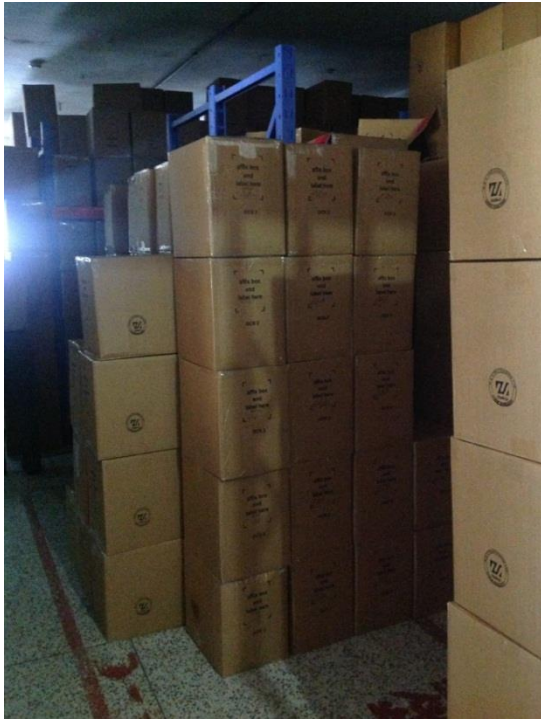
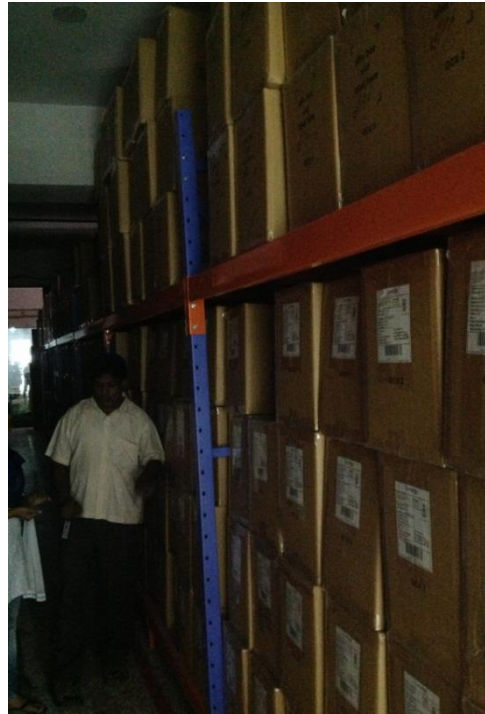
## Floor Slab Loading

**Floor slab thickness and allowable floor loads are not clear. Loading regime to be established**

**Material stacked to ceiling in storage level at mid level**

**Engineer to verify slab thickness and establish Allowable Floor loading plans for each floor level.**

| Item No. | Observation | Recommended Action Plan | Recommended Timeline |
|---|---|---|---|
| 6 | Slab thickness could not be confirmed. Loading regime to be established. | Building Engineer to confirm slab thickness at each floor level and review, by means of calculations, the slab and column capacity to verify Allowable Floor Loading Plans for each floor. | 6-weeks |
