# Barnali Textile and Printing Industries Ltd

Harizbagh, Godnail, Narayanganj, Dhaka

18<sup>th</sup> March 2014

# Observations

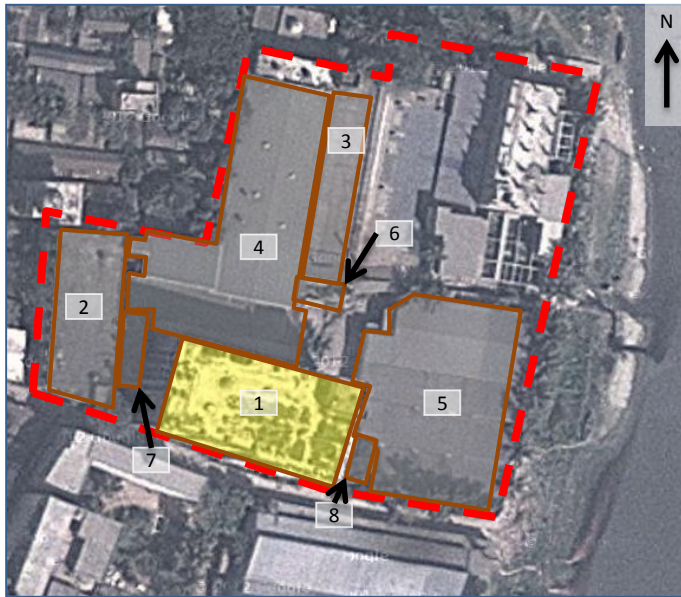
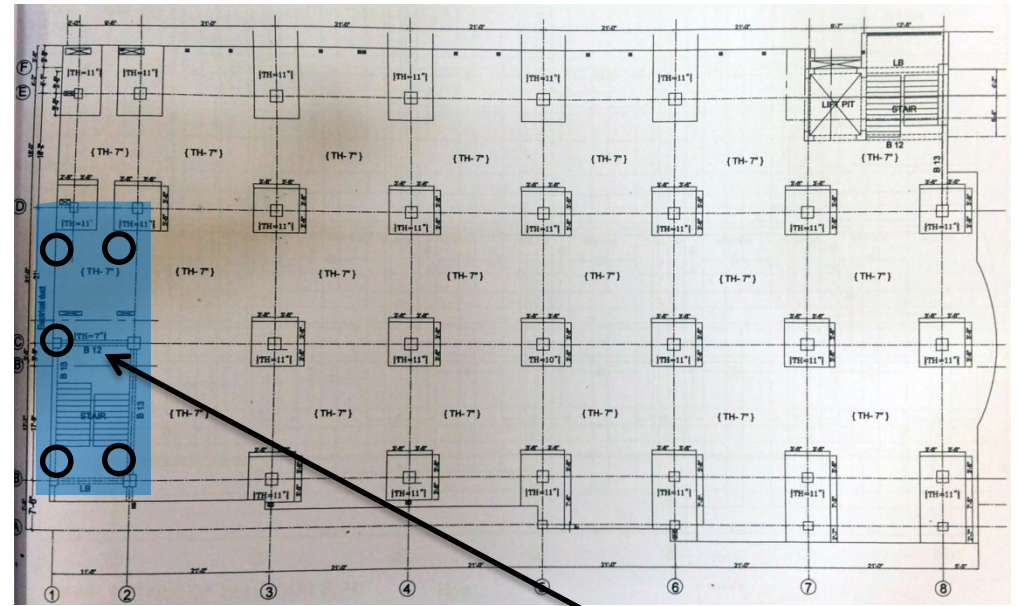
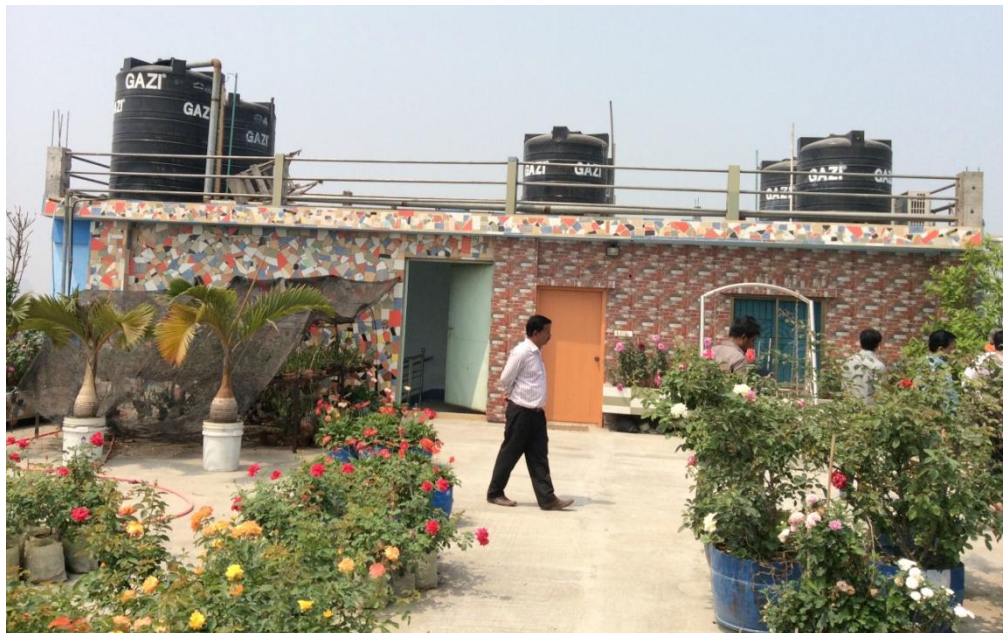
2no. 5000l tanks and 3no. 2000l tanks over stair core

Plastic water tanks in corner of building above stair core adds significant load to supporting structure. Tanks appear to be well placed near to columns.

| Item No. | Observation | Recommended Action Plan | Priority |
|---|---|---|---|
| 1 | BUILDING 1<br>Large water tanks at Roof Level. | Building engineer to check the structures and made proposals for the reduction of loads, if required | 6-months |

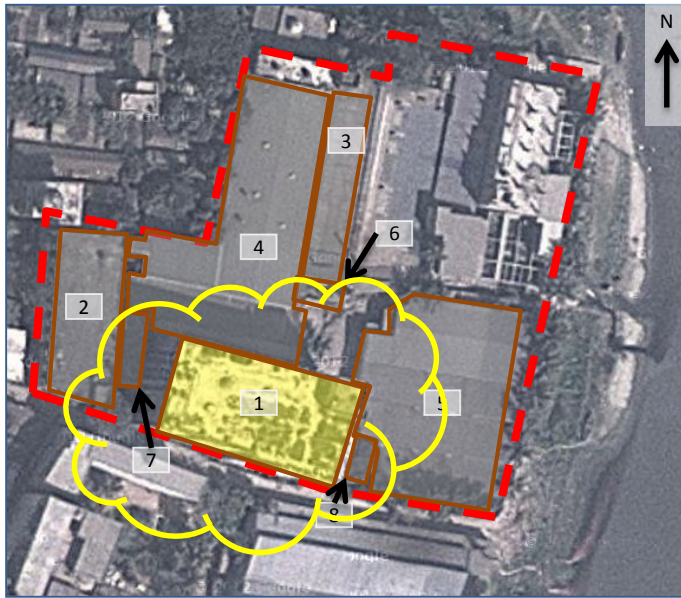
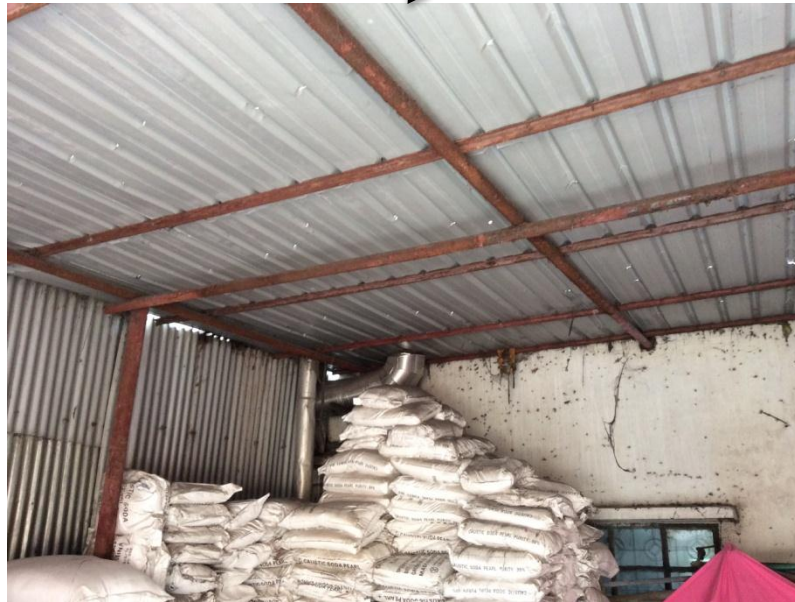
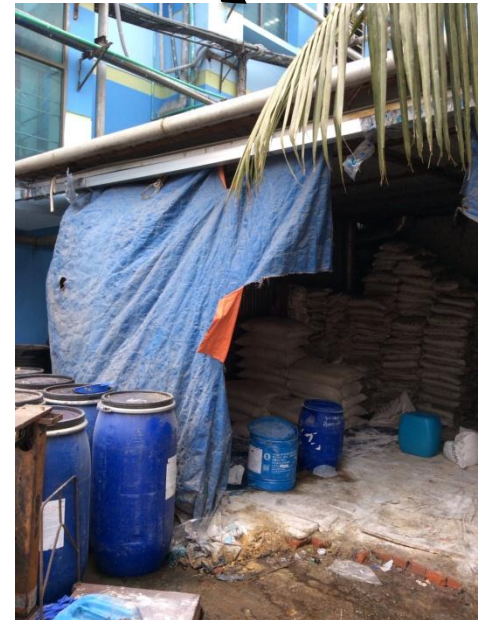
Non-engineered  
additional structures

Various structures appear un-engineered and possibly unstable including an unbraced roof structure in a single storey lean-to on the ground floor beside building 1

| Item No. | Observation | Recommended Action Plan | Priority |
|---|---|---|---|
| 2 | BUILDING 1<br>Non Engineered Steelwork to ancillary buildings. | Building engineer to check the structures and propose additional strengthening and bracing as required. | 6-months |

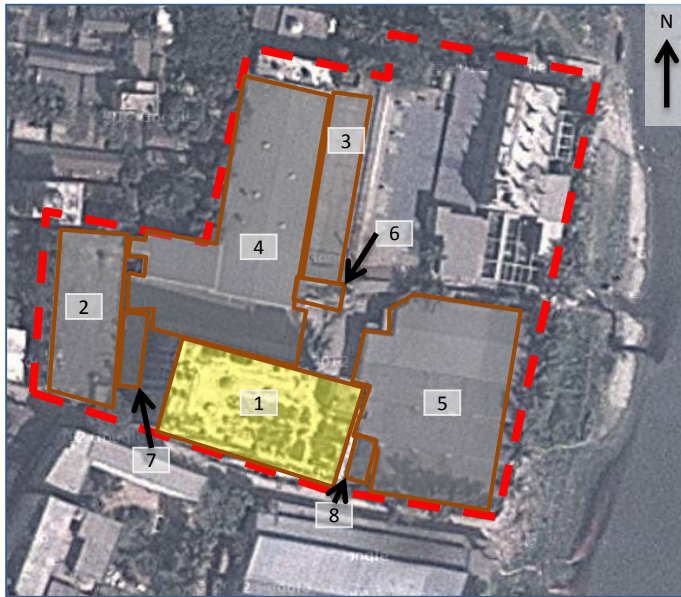
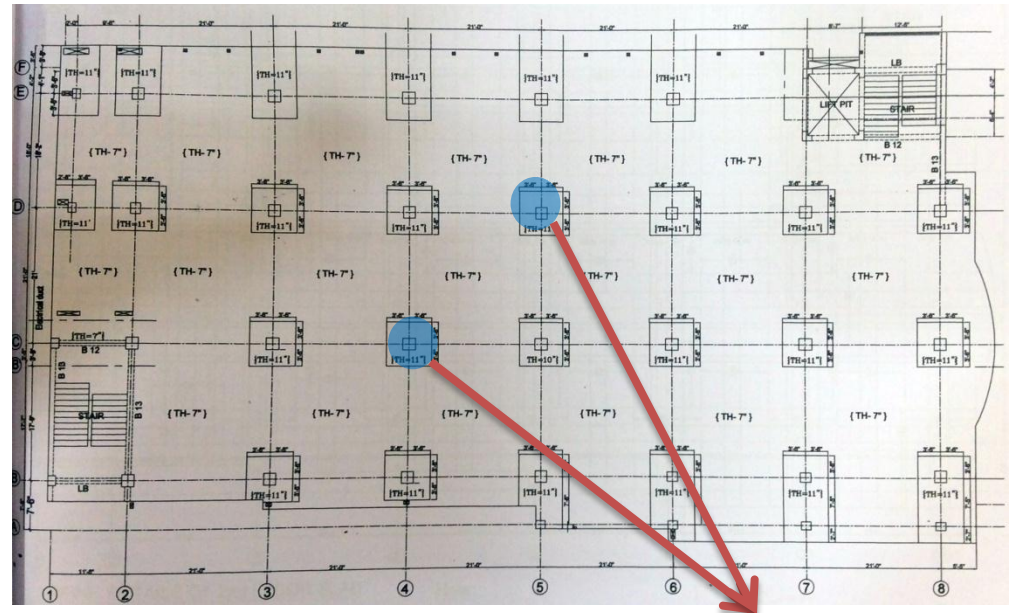
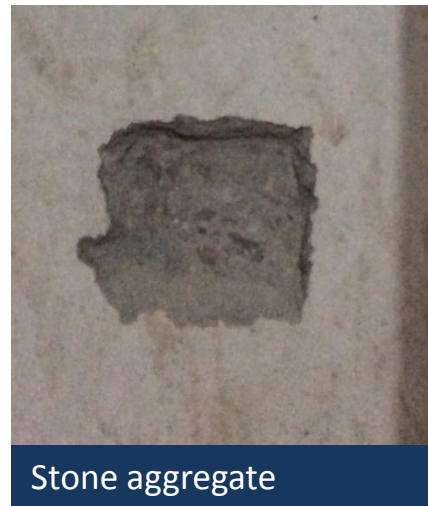
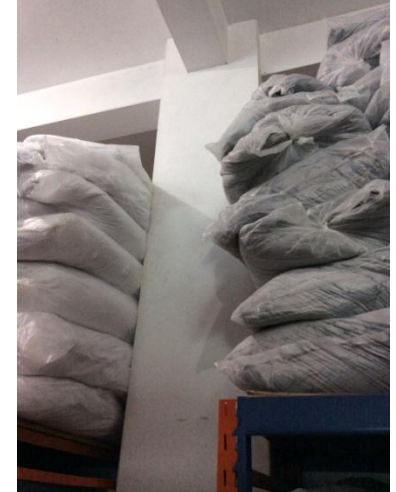
Design drawings are in good agreement with as-built structure. Local breaking out confirms aggregate type is stone throughout, and scanning on several columns indicates reasonable levels of reinforcement.

Building column tested at ground floor level

Stone aggregate

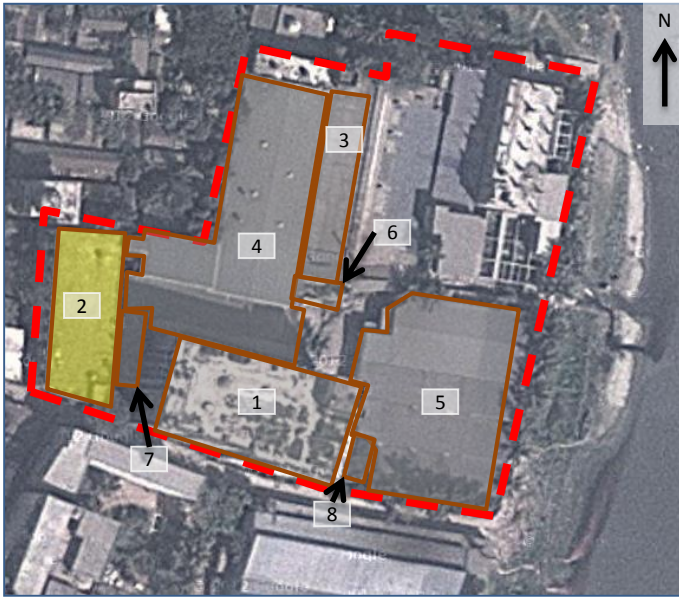
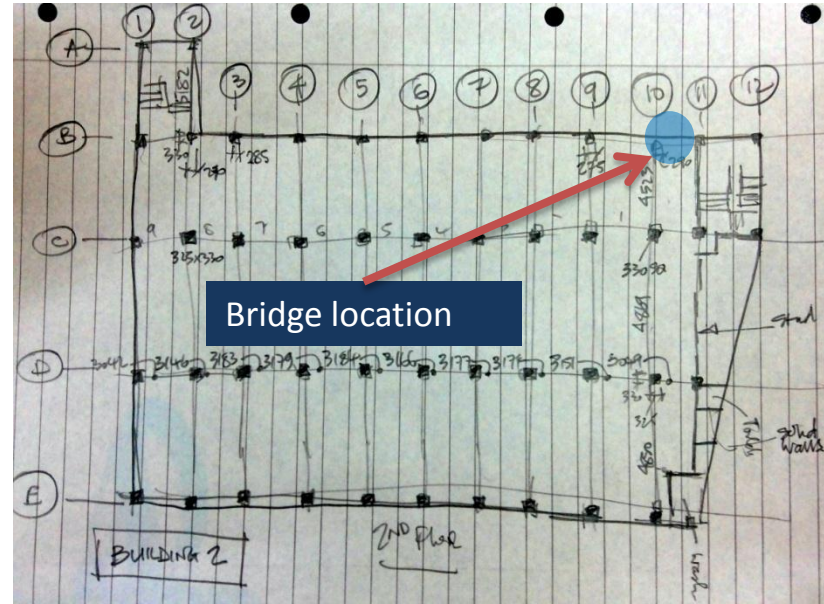
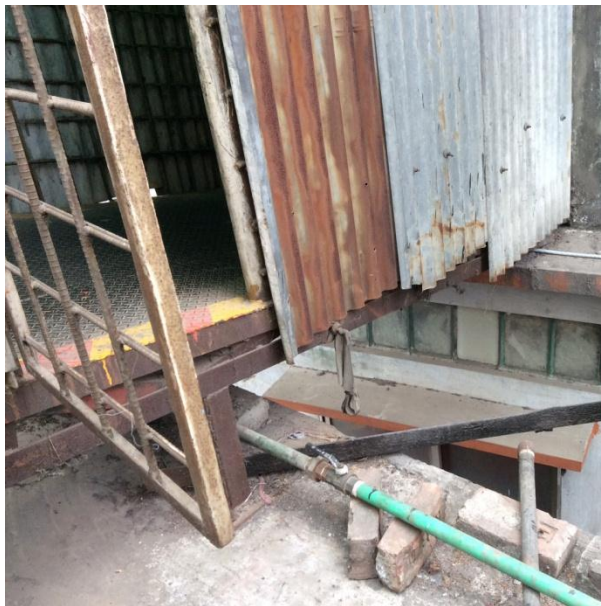
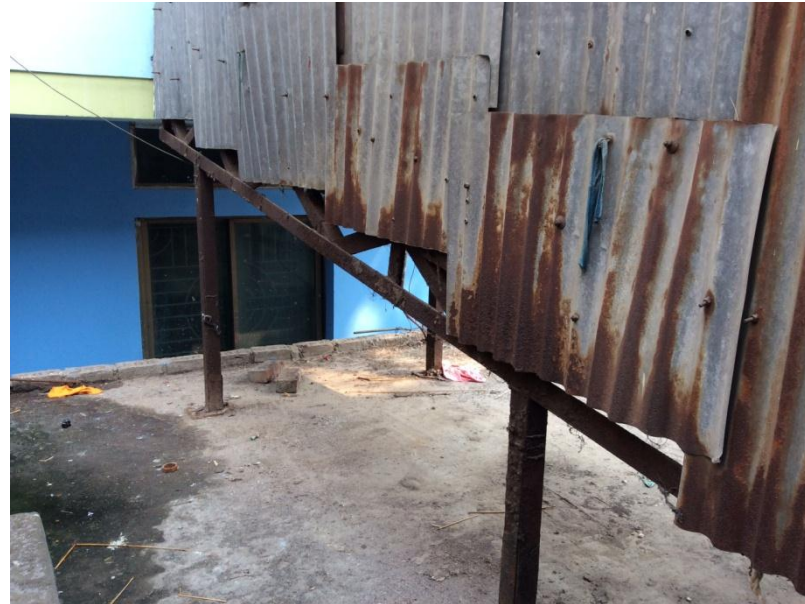
Bridge structure connecting Building 2 to Building 1 at level 2 appear to have inadequate protection from the environment and is beginning to corrode. The bridge did not appear to be heavily trafficked

| Item No. | Observation | Recommended Action Plan | Priority |
|---|---|---|---|
| 3 | BUILDING 2<br>Corrosion on the bridge link to Building 1. | Building engineer to check the structures and propose additional strengthening as required. | 6-months |

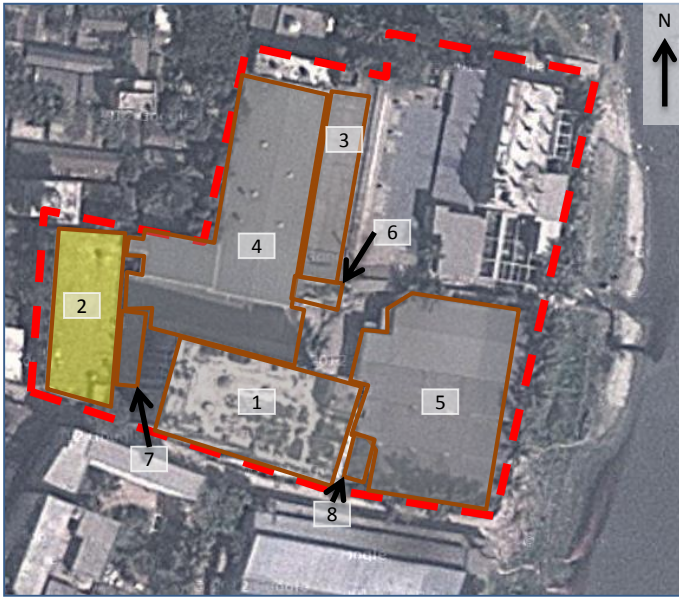
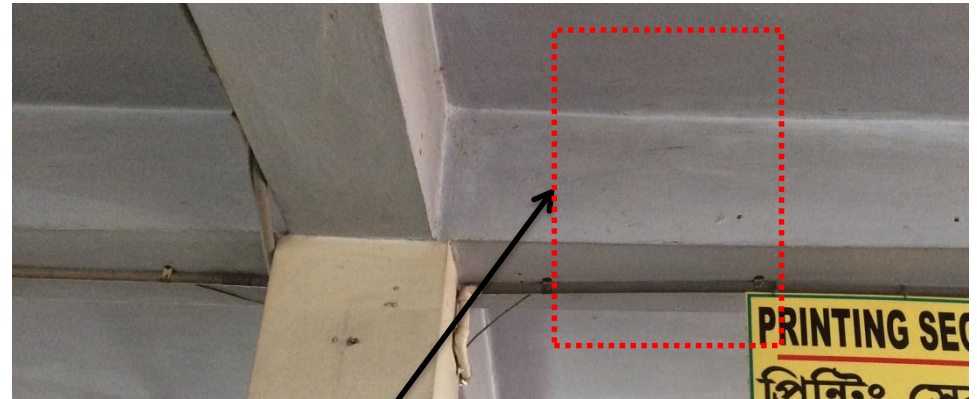
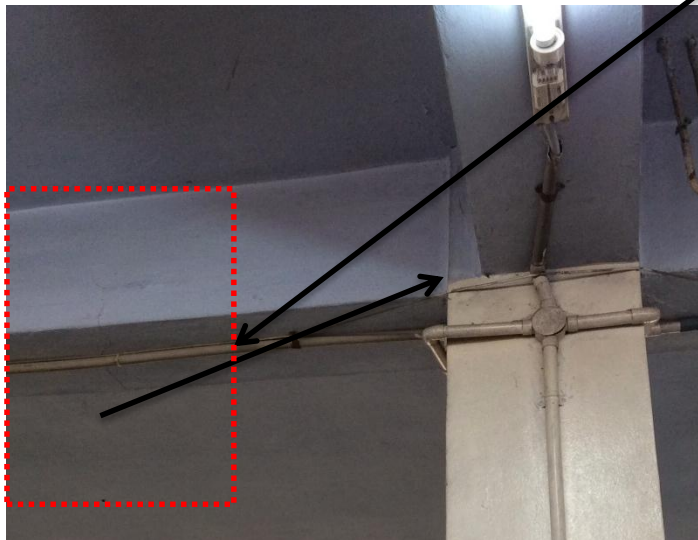
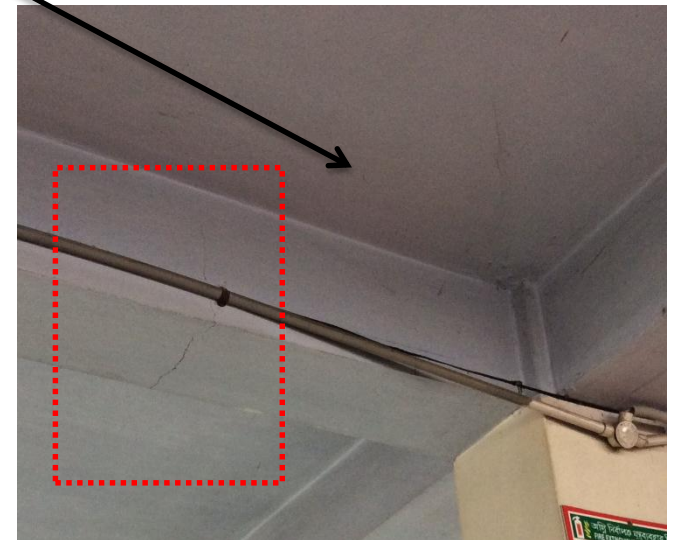
Beam cracking

Throughout Level 2 of Building 2 cracks were observed on beams on the underside of the Level 3 slab. Cracks were approximately 600mm to 1m from the ends of the beams

| Item No. | Observation | Recommended Action Plan | Priority |
|---|---|---|---|
| 4 | BUILDING 2<br>Cracking in beams at Level 2 (supporting Level 3). | Monitor cracks on beams. Engage an engineer to investigate if cracks are only in the plastering. | 6-months |
| 5 | BUILDING 2<br>Cracking in beams at Level 2 (supporting Level 3). | Engage an engineer to advise on load reduction and repair and strengthening of the beams if required. | 6-months |

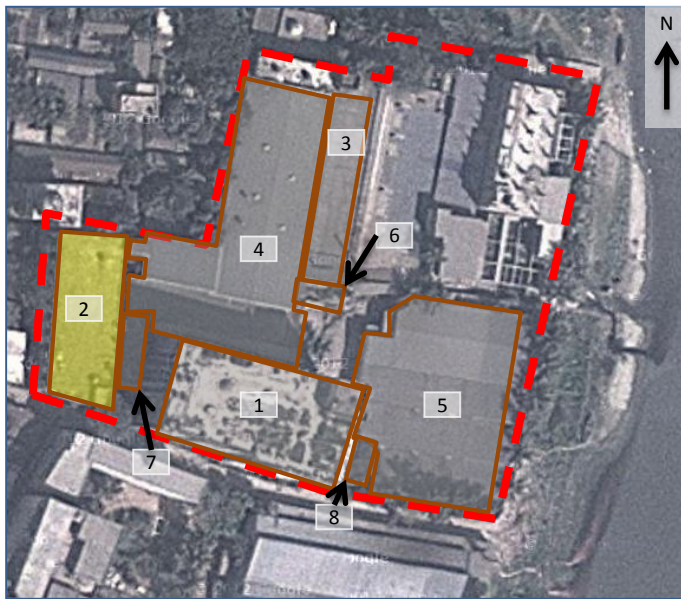
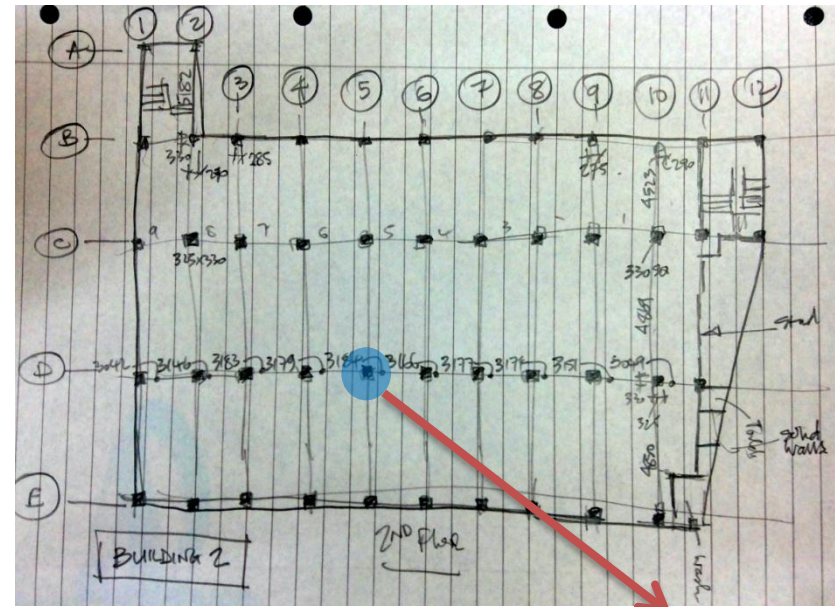
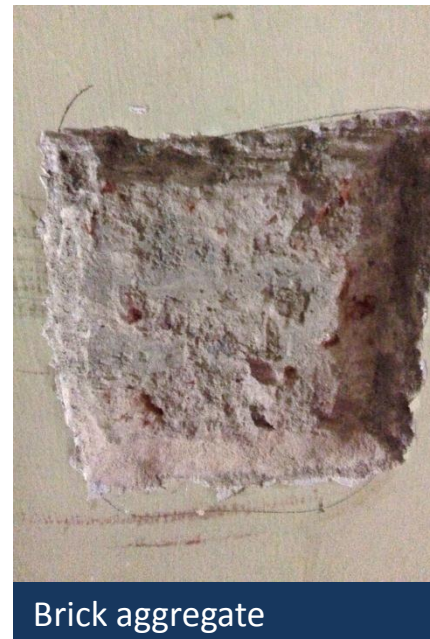
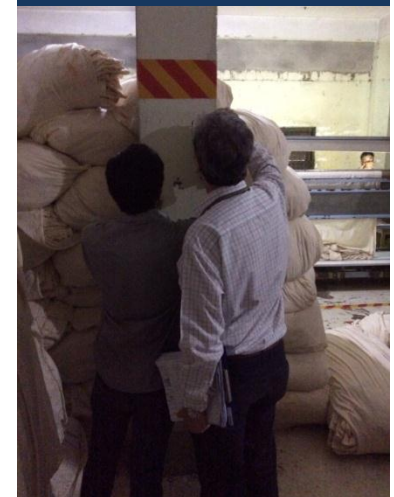
Architectural drawings quite different to the as-built structure, with actual structure having smaller grids and larger number of bays. Local breaking out confirms aggregate type is brick throughout, and scanning on several columns indicates typical levels of reinforcement.

Brick aggregate

Building column tested at ground floor level

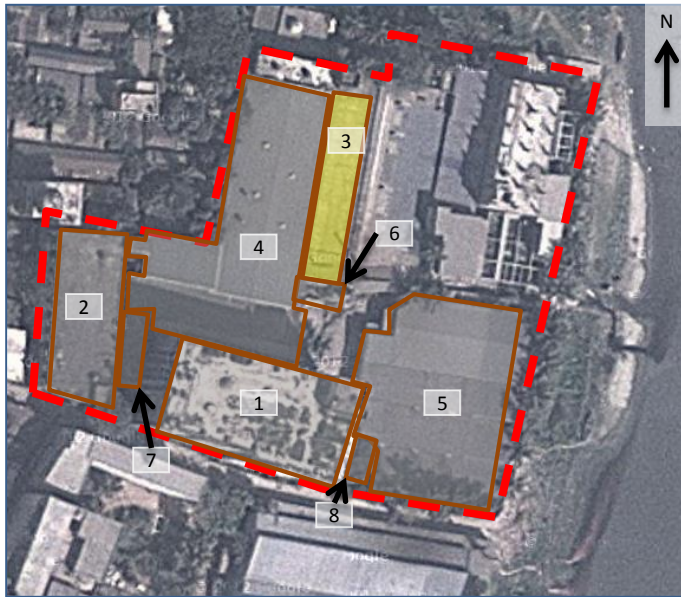
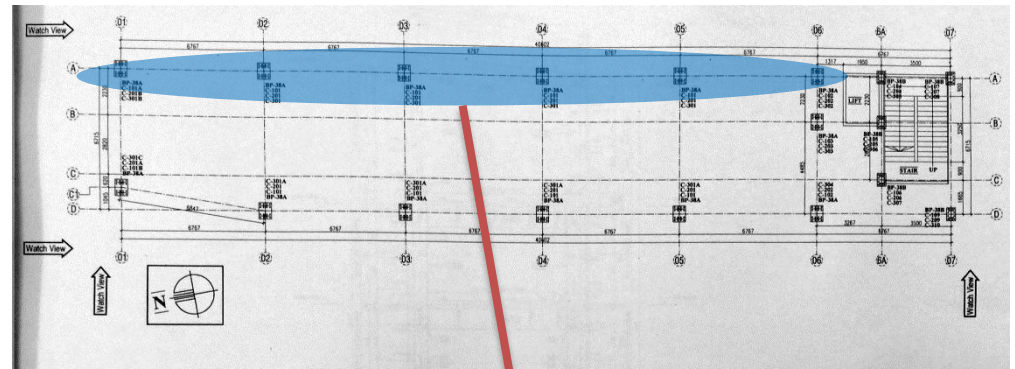
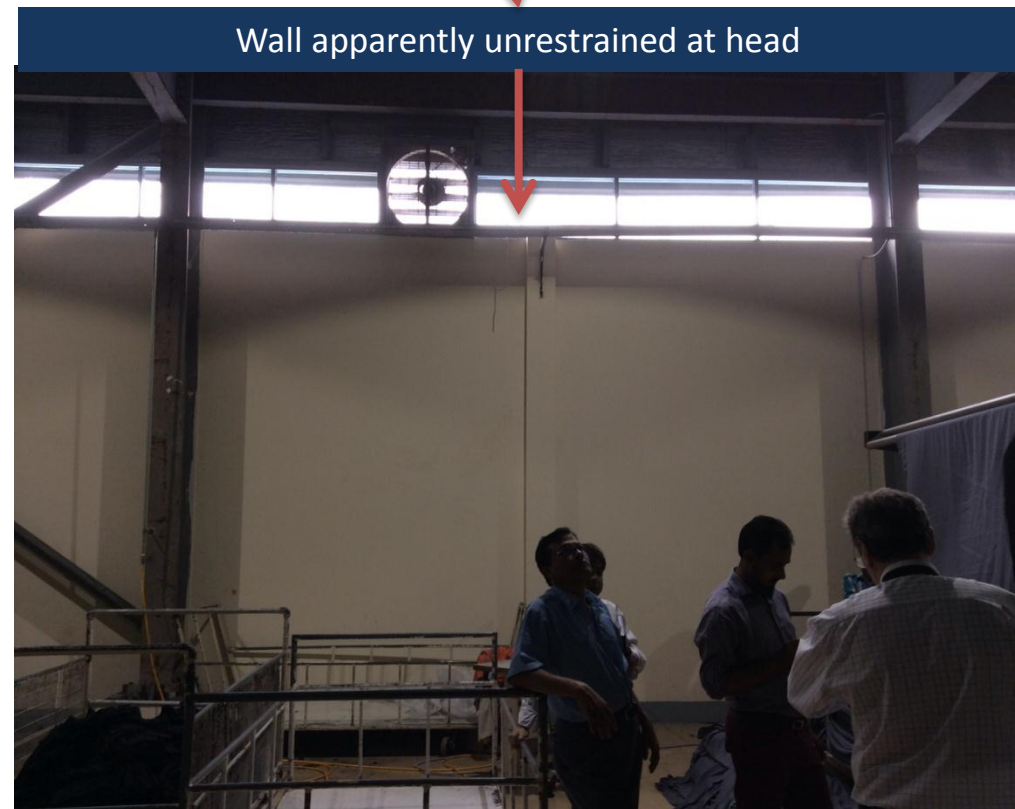
Ties between steel structure and ground floor masonry walls were not visible. This masonry panel appears too large to be safe if unrestrained.

| Item No. | Observation | Recommended Action Plan | Priority |
|---|---|---|---|
| 6 | BUILDING 3<br>Apparently unrestrained masonry walls at Ground. | Building engineer to check the external wall elements and propose additional lateral restraints if required. | 6-months |

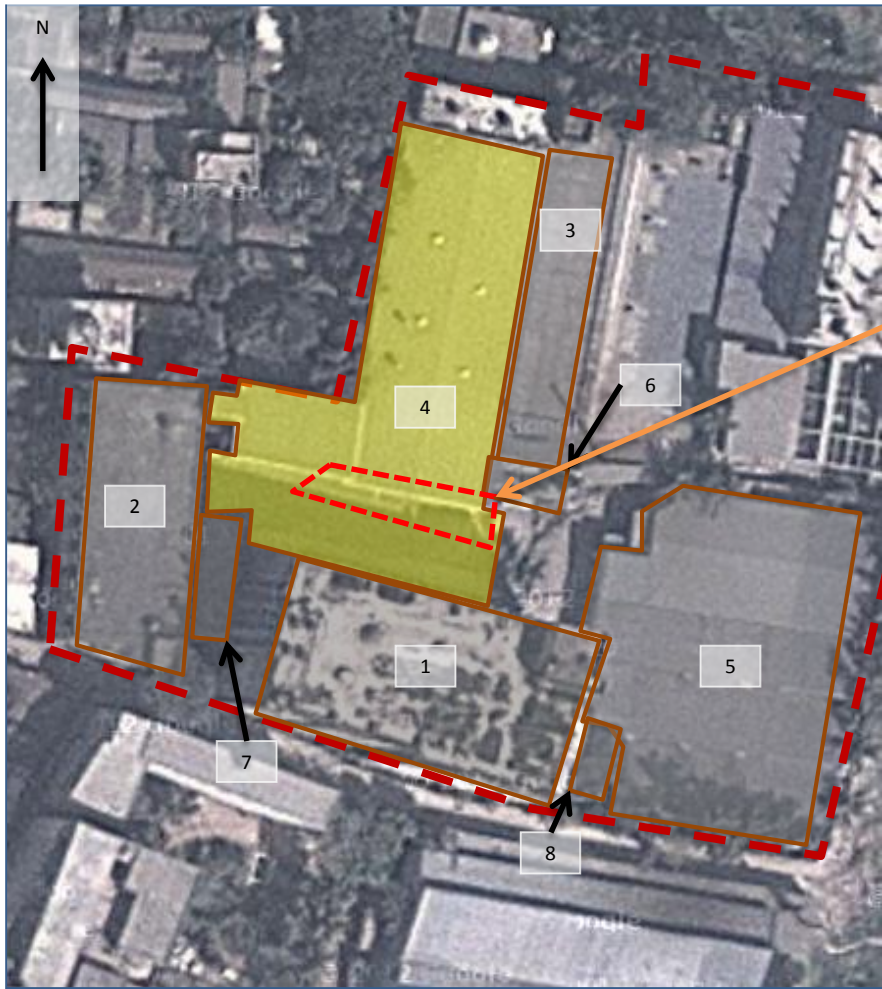
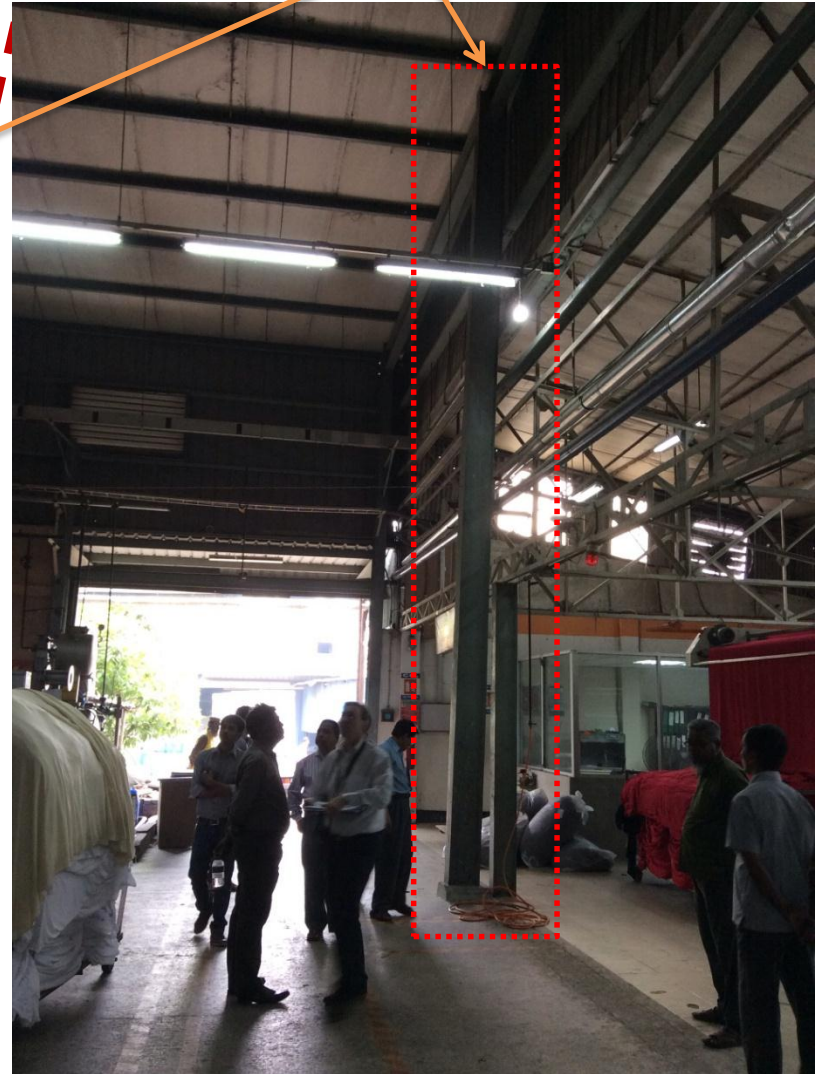
Wind post column at end of the portal frame appears to be leaning

| Item No. | Observation | Recommended Action Plan | Priority |
|---|---|---|---|
| 7 | BUILDING 4<br>Gable Stanchion/Wind Post out of alignment. | Building engineer to check the structural capacity of the stanchion and make proposals for its realignment if required. | 6-months |

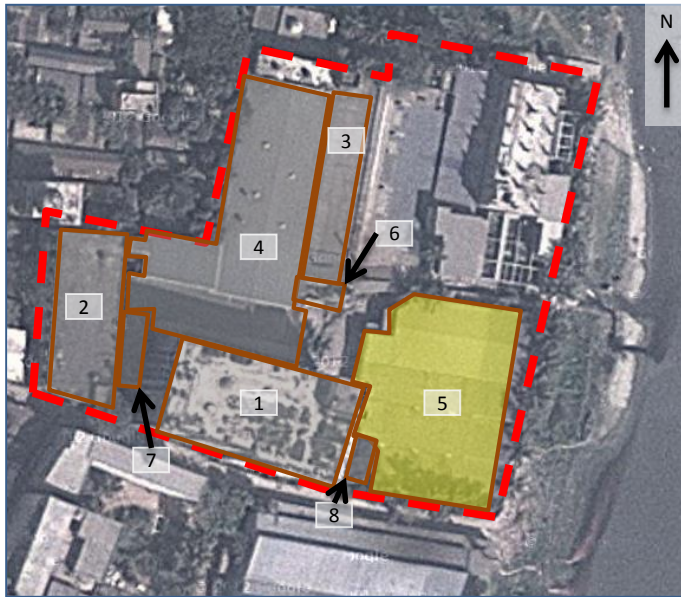
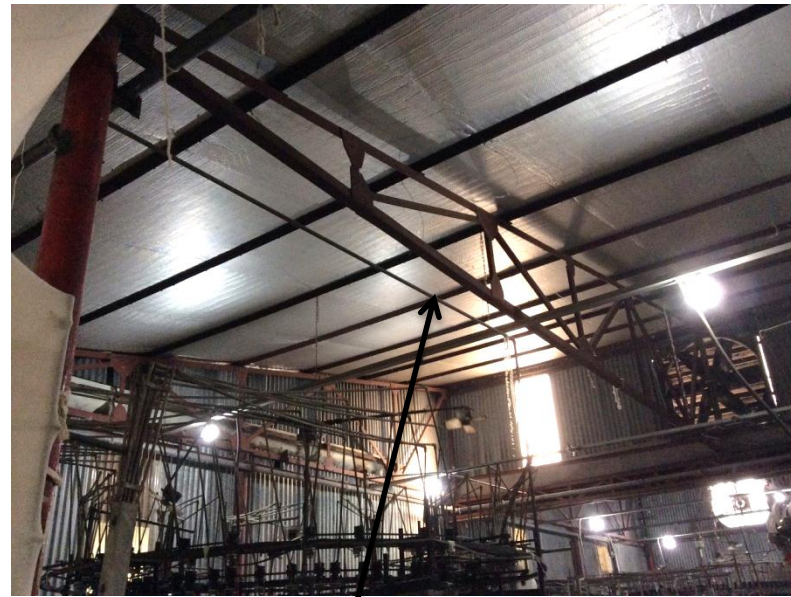
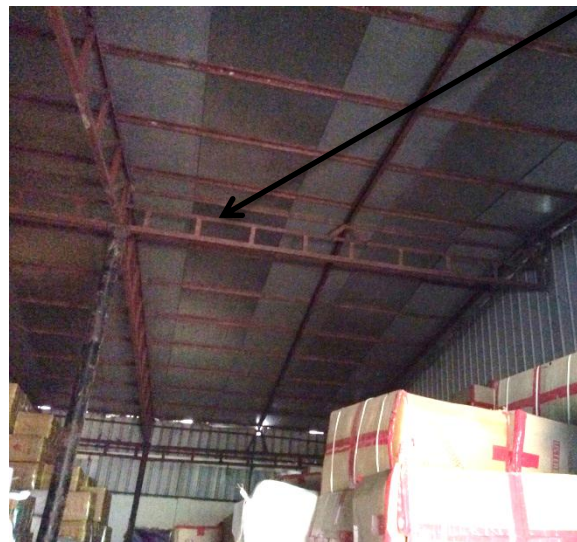
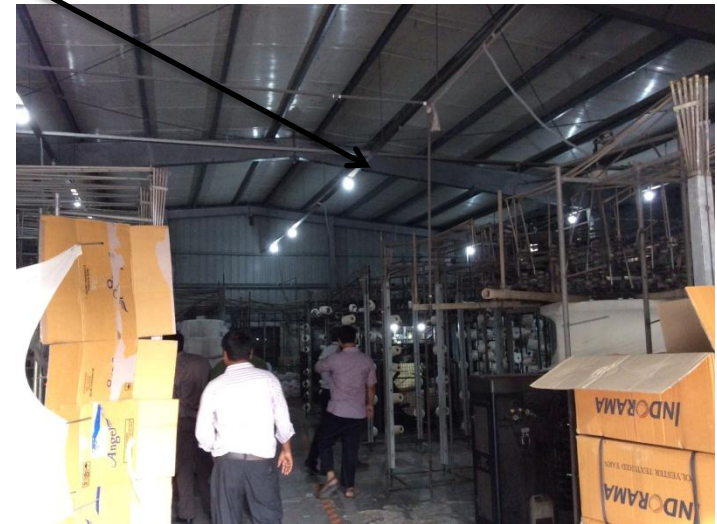
Possibly non-engineered structures

Building 5 is made up of various steel shed structures some of which appear un-engineered. Stability systems were not visible for some structures, and some connections appeared unconventional and unlikely to provide tying-down capacity where required

| Item No. | Observation | Recommended Action Plan | Priority |
|---|---|---|---|
| 8 | BUILDING 5<br>Non Engineered Steelwork to roof. | Building engineer to check the structures and propose additional strengthening and bracing as required. | 6-months |

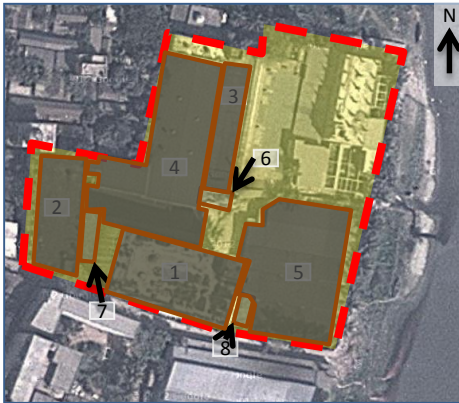
Various structures attached to the main buildings across the site appear un-engineered and possibly unstable. These include structures which appear to have been modified in an unplanned way during the life of the buildings (e.g. piggy back trusses) and structures supported off plant

Slender roof structure apparently supported by member attached directly to boiler

| Item No. | Observation | Recommended Action Plan | Priority |
|---|---|---|---|
| 9 | OTHER ANCILLARY BUILDINGS<br>Non Engineered Steelwork to Roofs. | Building engineer to check the structures and propose additional strengthening and bracing as required. | 6-months |

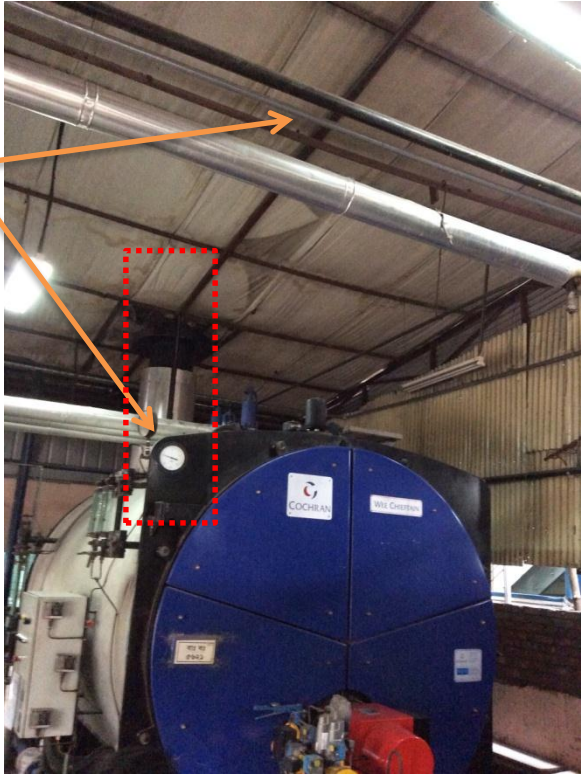
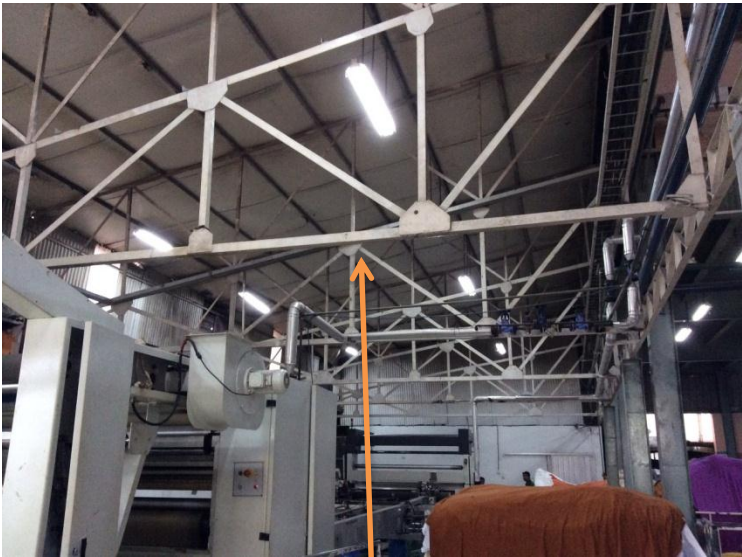
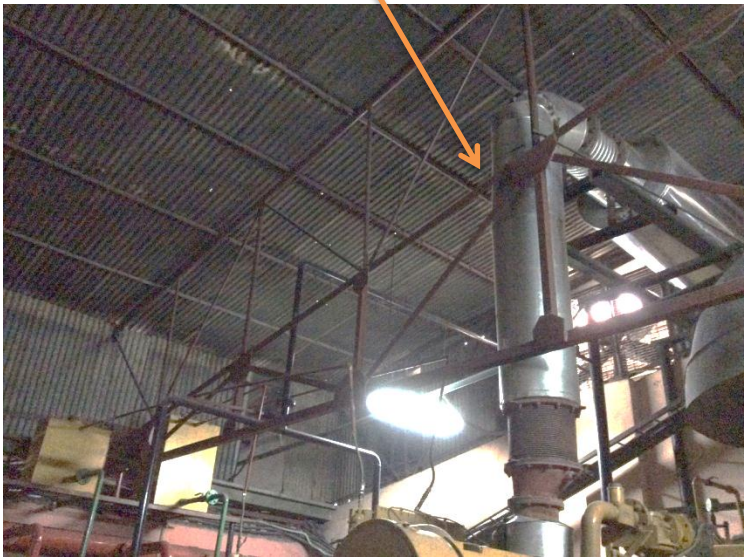
Piggy-back trusses
