Harry Fashion Ltd. (9690)

Voradoba, Valuka, Mymensing

02.July.2014

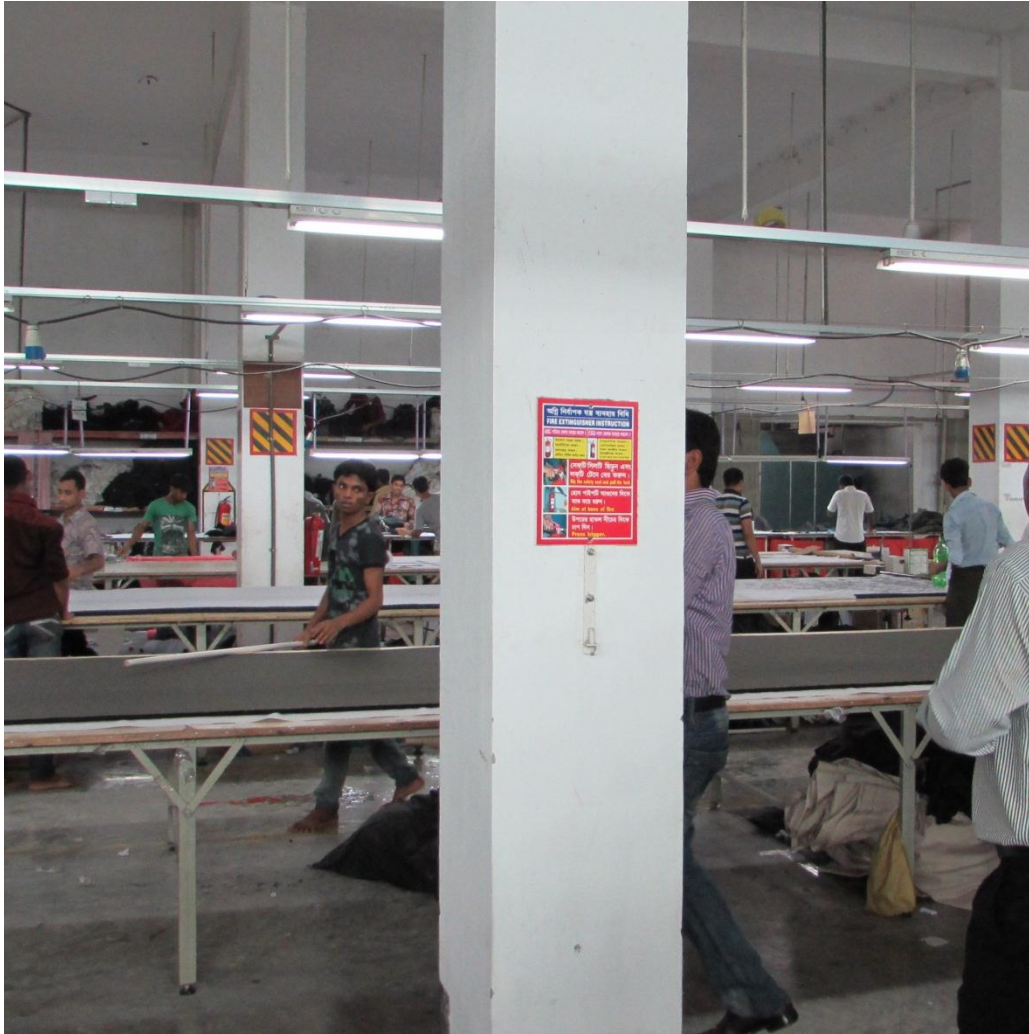
Priority 2 Concern

Based on the load rundown analysis with the agreed minimum design live load assignment, the typical columns have been found to possess loading capacity with a very low factor of safety, giving a AMBER warning. The building was constructed after 2005, with stone aggregate.

Column have low factor of safety

ITEM 2: (1st Priority 2) Typical columns have low factor of safety

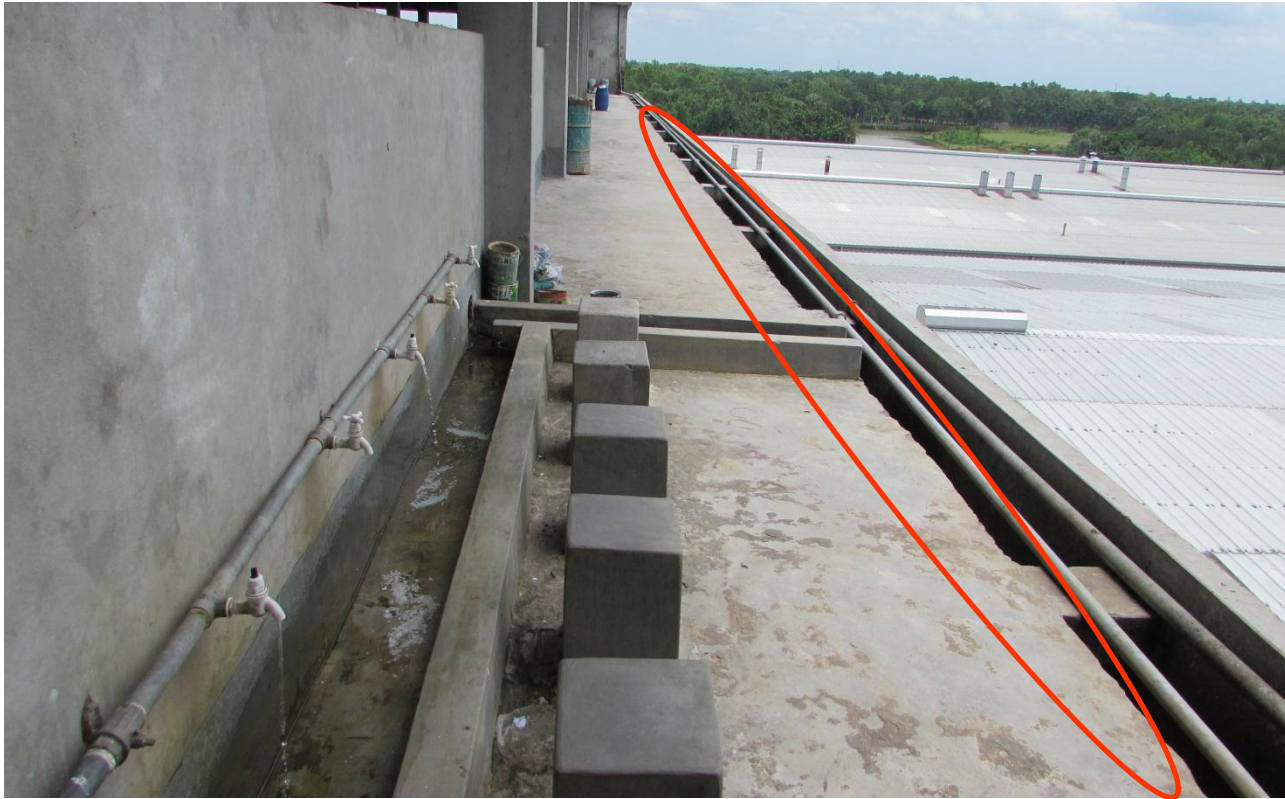
1st Priority 3 Concern

No boundary wall is provided on the edge beside dining shed on roof. That is very dangerous for workers from falling down

No boundary wall on roof besides dining shed

ITEM 3: (1st Priority 3) No boundary wall on roof besides dining shed

Item No.	Observation	Recommended Action Plan	Recommended Timeline
1	1st Priority 1 - Typical footings have been under designed.	The Factory's Building Structural Engineer should carry out a Detailed Engineering Assessment to check the capacity of the building in its existing state.	6-weeks
2	1st Priority 1 - Typical footings have been under designed.	As per results of DEA, factory engineer is to provide the strengthening work for foundation system	6-months
3	1st Priority 2 - Typical columns have low factor of safety.	Factory engineer to review design, loads and column stresses	Immediate – Now
4	1st Priority 2 - Typical columns have low factor of safety.	Conduct a detailed engineering assessment	6-weeks
5	1st Priority 2 - Typical columns have low factor of safety.	Carry out any recommendations put forth by the detailed engineering assessment.	6-months
6	1st Priority 3 - No boundary wall on roof besides dining shed	Construct boundary wall for this area	6-months

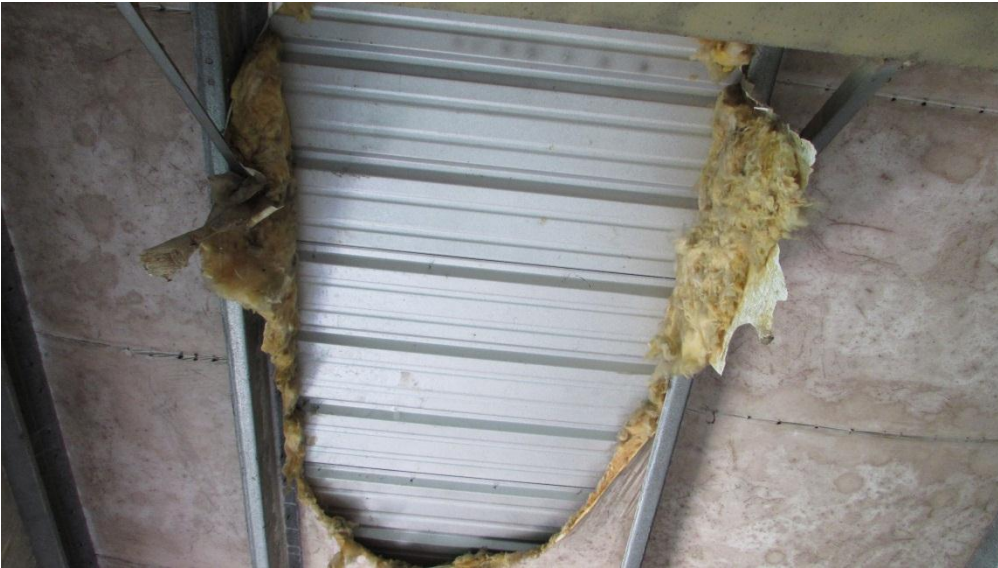
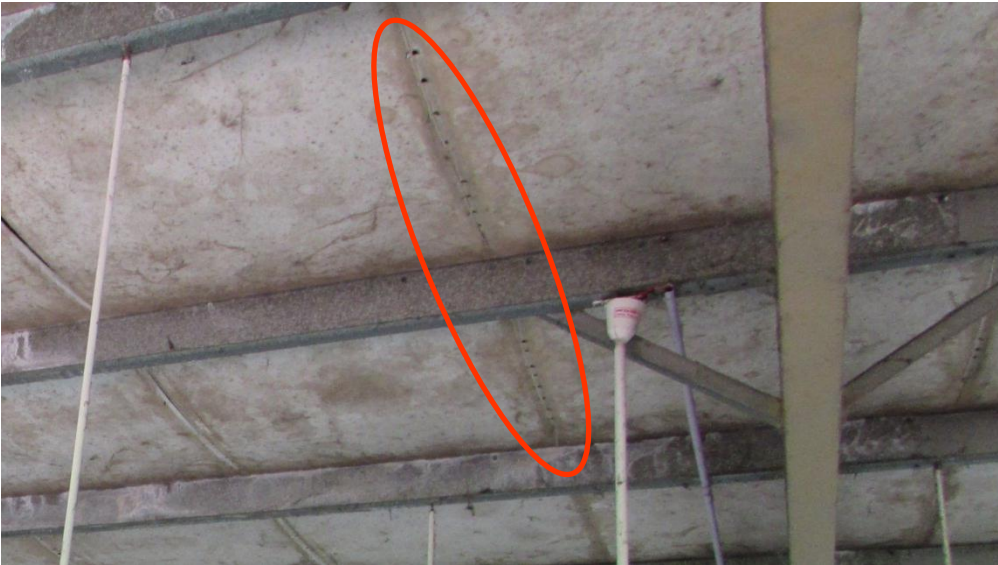
2nd Priority 3 Concern

Steel shed membrane was torn apart in some places so clear sign of leakage of water is observed. In rainy season water comes into through this area.

Sign of water leakage through steel shed membrane

ITEM 4: (2nd Priority 3) Sign of water leakage through steel shed membrane

7	2nd Priority 3 - Sign of water leakage through steel shed membrane	Repair membrane of steel shed	6-months
8	3rd Priority 3 - Tiles dropping down from main entrance of the building.	Conduct repairing work using cementing strong material and build a false roof on entrance gate.	6-months

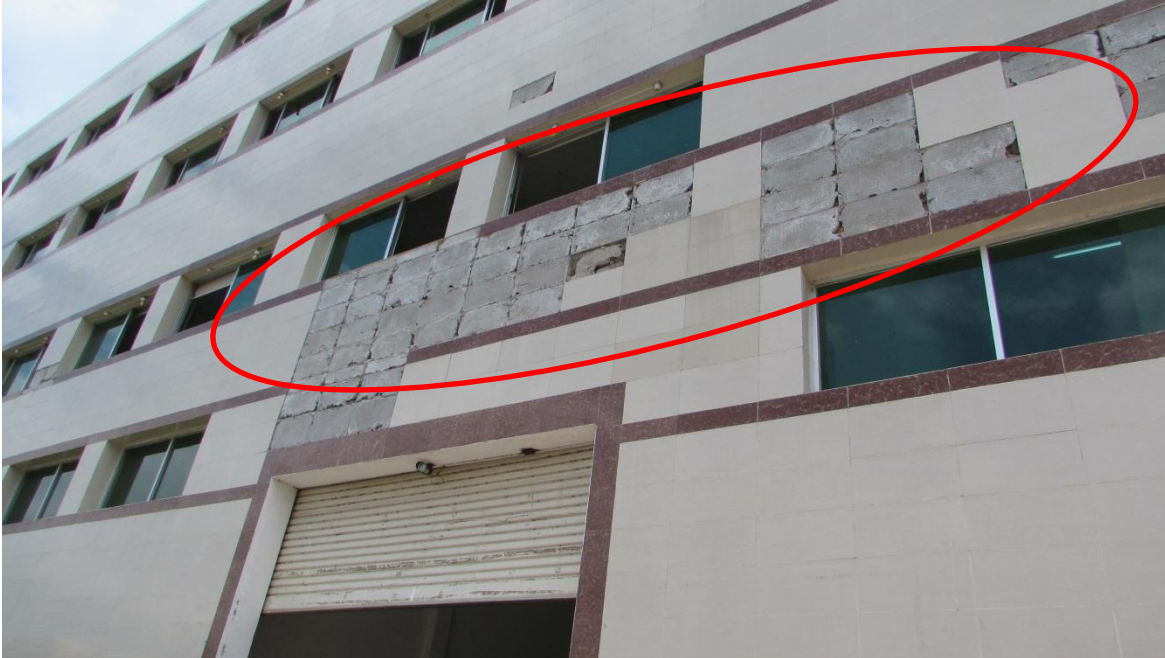
3rd Priority 3 Concern

At main entrance of the building tiles are dropping down. That can cause accident while workers/people get in the building.

Tiles dropping down from main entrance of the building could injure the people

ITEM 5: (3rd Priority 3) Tiles dropping down from main entrance of the building

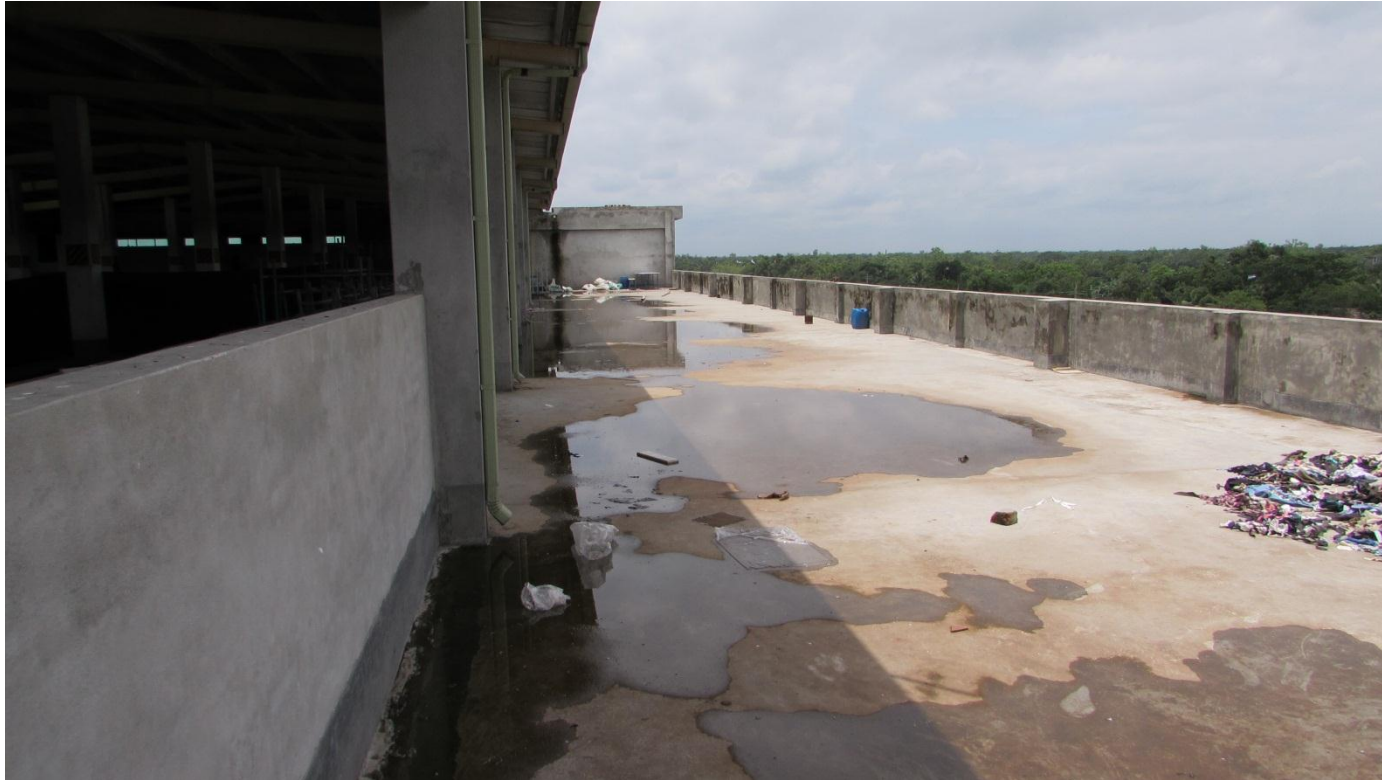
Water Ingress at Roof Level

No waterproofing membrane was visible on the roof of the building. This means that any cracks in the surface finishes on the roof will allow water to seep into the concrete slab beneath the finishes, and cause corrosion of the reinforcing steel.
