Rhine Dress Ltd. (11505)

Talla Road, Fatullah, Narayanganj.

02.July.2014

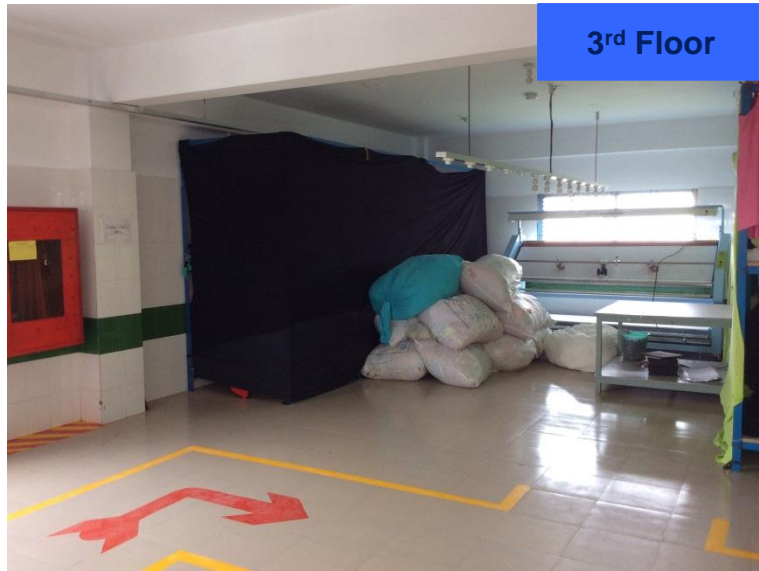
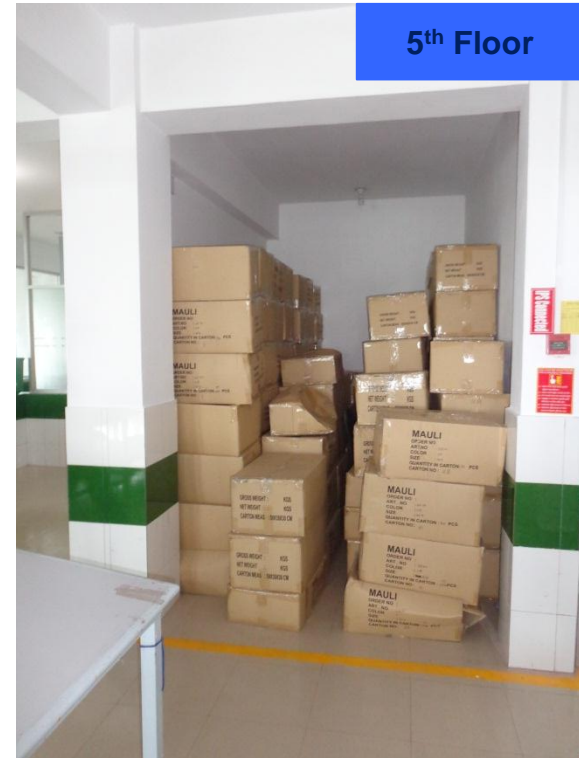
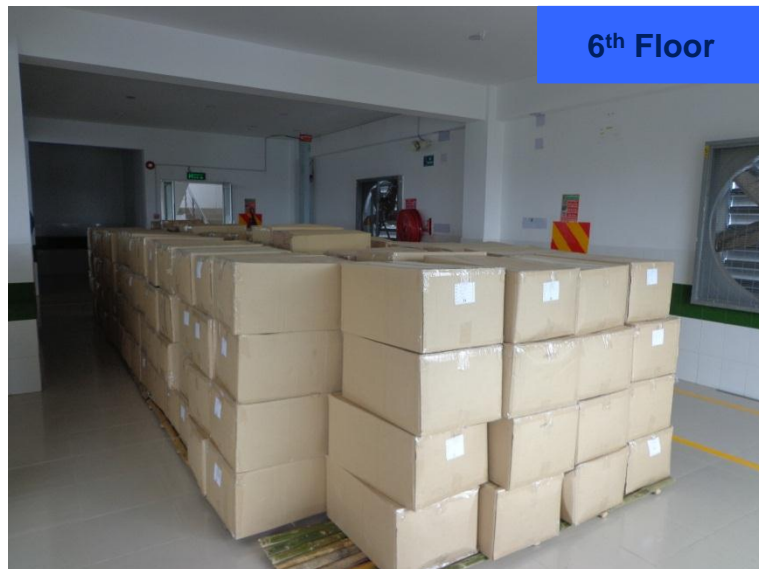
There are no floor load plans provided for each floor of each building.

A Detailed Engineering Assessment is required to review the design and loads.

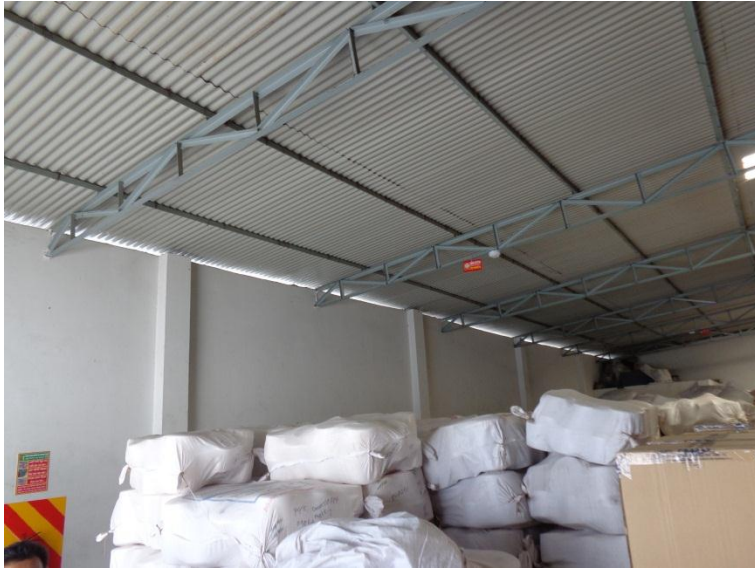
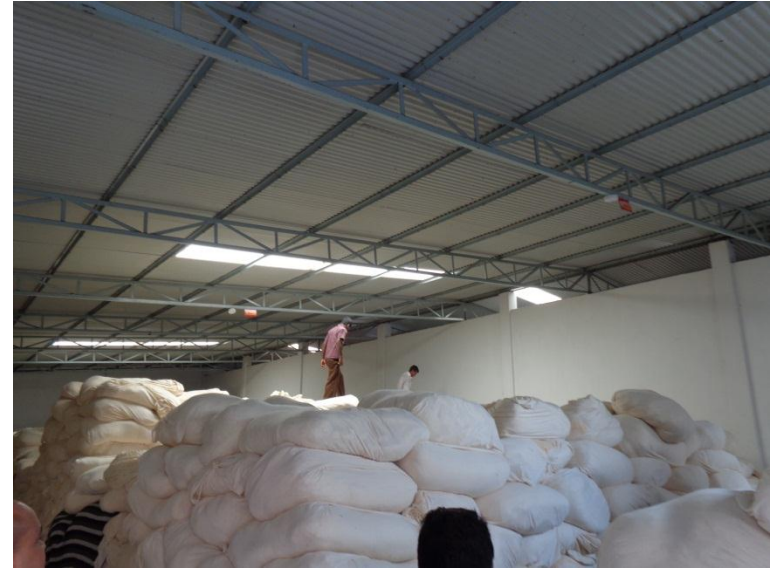
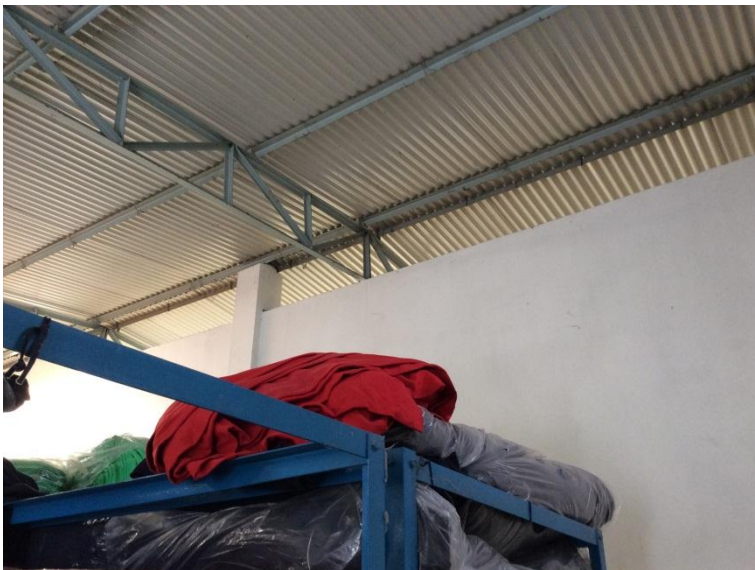
Concerns on the stability system for roof shed truss sitting on brick wall. The roof must be checked for stability and capacity especially the connections between steel structural elements and brick wall. Stability under wind uplift needs to be checked in particular.

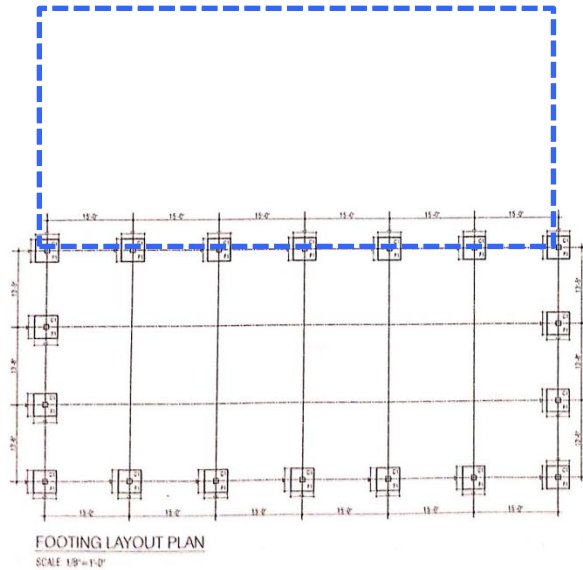
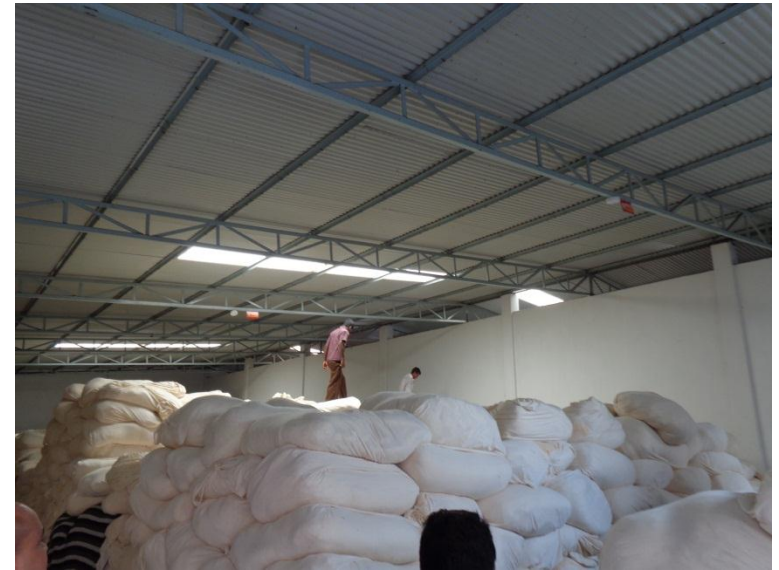
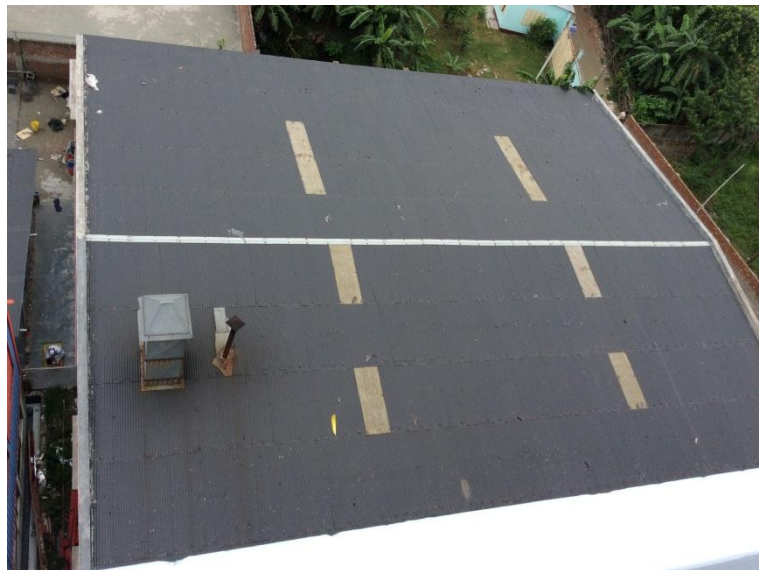
The structural details of this shed shown on structural drawings do not match the actual as-built conditions.

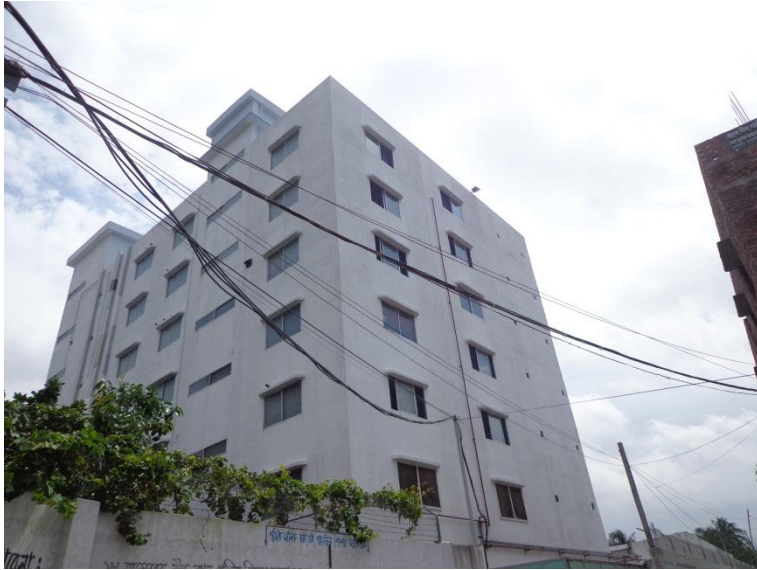
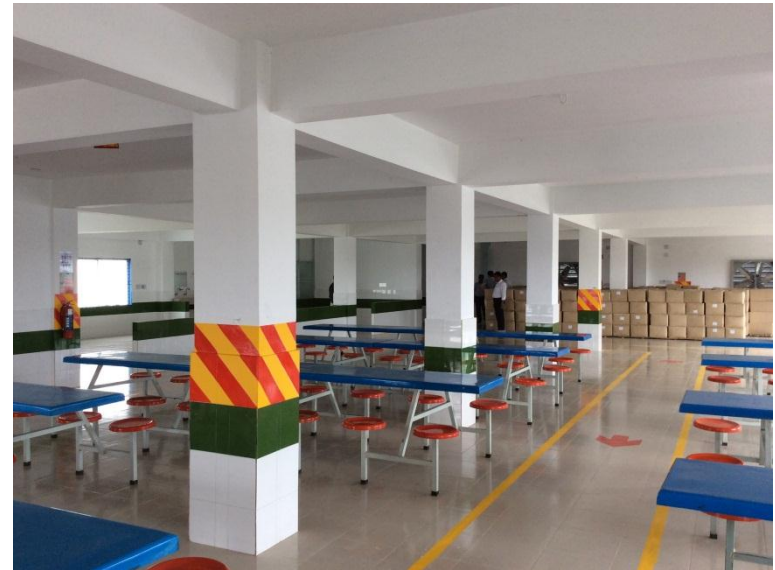
Overall Stability System

Concerns on the stability system for lateral loading. The lateral loading resistance for this 7 storeys high building is provided by moment frame action without any shear wall. Façade brickwork walls lack of moment capacity in the connections between columns and slabs.

We require that this building be investigated in a Detailed Engineering Assessment.

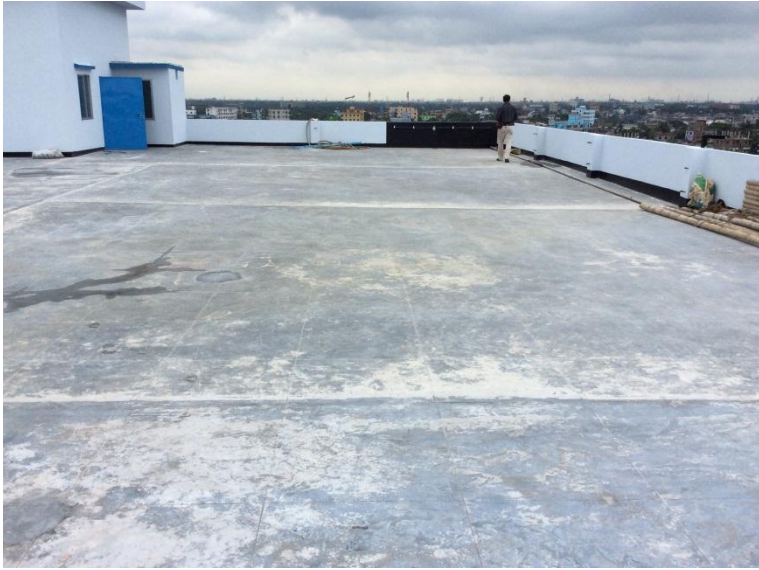
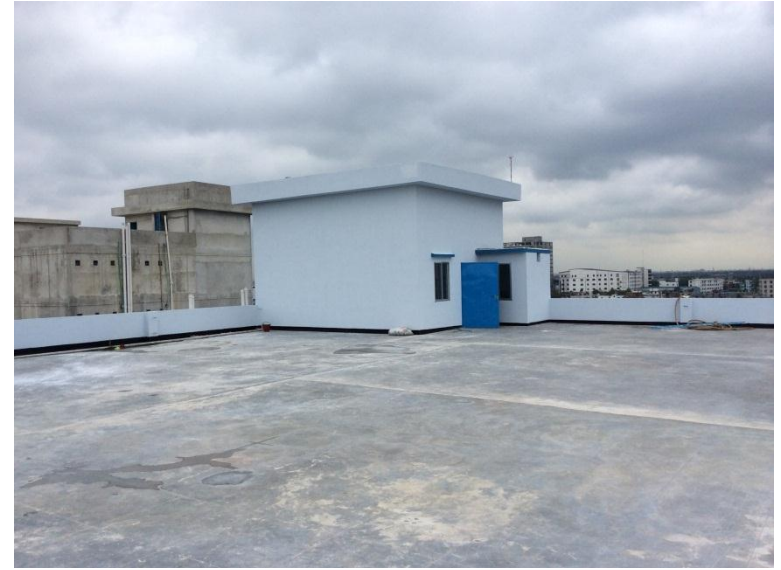
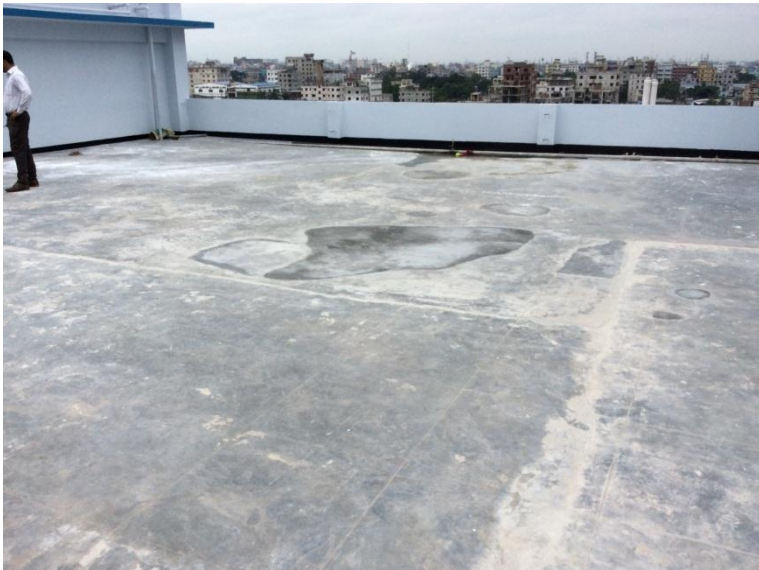
Water Ingress

Water ponding was found on the roof slab. And we were informed that there is no waterproofing material applied in this area.

6	Priority 3 - No waterproofing material applied on roof slab.	Waterproofing on the roof slab is to be applied. Moreover the roof slab drainage system should be investigated and improved.	6-months
