New Asia Fashions Ltd.

43/3 Anowar Jong Road, Charabag, Ashulia, Savar, Dhaka
(23.885858 N, 90.309833 E)
18th September 2017

Observation

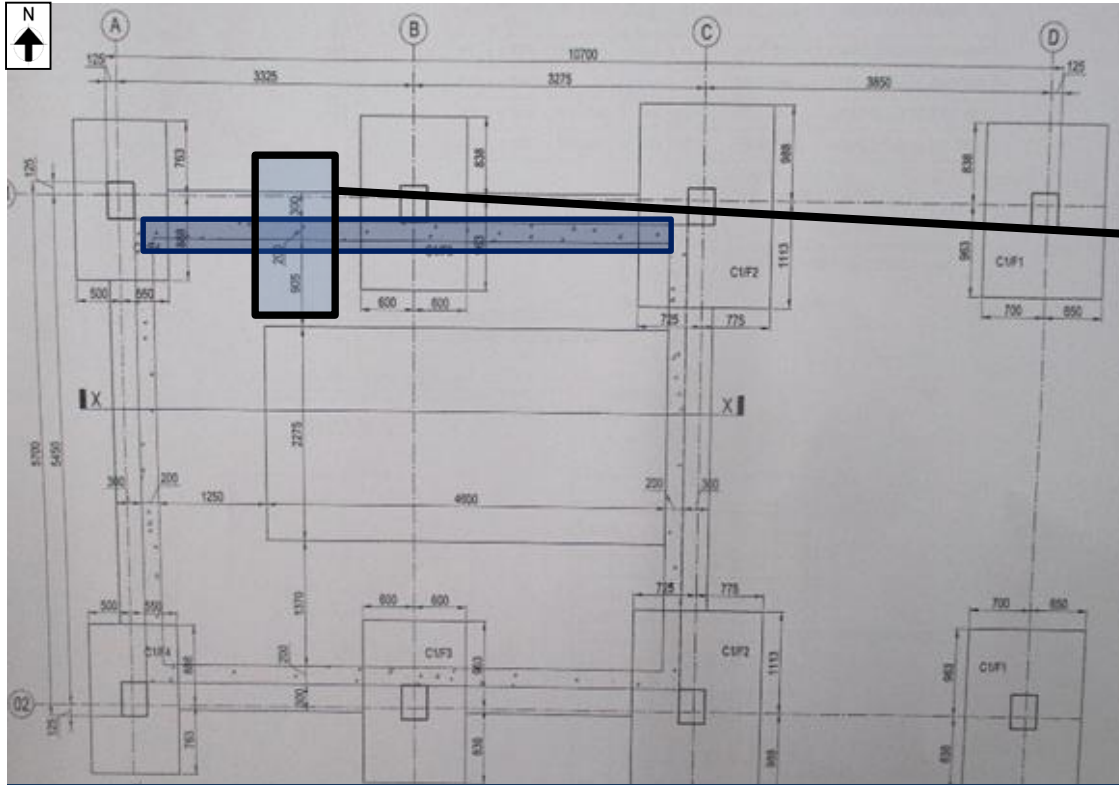
Footing Layout Plan

Discrepancy observed between As built drawing and on site condition

During inspection, Thickness of the retaining wall of the north portion of the building-4 was found 100mm instead of 200mm. Factory is required to revise structural drawing as per site condition and adequacy check required to carryout.

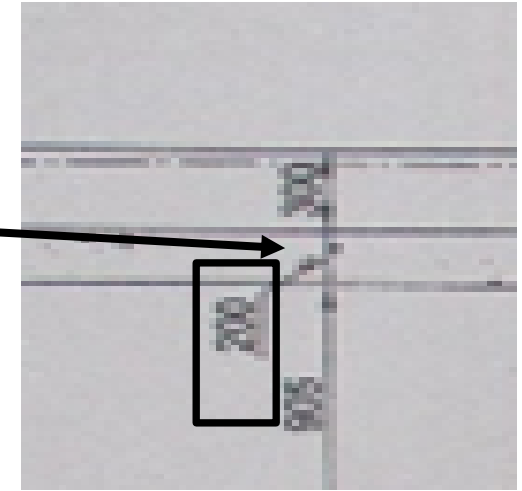
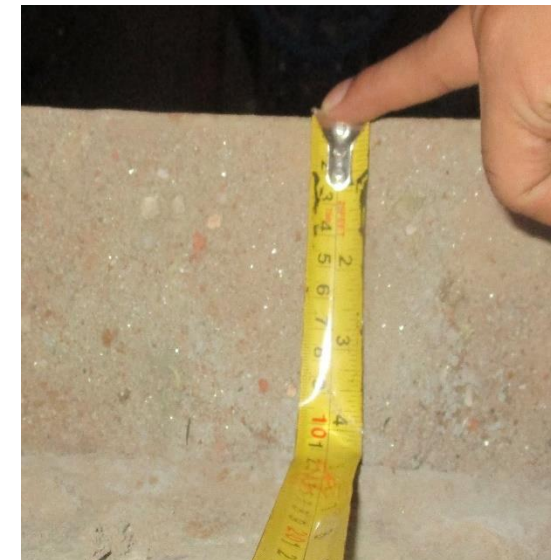
Thickness observed 100 mm

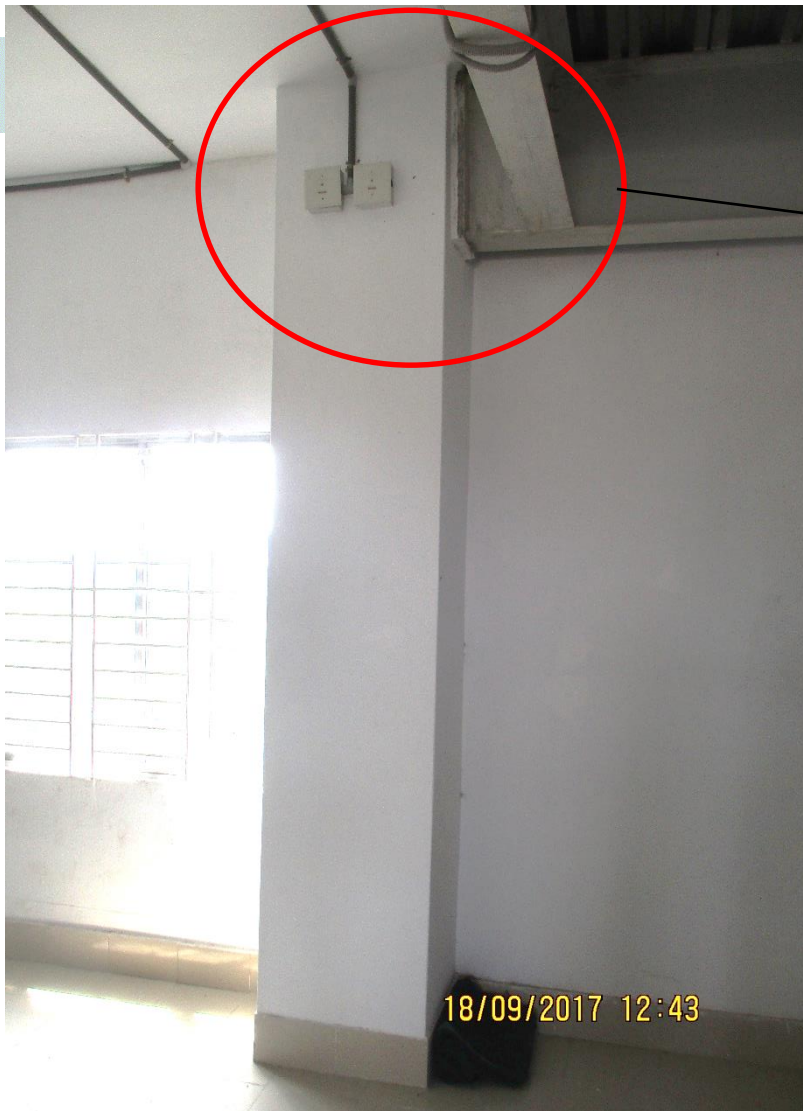
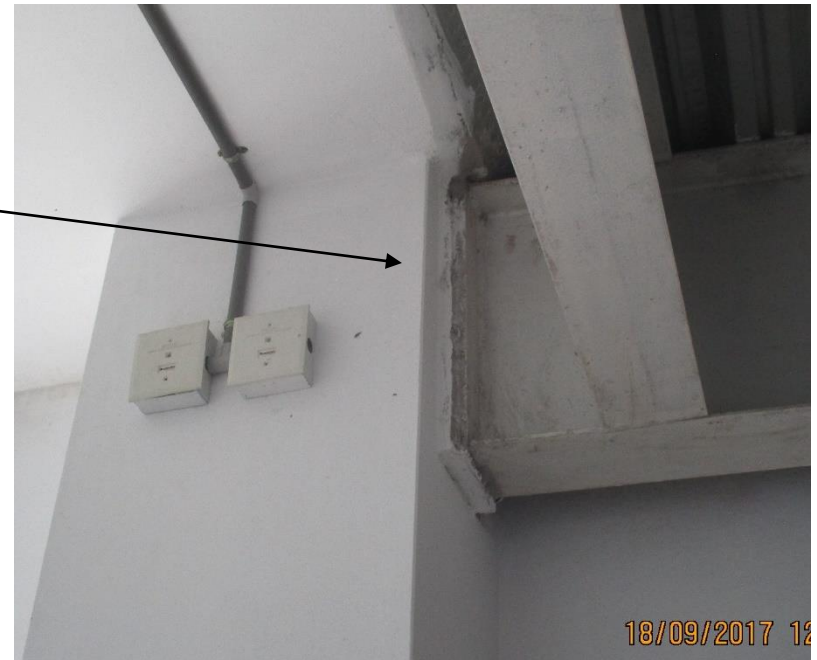
Joint between stair column (RCC) and steel beam

No detail of joint was found in the provided drawing. Factory is required to check the joint details and joint adequacy.

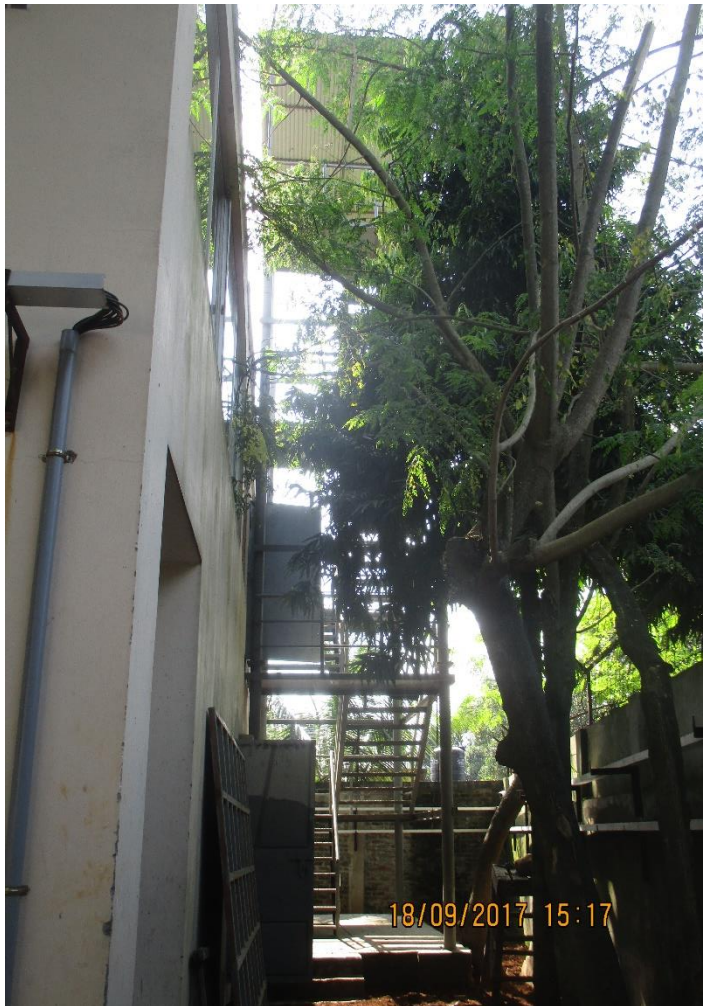
North side steel stair

Steel stair appeared to be non engineered

The support condition of the steel stair appeared to be non-engineered due to poor implementation of connection and undersized steel column support. Factory is required to check the stability of the stair.

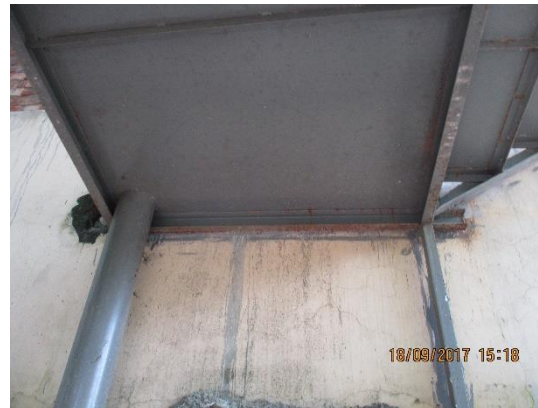
Weak support due to undersize steel box

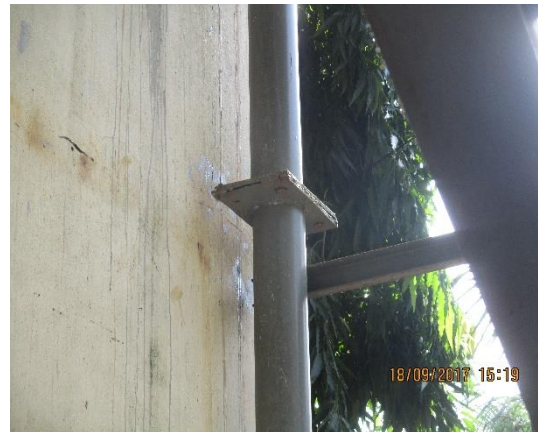
Weak joint of the pipe column due to poor welding
