Sterling Creations Ltd. (9620)

Beron, Earpur Union, Ashulia, Dhaka

02.July.2014

Identified Priority 1 Concerns

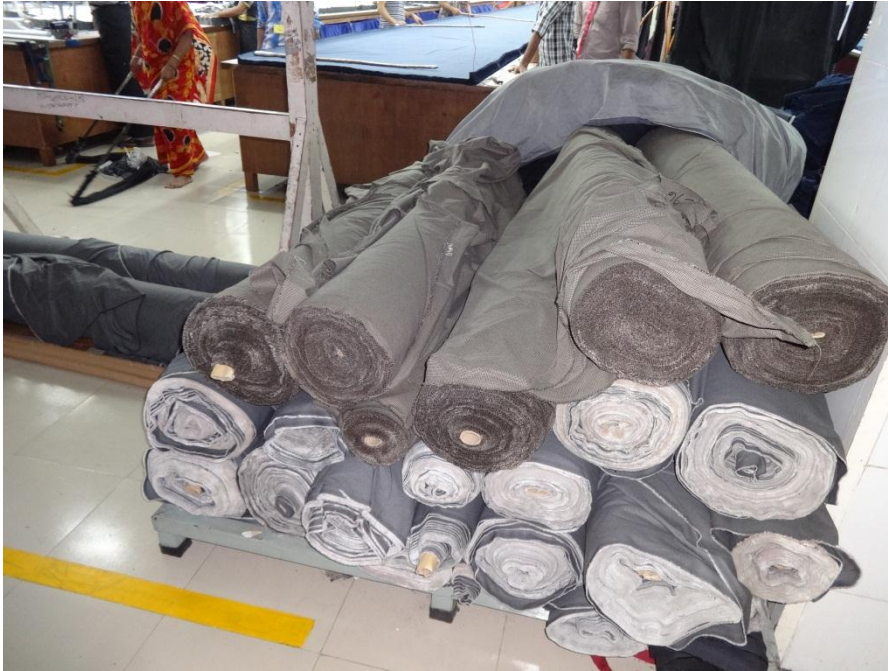
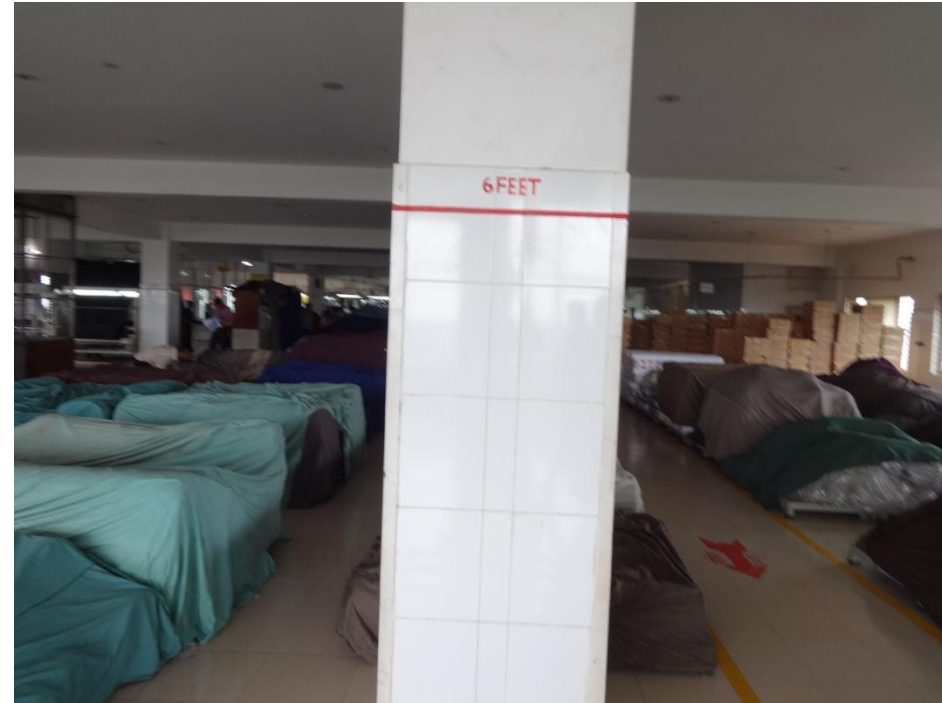
1st Priority 1 Concern

Localised overloading to slab & insufficient control measures in place to prevent overloading.

Mass of 1 roll – 20kg

If rolls are stacked 6' high (1.83m so 9 rolls high)

Dimensions 1500mm long, 200mmØ

$$[(20 \times 9.81)/(1.5 \times 0.2)] \times 9 = \underline{5.89\text{kPa}}$$

NOTE: the designer has stated the floor is designed for 80psf (4.0 kPa).

If rolls were stored 6' high the slab would be overloaded.

Item No.	Observation	Recommended Action Plan	Recommended Timeline
1	Priority 1 - Localised overloading to slab & insufficient control measures in place to prevent overloading.	Do not load the slab above 3.0kPa (60psf) in storage areas.	Immediate – Now
2	Priority 1 - Localised overloading to slab & insufficient control measures in place to prevent overloading.	Carry out a Detailed Engineering Assessment on the building to establish the existing floor design capacity to safely carry the existing load each floor (taking into account the column strengths detailed in item 2).	6-weeks
3	Priority 1 - Localised overloading to slab & insufficient control measures in place to prevent overloading.	Produce accurate loading plans for each level based on the Engineering Assessment. Ensure that these plans are displayed and actively managed.	6-months
4	Priority 2 - High stresses to internal columns, factor of safety between 1.5 & 1.86.	Carry out an Detailed Engineering Assessment on the columns, taking 100mm core samples where necessary to establish the strength.	6-weeks

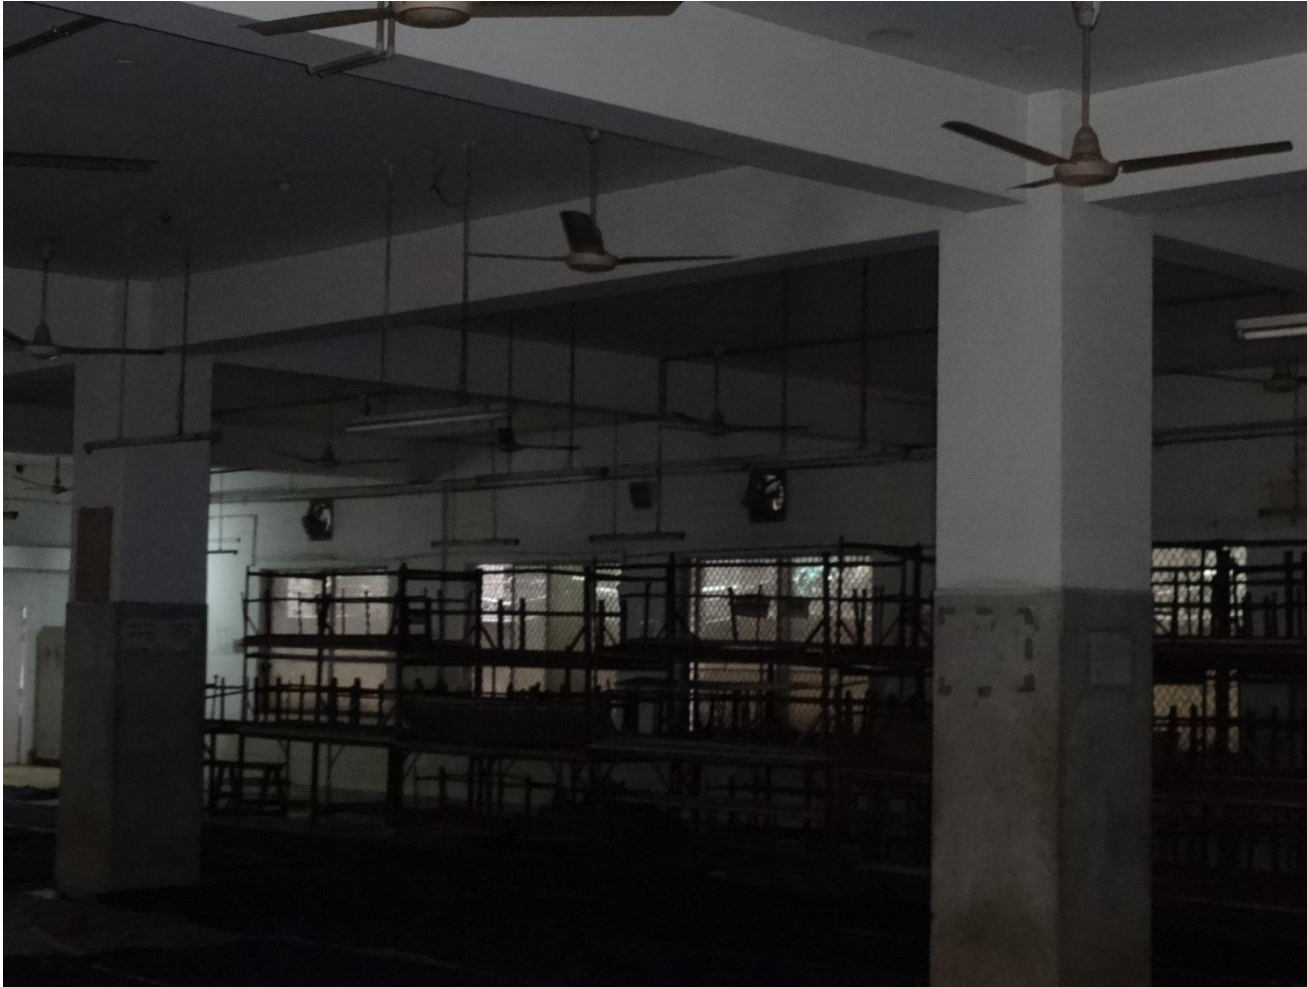
2nd Priority 2 Concern

High stresses to internal columns, factor of safety between 1.5 & 1.86 based on current loading.

We were advised that the design loadings for the floors were 80psf (4.0kPa). If all floors are loaded to 80psf the columns would be further overstressed.

5	Priority 2 - High stresses to internal columns, factor of safety between 1.5 & 1.86.	Carry out any recommendations highlighted in the Engineering Assessment.	6-months
6	Priority 2 - Structural drawings do not match column reinforcement discovered during Ferro-scanning.	Establish if drawings are original design or post dated as built drawings. Survey all columns as part of the Detailed Engineering Assessment to ascertain the existing design strength of the columns.	6-weeks
7	Priority 2 - Structural drawings do not match column reinforcement discovered during Ferro-scanning.	If drawings are as built remove any information that can not be verified by basic survey methods.	6-months

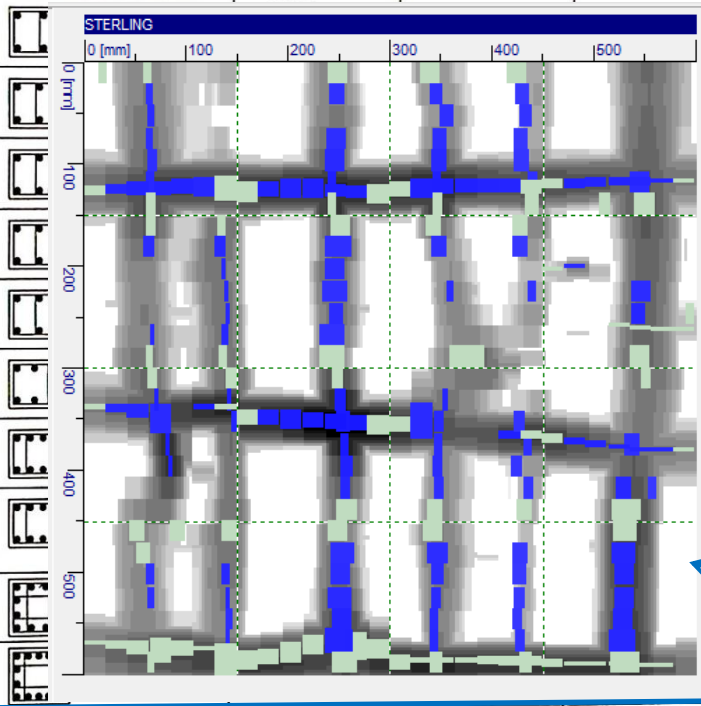
2nd Priority 2 Concern

Structural drawings do not match rebar discovered during Ferroscanning.

Based on the construction drawings provided we would have expected to see 24 bars in the **C12** column scanned.

While the drawings are dated 2005 it is possible that they may be as built drawings since construction started in 2004.

From the Ferroscon 6 bars were discovered on one face and 5 bars on the adjacent face. Therefore a total of 18 bars in the column.

The discovered results are a closer match with **C10**, which is the same size with fewer bars.

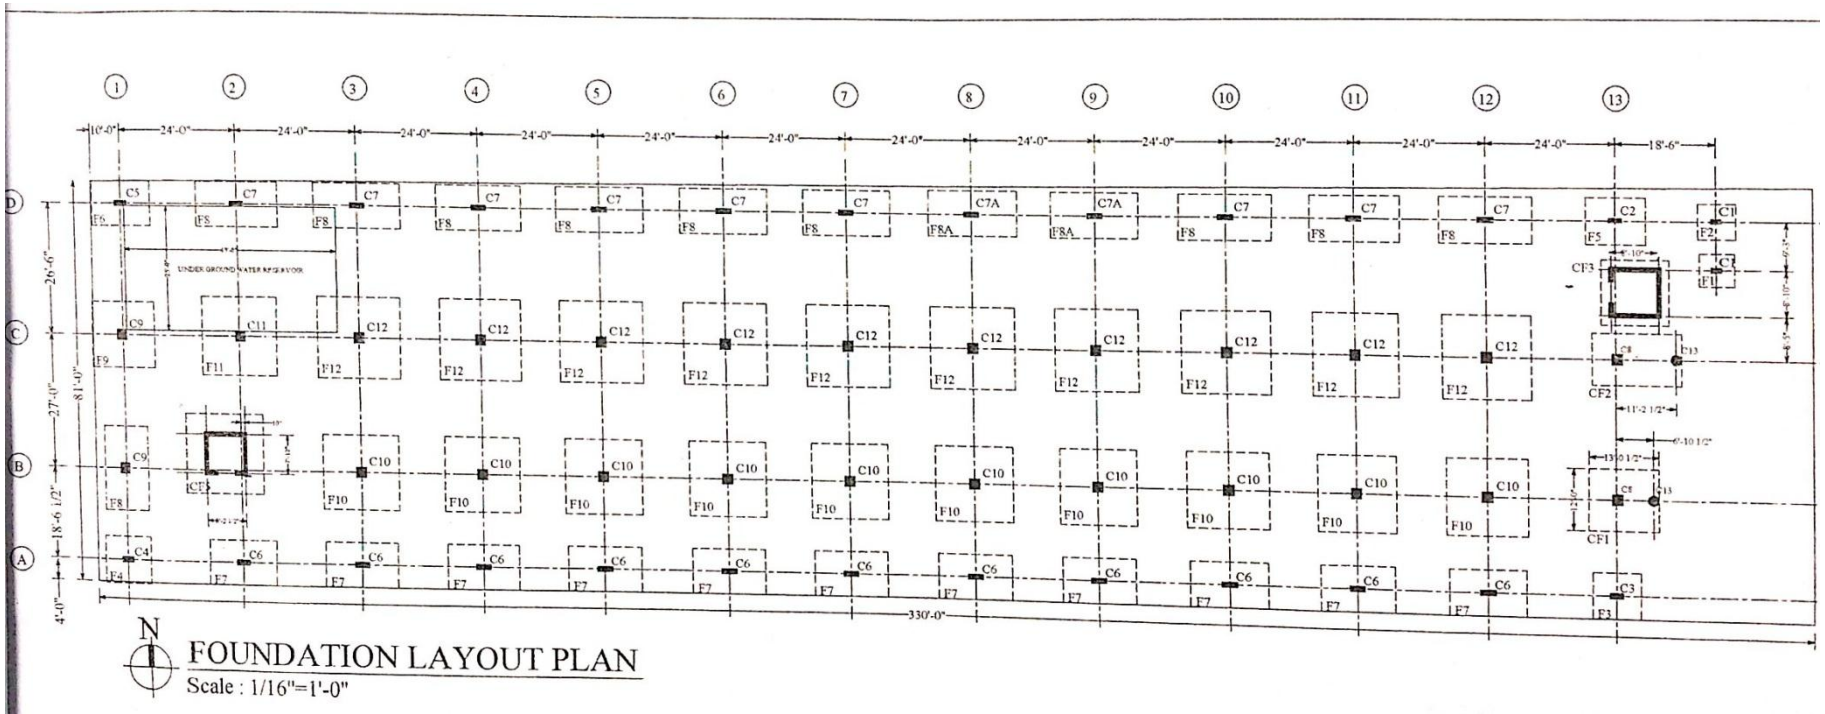
Overall Stability System

The building featured two reinforced concrete cores at the ends of the building. These were observed during the surveys and appear to be constructed as the design drawings show. These would appear to provide some lateral stability for the building. However the adequacy of the lateral stability system needs to be further assessed.

Item No.	Observation	Recommended Action Plan	Recommended Timeline
8	Priority 2 - Lateral stability system requires further assessment.	Carry out a Detailed Engineering Assessment on the building to verify that the building is stable under its lateral loading.	6-weeks
9	Priority 2 - Lateral stability system requires further assessment.	Carry out all recommendations of the Engineering Assessment.	6-months
10	Priority 3 - No waterproofing membrane to roof.	Cover the concrete roof with a suitable waterproofing membrane, e.g. waterproof screed.	6-months

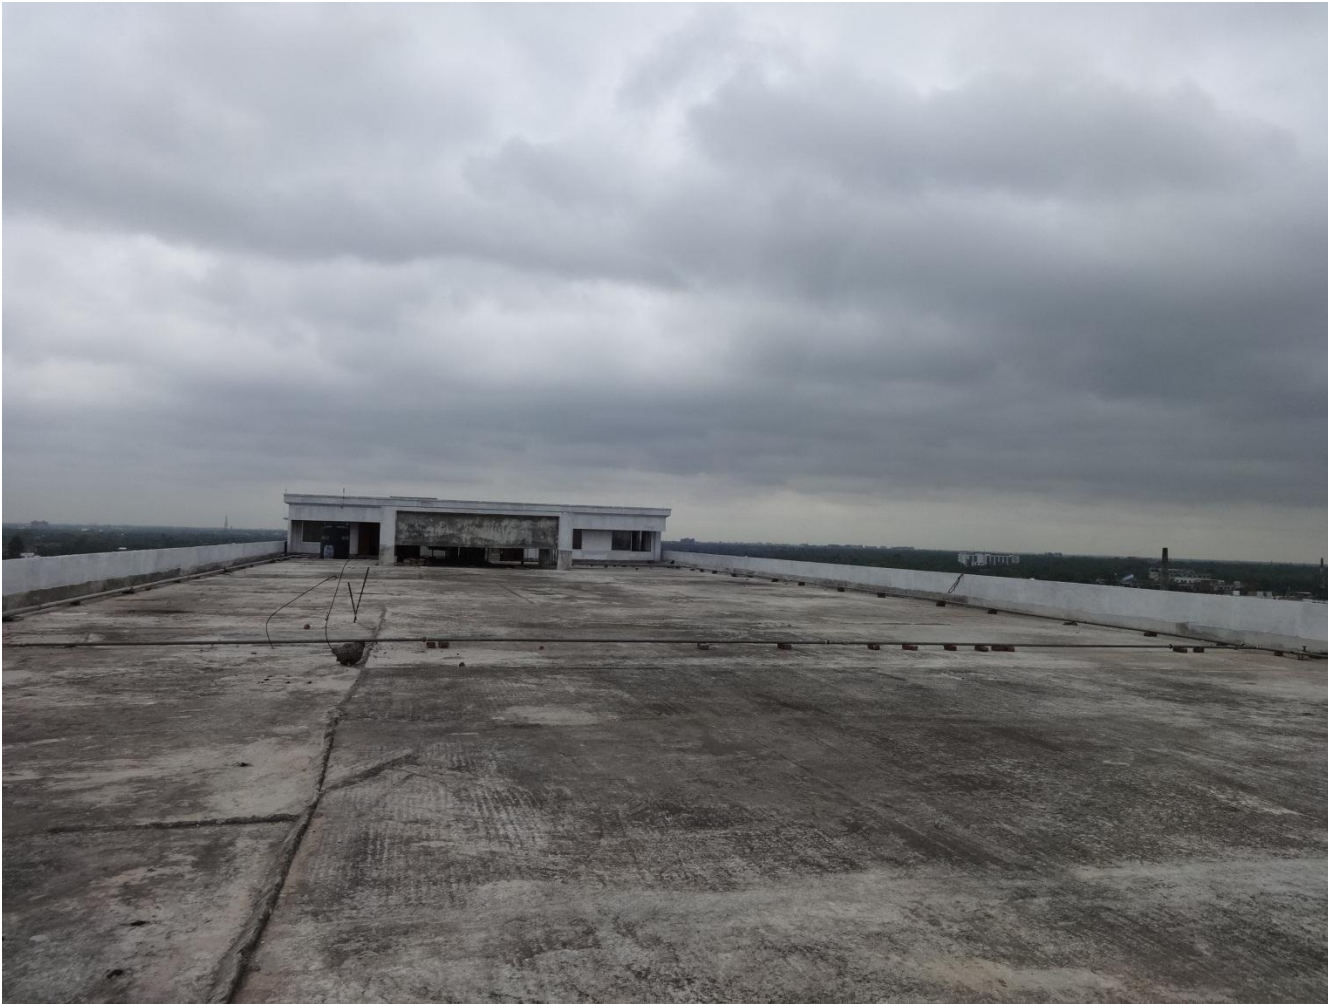
Water Ingress at Roof Level

No waterproofing membrane was visible on the roof of the building. This means that any cracks in the surface finishes on the roof will allow water to seep into the concrete slab beneath the finishes, and cause corrosion of the reinforcing steel.
