# Mondol Intimates Ltd. (11705)

Shirir chala, Bagher Bazar Gazipur

05.July.2014

# Identified Priority 3 Concerns

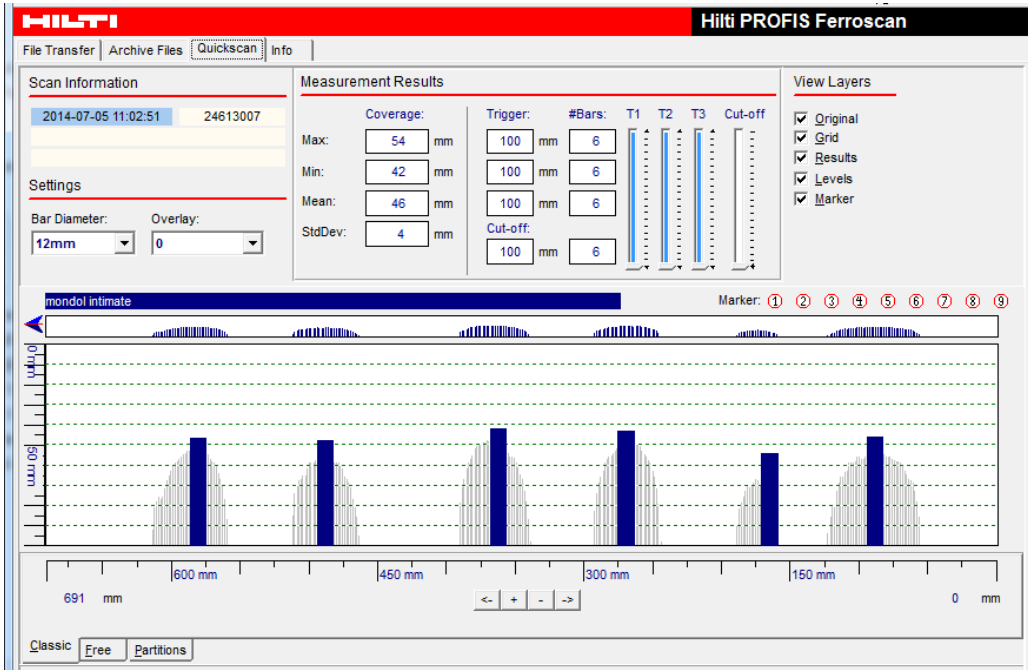
# 1st Priority 3 Concern

The Ferroskan image indicates 20 bars in the column C1 at the ground level in the building 1 rather than 22 bars as in structural drawing. Two bars are missing from the as-built column.

NAME OF COL.	GROUND & 1ST FLOOR		2ND&3RD FLOOR		4TH & 5TH FLOOR		6TH & 7TH FLOOR		8TH FLOOR	
	SIZE	VER. BAR	SIZE	VER. BAR	SIZE	VER. BAR	SIZE	VER. BAR	SIZE	VER. BAR
C1	24" X24"	22-25mmØ	24" X24"	18-25mmØ	24" X24"	14-25mmØ	24" X24"	8-25mmØ + 6-22mmØ	24" X24"	14-22mmØ

There is inconsistency of the reinforcement of typical columns in the building 1

Item No.	Observation	Recommended Action Plan	Recommended Timeline
1	1st Priority 3 - Structural record drawings do not reflect the as-built conditions.	Carry out full survey of all structural elements Based on the results of the detailed structural survey, the Factory Engineer is to prepare accurate structural records for the building, reflecting accurately the as-built condition.	6-months
2	2nd Priority 3 - Lack of proper waterproofing on the roof level results in significant water damage at wall, ceiling and beam locations.	Provide propping to the damaged concrete areas (if slab, beam and column)	6-weeks
3	2nd Priority 3 - Lack of proper waterproofing on the roof level results in significant water damage at wall, ceiling and beam locations.	Hack away the damaged concrete and expose reinforcement to check for corrosion Carry out replacement of reinforcement and proper re-grouting of structural elements Apply proper waterproofing to the roof slab	6-months

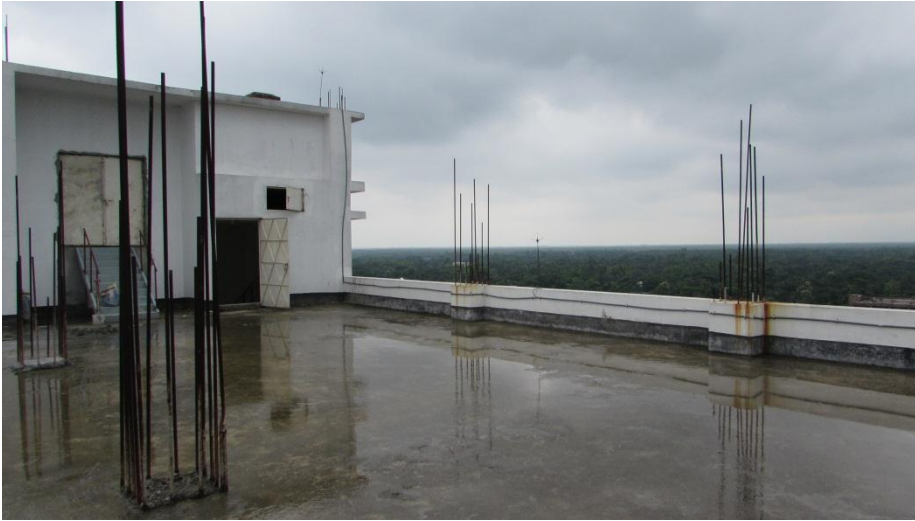
## 2<sup>nd</sup> Priority 3 Concern

It appears to lack proper waterproof on the roof floor leading to water penetration. There are many visible signs of water seepage on the ceiling and the wall at lower level

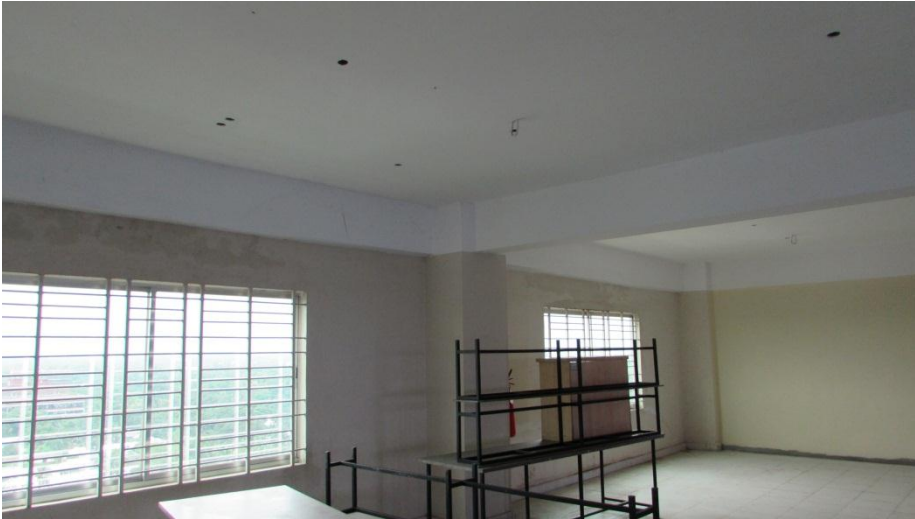
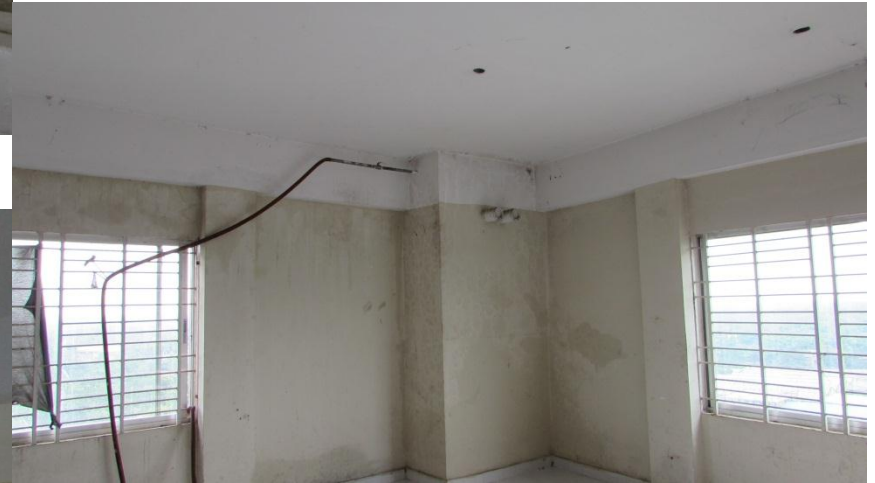
The signs of water seepage on the ceiling and on the wall at lower floor

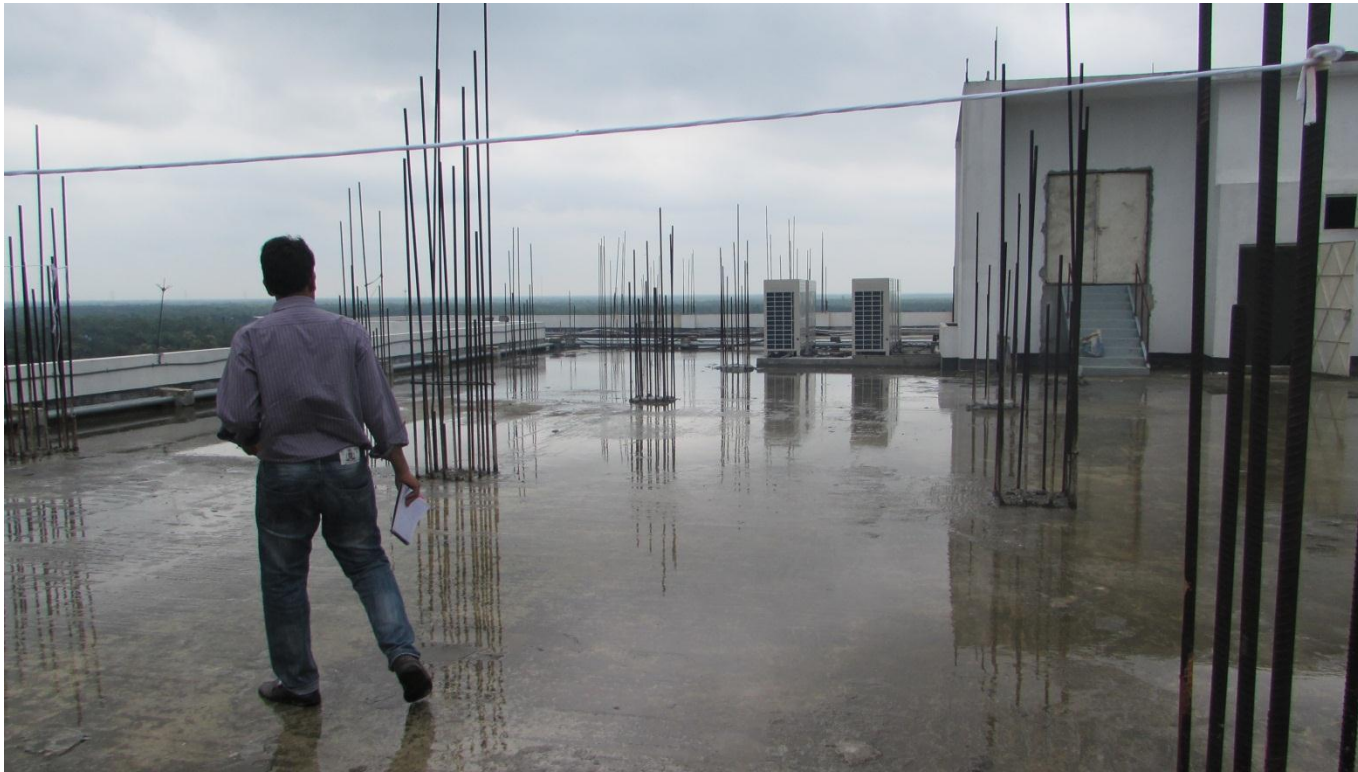
### 3<sup>rd</sup> Priority 3 Concern

The re-bars exposed on the roof have been planed for future extension.

It is not recommended to build up one more floor on top of existing building beyond what has been approved. That would place the building in unstable condition. Every structural modification needs to be investigated by licensed engineer.

4	3rd Priority 3 - The re-bars exposed on the roof have been planned for future extension.	Do not carry out any structural modification without any form of approval and design by licensed engineer.	6-months
5	4th Priority 3 - Lack of fireproofing for steel building.	Provide fireproofing for steel columns, beams and connections supporting floors in the steel building as per BNBC requirements.	6-months

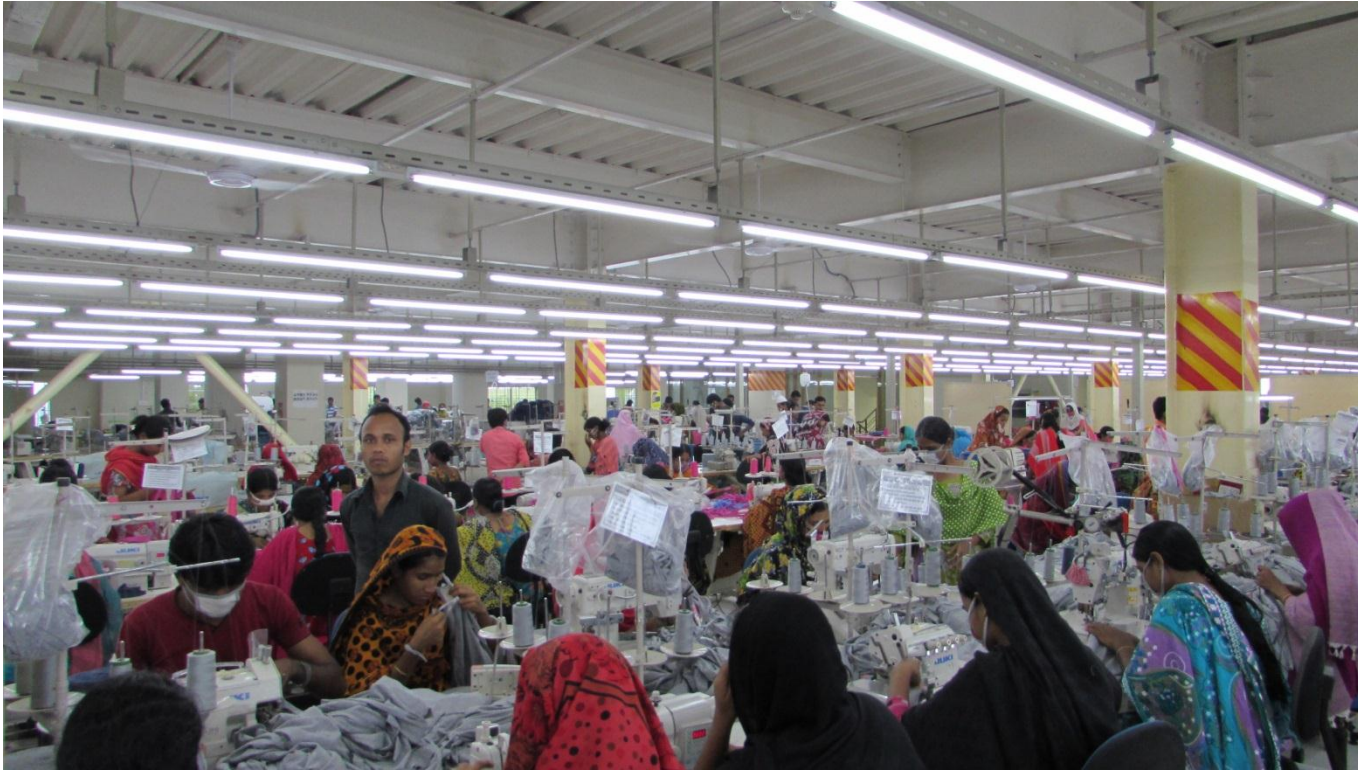
## 4<sup>th</sup> Priority 3 Concern

The steel structure has not been fireproofed. It is required to provide fireproofing for all columns, beams and connection supporting floors in a steel structure.
