# Shasha Garments Ltd. (9363)

220/A, 1/1 West Kafrul, Begum Rokeya Sharoni, Mirpur, Dhaka-1216

05.JULY.2014

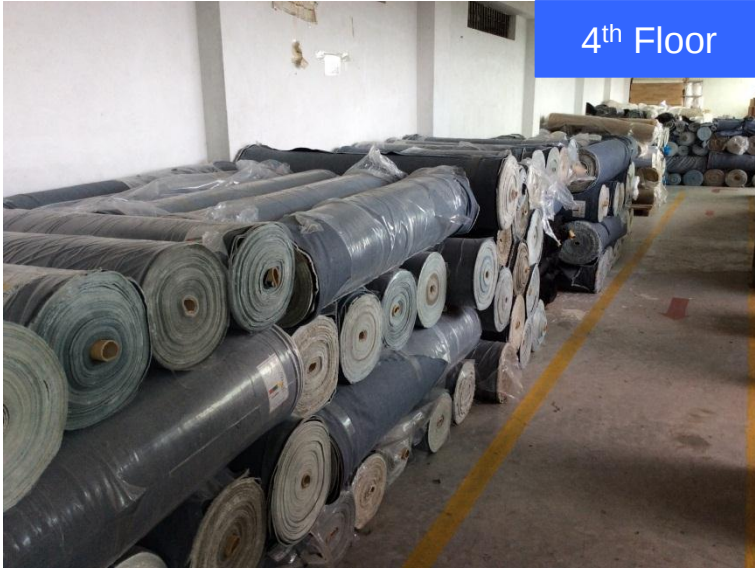
4<sup>th</sup> Floor

Uncontrolled heavy storage loading was found on 4<sup>th</sup> floor and 6<sup>th</sup> floor. We believed the loading on 4<sup>th</sup> floor and 6<sup>th</sup> floor to be 4.5 kPa (50 kg per roll, 1.50 x 1.50 m footprint, 20 rolls per stack) and 6.0 kPa (50 kg per bag, 0.70 x 0.60 m footprint, 5 bags per stack) respectively. Loading in this area should be reduced to 2.0 kPa and we require that these items be investigated in the Detailed Engineering Assessment.

| Item No. | Observation | Recommended Action Plan | Recommended Timeline |
|---|---|---|---|
| 1 | Priority 1 - Uncontrolled heavy storage loading on 4th floor and 6th floor. | Reduce stacking height to ensure total load does not exceed 2.0 kPa.<br>A Detailed Engineering Assessment is required to review the design and loads.<br>Factory Engineer to state the maximum weight that is allowed per square meter. Suggest that state the value on notice boards in these areas. (Loading Plans). | Immediate – Now |
| 2 | Priority 1 - Uncontrolled heavy storage loading on 4th floor and 6th floor. | Adopt some sort of signage/staff guidance to ensure that the maximum weight of storage is not exceeded. (Loading Plans). | 6-weeks |
| 3 | Priority 1 - Uncontrolled heavy storage loading on 4th floor and 6th floor. | Maintain standards of quality control to ensure that storage procedures are correctly followed so that overloading problems do not arise in the future.<br>Maintain and implement Loading Plans. | 6-months |

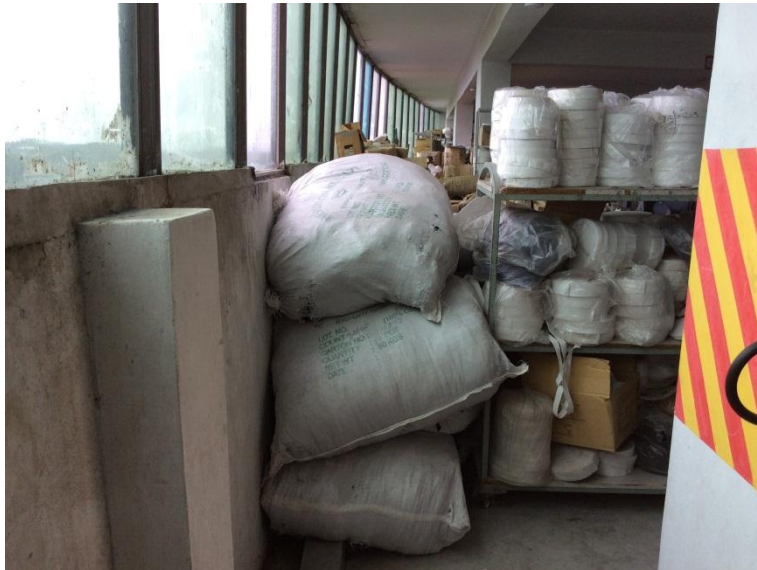
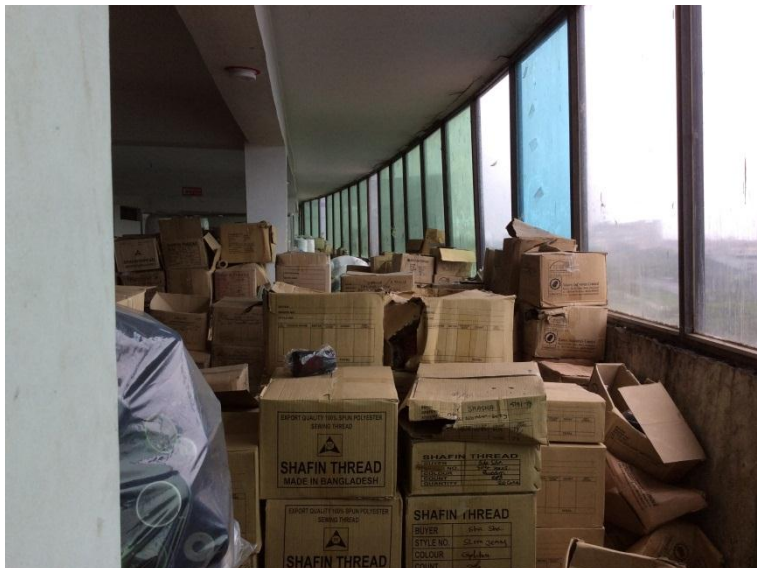
Uncontrolled heavy storage loading was found on 1<sup>st</sup> floor cantilevered slab. This loading was also leaning on the brick walls that lack in lateral load resistance.

Loading in these areas should be removed and we require that these items be investigated in the Detailed Engineering Assessment.

| Item No. | Observation | Recommended Action Plan | Recommended Timeline |
|---|---|---|---|
| 4 | Priority 1 - Uncontrolled heavy storage loading on 4th floor cantilevered slab. | Remove heavy storage loading in the area identified above.<br>A Detailed Engineering Assessment is required to review the design and loads.<br>Factory Engineer to state the maximum weight that is allowed per square meter. Suggest that state the value on notice boards in these areas. (Loading Plans). | Immediate – Now |

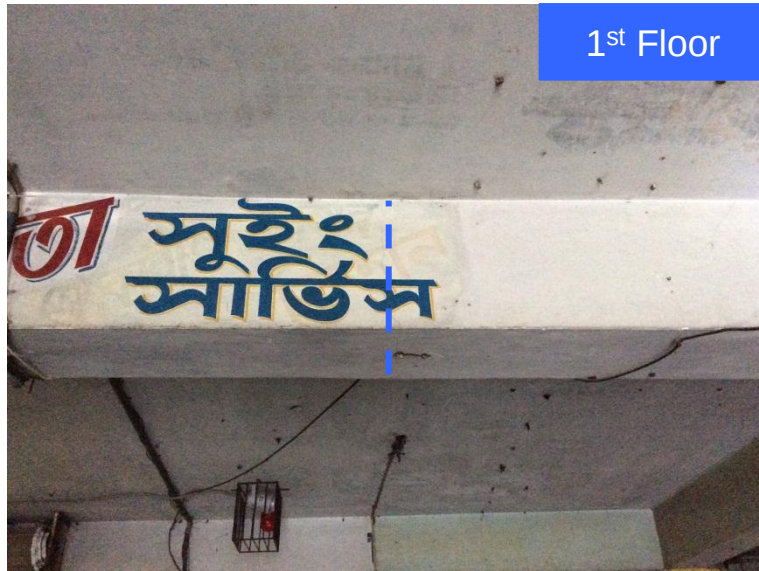
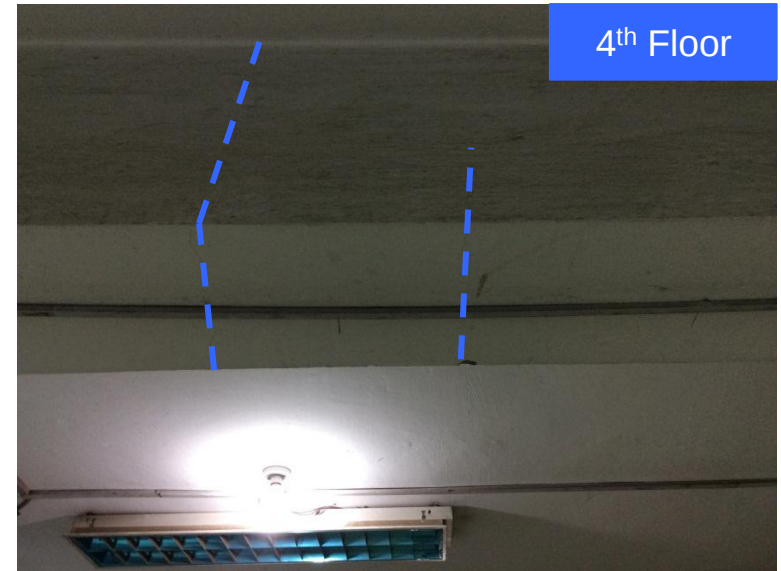
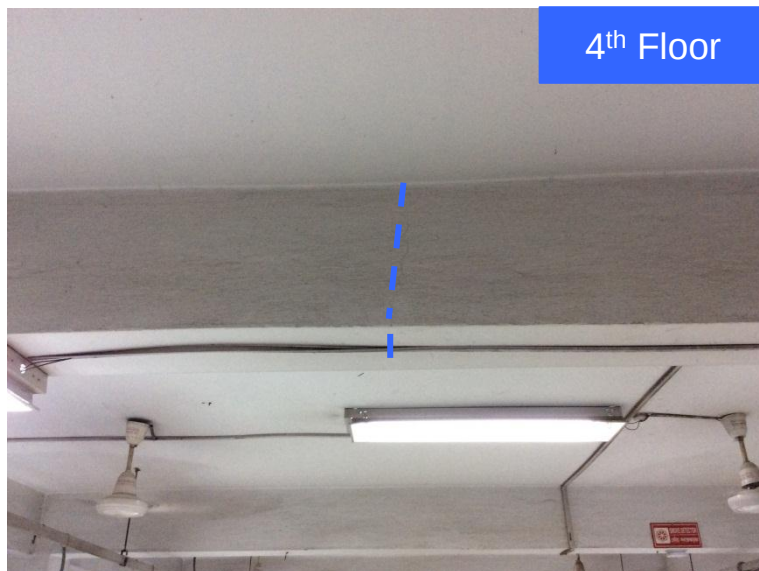
Cracks on 1<sup>st</sup> floor and 5<sup>th</sup> floor beams. The cause of cracks should be investigated by appropriate methods.

| Item No. | Observation | Recommended Action Plan | Recommended Timeline |
|---|---|---|---|
| 7 | Priority 2 - Cracks on 1st floor and 5th floor beams. | The Factory Engineer to investigate the cause of cracks by appropriate methods.<br>The distress found is to be suitably rectified and then repaired. | 6-weeks |
| 8 | Priority 2 - Cracks on 1st floor and 5th floor beams. | Create loading plans for each floor level.<br>Maintain standards of quality control to ensure that loading plan is correctly followed so that problems do not arise in the future.<br>Maintain and enforce the loading plans. | 6-months |

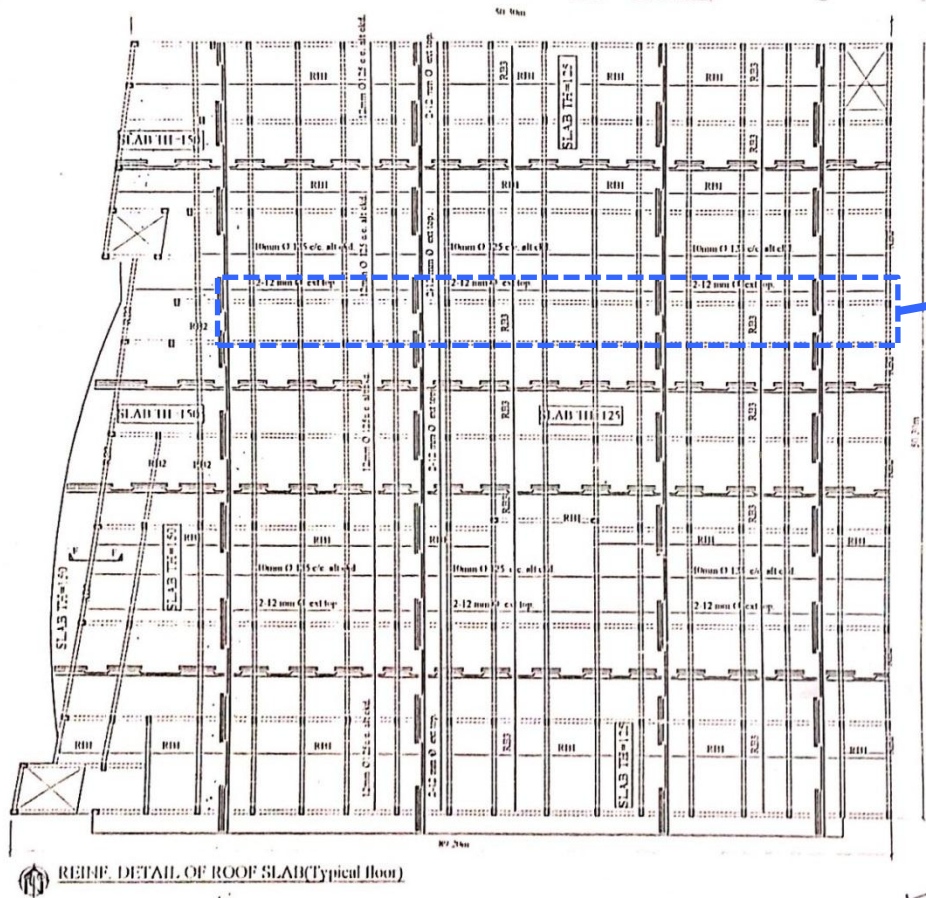
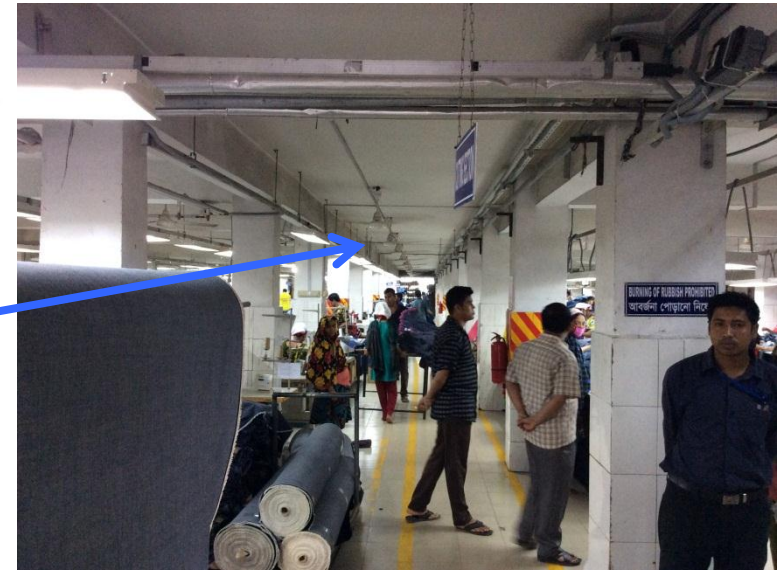
There are no 5<sup>th</sup> floor beams in area shown above. These do not match the structural drawings.

| Item No. | Observation | Recommended Action Plan | Recommended Timeline |
|---|---|---|---|
| 9 | Priority 2 - Inadequacies between the drawings and the actual as-built conditions. | Factory Engineer to survey the actual conditions and revise the drawings.<br>Any results of the Engineering Assessment which affect the structure should be taken on board. | 6-weeks |

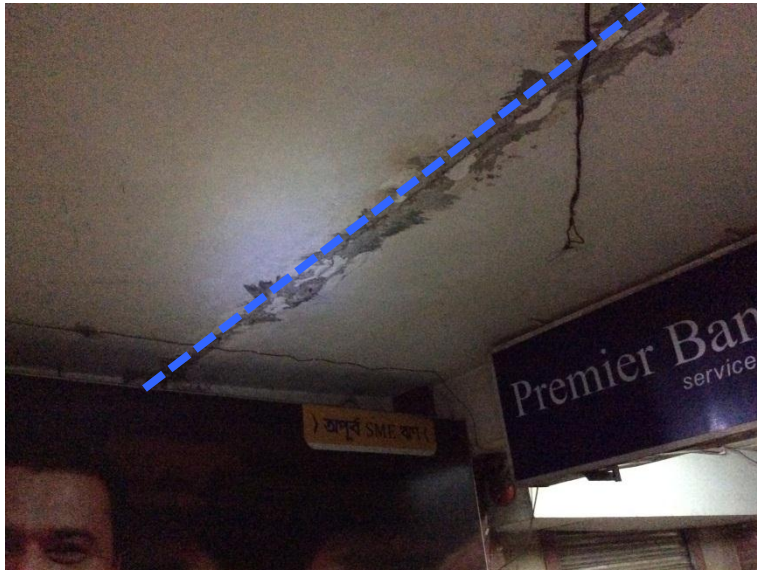
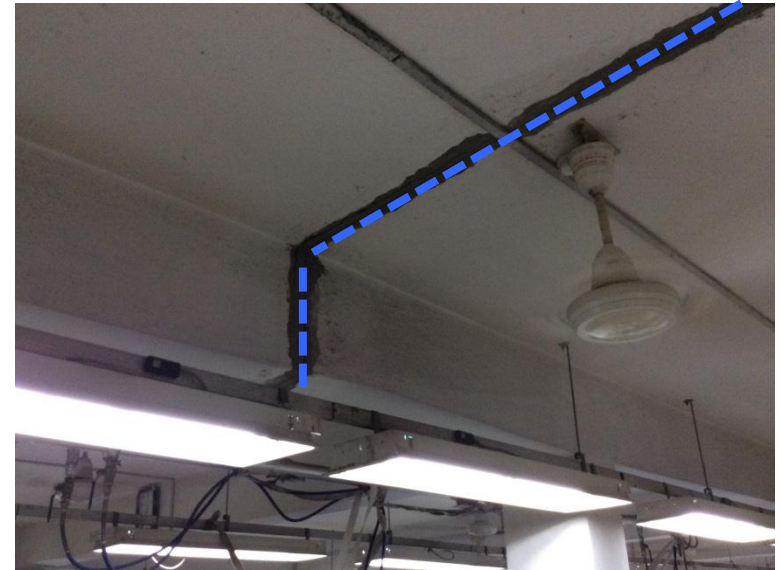
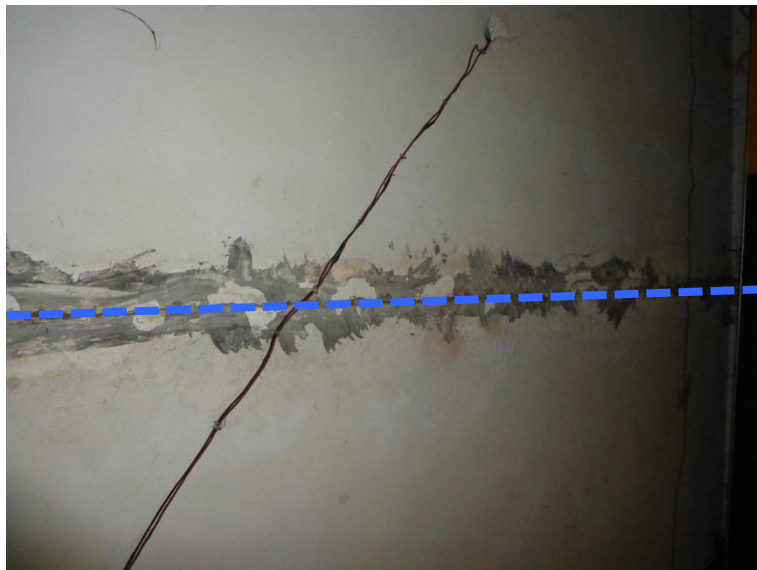
This building was constructed into 2 phases. The movement joint should be established properly where shown. However the joint was covered with mortar and/or finishes on the floors and cracks were noted along the joint profile.

| Item No. | Observation | Recommended Action Plan | Recommended Timeline |
|---|---|---|---|
| 11 | Priority 2 - Movement joint to be properly established. | The Factory Engineer should investigate to prove the capacity of the building in its existing state, a further building approval should be gained for the building as it exists, as altered since the original approval. Alternatively, the extension building should be separated by a non-structural joint and allowed to act as a fully structurally independent structure. | 6-weeks |
| 12 | Priority 2 - Movement joint to be properly established. | Do not construct any further buildings connected to the existing building without thorough structural design and full building approval. | 6-months |

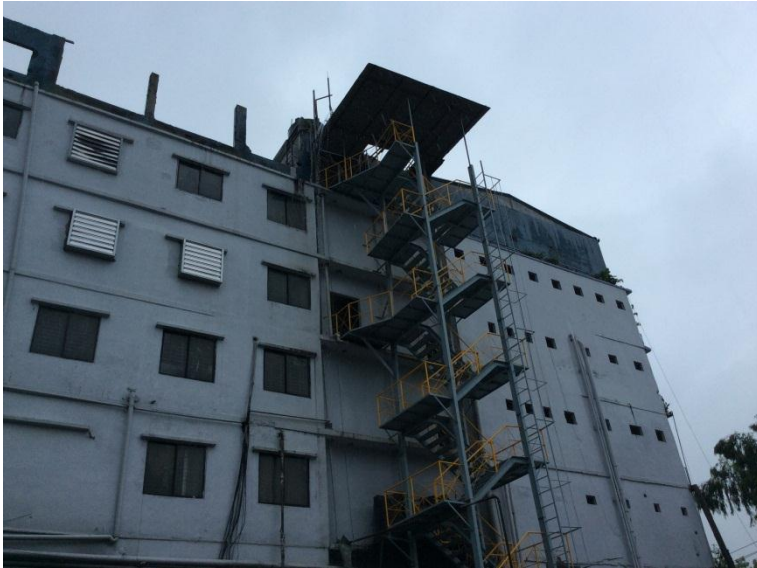
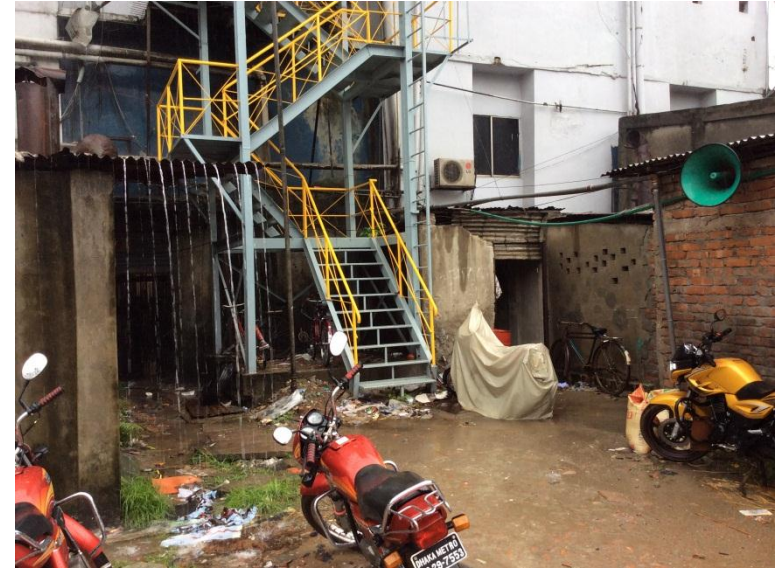
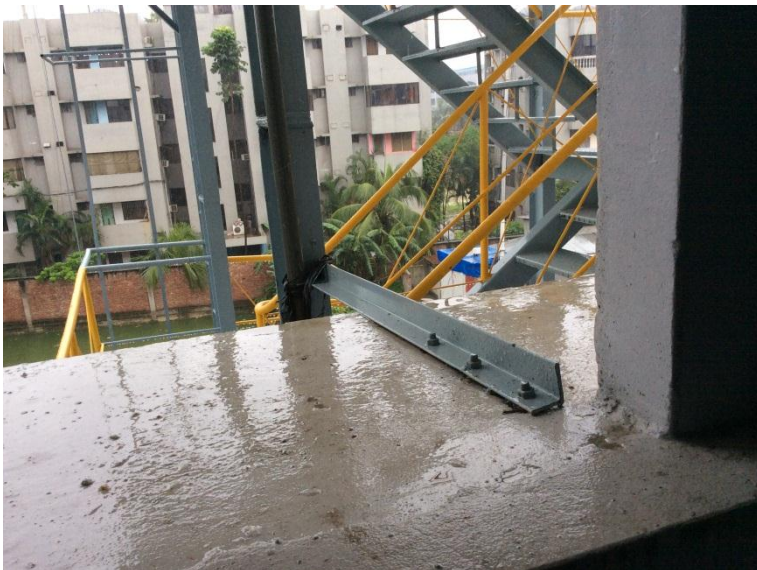
There are no drawings provided for the steel staircase on the east side of this building. The stability and capacity of this steel stair need to be investigated.

| Item No. | Observation | Recommended Action Plan | Recommended Timeline |
|---|---|---|---|
| 13 | Priority 2 - Stability and capacity check of the steel stair. | Factory Engineer to review design, loads and related elements in area identified above to confirm capacity and stability for these items. | 6-weeks |
| 14 | Priority 2 - Stability and capacity check of the steel stair. | Implement any corrective action found to be necessary. | 6-months |

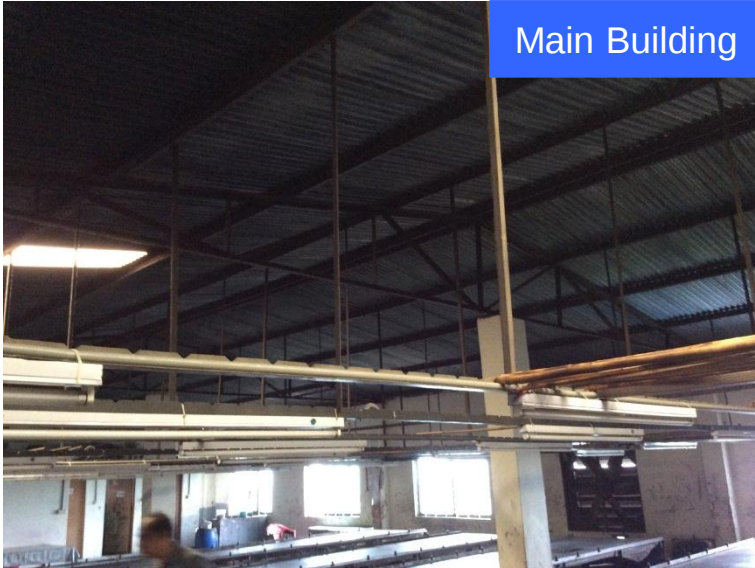
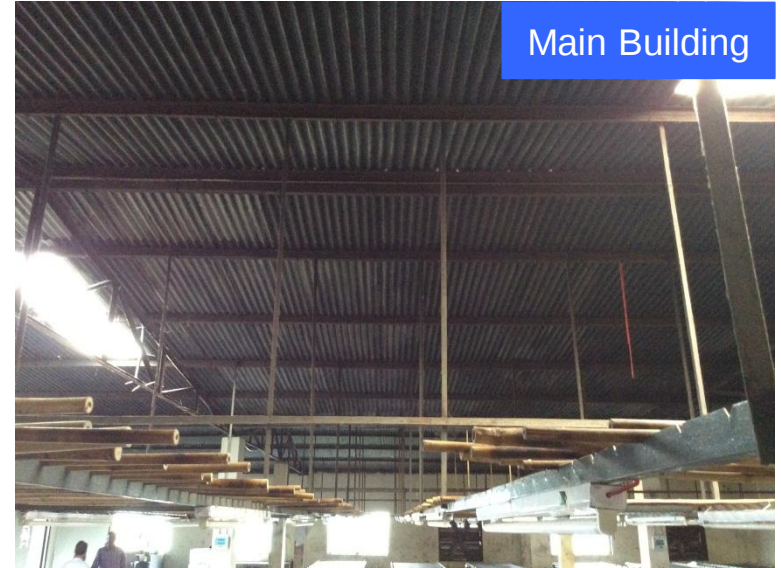
Main Building

There are no drawings provided for the roof shed of main building. The roof sheds of main building and auxiliary building must be checked for stability and capacity especially the connections. Stability under wind uplift needs to be checked in particular.

| Item No. | Observation | Recommended Action Plan | Recommended Timeline |
|---|---|---|---|
| 15 | Priority 2 - Stability and capacity check of the roof sheds. | Factory Engineer to review design, loads and related elements in area identified above to confirm capacity and stability for these items. | 6-weeks |
| 16 | Priority 2 - Stability and capacity check of the roof sheds. | Implement any corrective action found to be necessary. | 6-months |

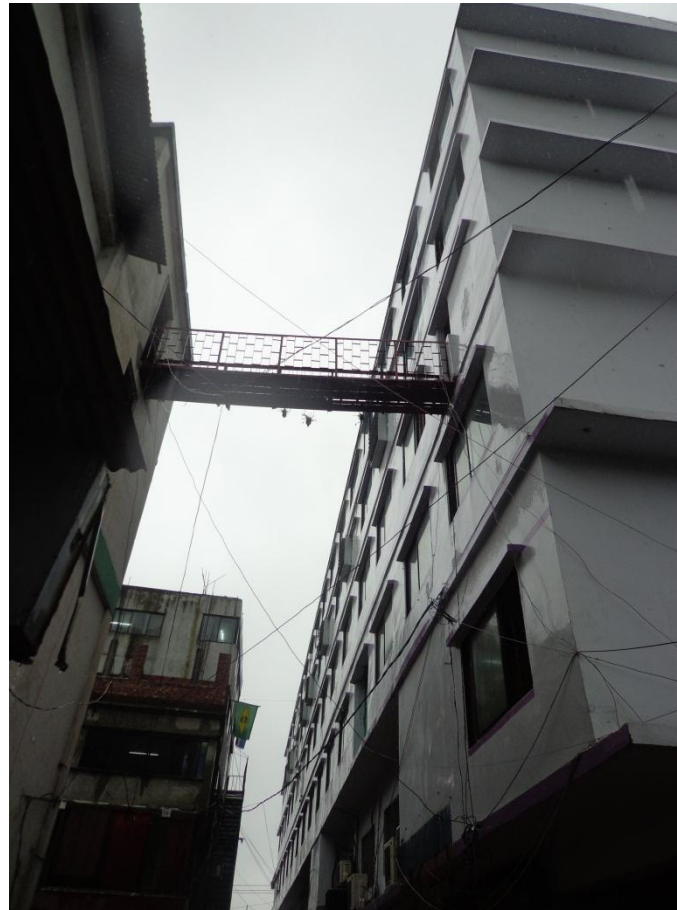
There is connecting bridge on the south side between this building and other building. The stability and capacity of this connecting bridge and related elements need to be verified.

| Item No. | Observation | Recommended Action Plan | Recommended Timeline |
|---|---|---|---|
| 17 | Priority 2 - Stability and capacity check of the connecting bridge. | Factory Engineer to review design, loads and related elements in area identified above to confirm capacity and stability for these items. | 6-weeks |
| 18 | Priority 2 - Stability and capacity check of the connecting bridge. | Implement any corrective action found to be necessary. | 6-months |

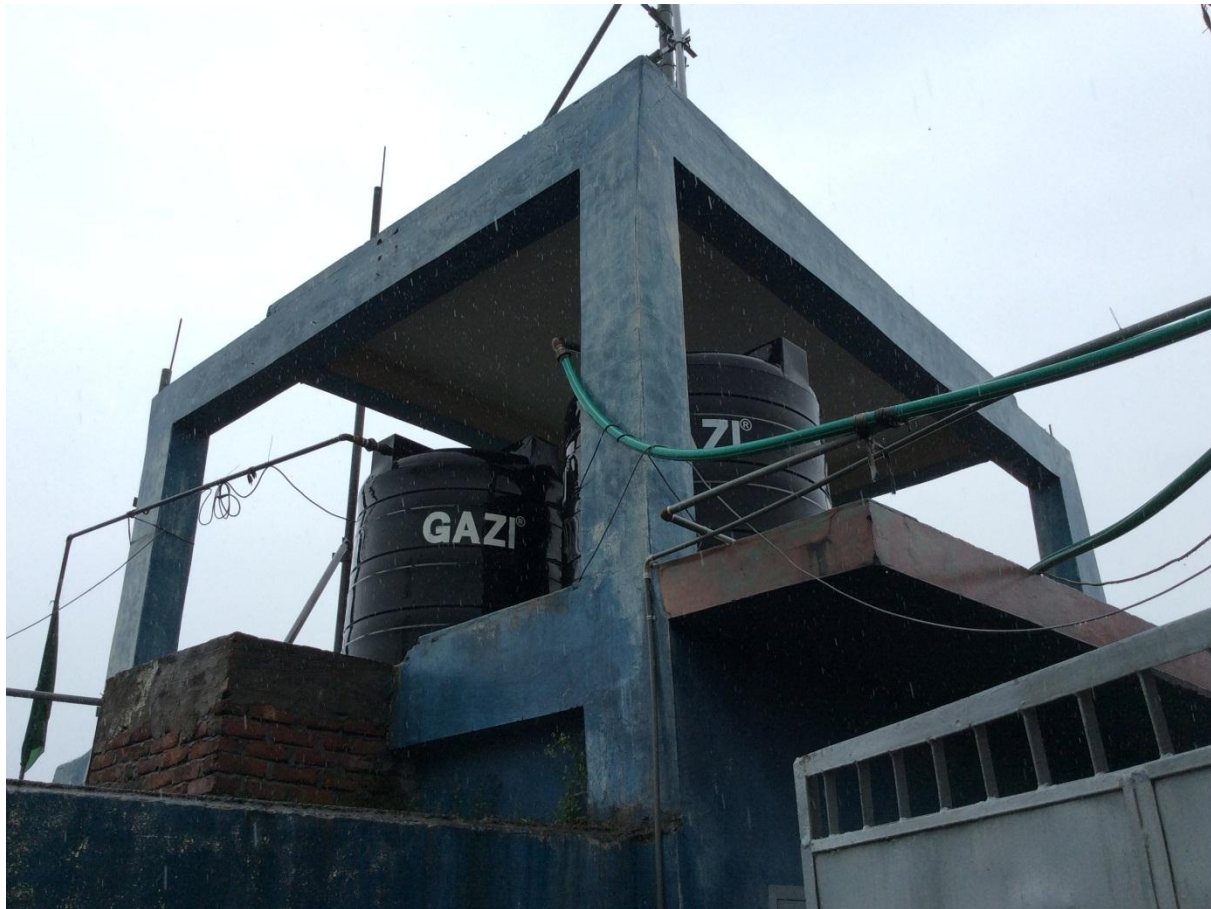
There are concerns with a section of slab that was supporting three water tanks. A capacity check of this slab and related elements need to be carried out.

| Item No. | Observation | Recommended Action Plan | Recommended Timeline |
|---|---|---|---|
| 19 | Priority 2 - Capacity check of the slab supporting water tanks. | Factory Engineer to review design, loads and related elements in area identified above to confirm capacity for these items. | 6-weeks |
| 20 | Priority 2 - Capacity check of the slab supporting water tanks. | Implement any corrective action found to be necessary. | 6-months |

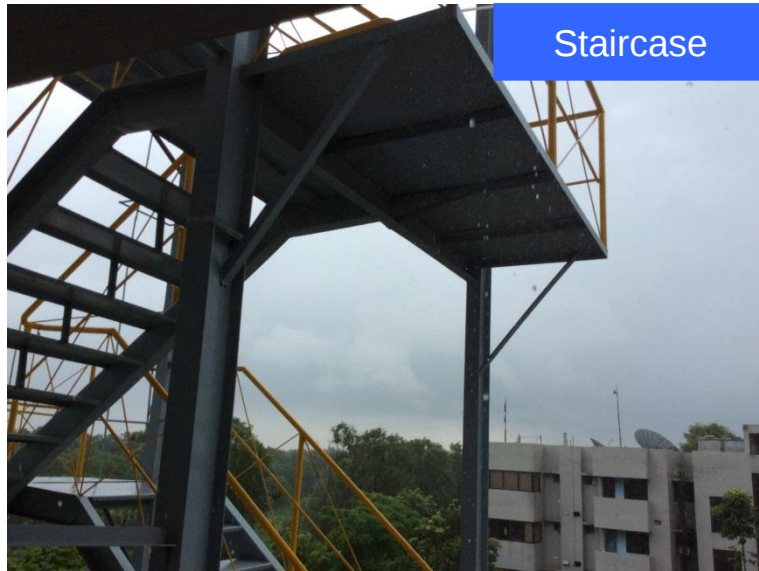
Staircase

No fireproofing material was noted on structural steel elements (if required).

| Item No. | Observation | Recommended Action Plan | Recommended Timeline |
|---|---|---|---|
| 21 | Priority 2 - No fireproofing material applied to structural steel elements (if required). | Fireproofing material for structural steel element is recommended as suggested in BNBC Codes. | 6-weeks |
| 22 | Priority 2 - No fireproofing material applied to structural steel elements (if required). | Maintain standard of quality control and protection of the fire protection. | 6-months |

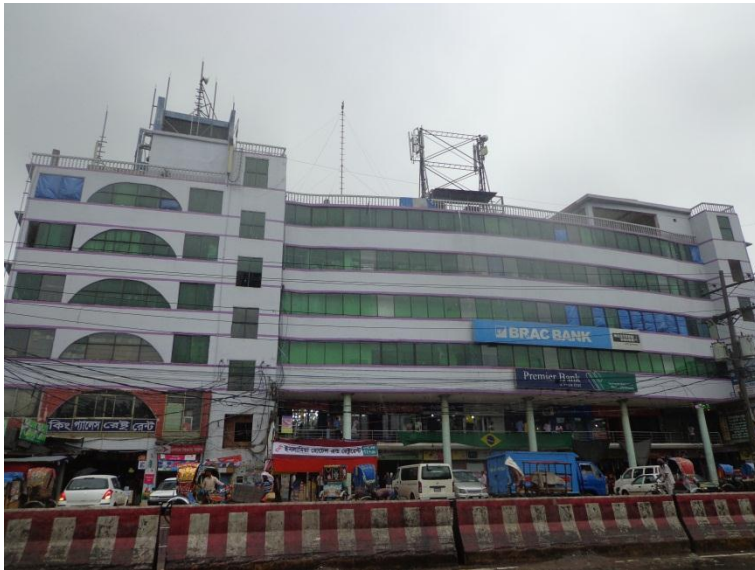
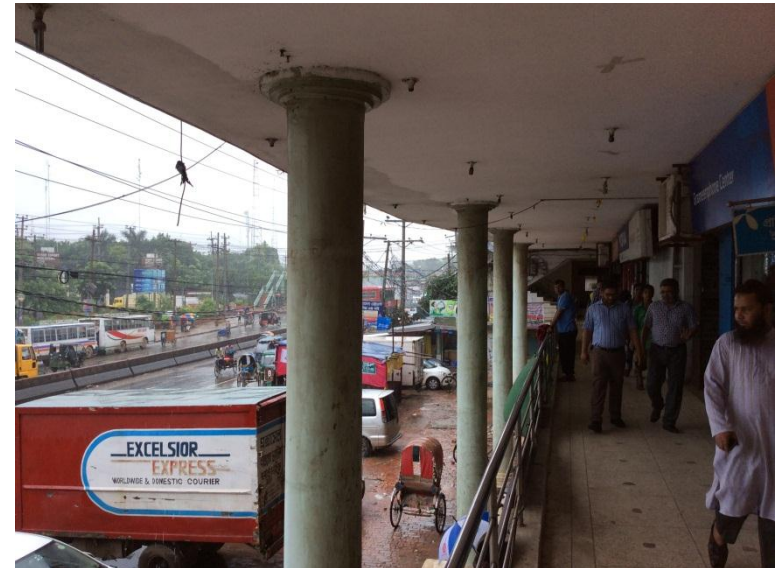
The lateral loading resistance for this 7-storey building is provided by moment frame action without any shear wall and the façade brickwork walls lack moment capacity due to their poor connections with the surrounding columns and beams. This building also has high unbraced length columns (2 storeys) on the west side.

We require that this building be investigated in a Detailed Engineering Assessment.

| Item No. | Observation | Recommended Action Plan | Recommended Timeline |
|---|---|---|---|
| 23 | Priority 2 - Overall stability system. | Request that a Detailed Engineering Assessment of the overall building to be carried out and in particular, stability and foundation aspects should be investigated in detail as per BNBC specified lateral loads. | 6-weeks |
| 24 | Priority 2 - Overall stability system. | Implement any corrective action found to be necessary. | 6-months |

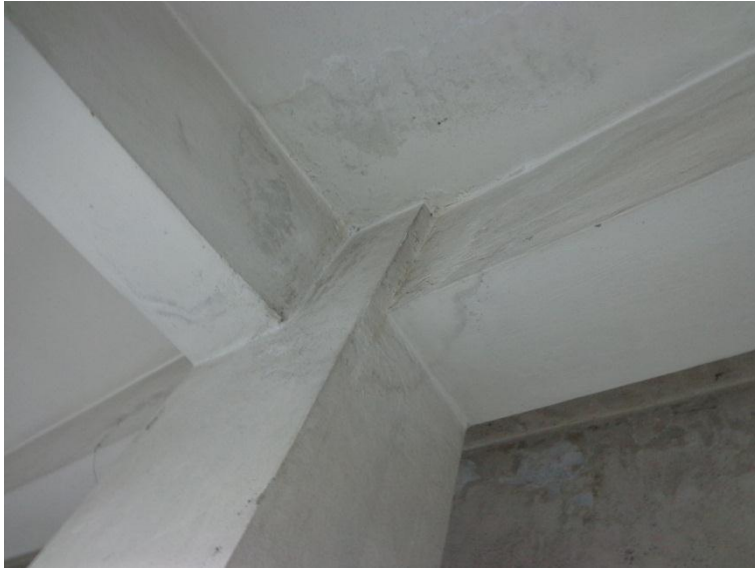
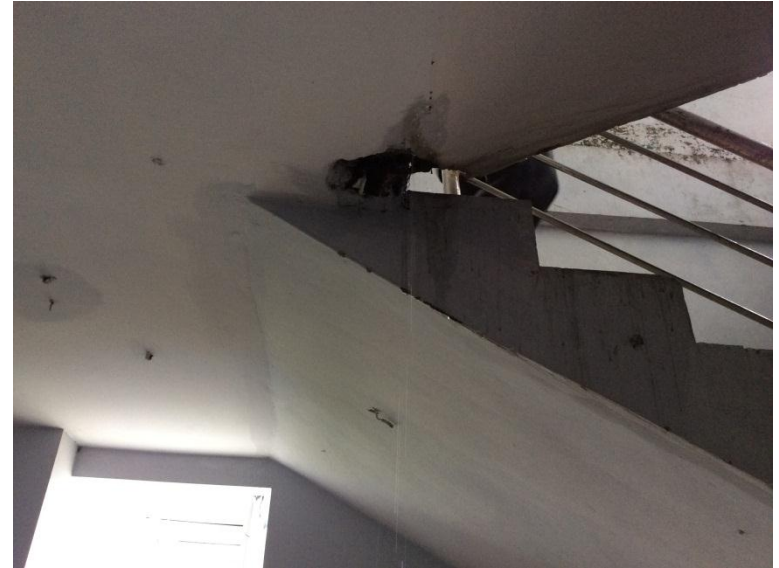
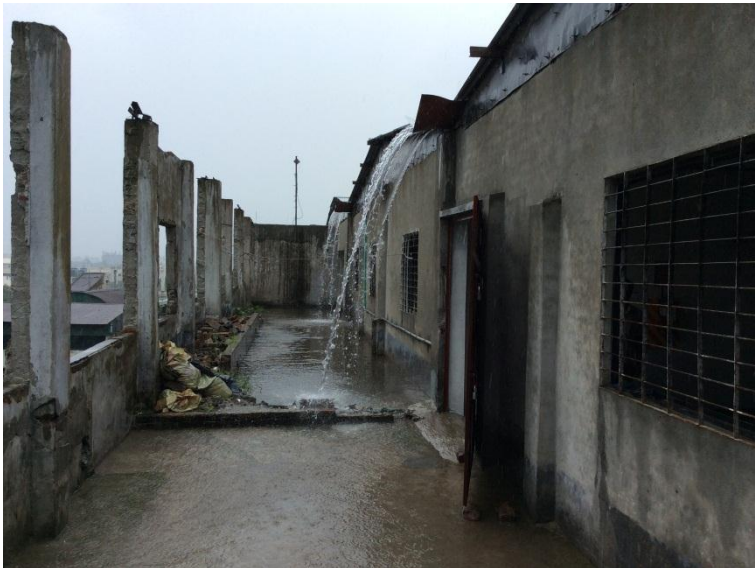
Distress due water ingress noted at slabs, beams, columns and walls. Water ponding was found at roof slab.

| Item No. | Observation | Recommended Action Plan | Recommended Timeline |
|---|---|---|---|
| 25 | Priority 3 - Distress due to water ingress. | Factory Engineer to inspect water damaged structures and repair with a suitable method.<br>Waterproofing on the roof slab is to be applied. Moreover the roof slab drainage system should be investigated and improved. | 6-months |
