# Tamishna Fashion Wear Ltd. (Unit-2) (10325)

8 no., Mulaid, Sreepur, Gazipur.

06.07.2014

# Identified Priority 1 Concerns

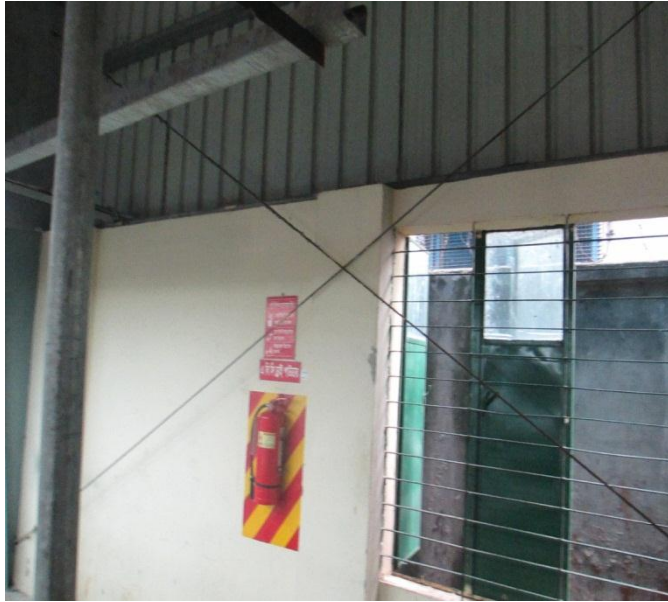
Old shed

At old shed the vertical bracings were not firmly connected with column and in some places we observed some missing bracing. The new shed has no vertical or horizontal cross bracing at all .

| Item No. | Observation | Recommended Action Plan | Recommended Timeline |
|---|---|---|---|
| 1 | 1st Priority 1 - No obvious lateral stability system at sheds. | A Detail Engineering Assessment of the sheds to be carried out and in particular, lateral stability, uplift, and foundation aspects should be investigated in detail. | Immediate – Now |
| 2 | 1st Priority 1 - No obvious lateral stability system at sheds. | Follow the results from the engineering assessment. | 6-weeks |
| 3 | 1st Priority 1 - No obvious lateral stability system at sheds. | If deemed necessary by the Factory Engineer, carry out any remedial works recommended. | 6-months |

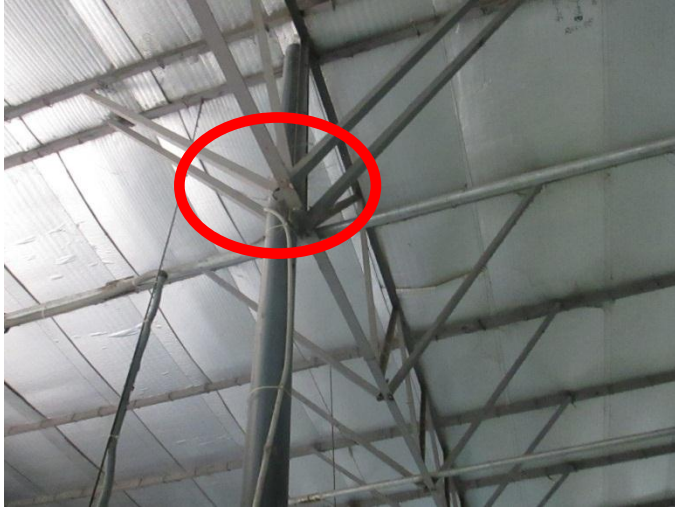
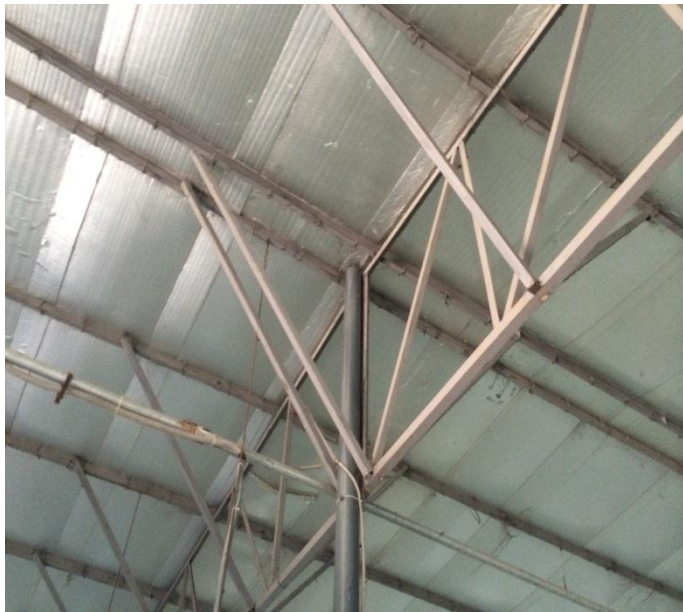
The connections of truss members with the circular column were very poor. Again the positioning of columns with respect to truss members is irregular.

| Item No. | Observation | Recommended Action Plan | Recommended Timeline |
|---|---|---|---|
| 4 | 2nd Priority 1 - The connections of truss member and the positioning of columns with truss members are irregular in the new shed. | Carry out a detailed engineering assessment of the issue mentioned above. | Immediate – Now |
| 5 | 2nd Priority 1 - The connections of truss member and the positioning of columns with truss members are irregular in the new shed. | Carry out actions from detail engineering assessment. | 6-weeks |
| 6 | 2nd Priority 1 - The connections of truss member and the positioning of columns with truss members are irregular in the new shed. | If deemed necessary by the Factory Engineer, carry out any remedial works recommended. | 6-months |

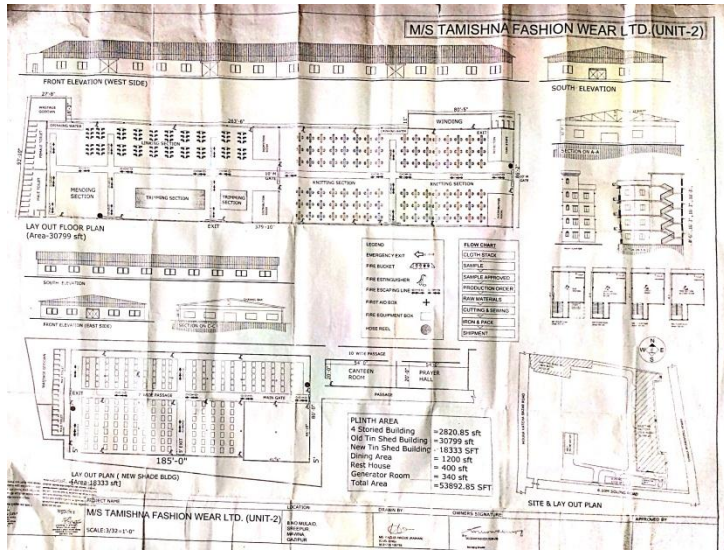
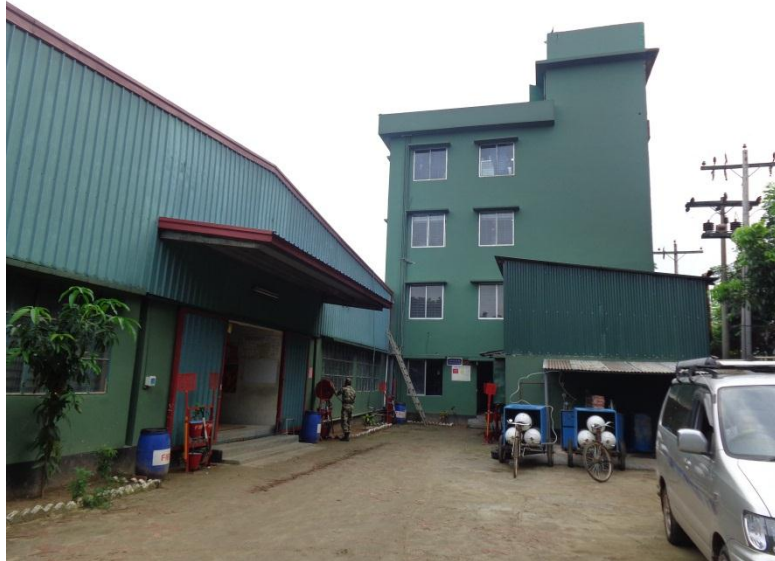
The 4 storey building and sheds did not have any structural drawings except permit drawings. Besides that they did not have any soil report.

| Item No. | Observation | Recommended Action Plan | Recommended Timeline |
|---|---|---|---|
| 7 | 1st Priority 3 - No structural drawings for any building and sheds | Begin a structural survey for all the buildings and sheds. | 6-weeks |
| 8 | 1st Priority 3 - No structural drawings for any building and sheds | Produce as built structural drawings that depict the actual site conditions. | 6-months |

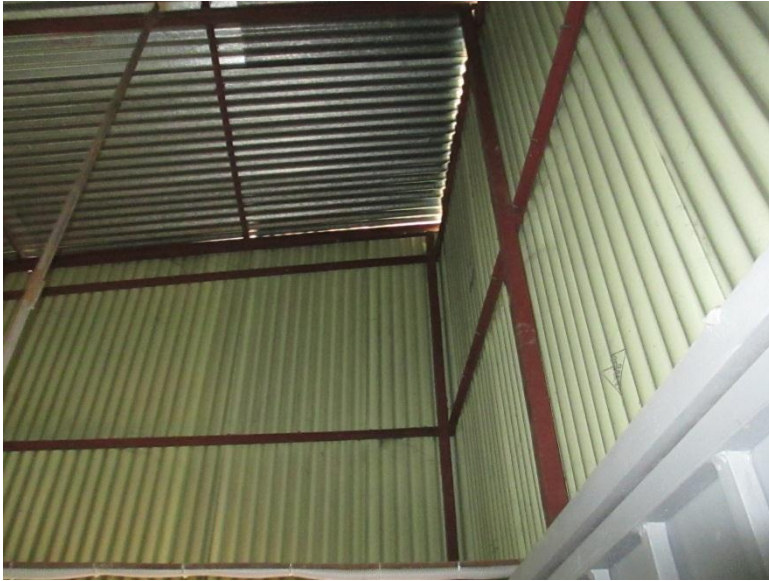
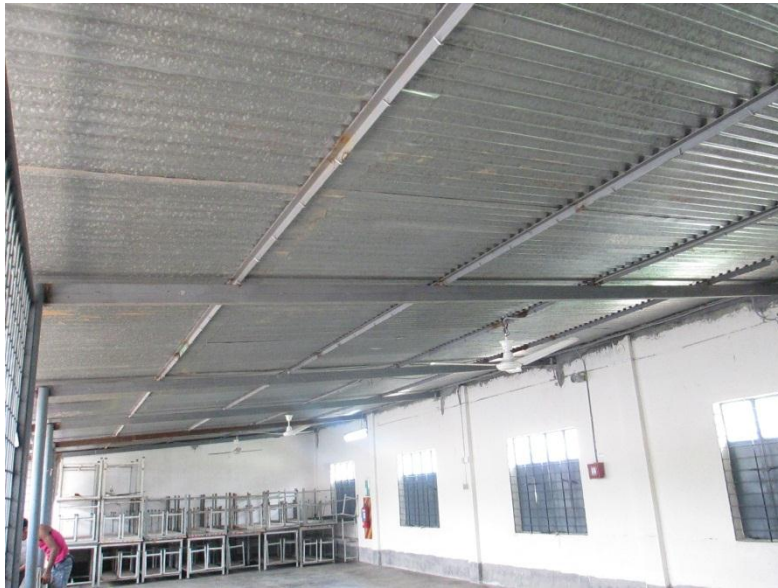
Inadequate steel detailing at roofs of sheds .

| Item No. | Observation | Recommended Action Plan | Recommended Timeline |
|---|---|---|---|
| 9 | 2nd Priority 3 - Inadequate steel detailing at roofs of ancillary buildings. | Carry out engineering assessment on the roofs of steel sheds. | 6-weeks |
| 10 | 2nd Priority 3 - Inadequate steel detailing at roofs of ancillary buildings. | If deemed necessary by the Factory Engineer, carry out any remedial works recommended. | 6-months |

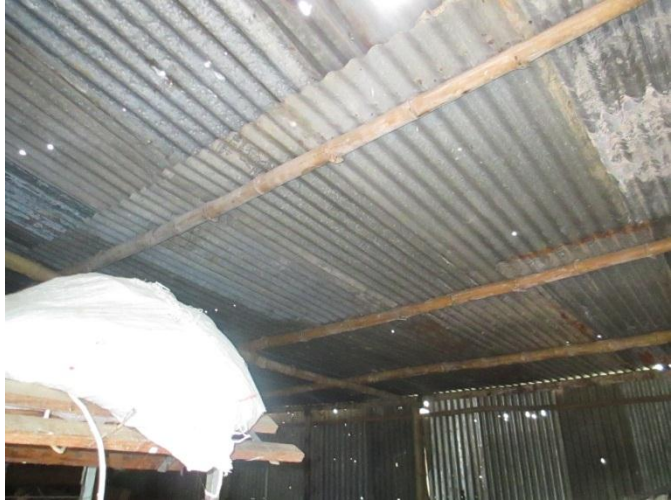
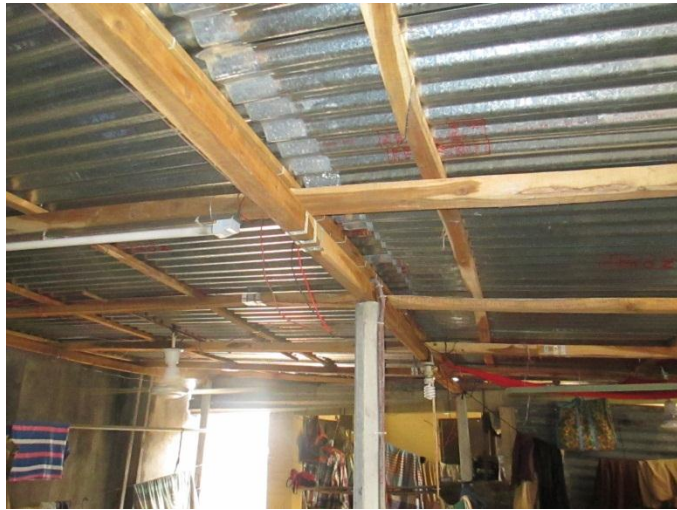
Roof with bamboo sheds and walls with bamboo posts were built inadequately as they do not have any strength against high wind pressure

| Item No. | Observation | Recommended Action Plan | Recommended Timeline |
|---|---|---|---|
| 11 | 3rd Priority 3 - Roof with bamboo sheds are built inaccurately. | An engineering assessment should be commenced with BNBC wind loads.<br>Try to find appropriate strengthening measures for these structures. | 6-weeks |
| 12 | 3rd Priority 3 - Roof with bamboo sheds are built inaccurately. | Strengthen the roofs to meet BNBC provisions, or replace with properly engineered steel roofs. | 6-months |

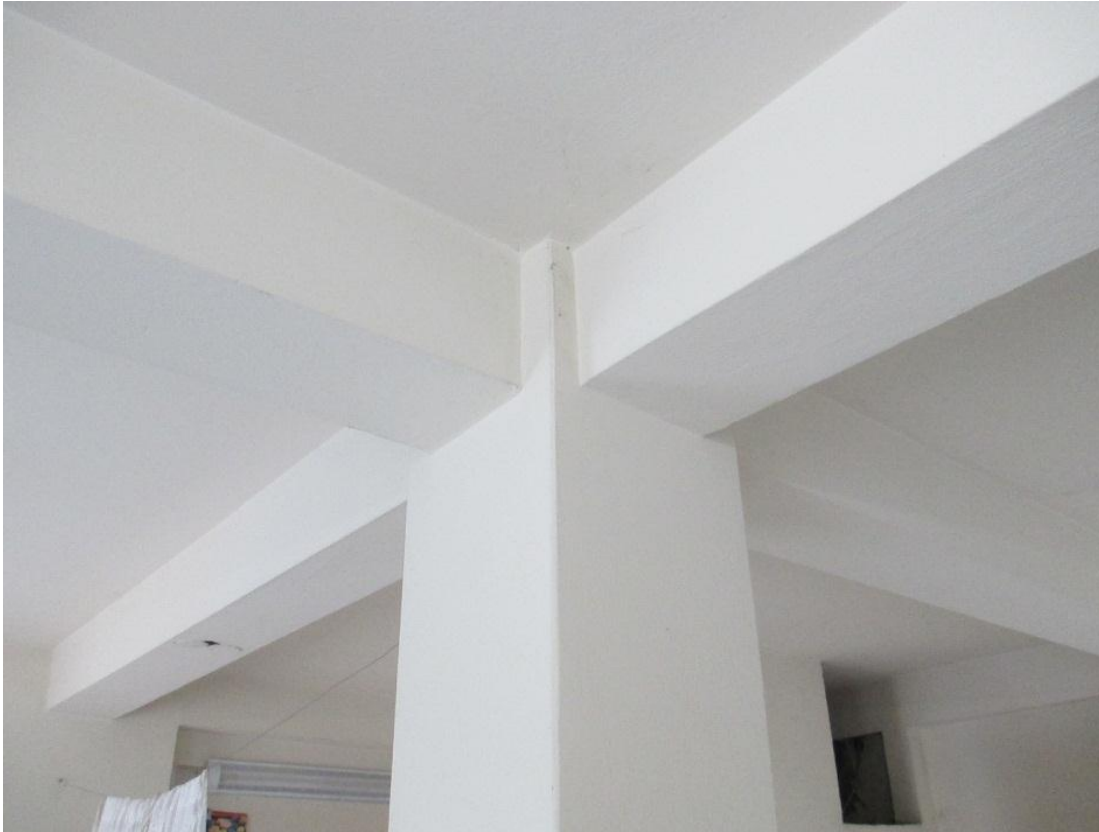
The 4 storey building did not feature any core or shear walls . Stability was achieved through sway action between beams and columns and masonry infill walls .

We require that these items be investigated in an Engineering Assessment

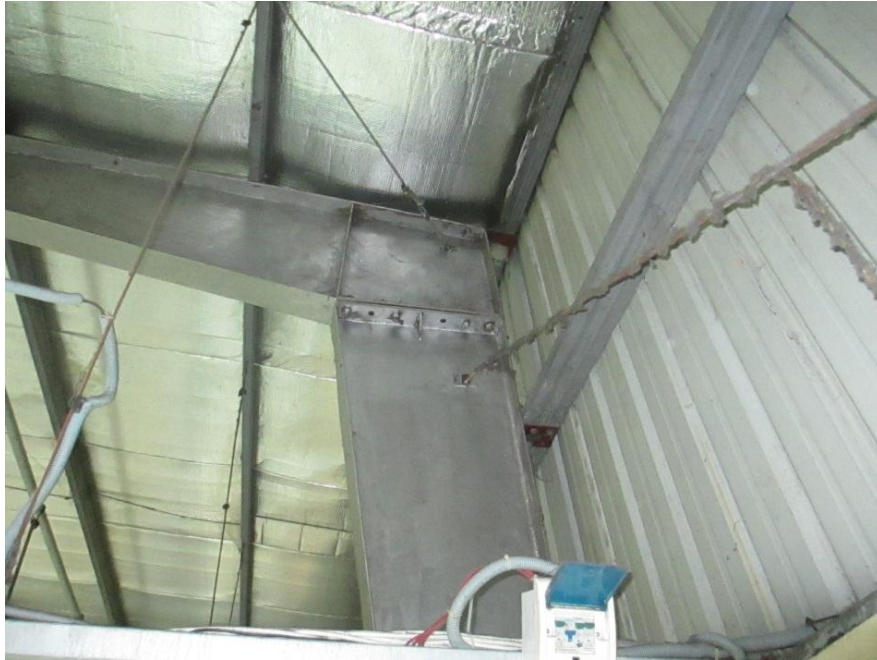
Old shed

At the old shed the vertical bracing were not connected firmly and there were some missing bracing too. At the new shed there was no vertical or horizontal bracing.

We require that these items be investigated in an Engineering Assessment

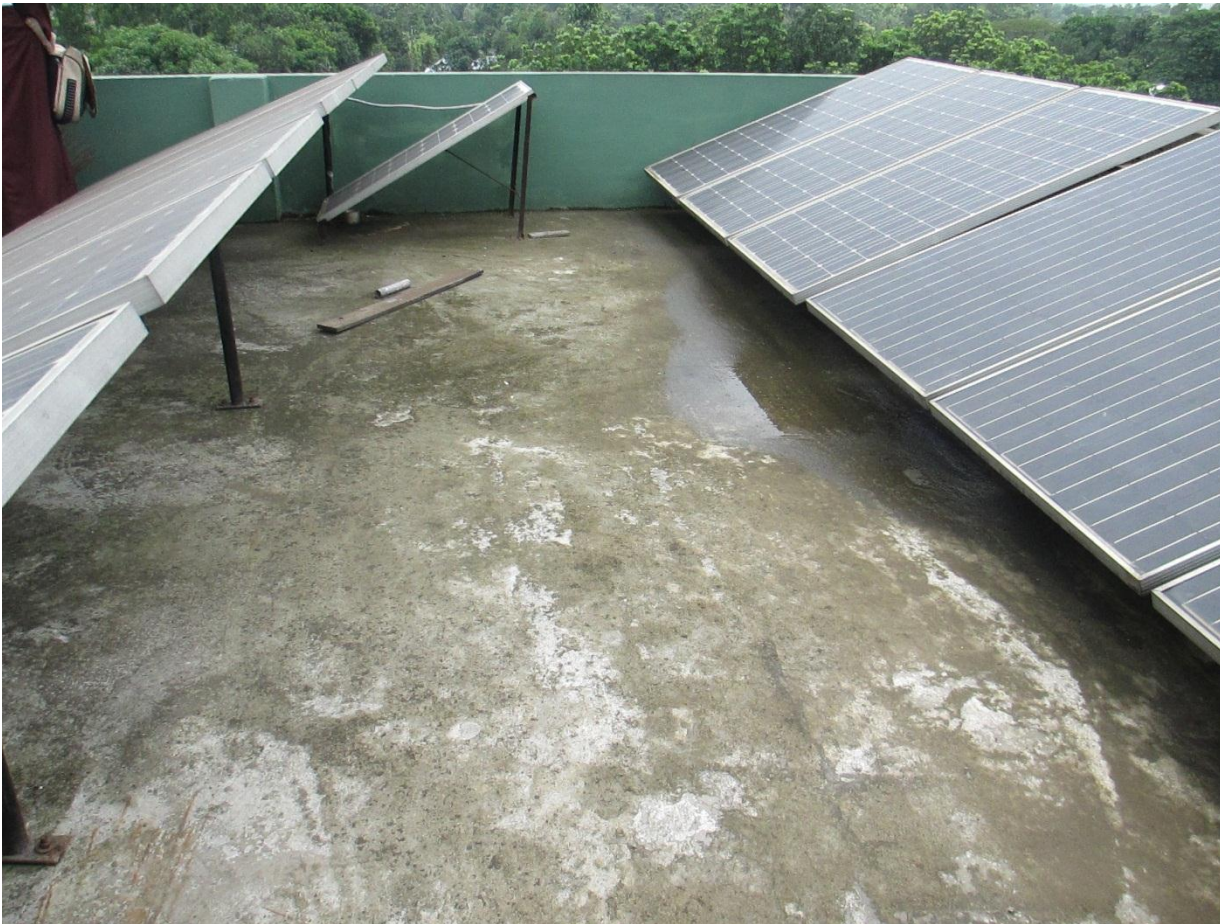
No waterproofing membrane was visible on the roof of the building. This means that any cracks in the surface finishes on the roof will allow water to seep into the concrete slab beneath the finishes, and cause corrosion of the reinforcing steel.
