# SATURN TEXTILES Ltd. (10936)

13/1, Abdus Sattar Master Road, West Gazipura, Tongi, Gazipur  
(+23.920873N, 90.392274E)

06 July.2014

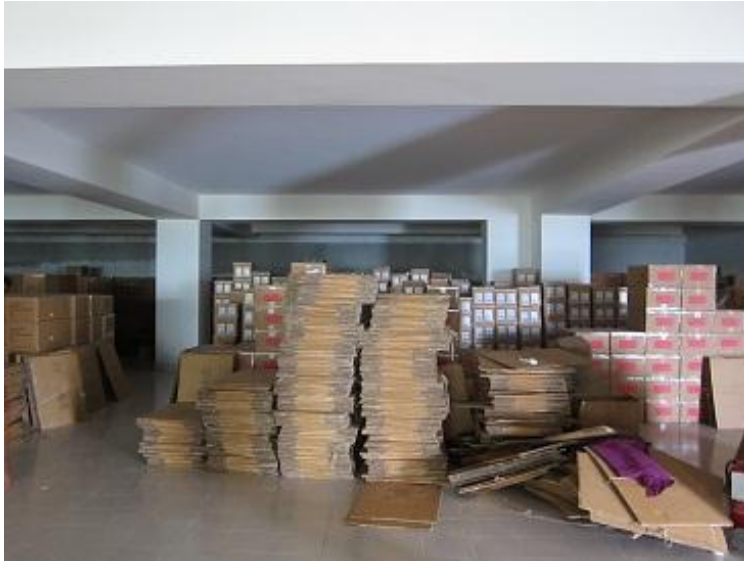
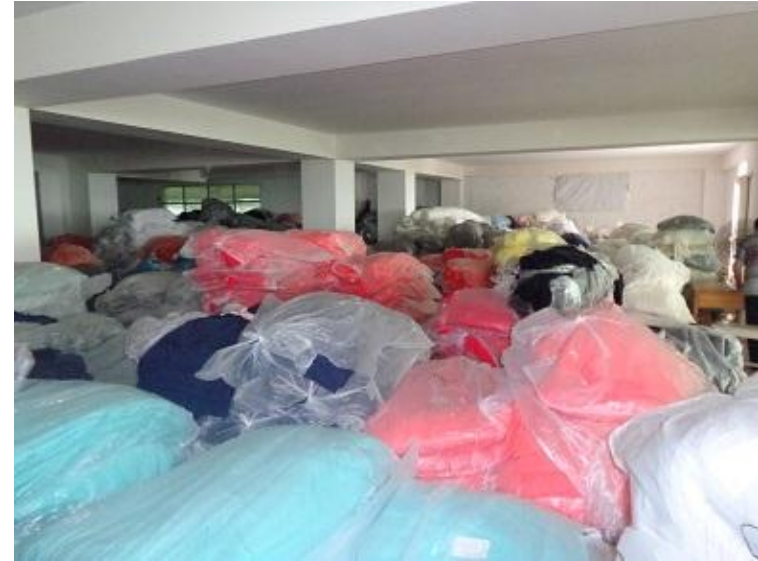
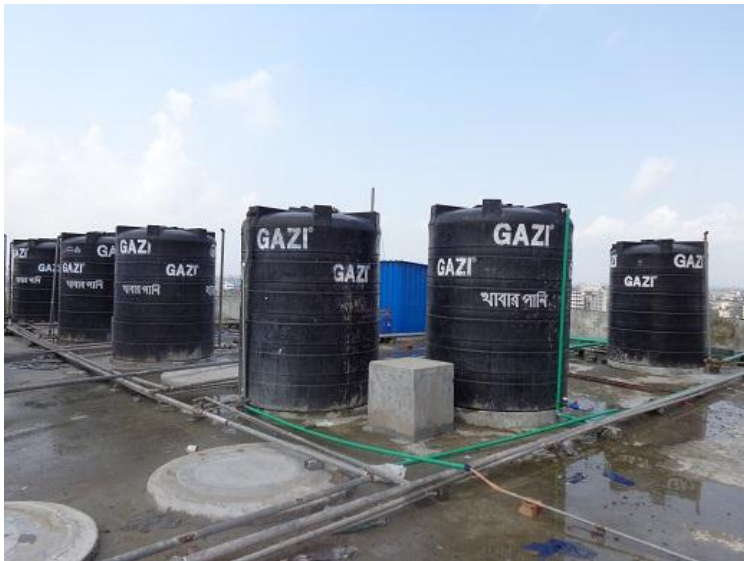
## 1<sup>st</sup> Priority 1 Concern

Column are highly stressed. All storage and floor loads must be immediately reduces to 2,0 kPa.

Item No.	Observation	Recommended Action Plan	Recommended Timeline
1	1st Priority 1 - Highly stressed columns	Carry out a Detailed Engineering Assessment to review the actual column capacity.	Immediate – Now
2	1st Priority 1 - Highly stressed columns	Carry out Detailed Engineering Assessment recommendations.	6-weeks
3	1st Priority 2 - Uncontrolled storage and no loading plans.	Carry out an Engineering Assessment to obtain loading plans for all floors of the building.	6-weeks
4	1st Priority 2 - Uncontrolled storage and no loading plans.	Carry out Engineering Assessment recommendations. Maximum loading in all loading area should be clearly identify.	6-months
5	2nd Priority 2 - Six (6) 5000 L water tanks in close proximity on the roof.	Carry out an Engineering Assessment to verify if the roof is capable of supporting the water tanks.	6-weeks
6	2nd Priority 2 - Six (6) 5000 L water tanks in close proximity on the roof.	Carry out Engineering Assessment recommendations.	6-months

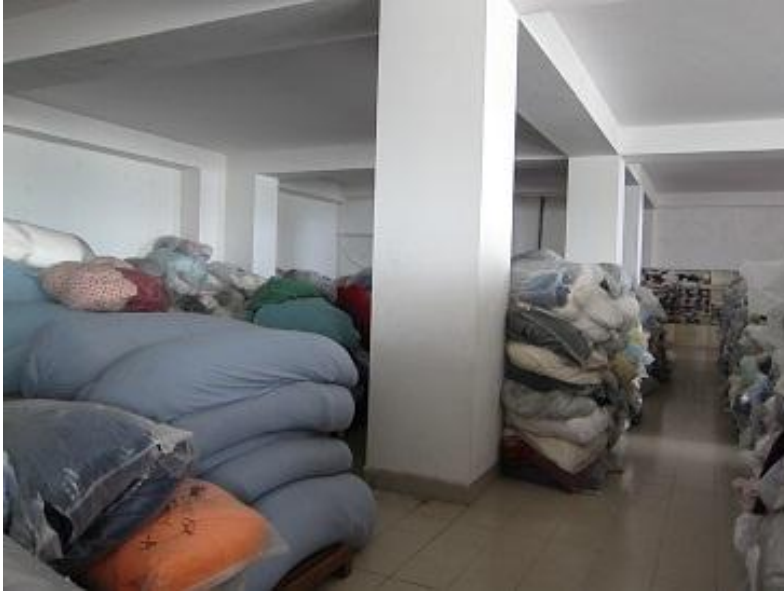
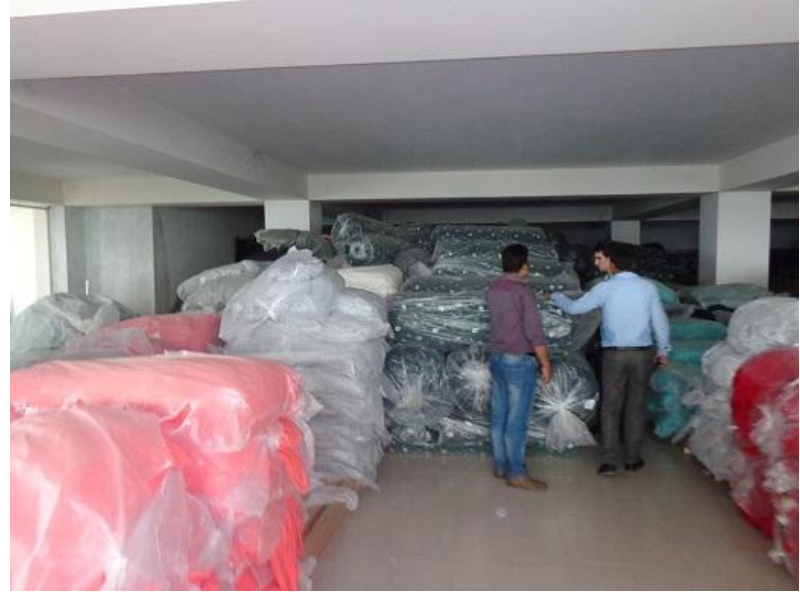
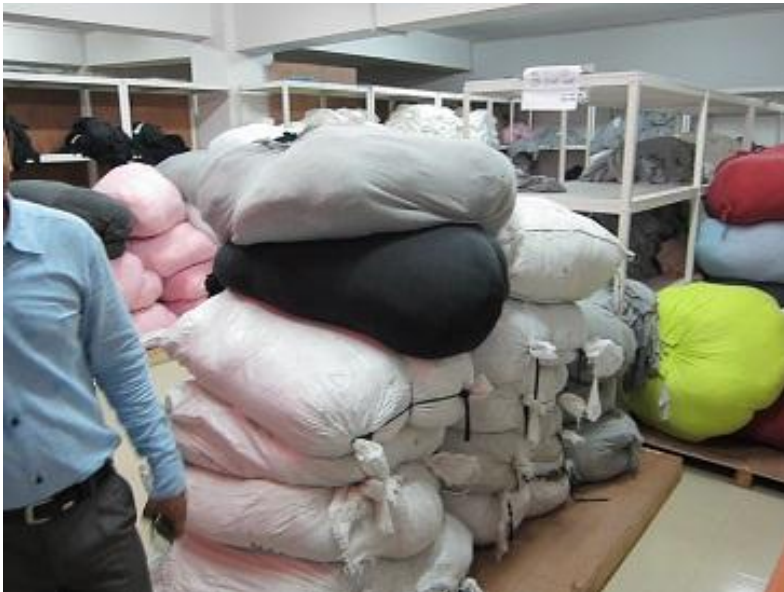
1<sup>st</sup> priority 2 concern

Uncontrolled storage area on several levels. No loading plans exist.

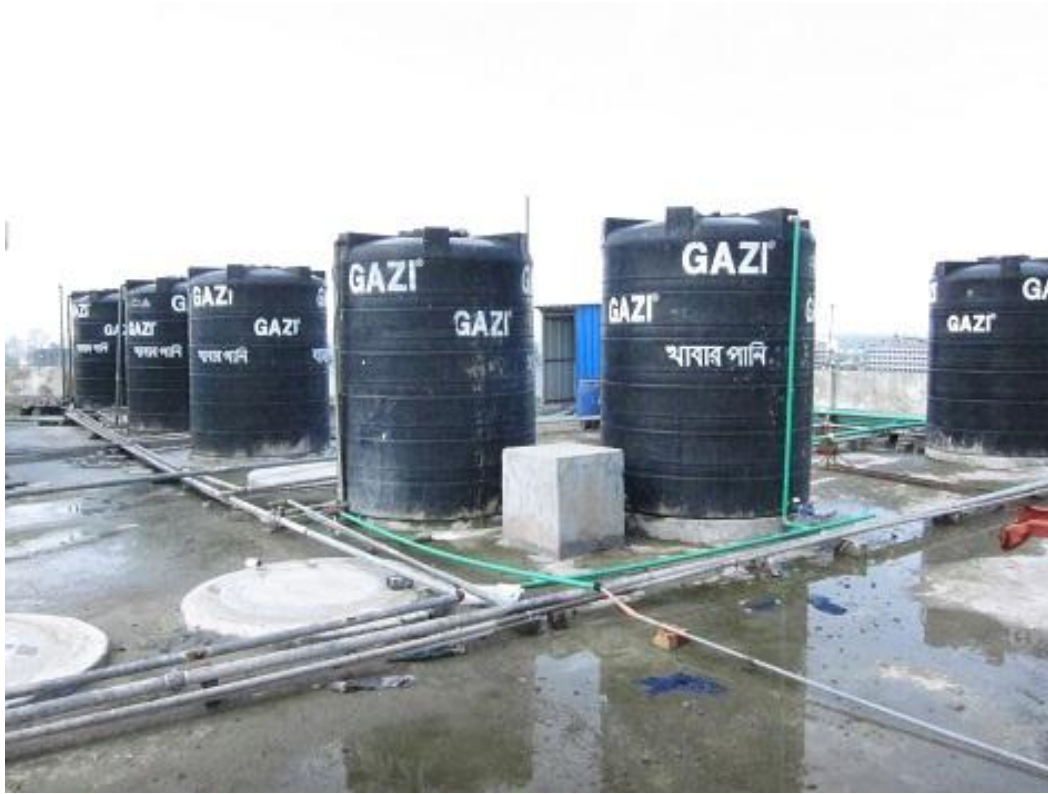
## 2<sup>nd</sup> Priority 2 Concern

Six (6) 5000 L water tanks in close proximity on the roof.

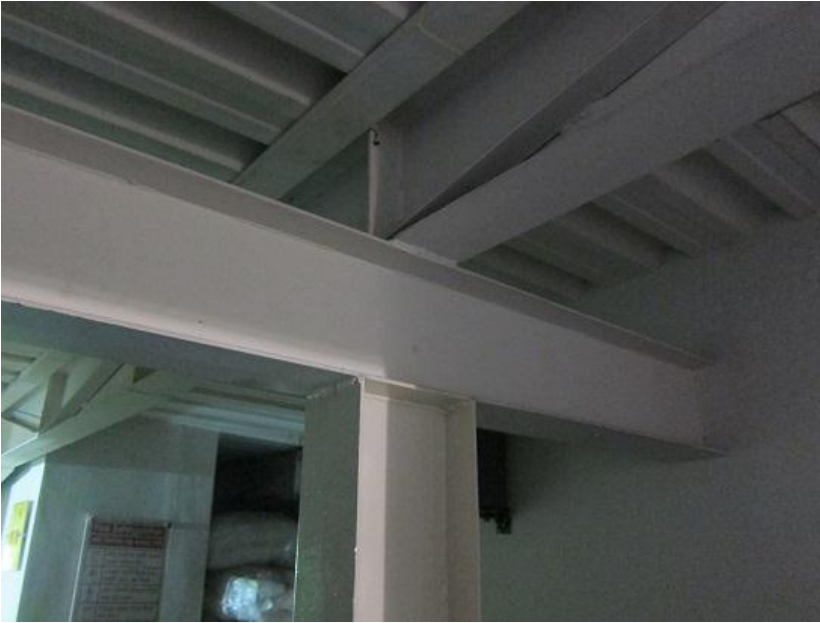
## 1<sup>st</sup> Priority 3 Concern

No fireproofing material was noted on structural steel elements of the mezzanine.

7	1st Priority 3 - No fireproofing on mezzanine steel structure	Fireproofing material for structural steel element is recommended as suggested in BNBC Codes. Maintain standard of quality control and protection of the fire protection.	6-months
8	Overall stability system	Carry out engineering assessment on the building and mezzanines to verify that it is stable under lateral loading as per BNBC seismic and wind load provisions.	6-weeks
9	Overall stability system	Carry out recommendations of engineering assessment.	6-months

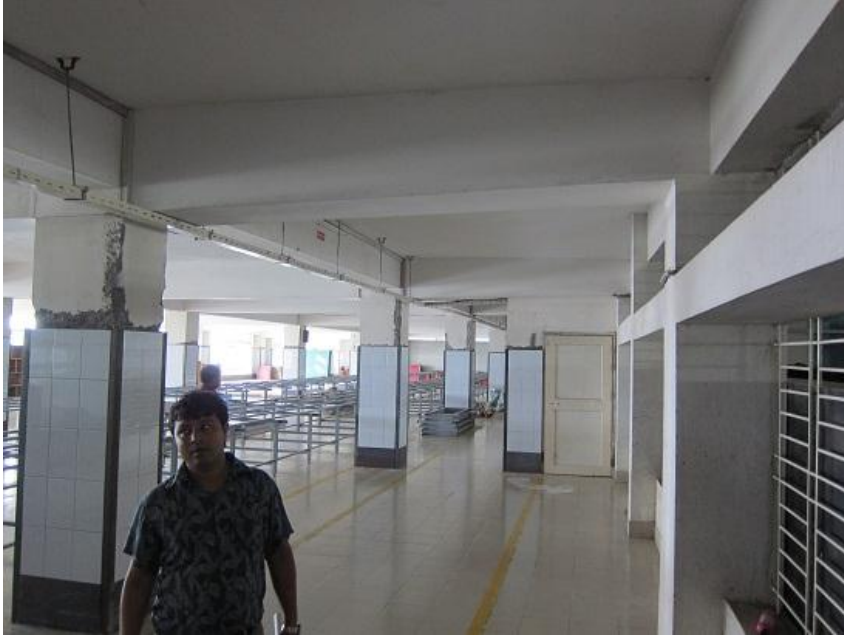
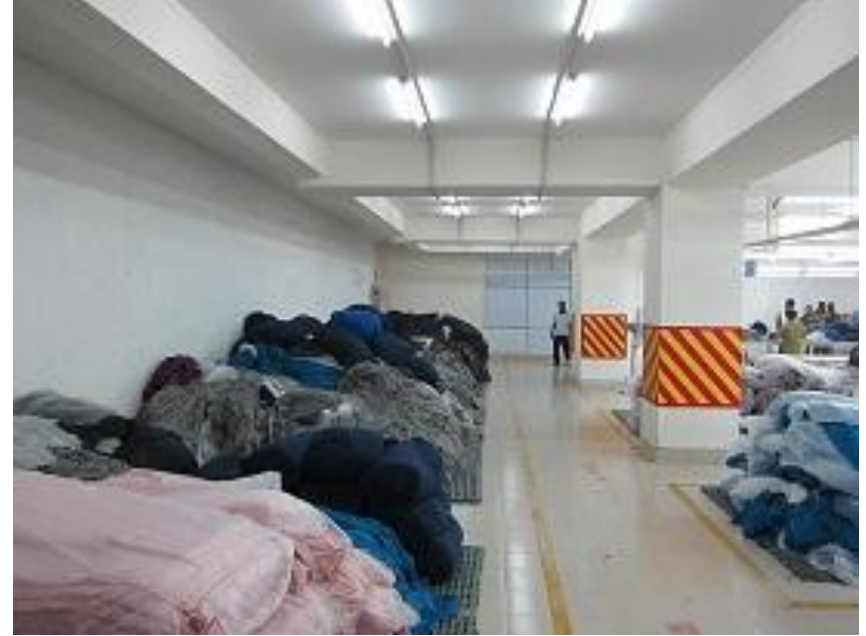
# Overall Stability System

The building did not feature any core or shear walls. Stability was achieved through sway action between beams and columns and masonry infill walls.

We require that these items be investigated in a Detail Engineering Assessment.

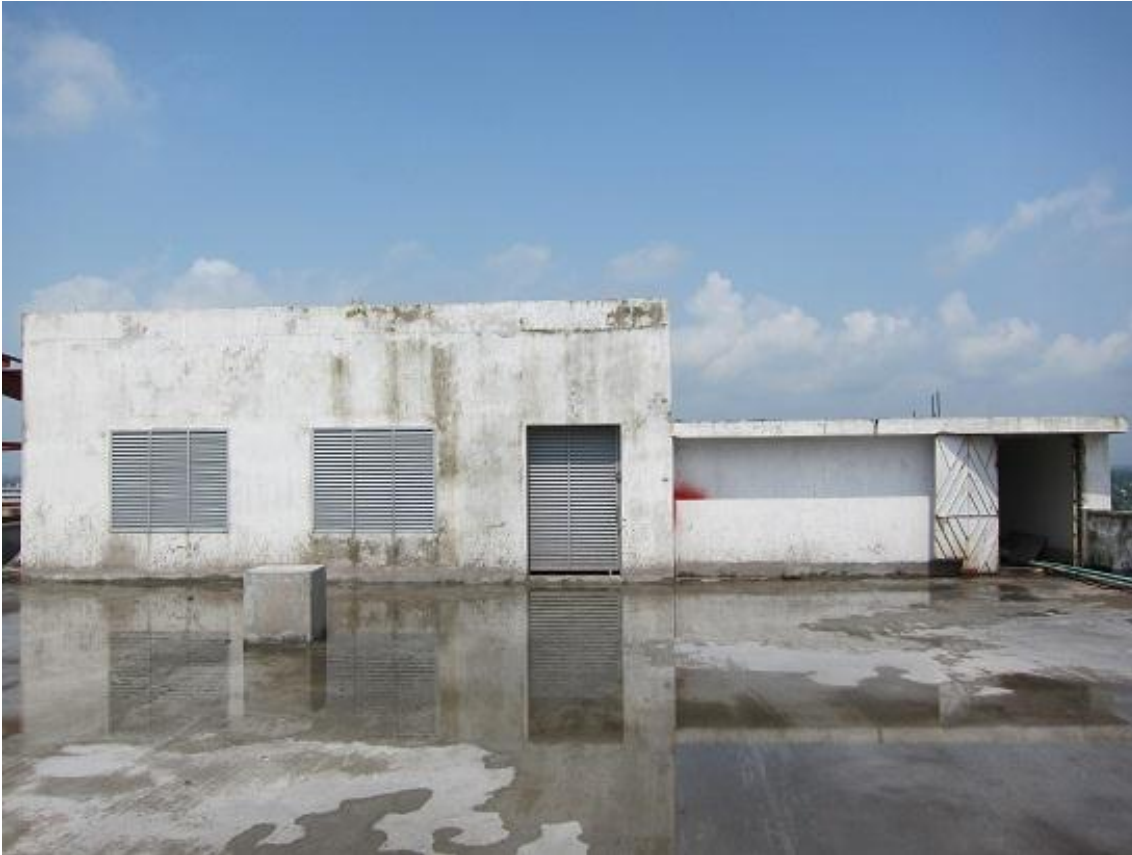
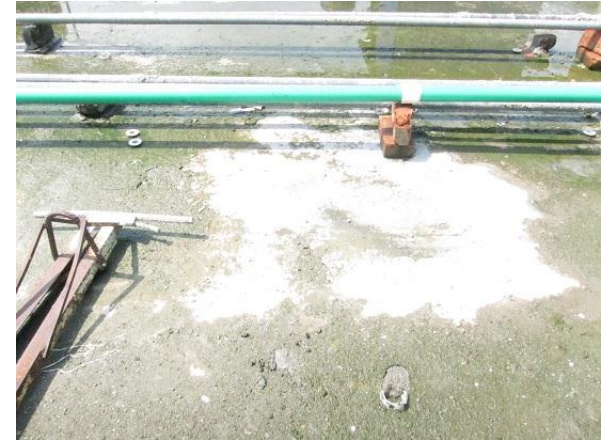
# Water Ingress at Roof Level

No waterproofing membrane was visible on the roof of the building. This means that any cracks in the surface finishes on the roof will allow water to seep into the concrete slab beneath the finishes, and cause corrosion of the reinforcing steel.
